WCAP-12872
Revision 2

J. M. Farley Units 1 and 2
SG Tube Plugging Criteria for
ODSCC at Tube Support Plates

Westinghouse Energy Systems

February 1992

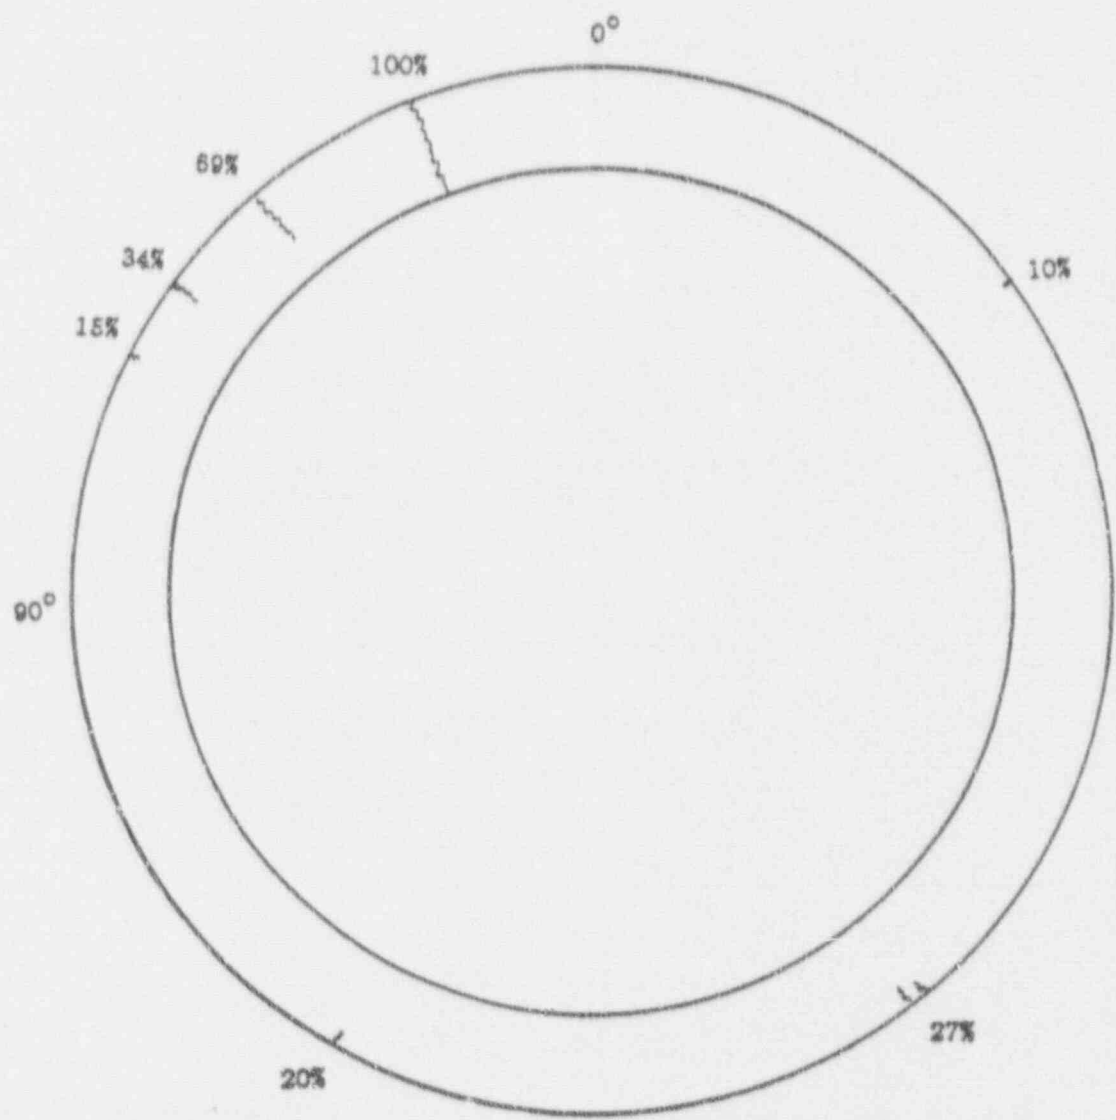
Figure 4 - 10. Sketch of crack distribution and depth within the center of the first support plate intersection in tube R4-C73.

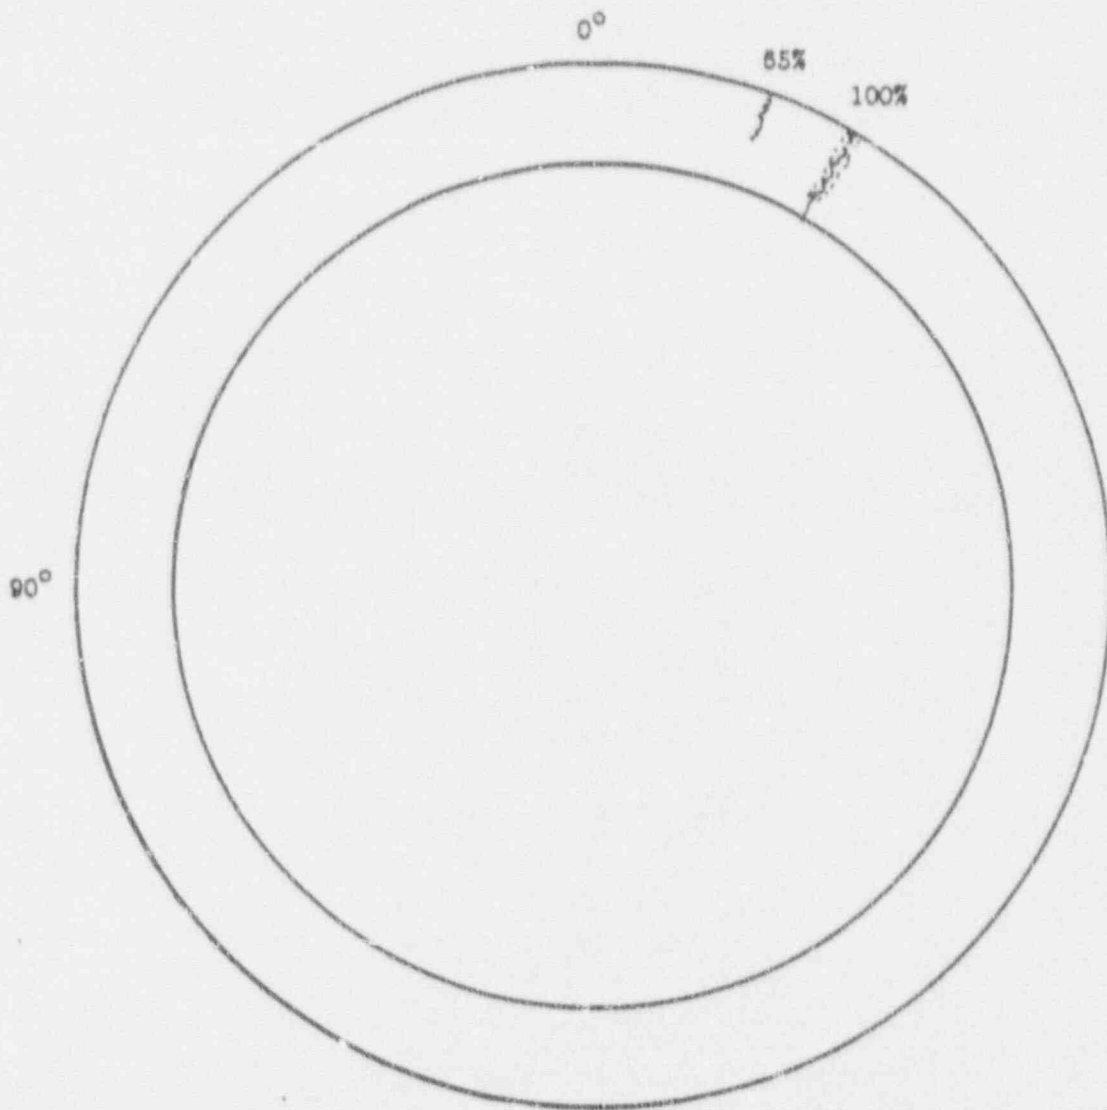
Figure 4 - 13. Sketch of crack distribution and depth within the first support plate crevice region in tube R21-C22.

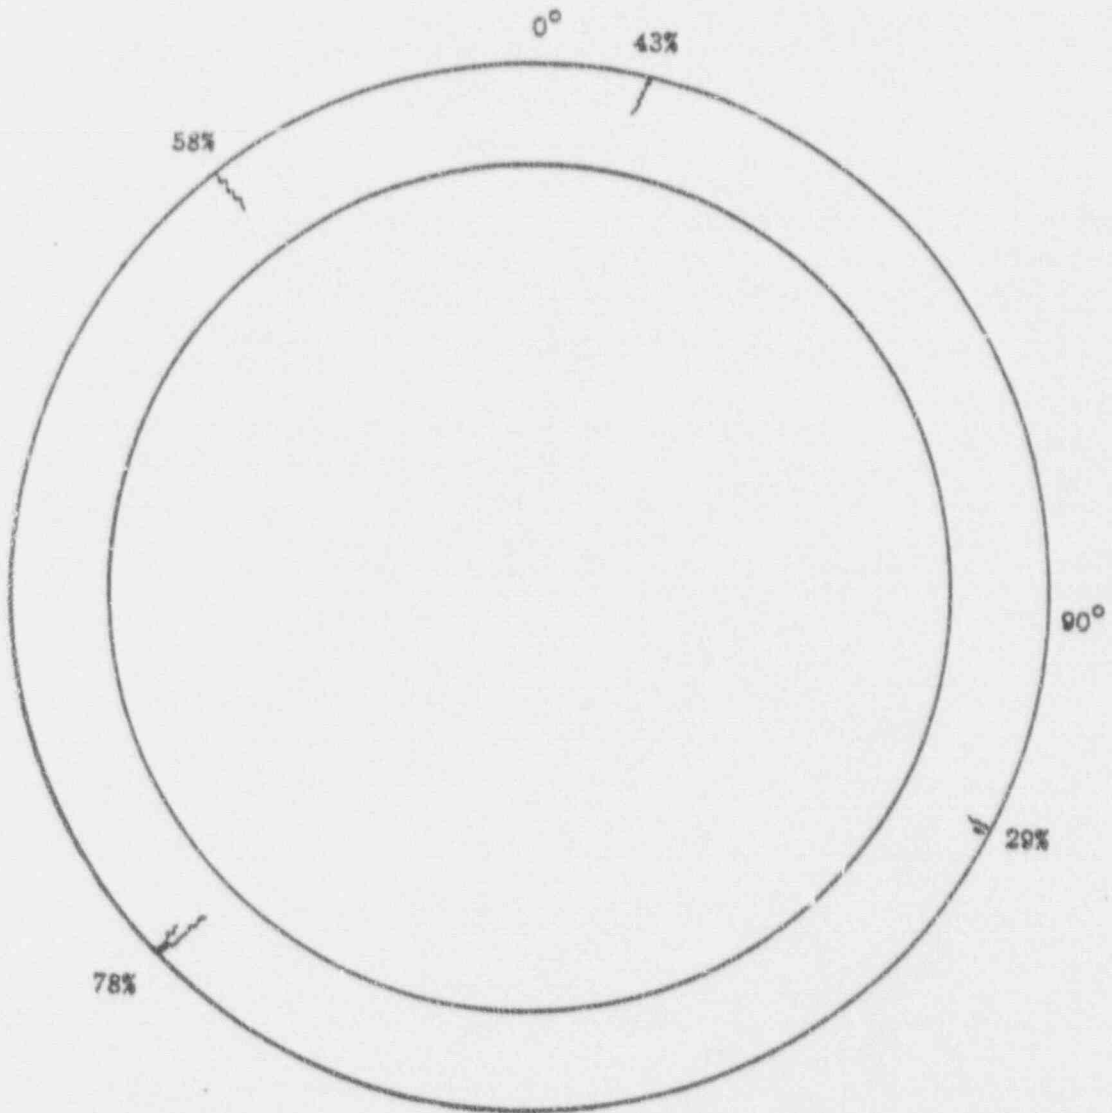
Figure 4 - 16. Summary of distribution and maximum depth of cracks found within the first support plate crevice region of tube R38-C46.

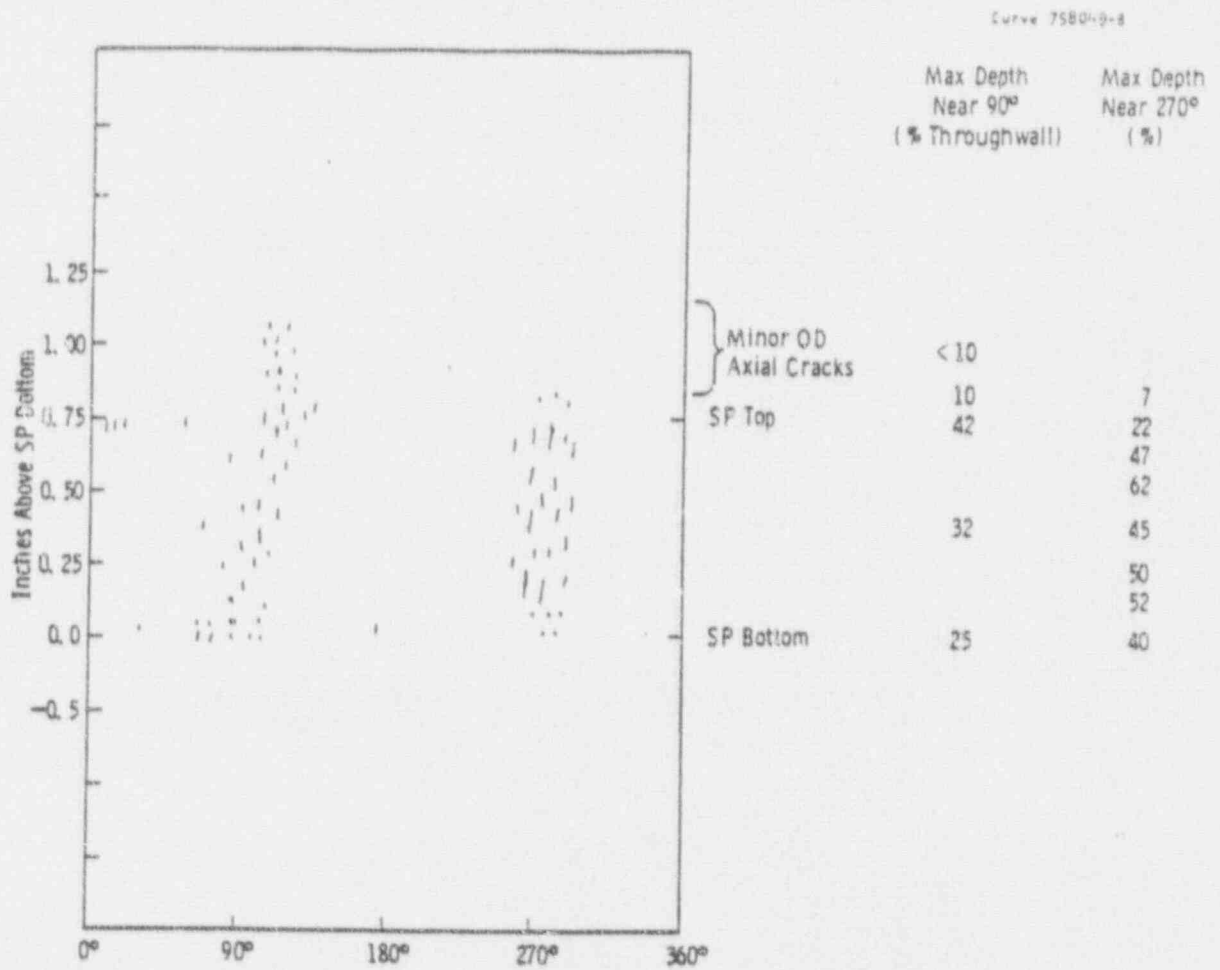
Figure 4 - 21. Crack network location at first support plate region on tube R20-C26 HL.

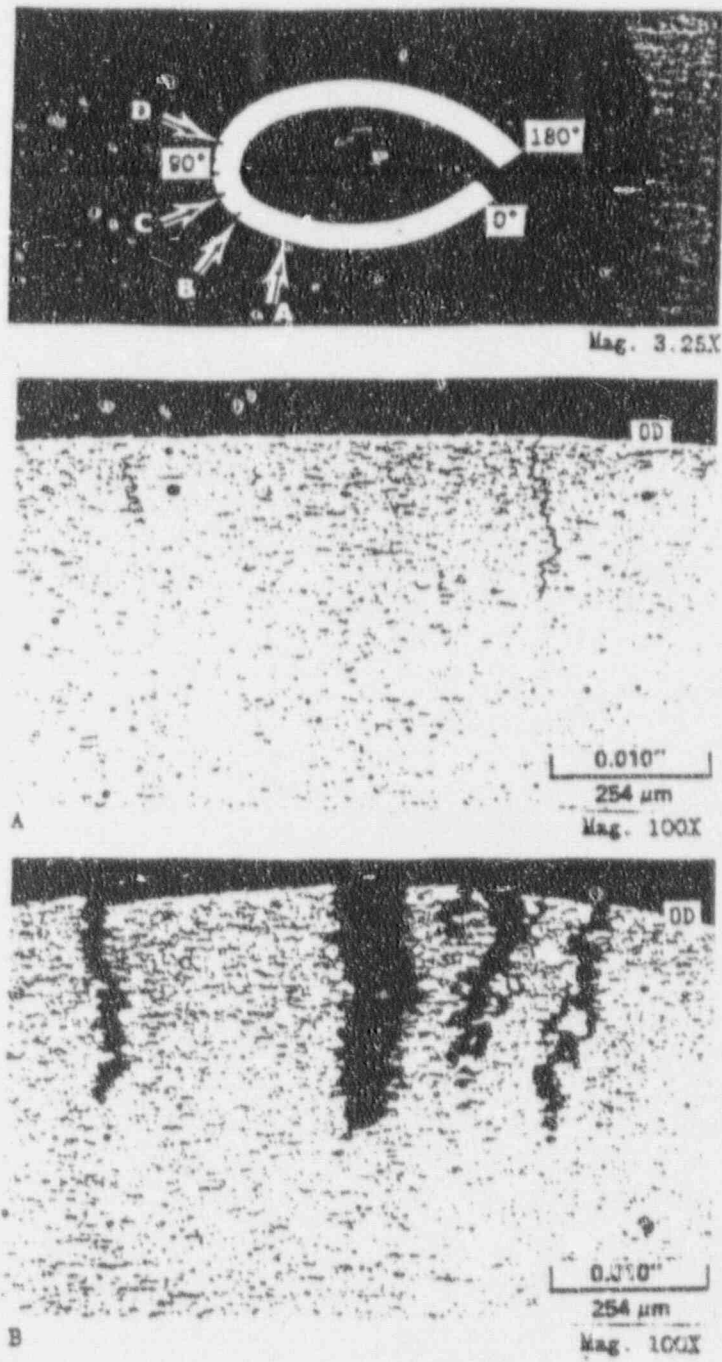
Figure 4 - 22. Transverse metallographic section through tube R20-C26 HL at the mid-point of the first support plate crevice region (90° deformed half) with crack details in Areas A and B.

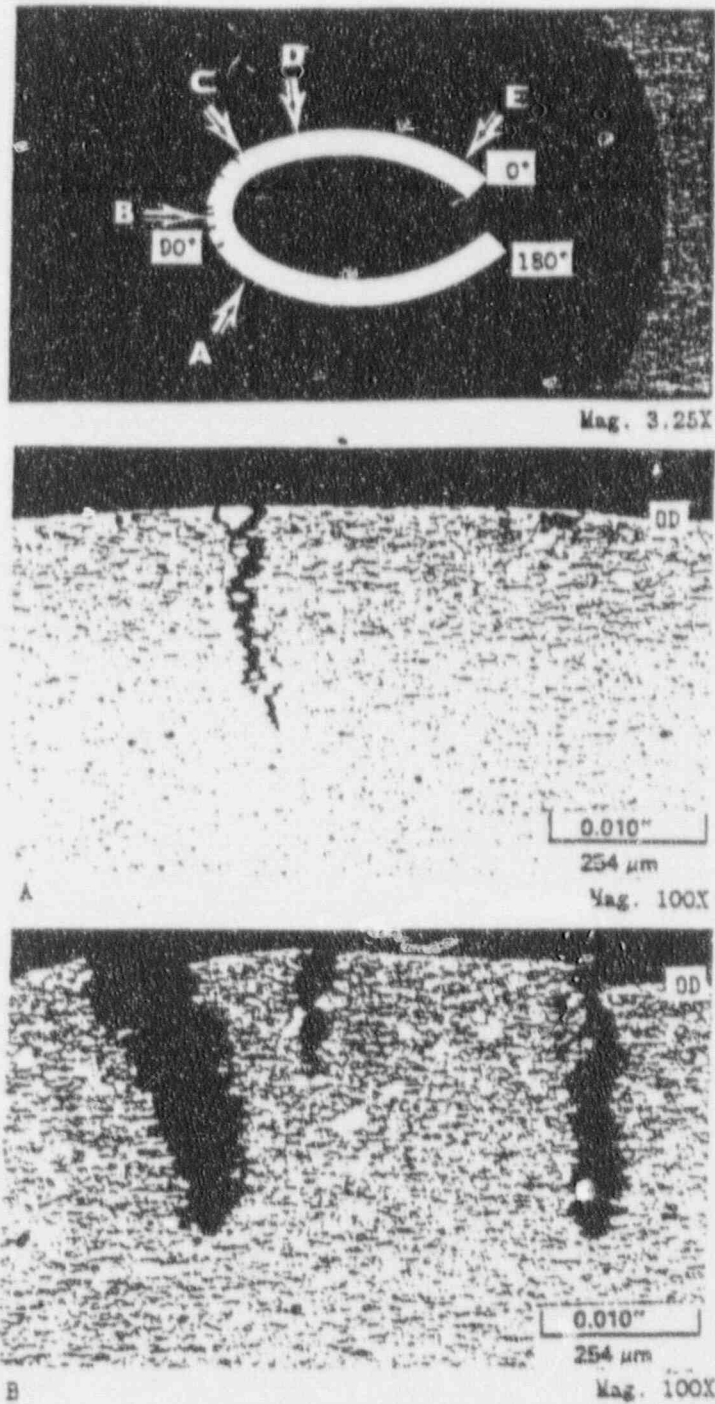
Figure 4 - 23. Transverse metallographic section through Farley-1 tube R20-C26 HL at the first support plate crevice region (90° deformed half) below the support plate crevice top with crack details in Areas A and B.

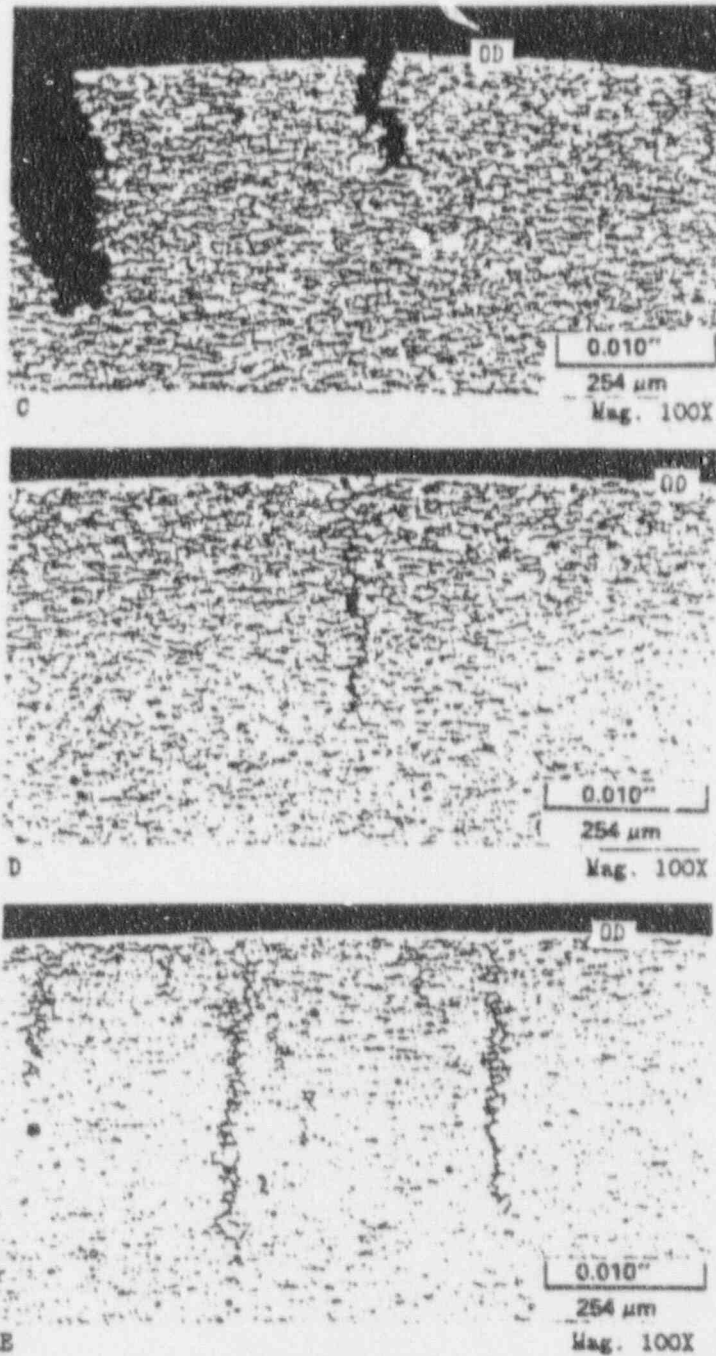
Figure 4 - 24. Crack details in Areas C, D, and E of metallographic cross section shown in previous figure, tube R20-C26 HL, Farley-1.

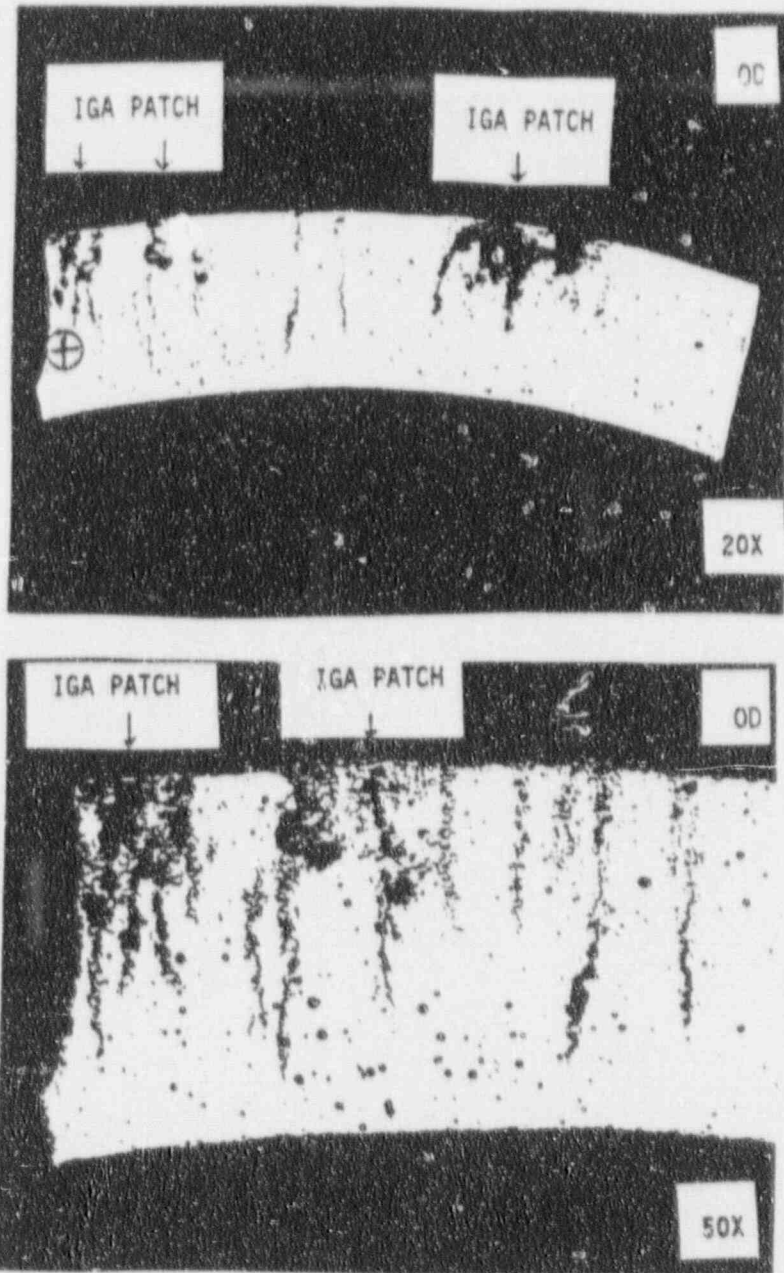
Figure 4 - 25. Transverse optical micrographs obtained just below the circumferential fracture at the center of the support plate. The circumferential location is that where the deepest corrosion was found. The deepest axial IGSCC is 85% through wall and three IGA patches are observed: one 43% through wall and 0.015 inch long, one 33% through wall and 0.05 inch long, and one 28% through wall and 0.015 inch long. The axial IGSCC had IGA aspects to individual cracks. These aspects can be characterized by ratios comparing the crack length (depth from OD surface) to IGA width at the mid-crack location. L/W ratios vary from 6 to 18. Plant L, R12C8

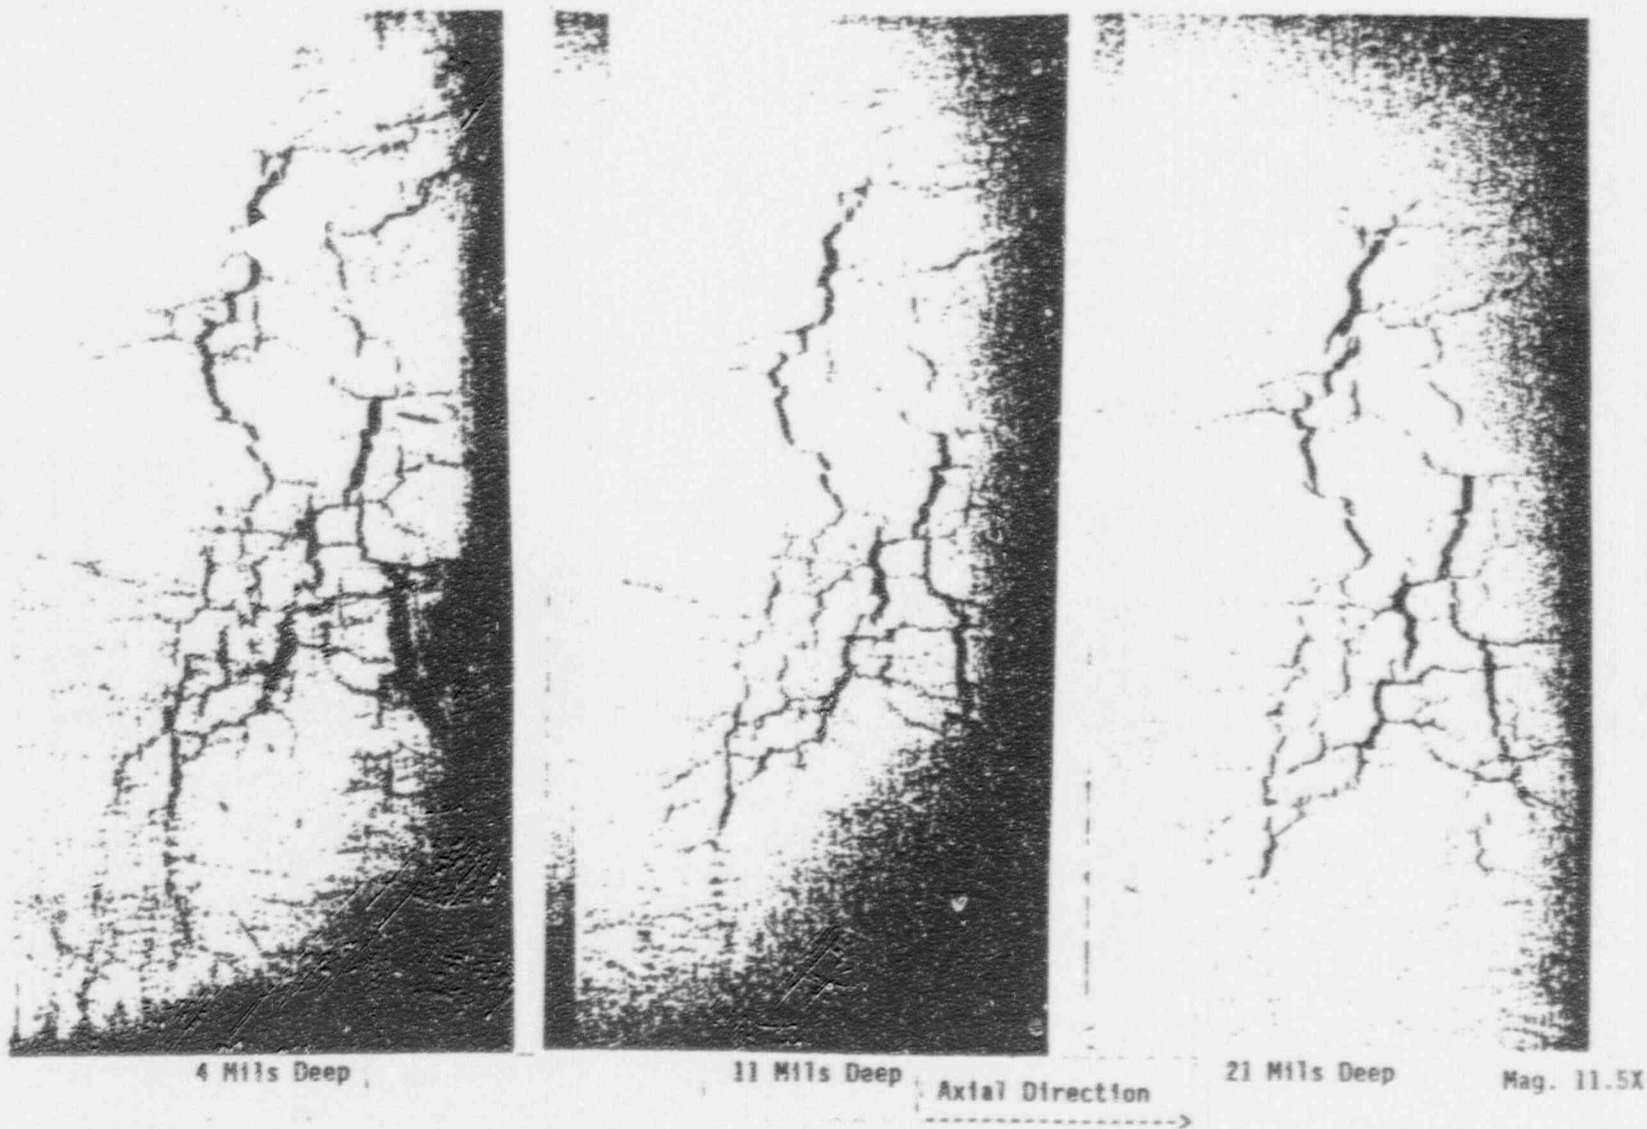
Figure 4 - 26. Photomicrographs of radial metallography performed on a region with axial and circumferential degradation on tube R16-C74, support plate 1. Cellular IGA was found with little change in the cell shape and cell wall thickness at depths of 4, 11 and 21 mils below the OD surface. Note that the cut section was flattened, preferentially opening the circumferential wall of the cells.

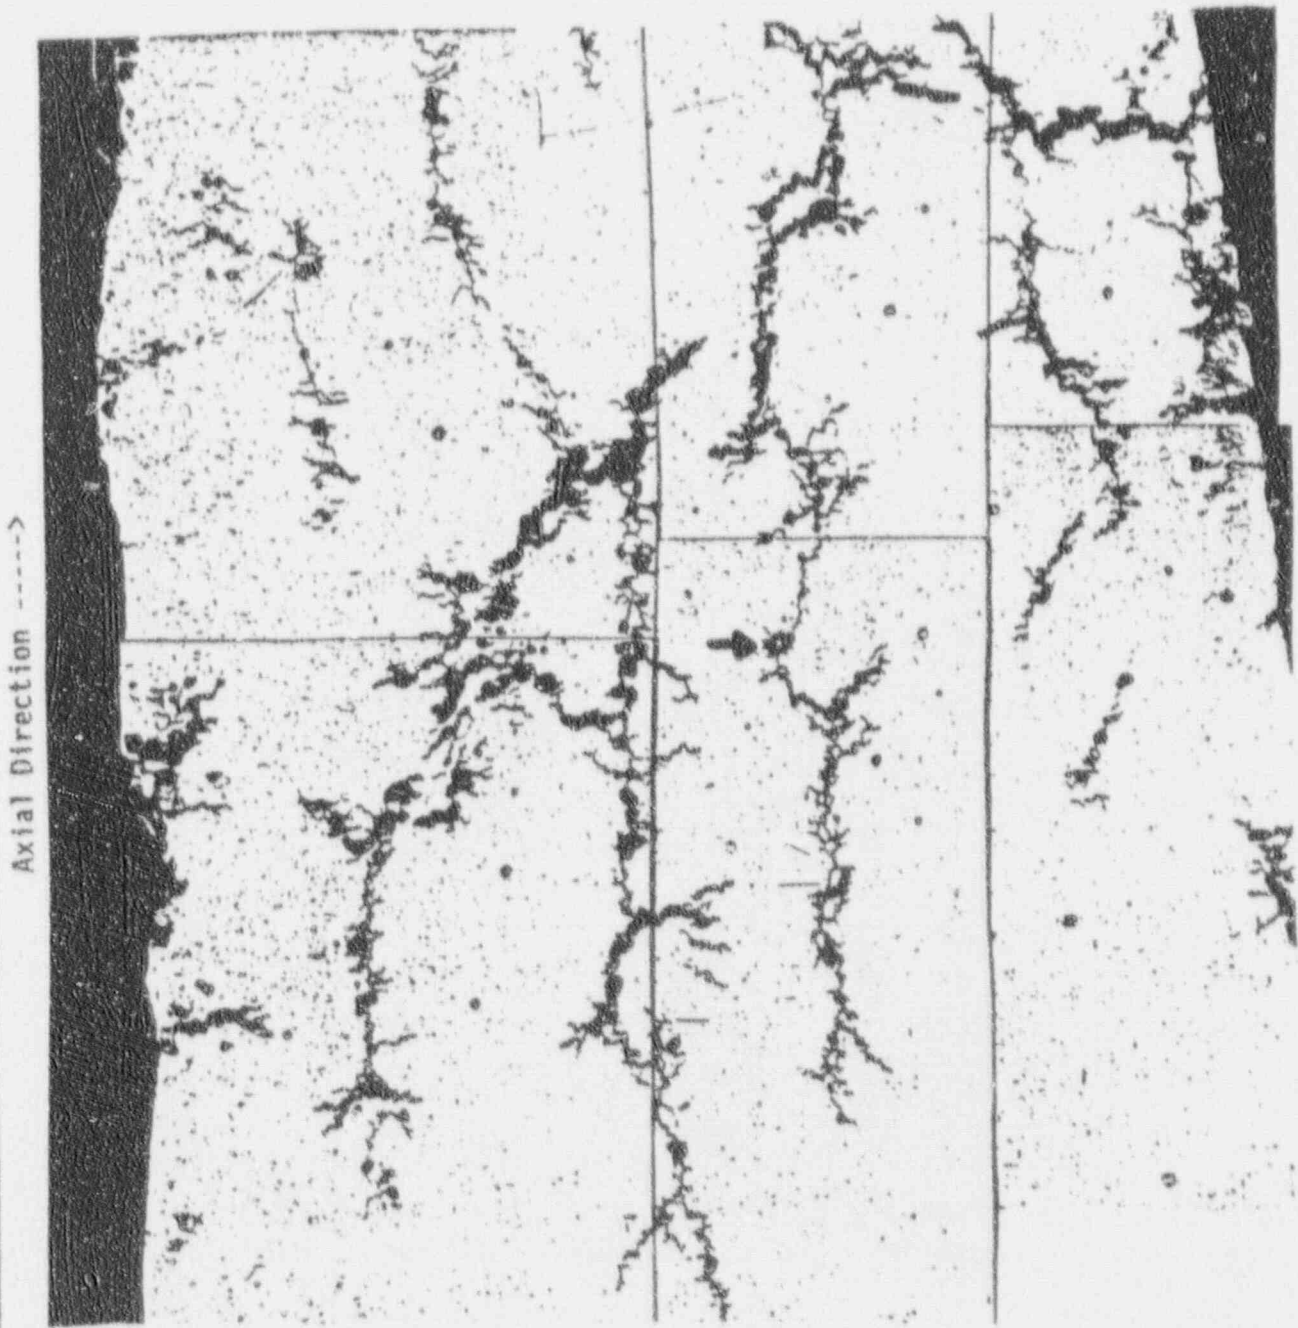
Figure 4-28 Radial metallographic section through a portion of the third support plate crevice region of tube R19-C35 from Plant E-4. A cellular IGA/SCC structure is observed. The depth of the section was not specified.

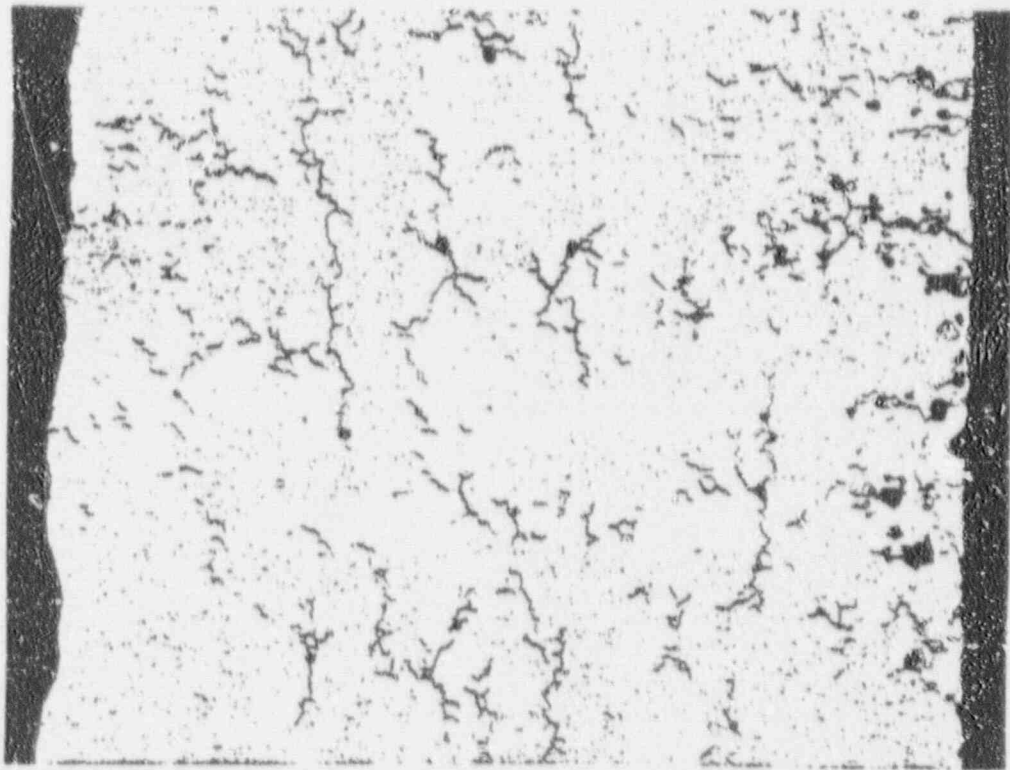
Figure 4-29 Radial metallographic section through a portion of the fourth support plate crevice region of tube R19-C35 from Plant E-4. A cellular IGA/SCC structure is observed. The depth of the section was not specified.

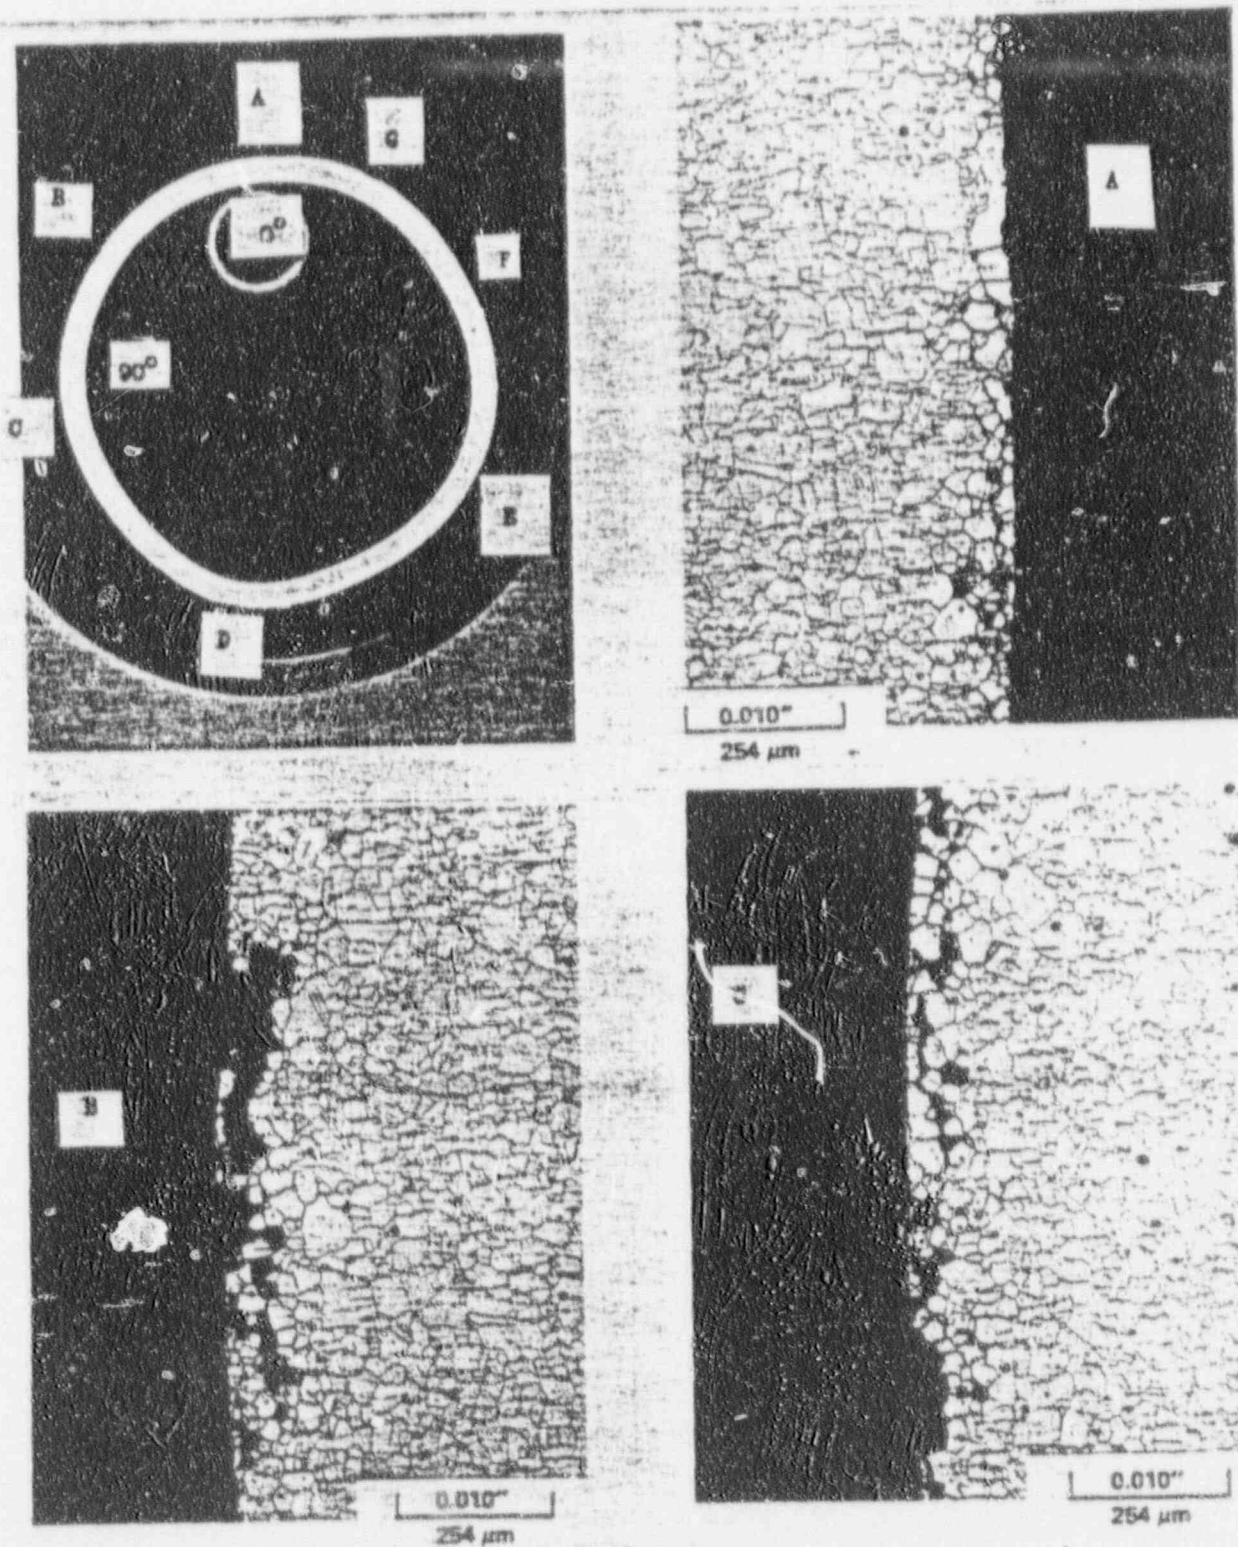
Tube R29-C46 CL, Plant M-2

Figure 4 - 30. Transverse metallography at 0.2 inches above first support plate bottom edge showing almost continuous OD IGA around circumference. Maximum depth is 24%.

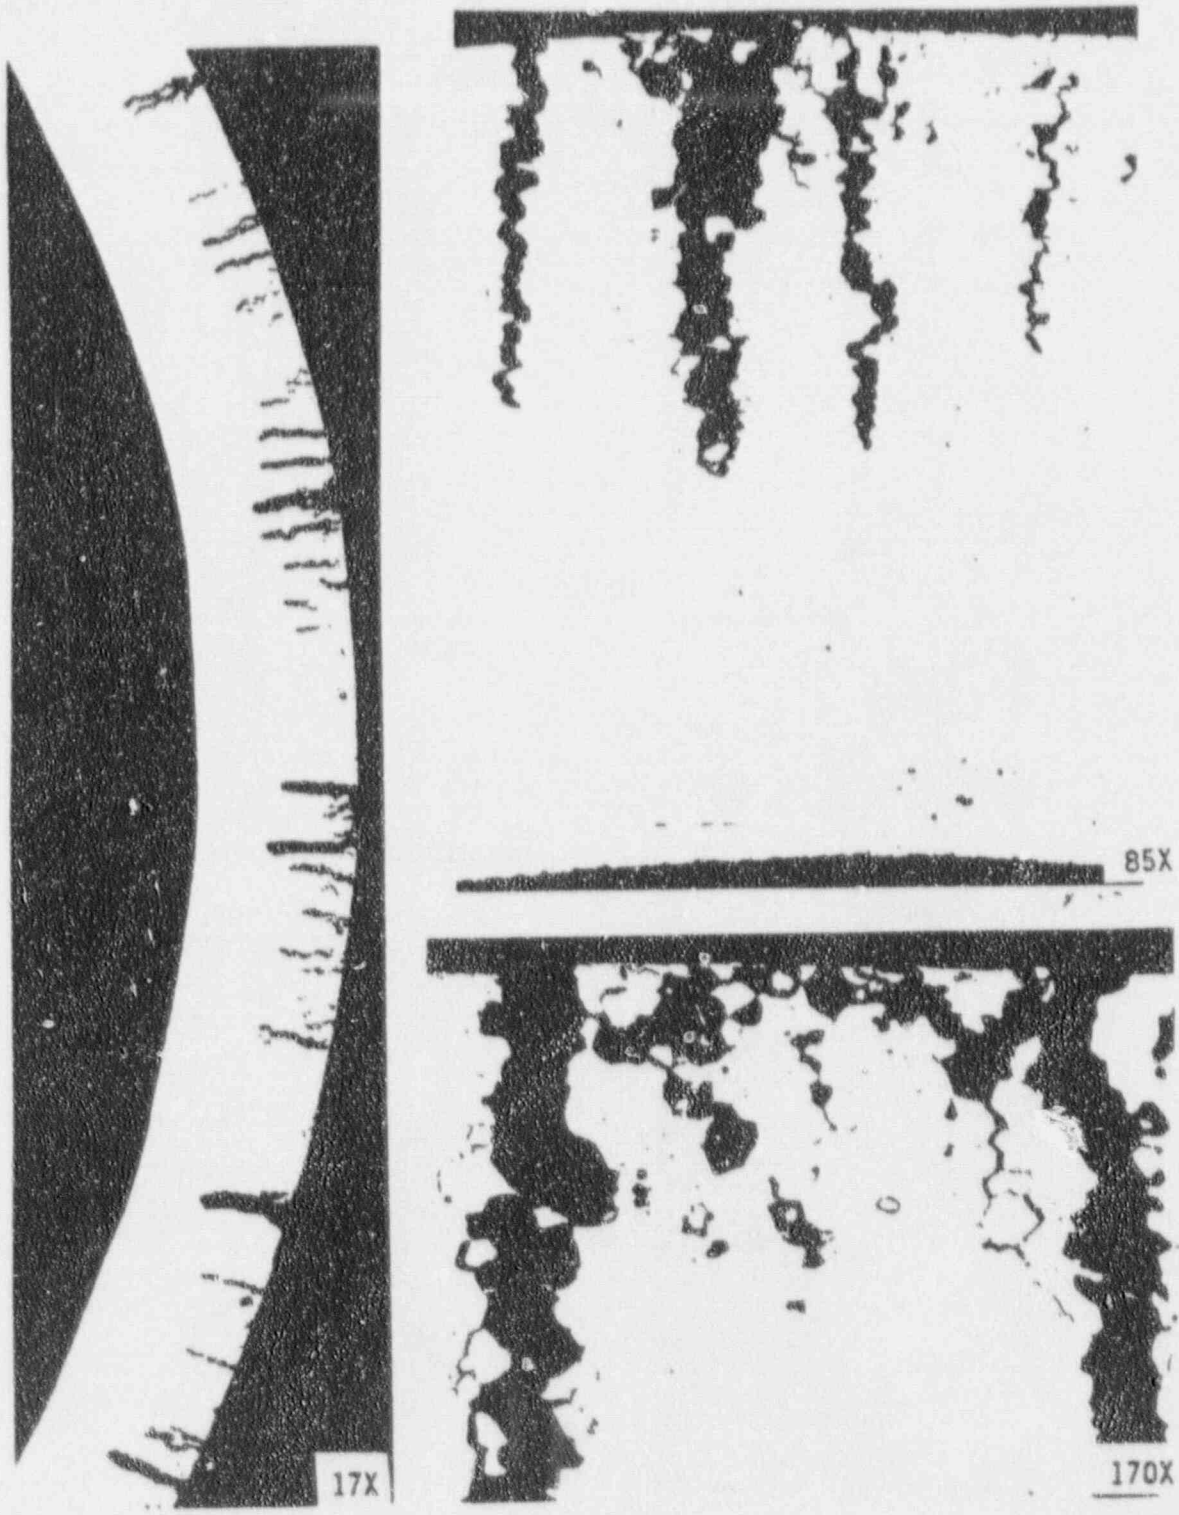
Figure 4 - 32. Transverse photomicrographs of intergranular corrosion at the second support plate region of tube LB-C74 from Plant J-1
