November 13, 1995

2CAN119504

Subject: Arkansas Nuclear One - Unit 2
Docket No. 50-368
License No. NPF-6
Special Report: Steam Generator Tube Surveillance - Category C-3 Results

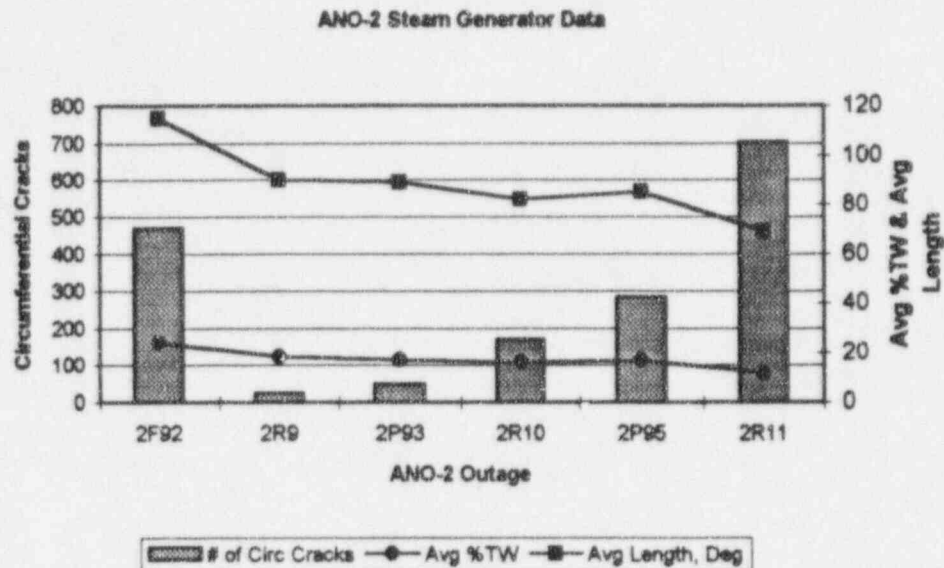
Figure 1

This was the sixth inspection of the ET region with a RECP. The average size (both length and depth) of the cracks has generally decreased in successive outages, as shown in Figure 1. The increased number of circumferential cracks detected may be a result of the advances in eddy current technology. Based on studies performed by Entergy and pulled tubes from other utilities, the threshold of detection of the plus point coil is clearly lower than that of the pancake coil, thus resulting in the detection of smaller indications which would have previously gone undiscovered. The following data illustrates the changes in technology and the corresponding number of indications.

<u>Outage</u>	<u># Cracks</u>	<u>Avg. Length, Deg.</u>	<u>Avg % TW</u>	<u>Detection Probe and Coil</u>
2F92 (3/92)	469	115	24.0	.080 MRPC
2R9 (9/92)	25	90	18.4	.080 MRPC
2P93 (5/93)	48	89	17.2	.080 MRPC
2R10 (3/94)	170	82	16.1	.115 MRPC, low loss cables
2P95 (1/95)	283	85	17.0	.115 MRPC, MIZ-30, low loss cables, terrain maps utilized
2R11 (9/95)	702 *	69	11.6	Plus Point, MIZ-30 App. H settings, low loss cables, terrain maps utilized

* Only includes the hot leg circumferential cracks. Total number including the cold leg is 738. Inclusion of cold leg cracks would reduce avg %TW and avg length values.

The average % TW (average depth) shown above is calculated based on the maximum depth and arc length. Average depth can also be viewed as the crack "area" and is indicative of the structural limit of the flaw. This has been demonstrated by numerous burst tests in the industry and as detailed in a report submitted to the NRC titled "Repair Limit for Circumferential Cracks in Steam Generator Tubing" dated August 28, 1995 (2CAN089507). During the 2R11 examination, the largest crack was determined to be 71% average depth. In terms of structural adequacy to meet Regulatory Guide (RG) 1.121, based on a limiting differential pressure of 4050 psig ($3\Delta P$), a 79% average crack would maintain the required safety margin. This conservative approach takes no credit for partial depth crack extent or ligaments which are expected to be present based on typical stress corrosion crack morphology.

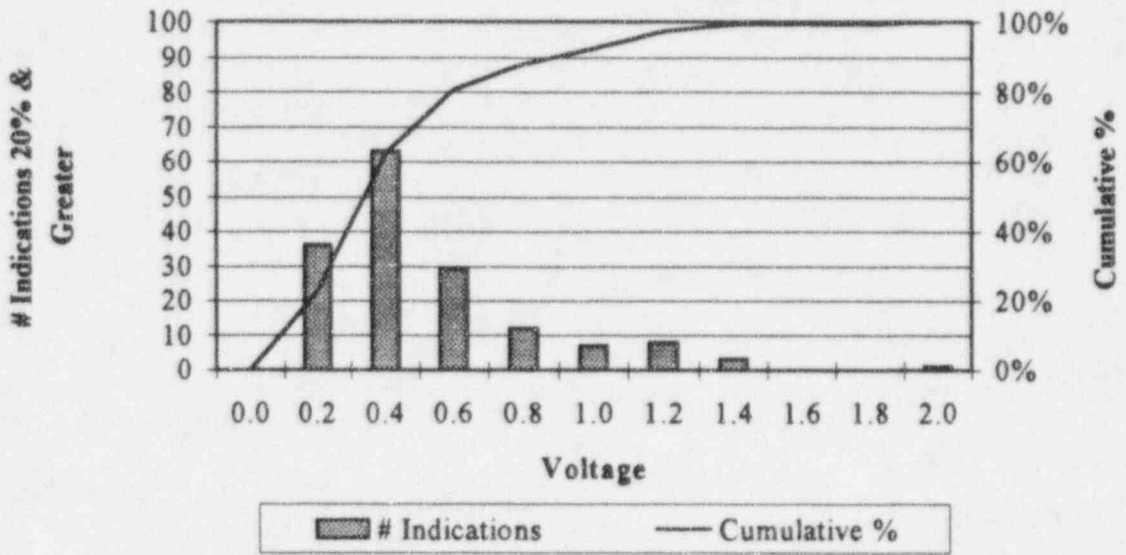
Cracking at eggcrates was first detected at ANO-2 in 1991. Based on the examination results of tubes removed during 2F92, the eggcrate support indications are classified as axially oriented stress corrosion cracking. The cracking can be single cracks or multiple cracks interconnected in the tube within the eggcrate support. The distribution of axial eggcrate cracks 20% and greater is shown in Figure 2 for SGA and Figure 3 for SGB.

**2R11 Bobbin Data
 SG A Eggcrate Crack Amplitude**

In 2R11, the average size of all eggcrate indications 20% and greater was 0.56 volts. While not identical, these voltage readings are comparable to those utilized for cracking at drilled tube support plates at Westinghouse designed plants. Thus, a comparison of burst test data for Westinghouse plants vs. voltage can be made and assessments of structural significance for amplitude values at ANO-2 can be performed. These comparisons show that eggcrate cracks at ANO-2 have historically been structurally insignificant. In addition, burst testing of eggcrate cracks of tubes removed in 1992 from ANO-2 were found to exhibit burst pressures in excess of 8000 psig, which reasonably agrees with the Westinghouse plant data.

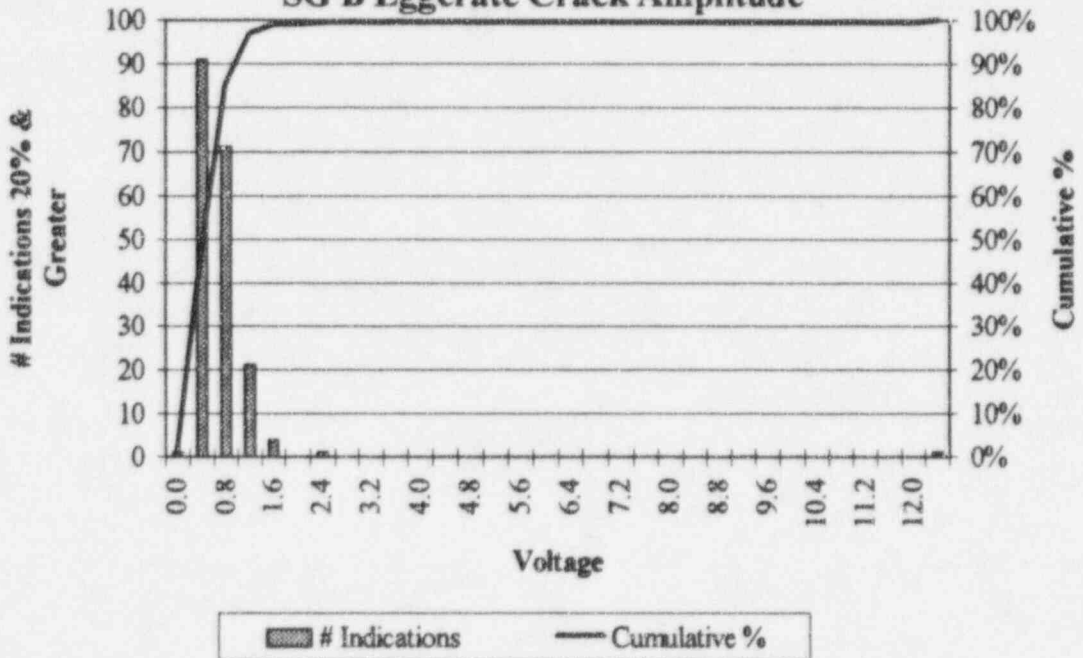
Figure 3

**2R11 Bobbin Data
 SG B Eggcrate Crack Amplitude**

One eggcrate flaw in SGB was found by bobbin and appeared to be an exception based on its size. The flaw was sized by bobbin at 12.21 volts and 86% TW. This flaw was analyzed using the plus point probe and was sized to be 90% TW. Average voltages suggest this was an isolated case. All other flaws exhibited expected results. An in-situ test of this flaw was performed at 3 different pressures as shown below:
