NRC FORM 366 (5-92)		U.S. NUCLEAR REGULATORY COMMISSION  <b>LICENSEE EVENT REPORT (LER)</b>  <small>(See reverse for required number of digits/characters for each block)</small>			<b>APPROVED BY OMB NO. 3150-0104</b> <b>EXPIRES 5/31/95</b>  <small>ESTIMATED BURDEN PER RESPONSE TO COMPLY WITH THIS INFORMATION COLLECTION REQUEST: 50.0 HRS. FORWARD COMMENTS REGARDING BURDEN ESTIMATE TO THE INFORMATION AND RECORDS MANAGEMENT BRANCH (MNBB 7714), U.S. NUCLEAR REGULATORY COMMISSION, WASHINGTON, DC 20555-0001, AND TO THE PAPERWORK REDUCTION PROJECT (3150-0104), OFFICE OF MANAGEMENT AND BUDGET, WASHINGTON, DC 20503.</small>							
FACILITY NAME (1) <b>MONTICELLO NUCLEAR GENERATING PLANT</b>				DOCKET NUMBER (2) <b>05000 - 263</b>		PAGE (3) 1 OF 14						
TITLE (4) <b>Mis-Positioning of Division B Drywell Spray Block Valve</b>												
EVENT DATE (6)			LER NUMBER (6)		REPORT NUMBER (7)			OTHER FACILITIES INVOLVED (8)

FACILITY NAME (1)	DOCKET NUMBER (2)	LER NUMBER (8)			PAGE (3)
		YEAR	SEQUENTIAL NUMBER	REVISION NUMBER	
MONTICELLO NUCLEAR GENERATING PLANT	05000 263	95	007	00	2 of 14

### Description

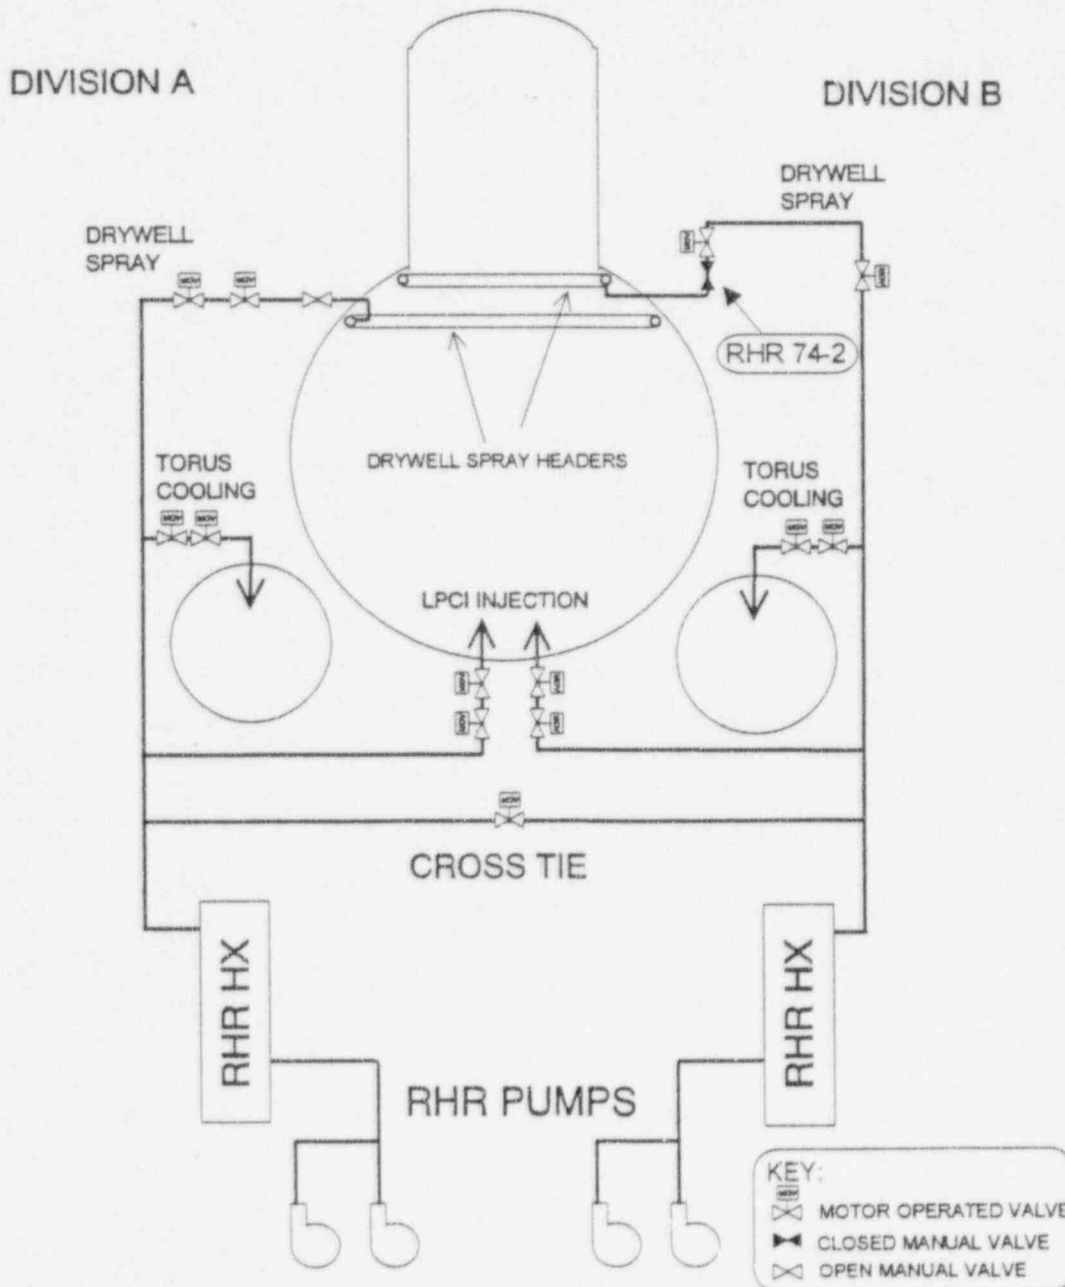
**FIGURE 1 - SIMPLIFIED RHR SYSTEM  
SHOWING AS FOUND CONDITION**

While at 100% power on October 12, 1995, valve RHR 74-2 was found closed and unlocked with a Hold card from the 1994 outage attached to it. RHR 74-2 is the manual Division "B" drywell spray block valve in the Residual Heat Removal (RHR)(EHS System Code:BO) system. It is required to be locked open at power. This error was discovered during on-line maintenance activities on the RHR system.

RHR 74-2 is located outside the drywell between the RHR Drywell Spray motor operated valves and the spray header inside the drywell (See Figure 1). RHR 74-2 is in the reactor water cleanup pump area, near the reactor water cleanup line which makes the area a high radiation area. The valve is a 10" rising stem valve, with no remote indication. Its closure blocks one of two paths for drywell spray to be injected into the drywell atmosphere.

RHR 74-2 was mis-positioned as a result of personnel errors. An investigation team has interviewed all personnel involved, and has done an extensive review of all associated documents, logs, procedures and work packages. The results have been reviewed by a working level committee, a management oversight committee and the quality services group. Other associated events have been reviewed for applicability. The investigation has not identified the exact cause of the event; however, a most probable scenario has been determined and is discussed below.

1. The hold card was removed from RHR 74-2 on October 12, 1995, and the valve was opened and locked in the open position.
2. All locked valves outside the inerted drywell have been verified to be locked in their proper position.

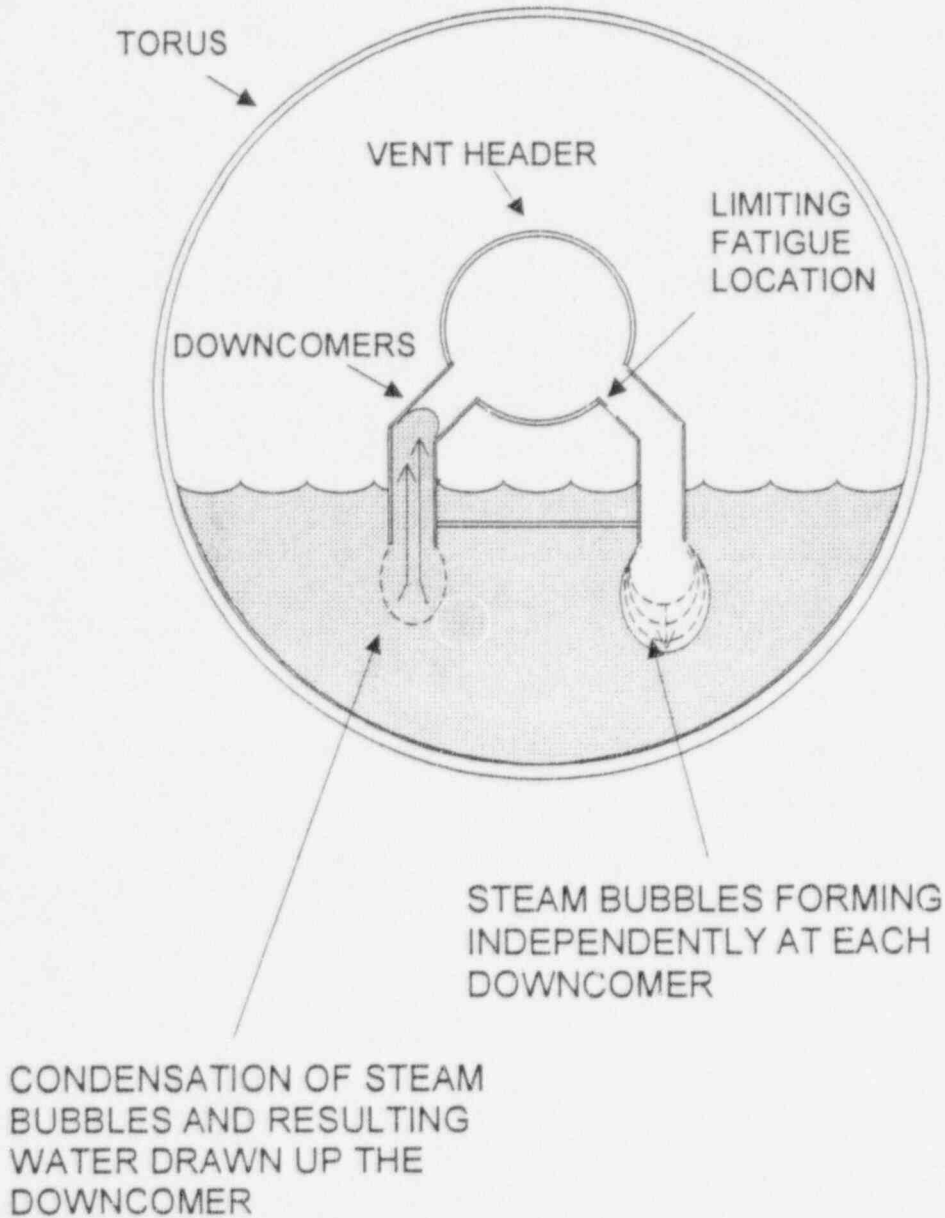
**FIGURE 2 - CHUGGING IN THE TORUS**

Chugging loads are the cyclic stresses caused by condensation of steam at the downcomer openings of the drywell vents. When a steam bubble collapses at the exit of the downcomers, the rush of water drawn into the downcomers to fill the void induces stress at the junction of the downcomers and the vent header (See Figure 2). Repeated application of such stresses could cause fatigue failure of the joints, thereby creating a direct path between the drywell and the torus airspace. Use of the drywell sprays in accordance with the Emergency Operating Procedures limits the fatigue stress cycles to ensure that no vent header failures occur.

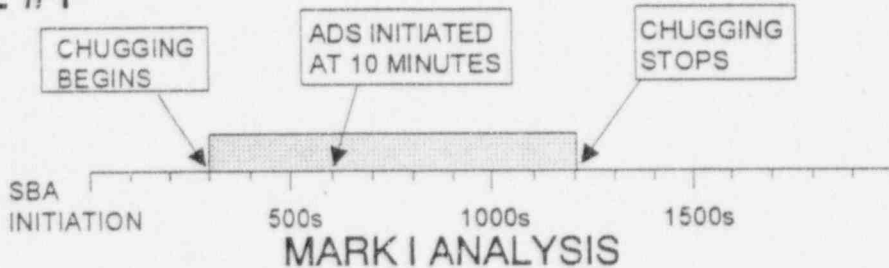
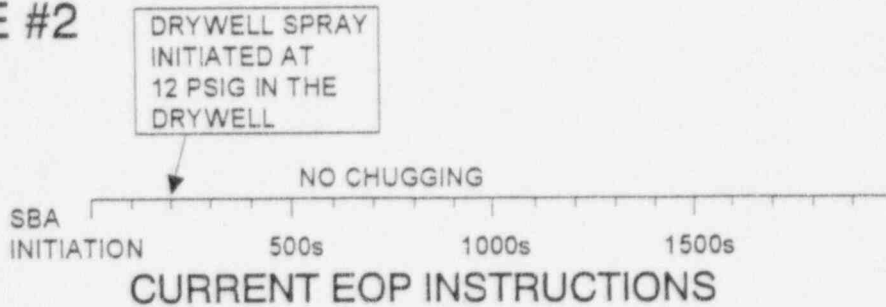
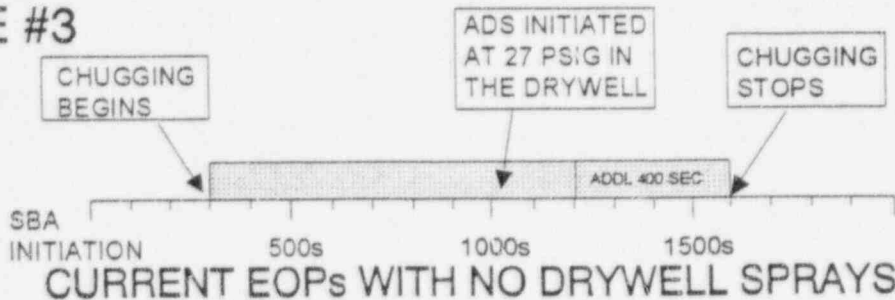
**FIGURE 3 - VENT SYSTEM CHUGGING**

No failures of suppression pool (torus) structures would have occurred during the limited time when both divisions of drywell spray were isolated, even if the drywell sprays were not restored. For a small break accident, the Mark I analysis predicts that chugging loads start 300 seconds following the initiation of the event (See Figure 3, Case #1). At 600 seconds (10 minutes) following the initiation of the event, reactor depressurization is assumed to be manually initiated. Chugging loads are assumed to be terminated at 1200 seconds. Since the completion of the Mark I evaluations, the Emergency Procedure Guidelines were changed such that chugging loads are terminated by the initiation of drywell sprays. Monticello's Emergency Operating Procedures would have drywell sprays initiated at 12 psig, which would occur approximately 220 seconds following the initiation of the small break accident (See Figure 3, Case #2). With the drywell sprays initiated at 220 seconds, chugging loads would be eliminated and the Mark I analysis is conservative. If a small break accident would have occurred when both subsystems of the drywell sprays were inoperable, the Emergency Operating Procedures would have directed the operators to depressurize the reactor at 27 psig in the drywell (See Figure 3, Case #3). This is identical to the action assumed in the Mark I analysis, but it would occur at a later time than assumed in the Mark I analysis. The primary containment response to a small break accident indicates that 27 psig would be reached at approximately 1000 seconds following the initiation of the event. Reactor depressurization would have been initiated 400 seconds later ( $1000 - 600 = 400$  sec). The additional 400 seconds of chugging loads have been analyzed and the limiting fatigue usage factor has been determined to meet code requirements. Thus, without drywell sprays no fatigue failure would occur.
