MIDLAND PLANT UNITS 1 AND 2  
BECHTEL JOB 7220

WELL OBS-4 SUBSIDENCE REPORT

Prepared by Steven W. Hunt  
Reviewed by John E. Anderson  
June 11, 1982

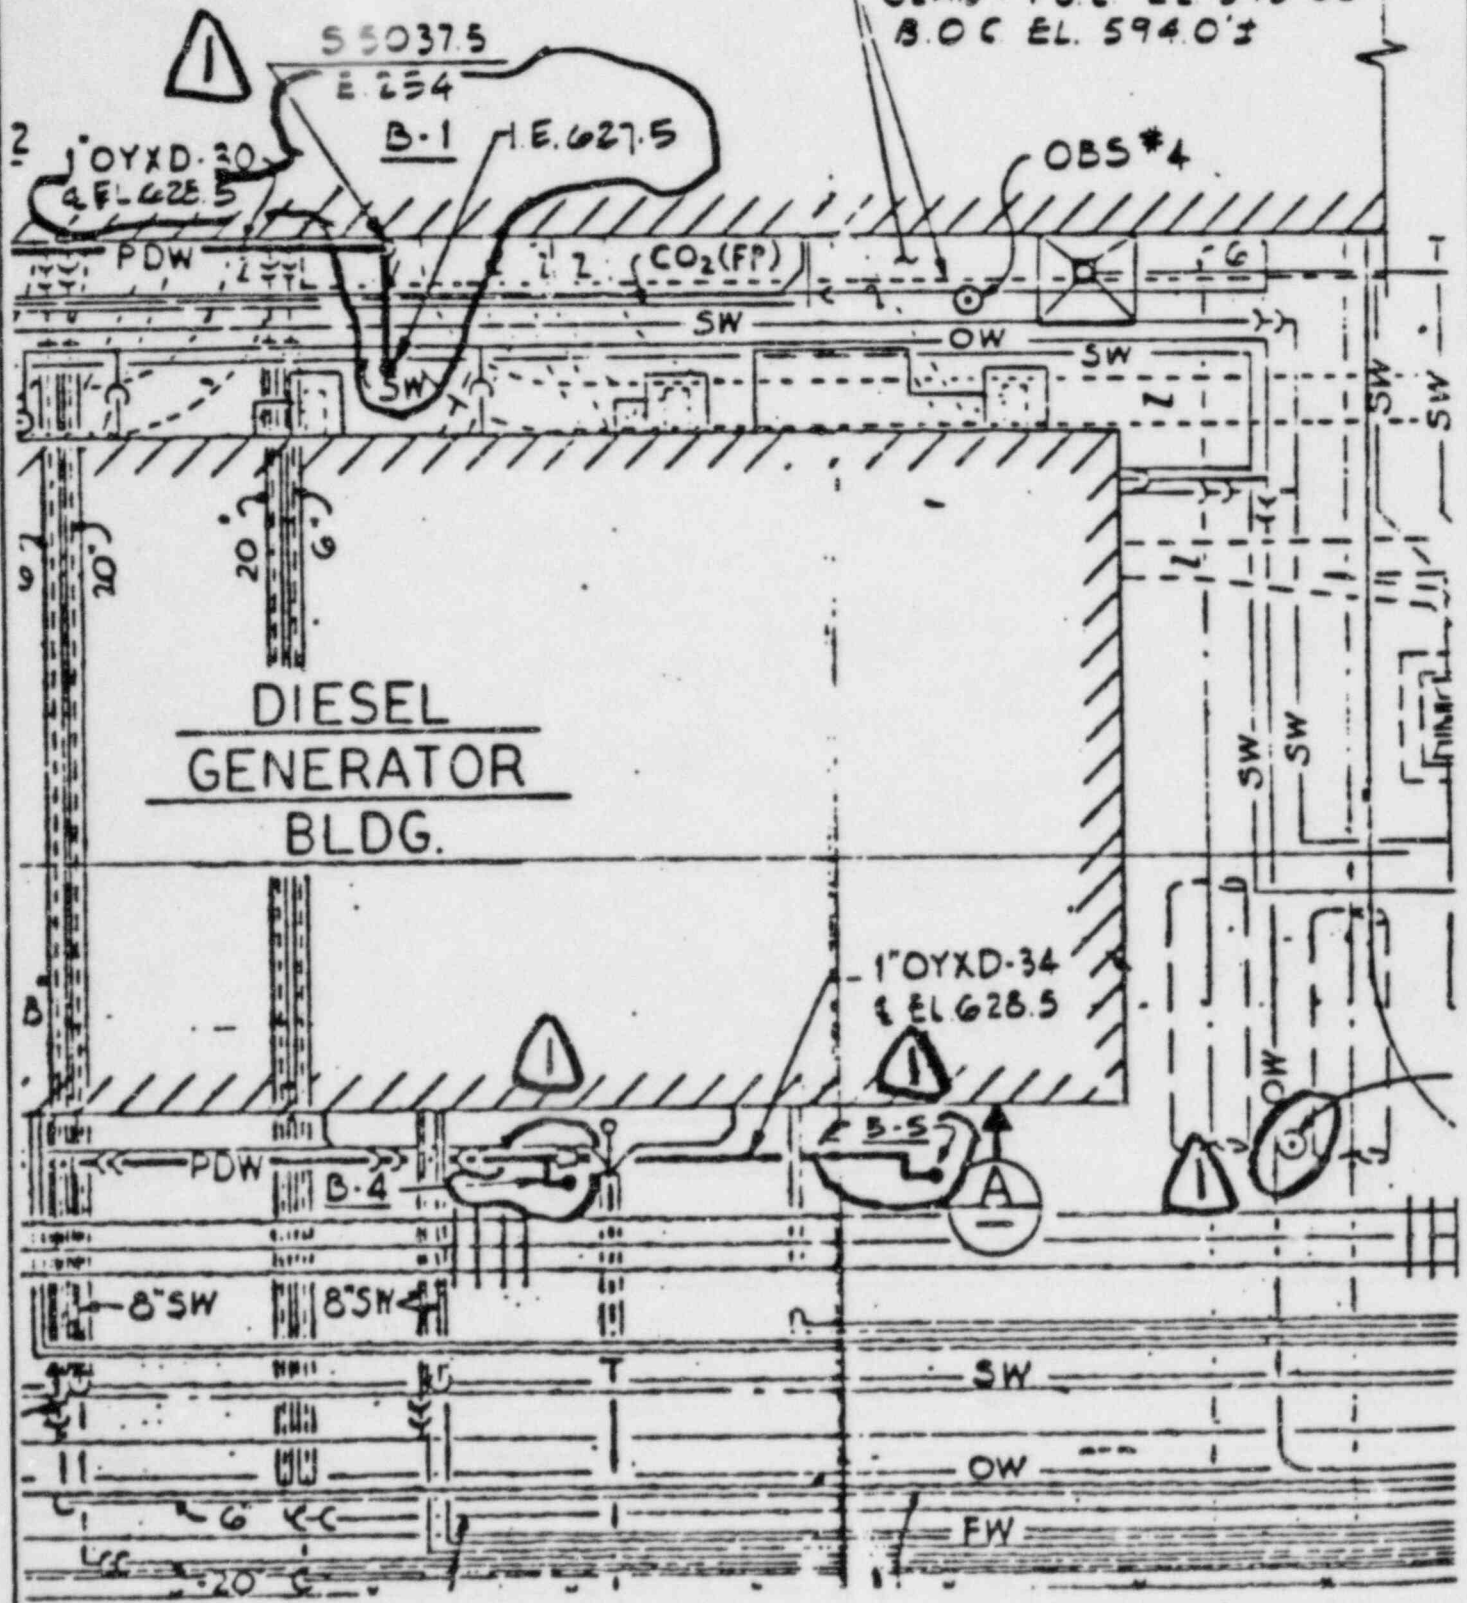
PIPING AND STRUCTURES NEAR WELL OBS-4  
 FROM DRAWING 7220-C-2017-As. Rev. Scale 1"=20'

Observation Well OBS-4 was part of the permanent dewatering system planned to prevent liquefaction of loose soil fill. Sheet 1 of the attachment shows that well OBS-4 was located between the Turbine Building and the northeast corner of the Diesel Generator Building.

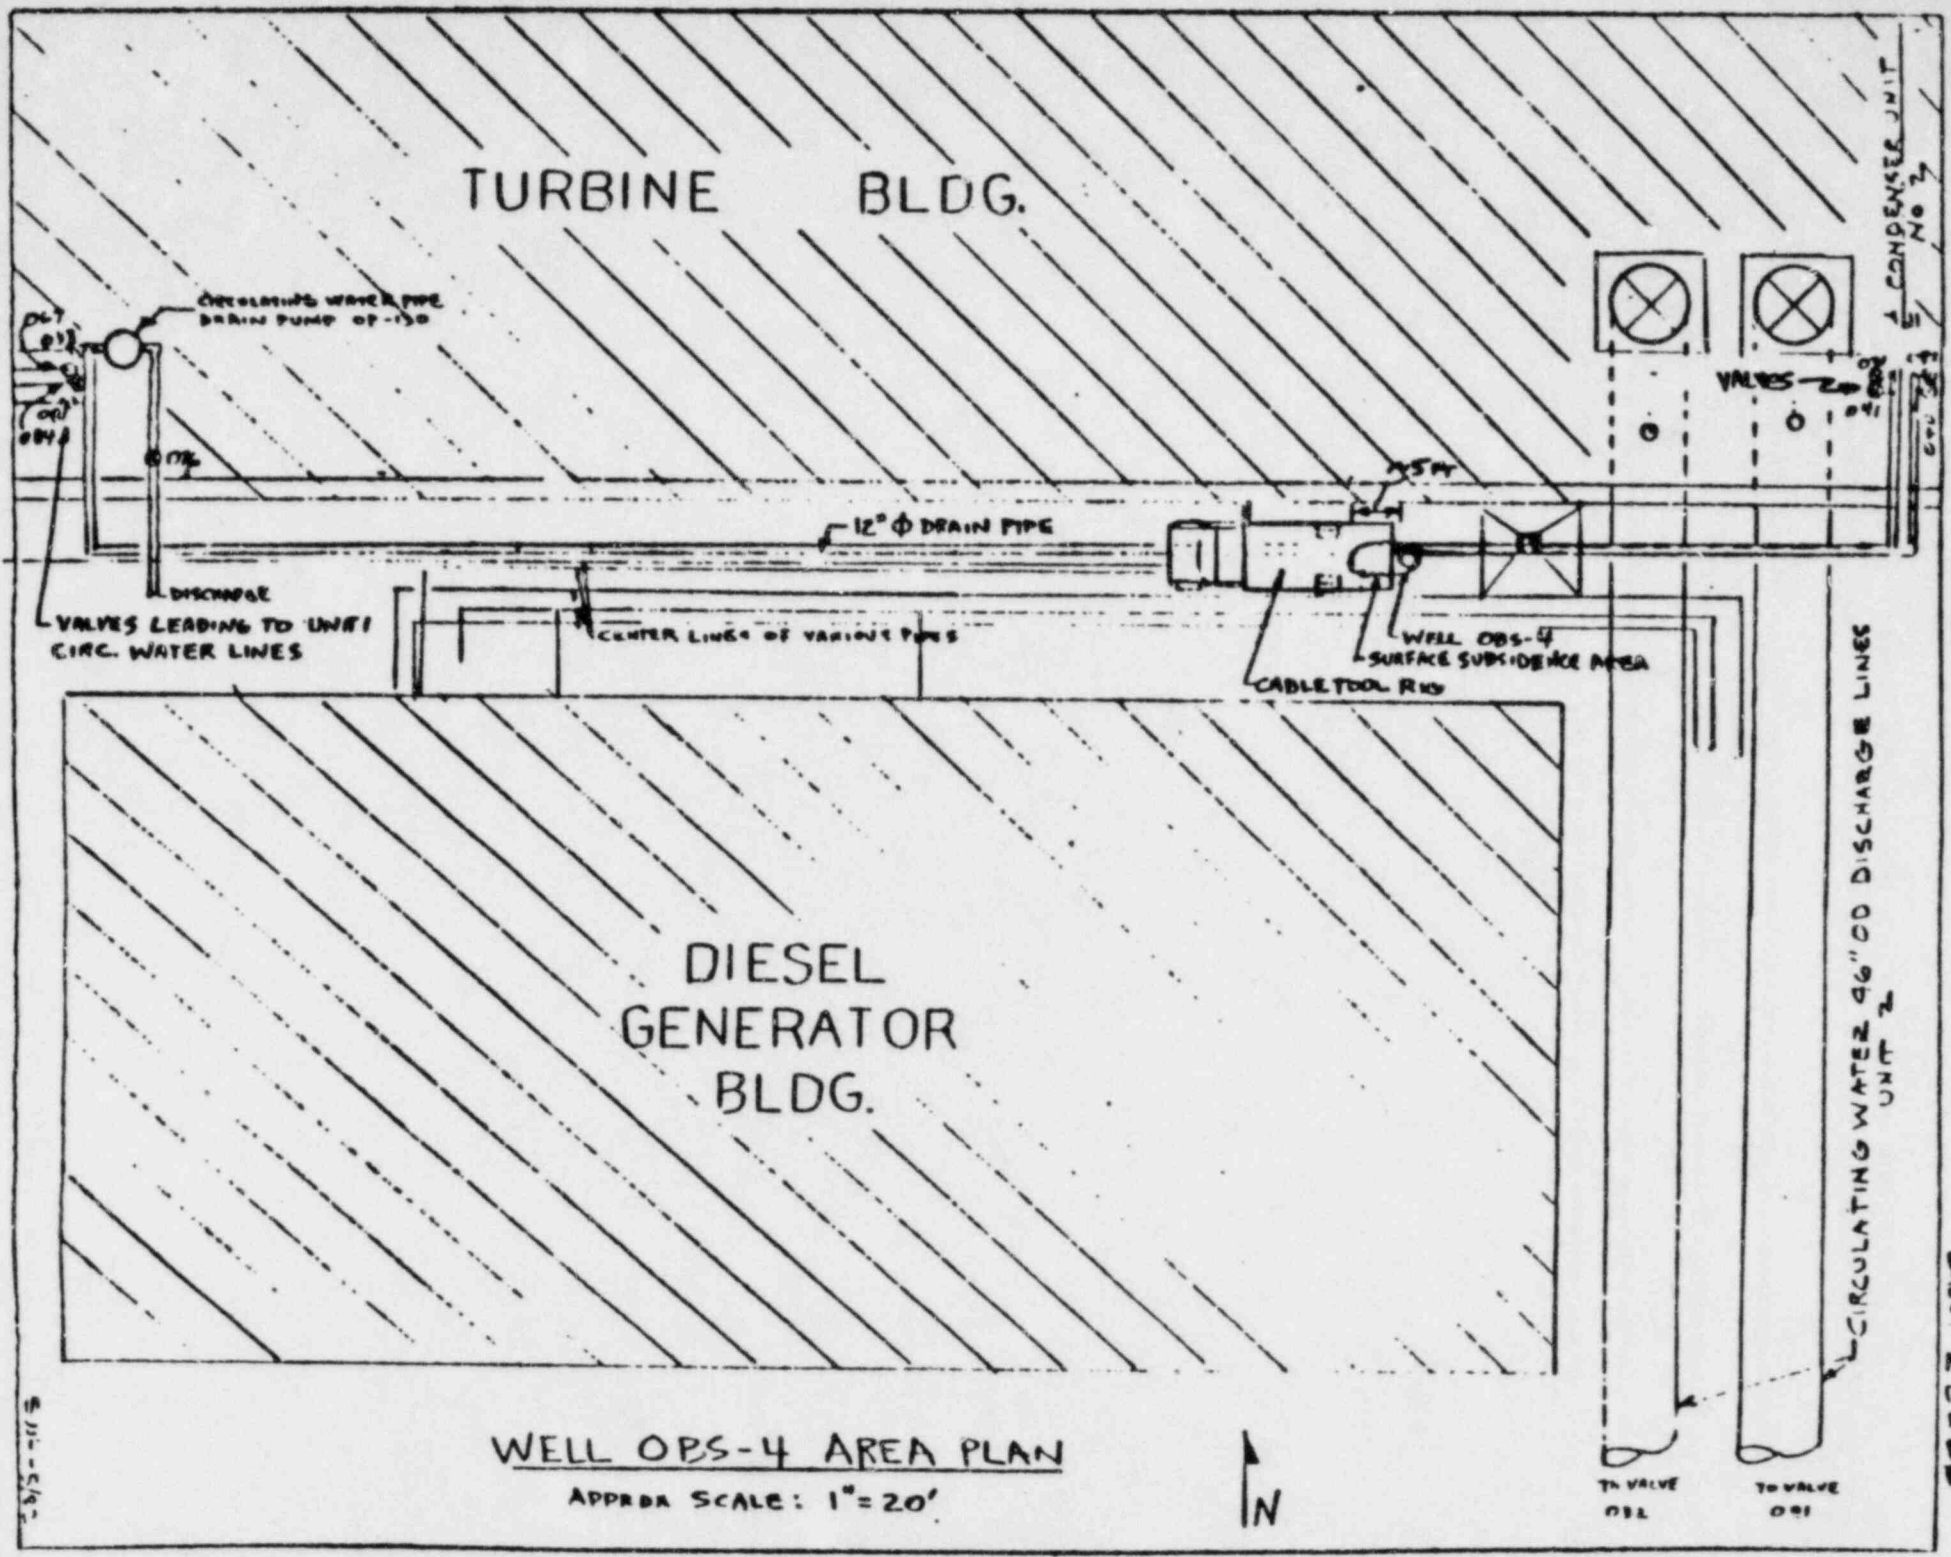
SHEET 2 OF 26

At about 10:15 a.m. driving resumed. After about 10 minutes driving was stopped when subsidence was noted immediately west of the casing. The approximate location of the area of subsidence is shown on Sheets 2 and 3 of the attachment. Immediately after development of the subsidence, Chuck Wilson and Jim Betts of Bechtel Construction were informed and at about 11:30 a.m. they examined the hole. At about 11:45 a.m. Dave Miller, a Bechtel on-site geotechnical engineer, and Don Sibbald of Consumers Power Company were informed and brought to the well site. Initially a decision was made to crib over the hole and remove the rig. At about 12:10 p.m. Jim Meisenheimer of Consumers Power Company arrived at the site and joined the discussions. At about 12:30 Paul Goguen of Bechtel Construction also arrived at the site.

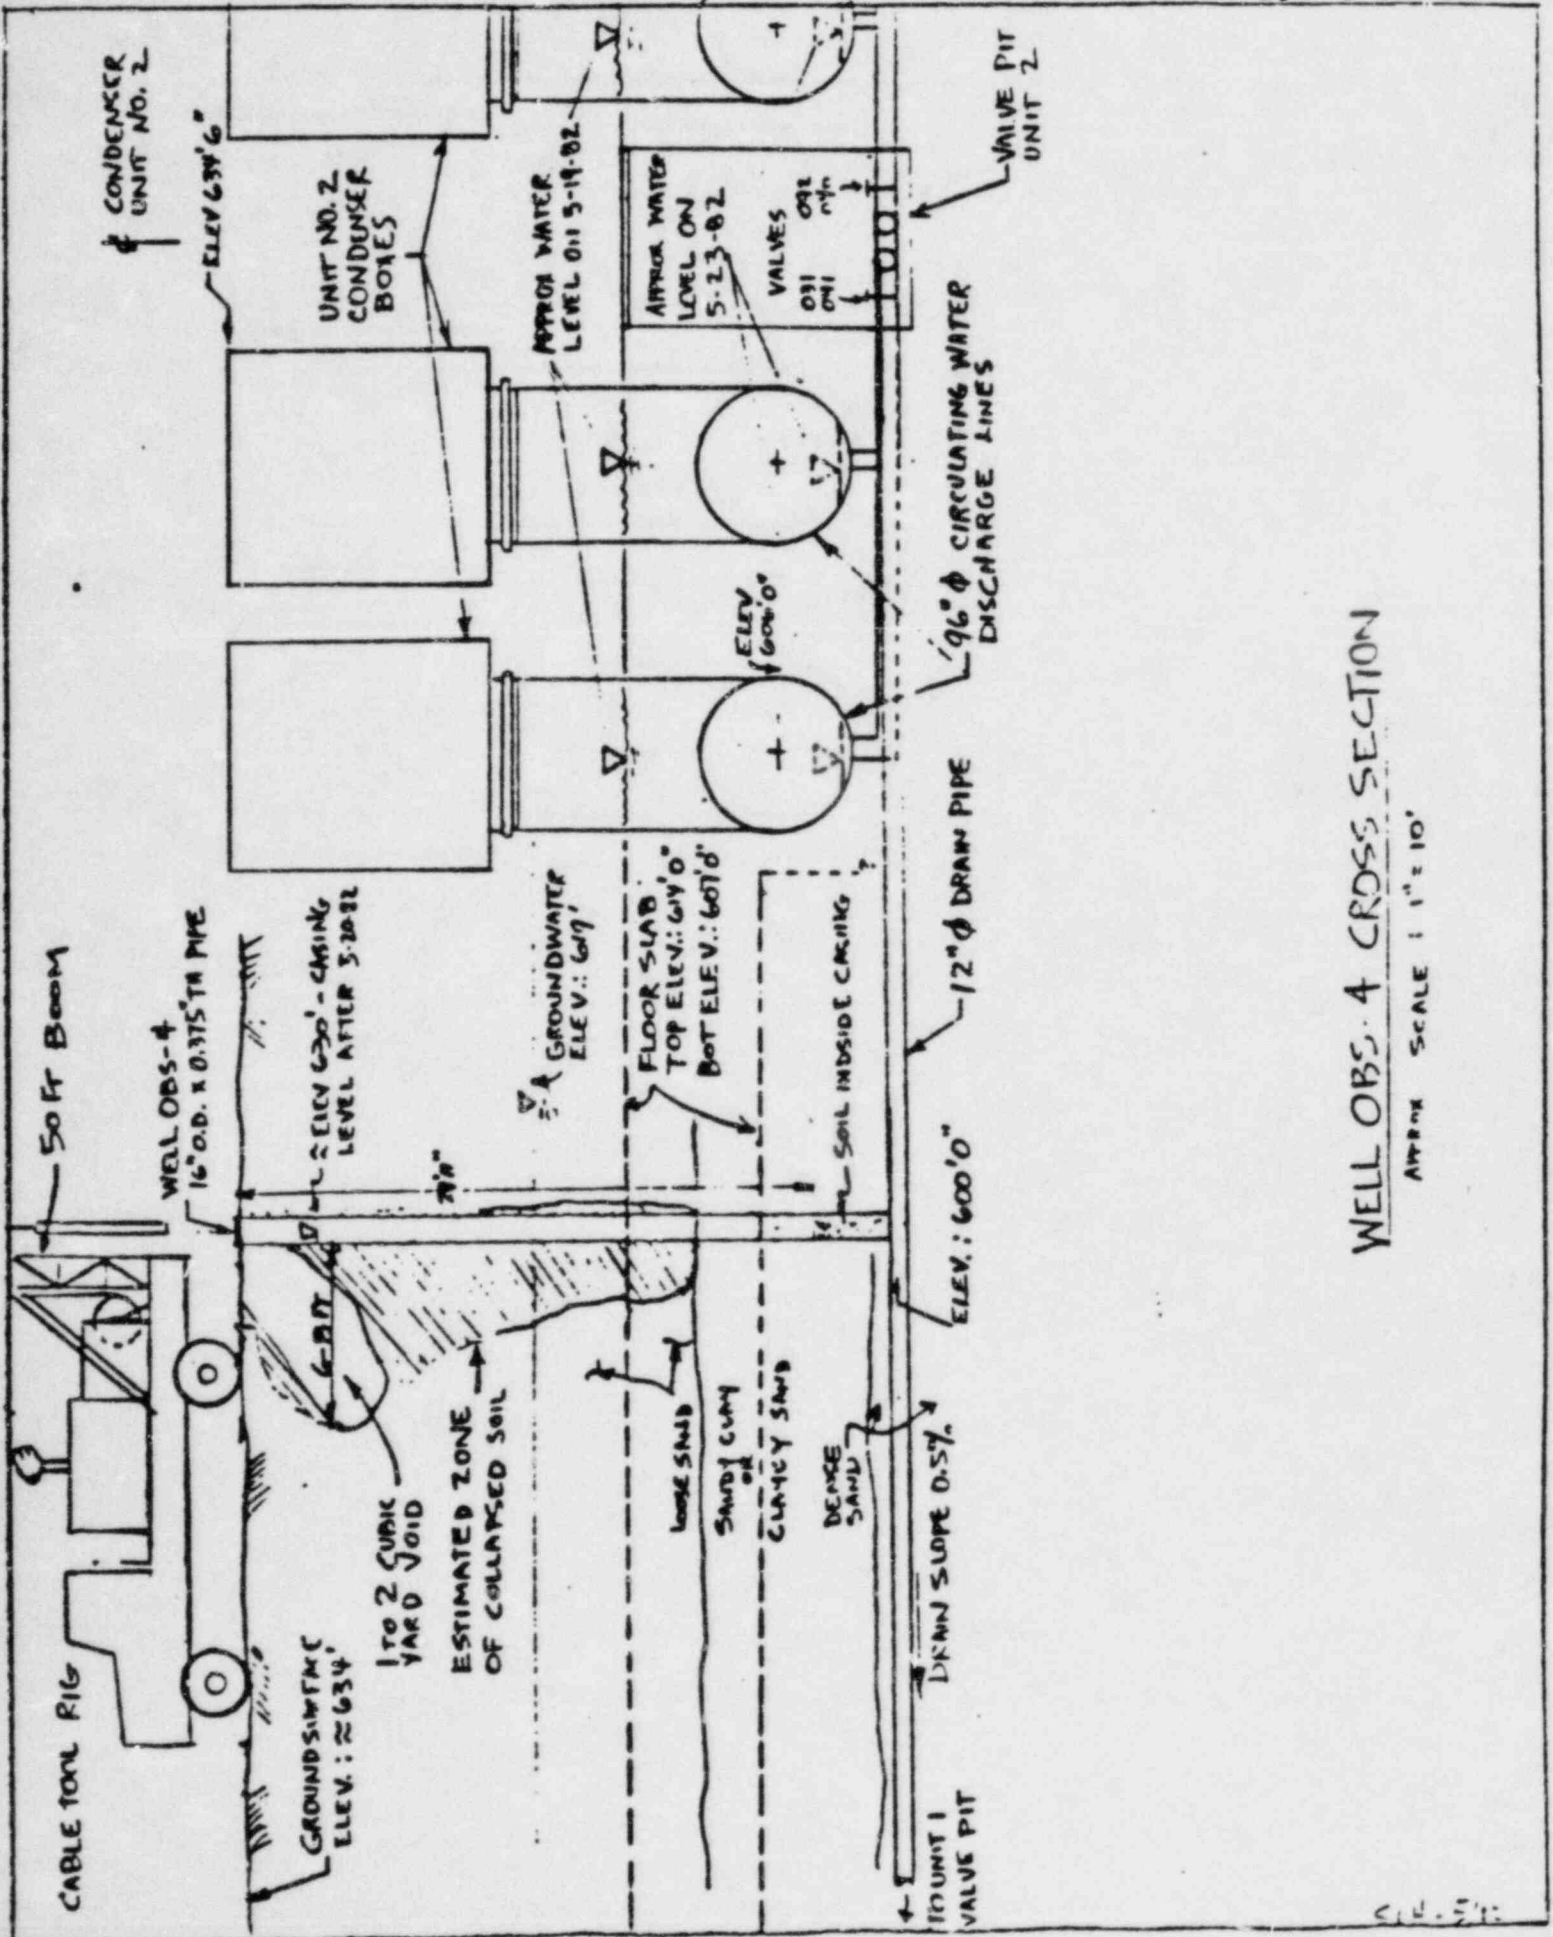
WELL OBS-4 CROSS SECTION

The estimated extent and shape of the zone of subsidence were shown on Sheet 1 of the attachment to the Hunt trip report. The zone was estimated to be an inverted cone shape (common for subsidence) located west of, and extending 6 to 8 feet from, the well casing. All voids should have collapsed as the subsidence propagated to the surface. The disturbed material should remain stable in its present condition unless influenced by vibrations or dewatering which could cause densification and settlement within the zone of subsidence.
