Subject: McGuire Nuclear Station Unit 1
Docket No. 50-069
Licensee Event Report 369/92-05

LICENSEE EVENT REPORT (LER)

TITLE(4) Essential Trains A and B were inoperable due to a missed Technical Specification requirement caused by Inappropriate Actions and a Procedure Deficiency

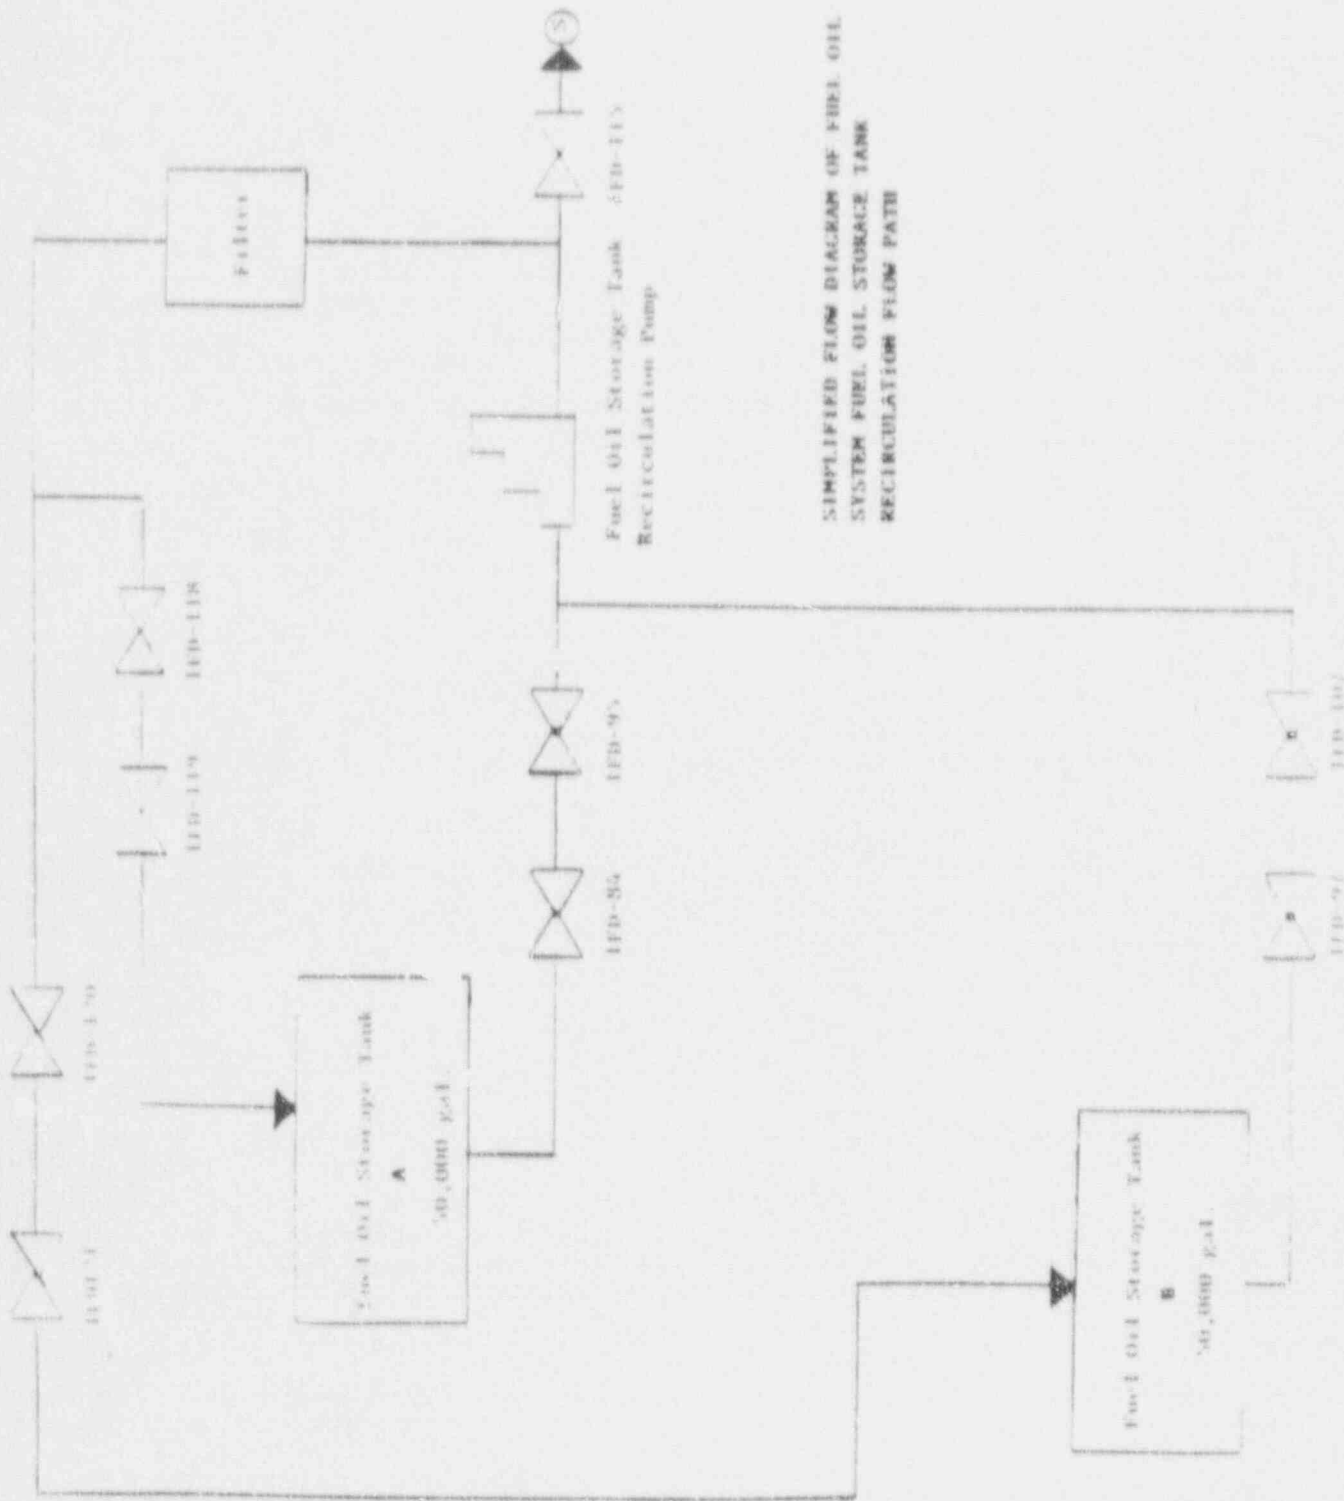
SIMPLIFIED FLOW DIAGRAM OF FUEL OIL SYSTEM FUEL OIL STORAGE TANK RECIRCULATION FLOW PATH

At 1300, CHM Technicians A and B proceeded to the Unit 1 FOST location to obtain a sample from FOST 1A and place FOST 1B in the recirculation mode. CHM Technician B obtained the fuel oil samples for FOST 1A as directed by procedure steps 4.1.12 through 4.1.26. CHM Technician A then unlocked and opened valves 1FD-120, FOST 1B Recirculation Line Isolation, and 1FD-121, FOST 1B Recirculation Line Isolation, in the discharge header of the FOST recirculation pump, while CHM Technician B unlocked and opened valves 1FD-97, FOST 1B Recirculation Line Isolation, and 1FD-107, FOST 1B Recirculation Line Isolation, in the suction header of the FOST recirculation pump, as directed by procedure step 4.1.27. Discharge valves 1FD-118 and 1FD-119 for FOST 1A were then closed and locked. The FOST Recirculation Pump was then energized and CHM Technicians A and B returned to a chemistry lab for other duties while they waited for FOST 1B to recirculate for the required 4 hours. CHM Technicians A and B did not realize that suction valves 1FD-84 and 1FD-95 had been left open and the procedure did not specify an individual sign off for the valve position. Therefore, during the 4 hour recirculation period, the Unit 1 FOST Recirculation Pump had suction on both FOST 1A and 1B but was discharging to FOST 1B only.

At 1800, CHM Technicians A and B proceeded to the Unit 1 FOST location to obtain a sample from FOST 1B. CHM Technicians A and B did not realize that suction valves 1FD-85 and 1FD-95 were still open.

Investigation of the event, it could not be proven that valves 1FD-84 and 1FD-95 were closed when required by procedure CP/1/A/8600/41. Neither CHM Technician A nor B could remember whether all valves were left locked closed. There was no evidence found that CHM Technicians A and B had made an effort to verify correct valve alignment before proceeding with the next procedure step.

- Subsequent:
1. FOST 1A valves 1FD-84 and 1FD-95 were closed and locked by CHM personnel.
 2. OPS personnel returned 5,000 gallons fuel oil from FOST 1B to FOST 1A.
 3. Procedure CP/1/A/8600/41 was revised by CHM staff personnel to require sign offs on individual valve alignments.
 4. Procedure CP/2/A/8600/41 was revised by CHM staff personnel to require sign offs on individual valve alignments.
 5. CHM Management personnel discussed the event with the CHM technicians involved.
 6. CHM personnel resampled FOST 1B.
