Investigation and Analysis of Suspect Fasteners

Event 29257

Final Report

Prepared by Cardinal Industrial Products Division of B&G Manufacturing Co., Inc.

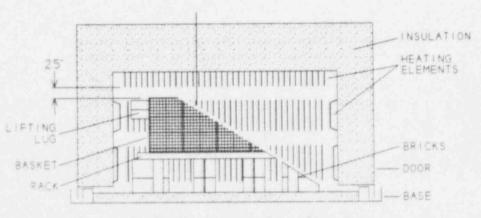
Figure 3 · Furnace Door Closed

Figure 3 is a side view of the furnace with the oven door in the closed position. With the oven door closed, there is approximately 2 1/2 inches of clearance between the top of the basket and the upper heating elements. The thermocouple protrudes eight inches from the ceiling and extends into the basket approximately two inches.

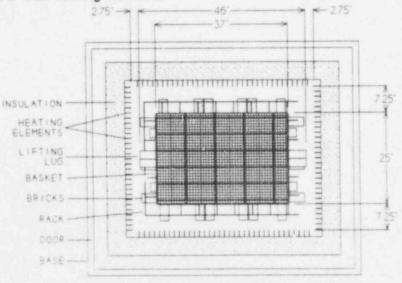
Figure 5 - Top View of Base with Basket

Figure 5 is a top view with the same perspective as Figure 4. This view shows the parts basket placed on the rack and a cutaway view of the door showing the clearance between the basket and the side heating elements.

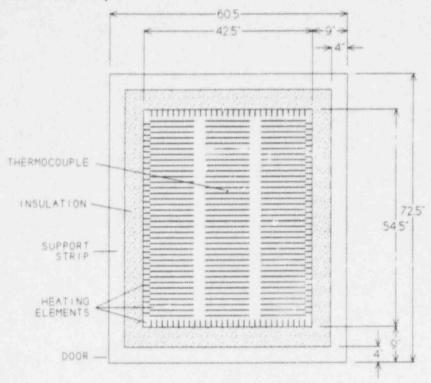
Figure 6 - Top View of Door

register its temperature is positioned in the upper region of the furnace (See Addendum 3). The results of the test charges demonstrated that not all the contents of a charge reach the indicated temperature at the same time. The time required for the bottom layer of fasteners to reach temperature was affected by the weight of the charge and the charge density.

Figure 6 is a top view of the door as viewed from the base looking up. The right side of the drawing faced the quench tank. This view shows the upper three rows of heating elements and the location of the thermocouple.
