PRELIMINARY NOTIFICATION OF EVENT OR UNUSUAL OCCURRENCE--PNO-77-35

Facility: Consumers Power Company (Midland Unit 2)
(Docket No. 50-330) Midland, Michigan

Subject: BULGE IN CONTAINMENT LINER PLATE

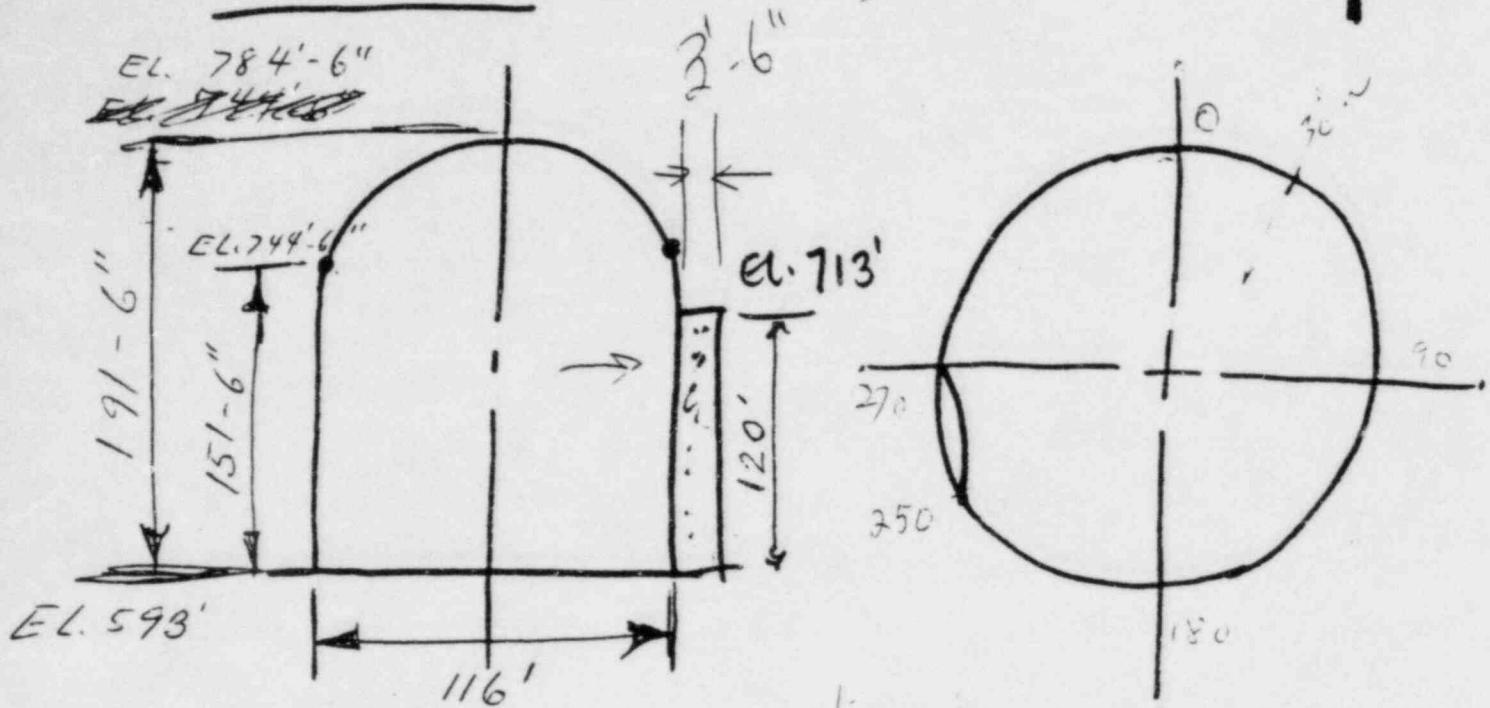
Unit 2

~ 108' high
~ 20' wide

1/4 liner plate

L $3 \times 2 \times \frac{1}{4}$

Spaced ~ 14"

Liner plate + L iron spliced from the channel

Problem identified: 2/26/77 Sat. by Reactor
 Reported to CP on 2/27/77 @ 11:00 am
 - Cf 58 55(e) report to NRC III 2/28/77 @ 1:15 pm

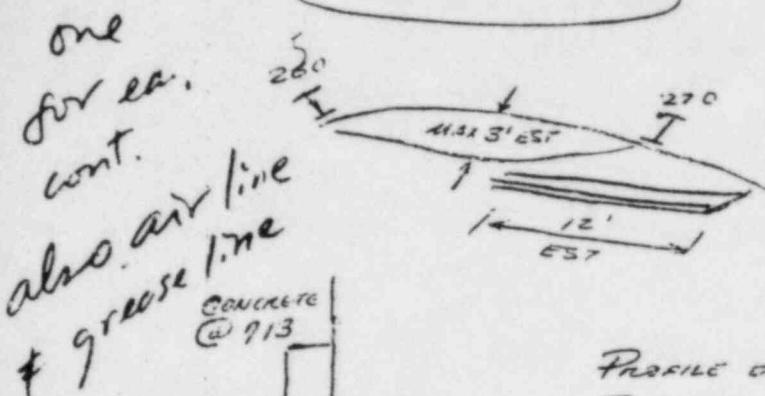
BUBBLE DAMAGE
CROSS SECTION AND
SECTION OF LINER
GIRT TOOK LOOSE @ 670°
ABOUT 12' HORIZONTAL

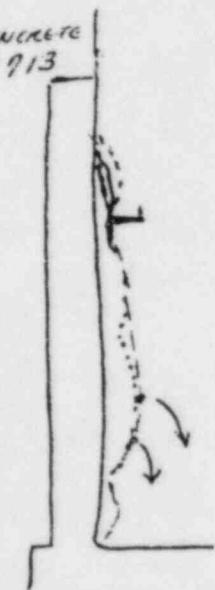
PROFILE OF DAMAGE
BUBBLE STARTS ABOUT 15' ABOVE
WIND GIRT
Some CONCRETE SPALLING (O.Holman-Bechtel)
Some HOLES IN PLATE WHERE L
STIFFENER TOOK LOOSE
WATER STREAMING OUT SOME HOLES
PENETRATION HOLE PLATE BACK SOME
NEAR BOTTOM
