UNITED STATES
NUCLEAR REGULATORY COMMISSION
WASHINGTON, D. C. 20555

APPLICANT: Consumers Power Company
FACILITY: Midland Plant, Units 1 and 2
SUBJECT: SUMMARY OF THE MAY 23, 1980 MEETING ON PRESERVICE FAILURE OF
THREE REACTOR VESSEL HOLD-DOWN STUDS

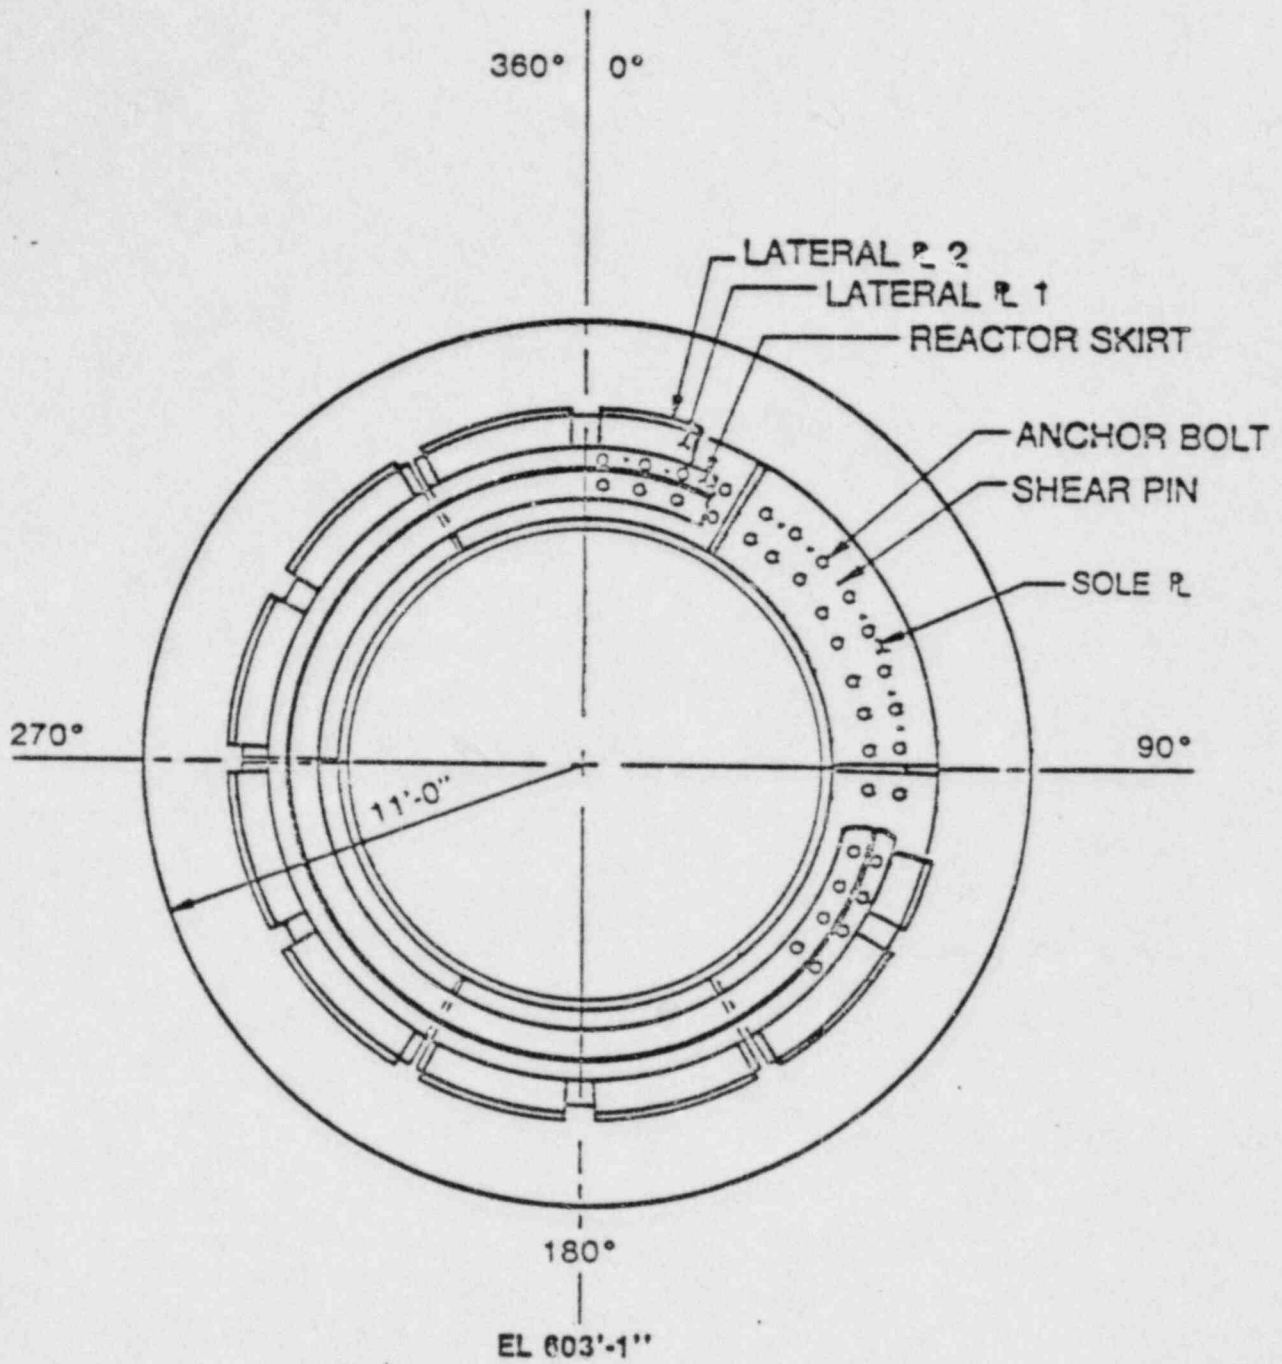
Slide 2

As shown on Slide 2, the vessel skirt design also includes shear pins, 2 inches in diameter and 6 1/16 inches in length, to transmit lateral loads to the 5 1/2 inch thick annular sole plate segments beneath the skirt. Shear lugs are welded beneath the sole plate. Lateral and torsional loads therefore, are resisted by friction, bearing, shear pins, and shear lugs, and transmitted to an inner ledge of the primary shield wall. The studs are intended to resist overturning moments and uplift forces acting on the reactor vessel, such as would result from a loss of coolant accident located so as to pressurize the reactor vessel subcompartment.

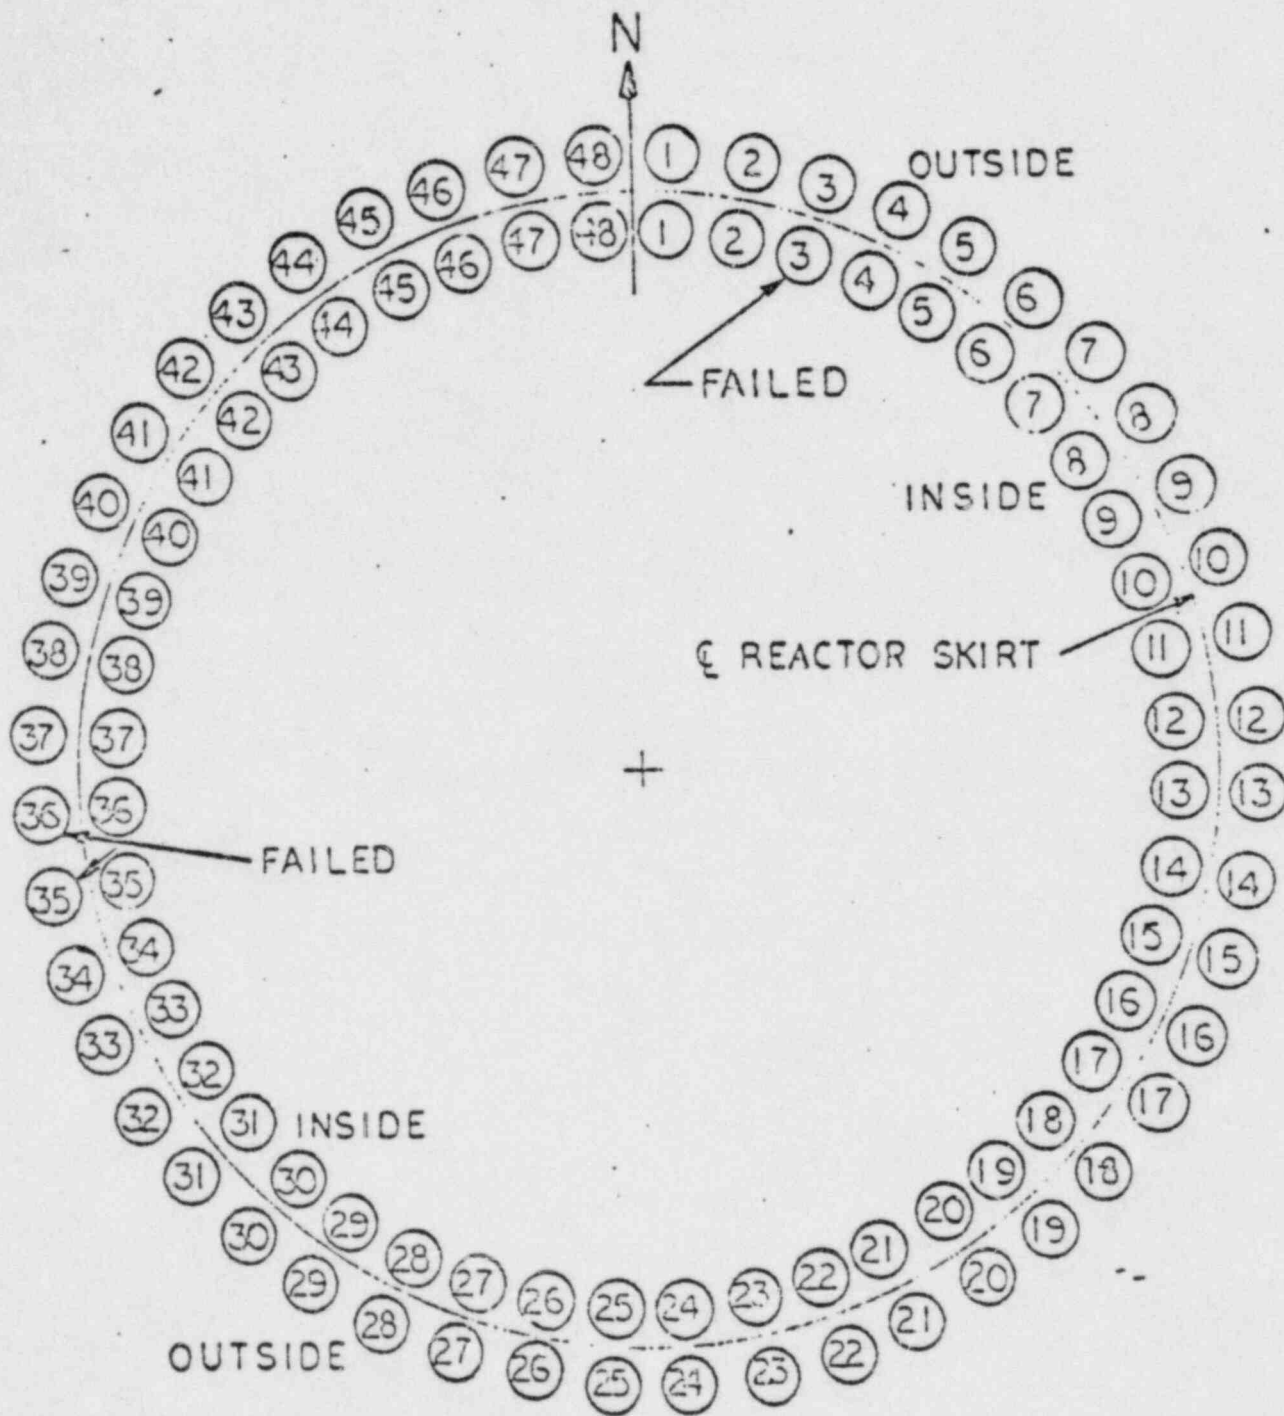
FIGURE 1.
 POSITION AND NUMBERING OF STUDS IN UNITS 1 AND 2
slide 4.

The identification of individual studs relative to position on the reactor vessel skirt are indicated in Slide 4 of Enclosure 3. The points of failure along the length of the three failed studs are shown by Slide 5.

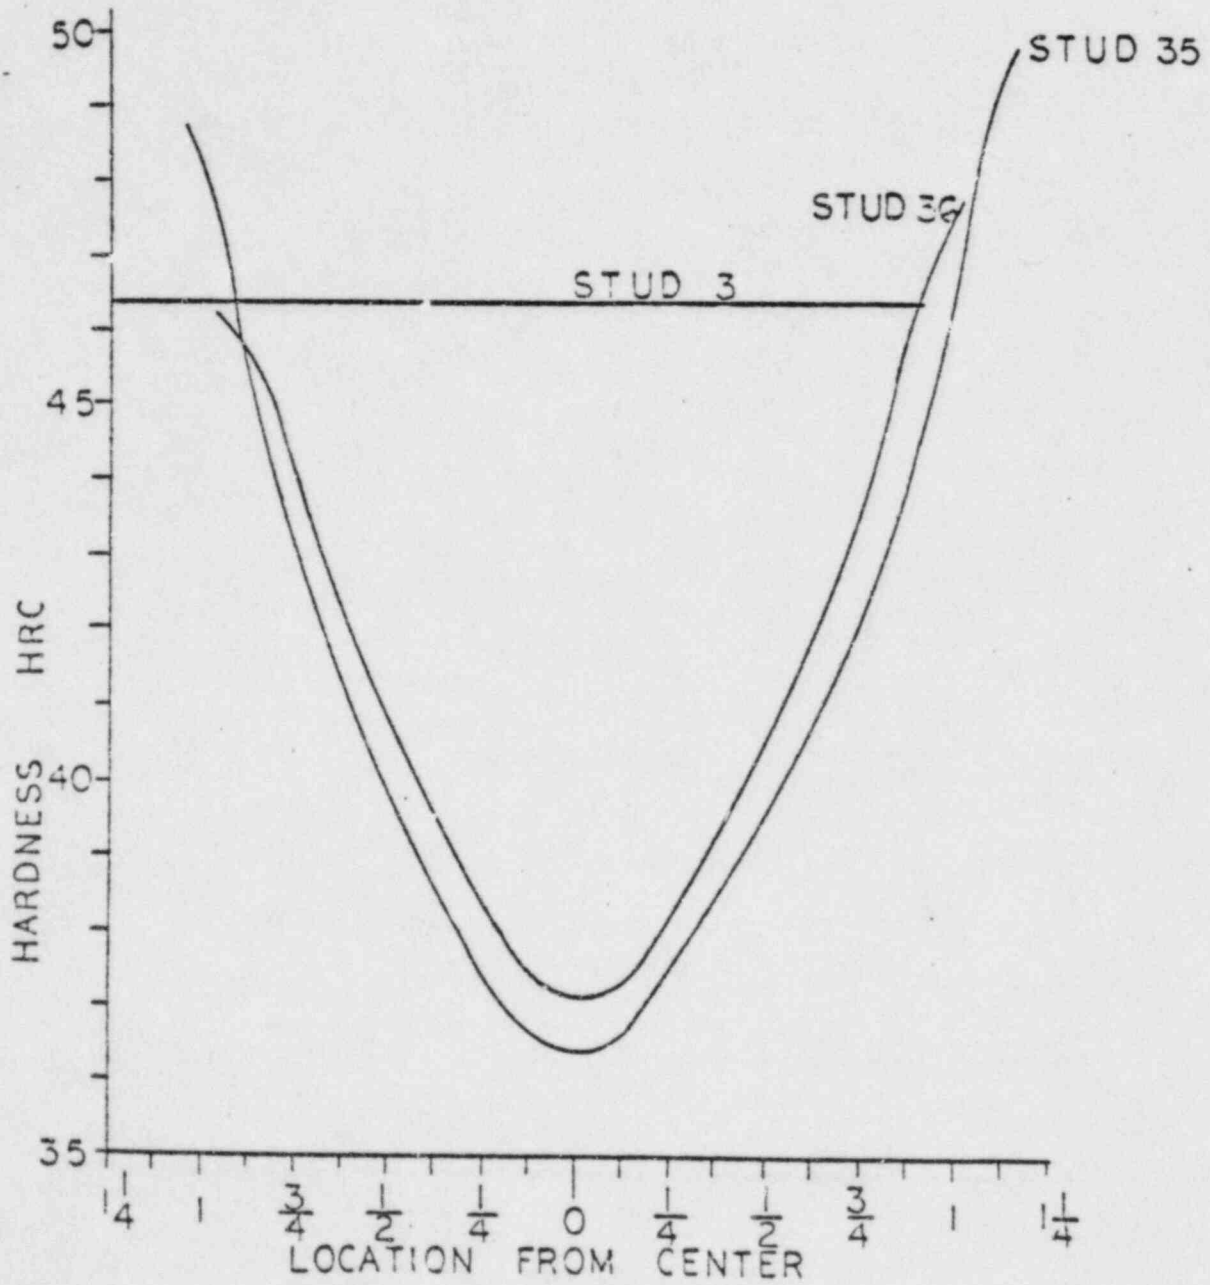
slide 6

The Rockwell hardness tests (HRC) performed by Teledyne behind the fracture surface and on the ends of the failed studs indicated a significant hardness gradient across the diameter of studs 35 and 36. It is also believed that a gradient exists along the axis of the studs. However, stud 3 had no hardness gradient across its diameter nor along its length. Teledyne concludes that the maximum permissible surface hardness for the Unit 1 or Unit 2 material should be 41 HRC for the specified maximum center hardness of 38 HRC. Results of the hardness traverse across the diameter of the three failed studs are shown on Slide 6 of Enclosure 3. Field hardness testing of the remaining studs of Unit 1 and Unit 2 show that some of the Unit 1 studs also have a hardness gradient, but none of the Unit 2 studs exhibited a gradient. The Unit 2 studs had a nominal hardness of 38 HRC, for which 14 were at this nominal value, 42 were softer, and 40 were harder.

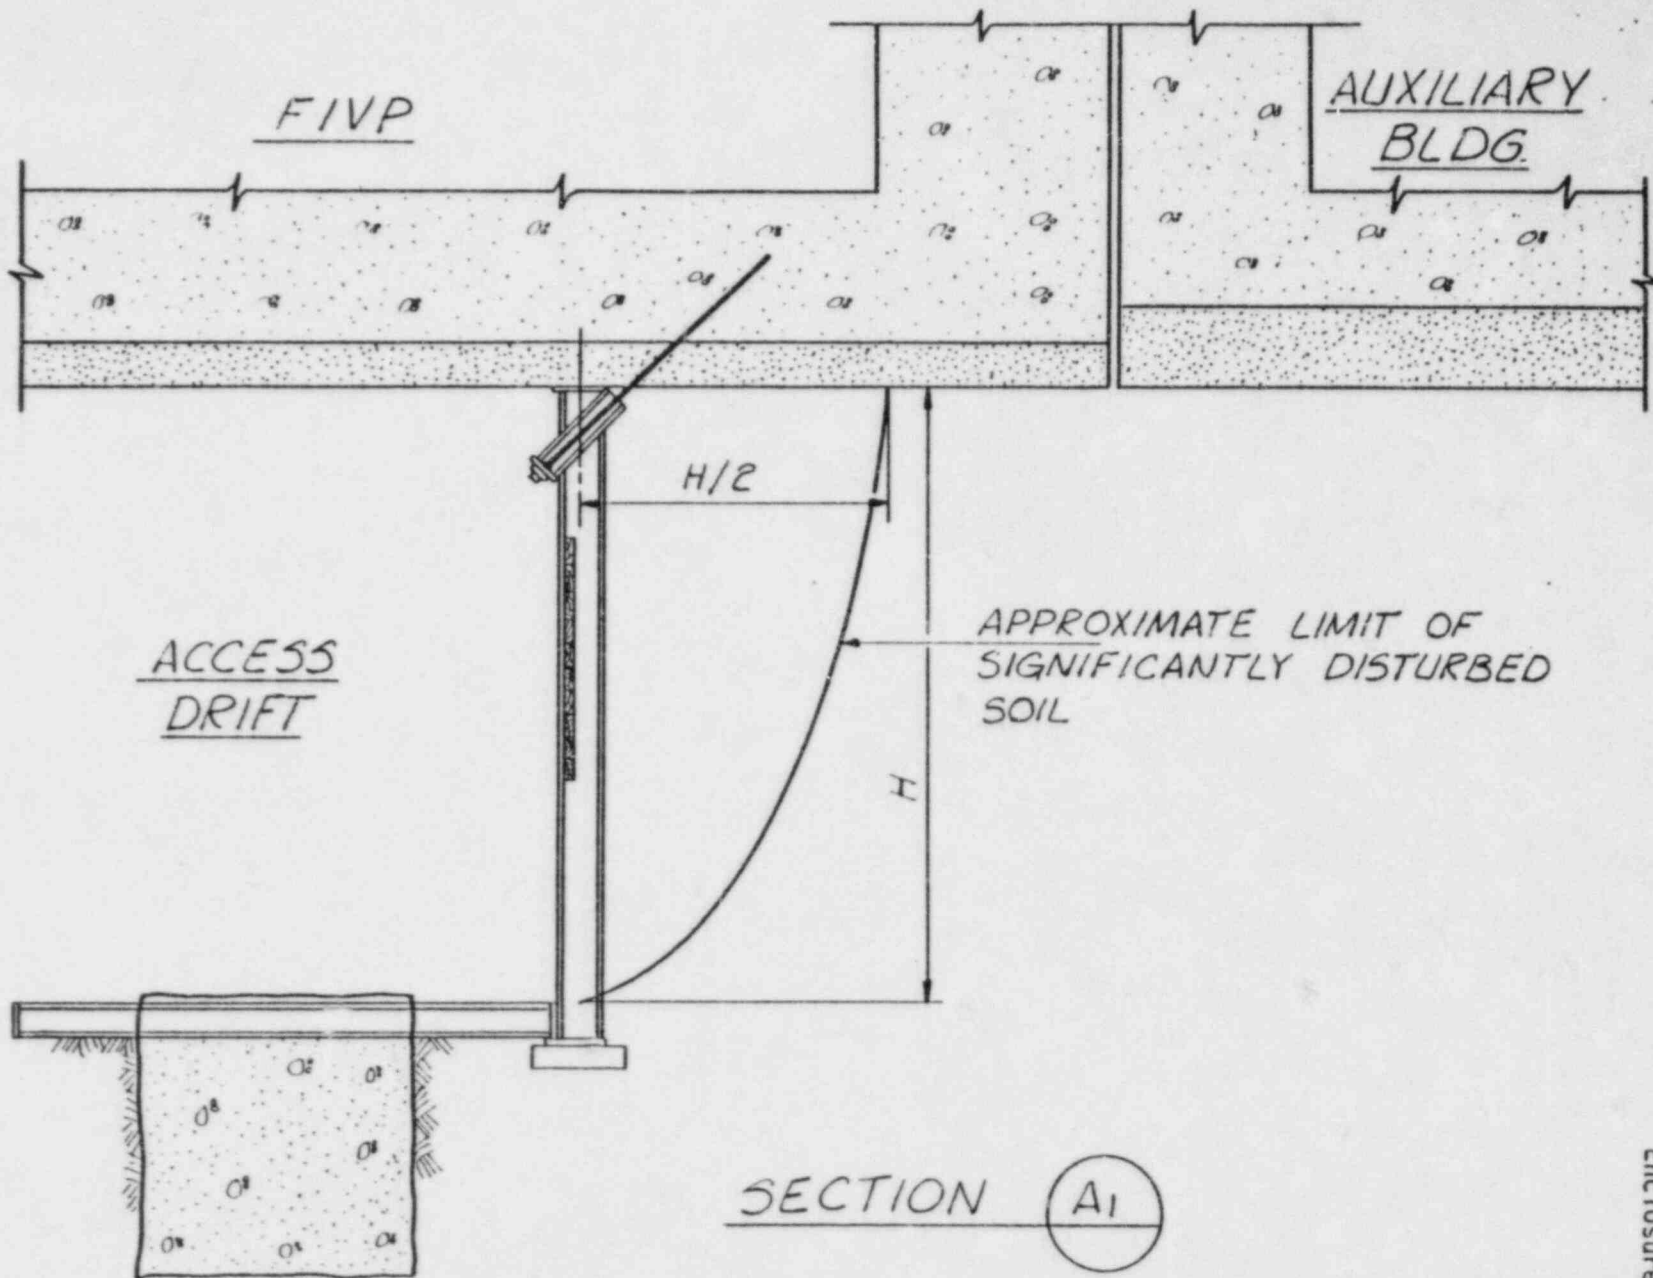
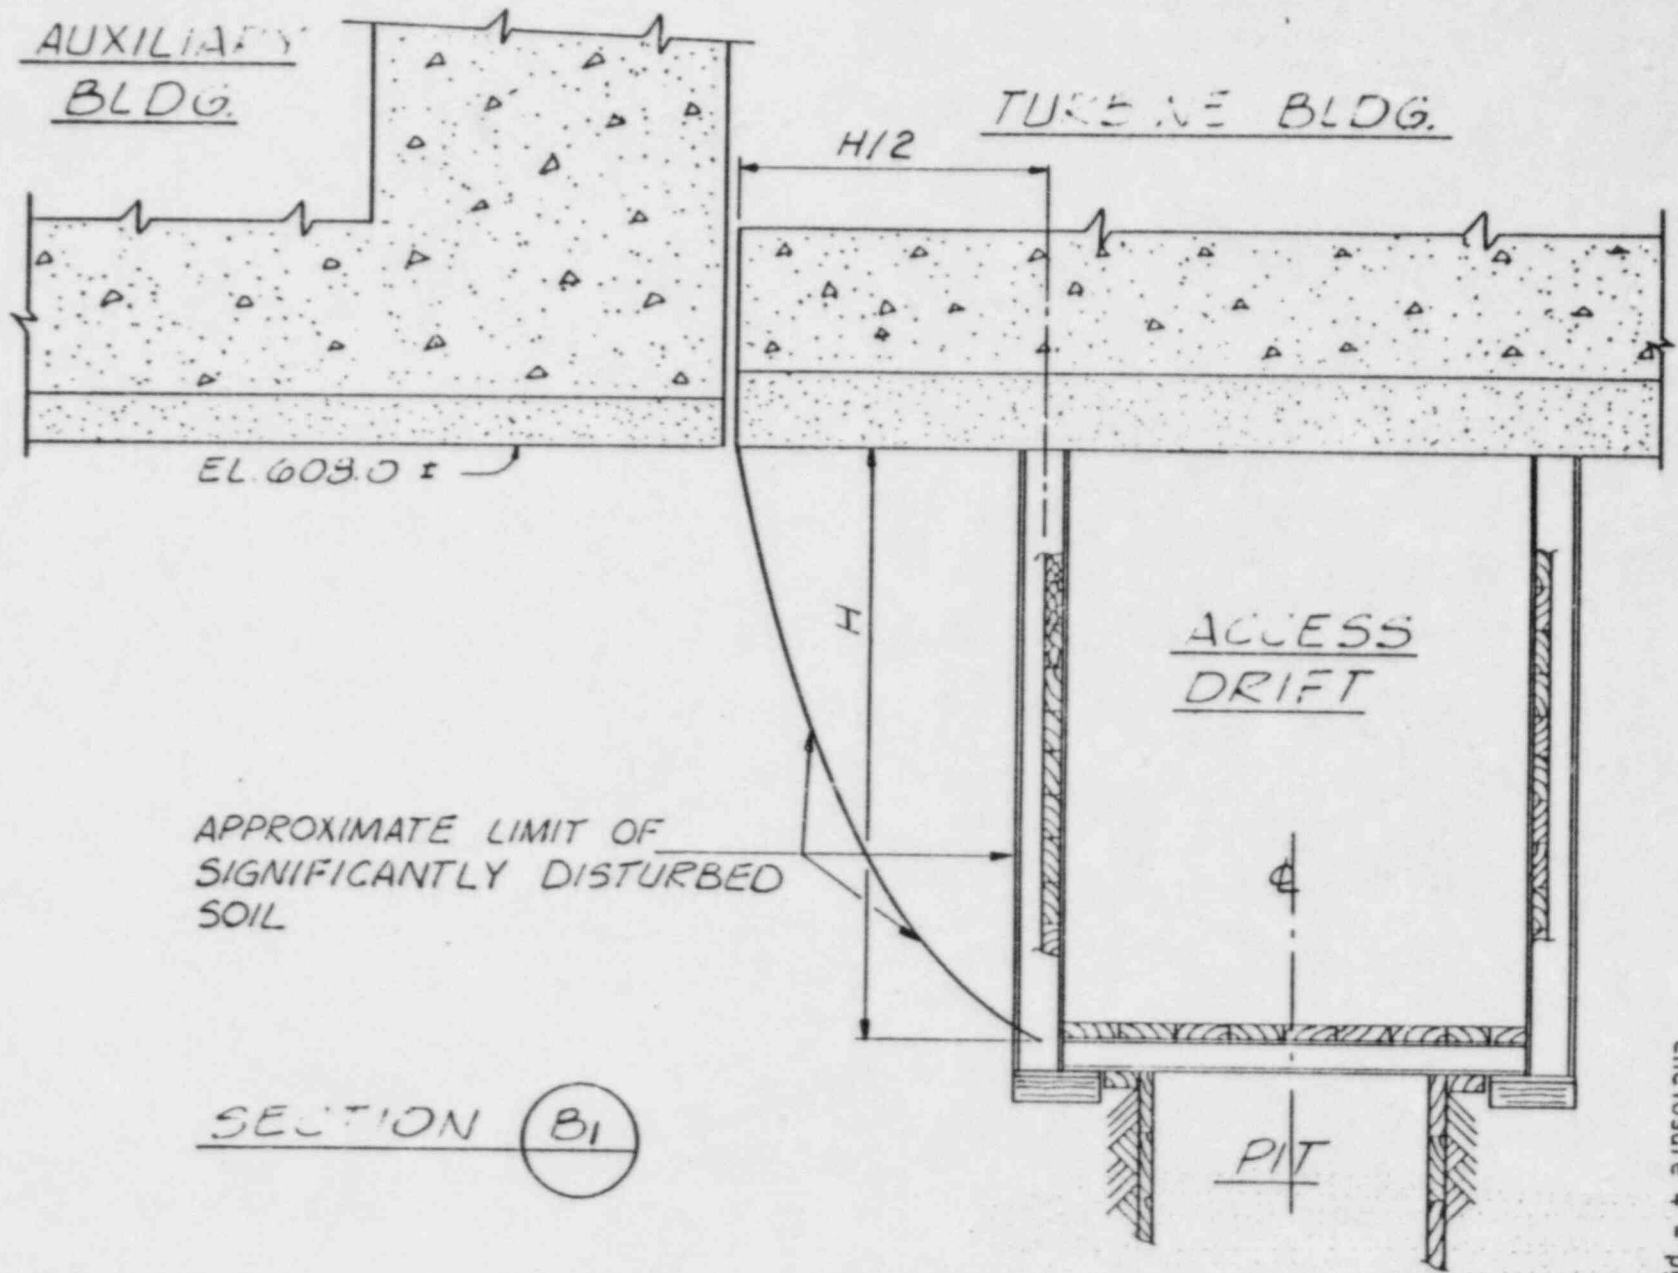
However, there is an overlap of the zone of influence of significantly disturbed soil from Figures A1 and B1 with the 0.1 pressure bulb. This overlap will cause a redistribution of pressure, but because it occurs in a zone of low pressure the effect on the auxiliary building will be insignificant.

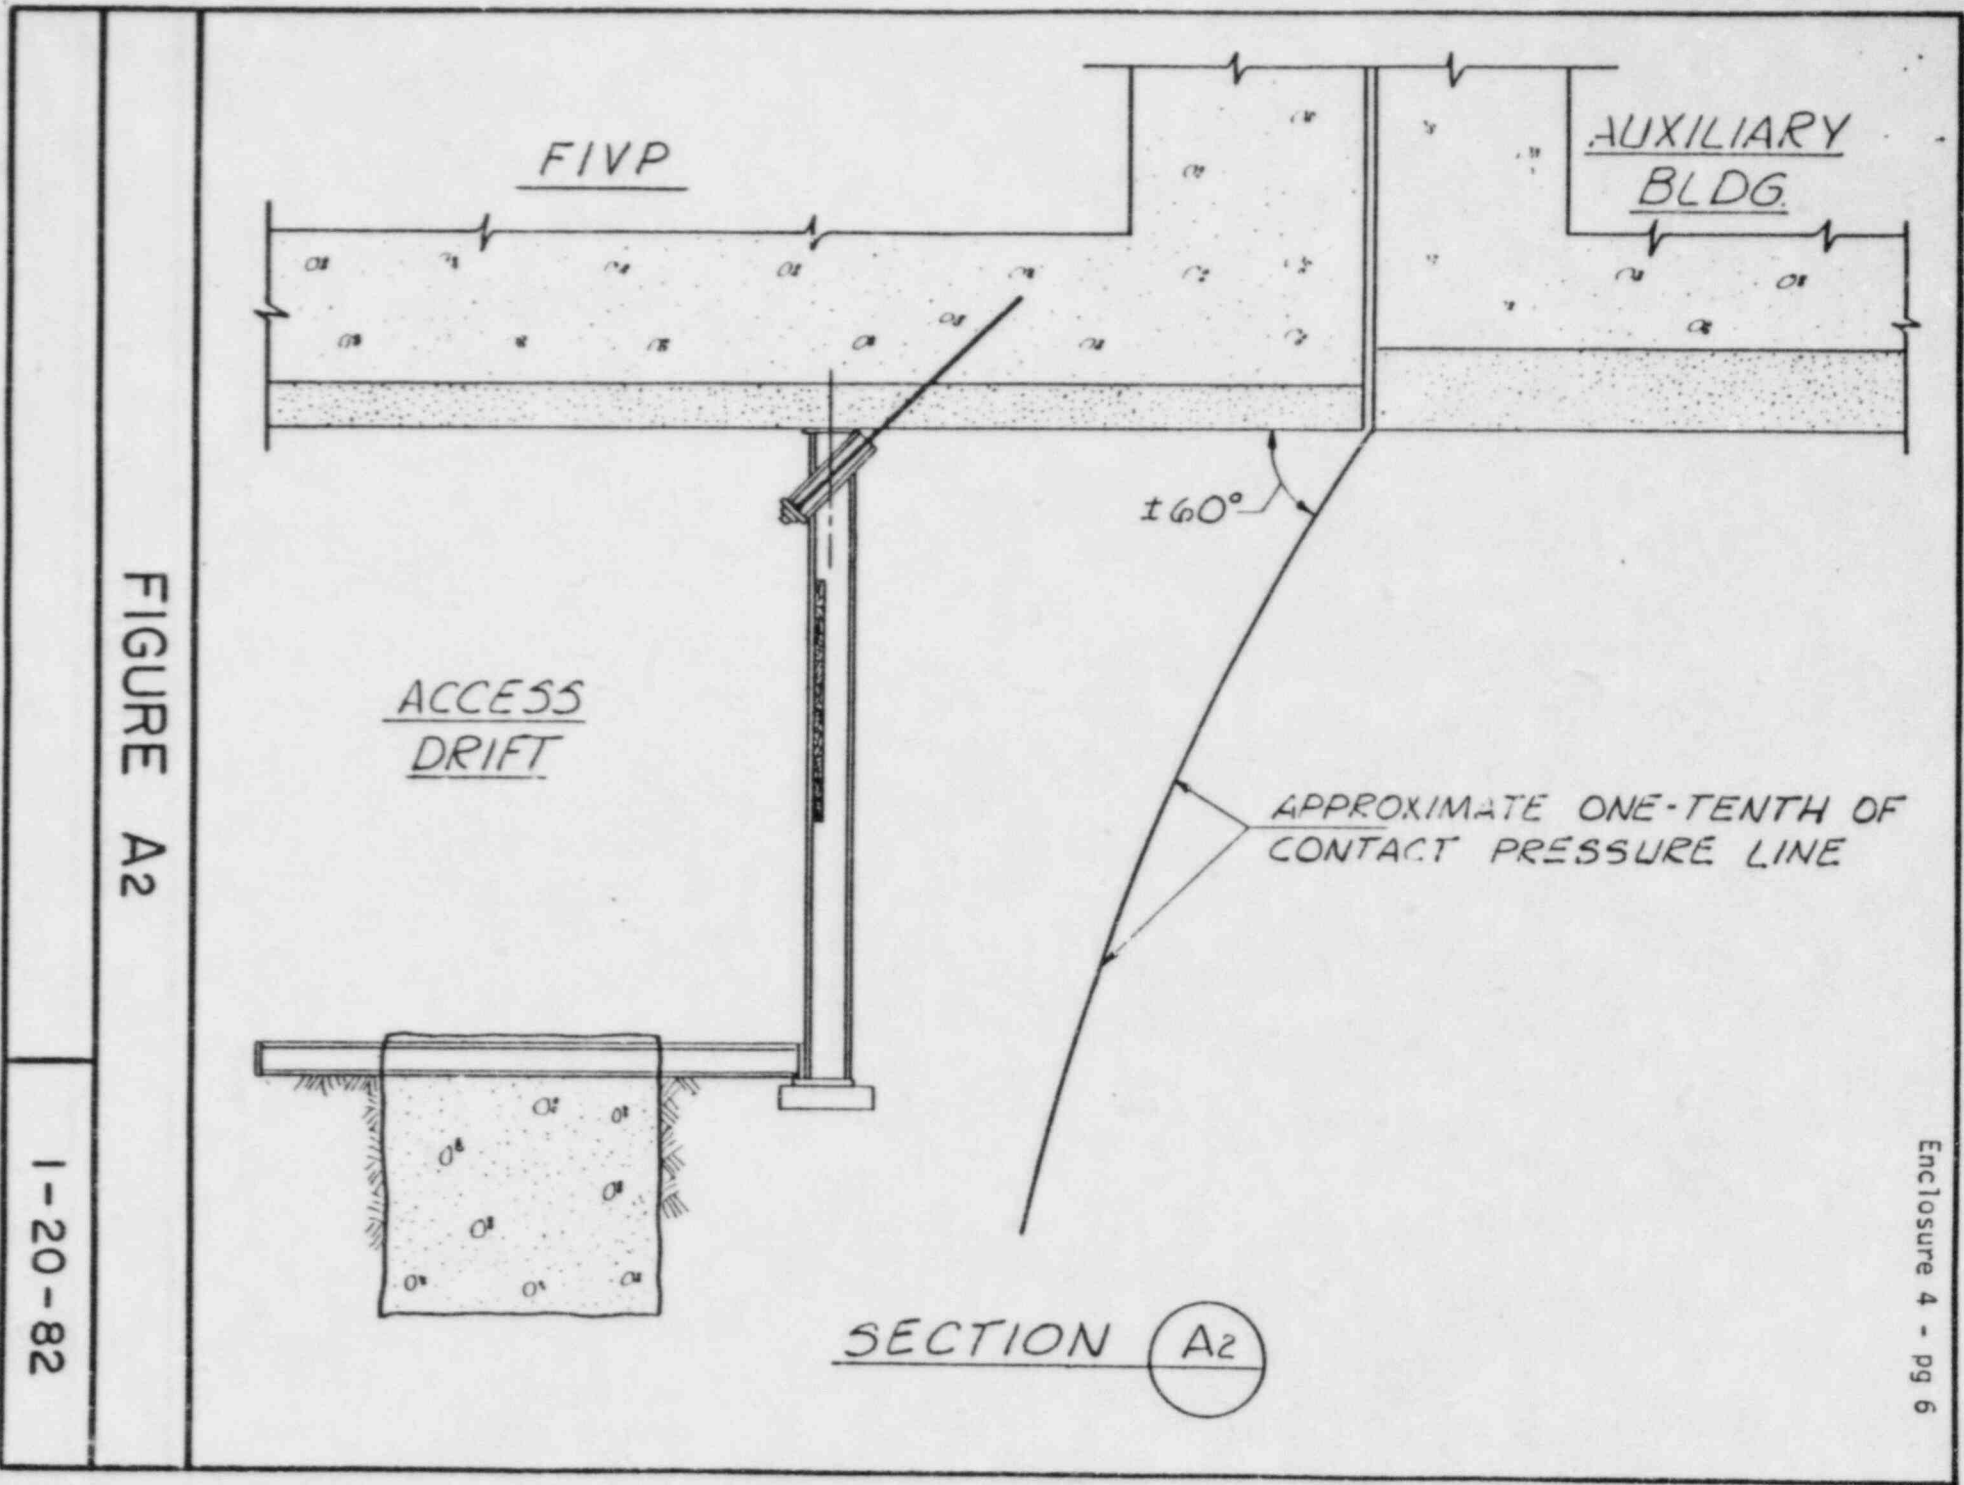
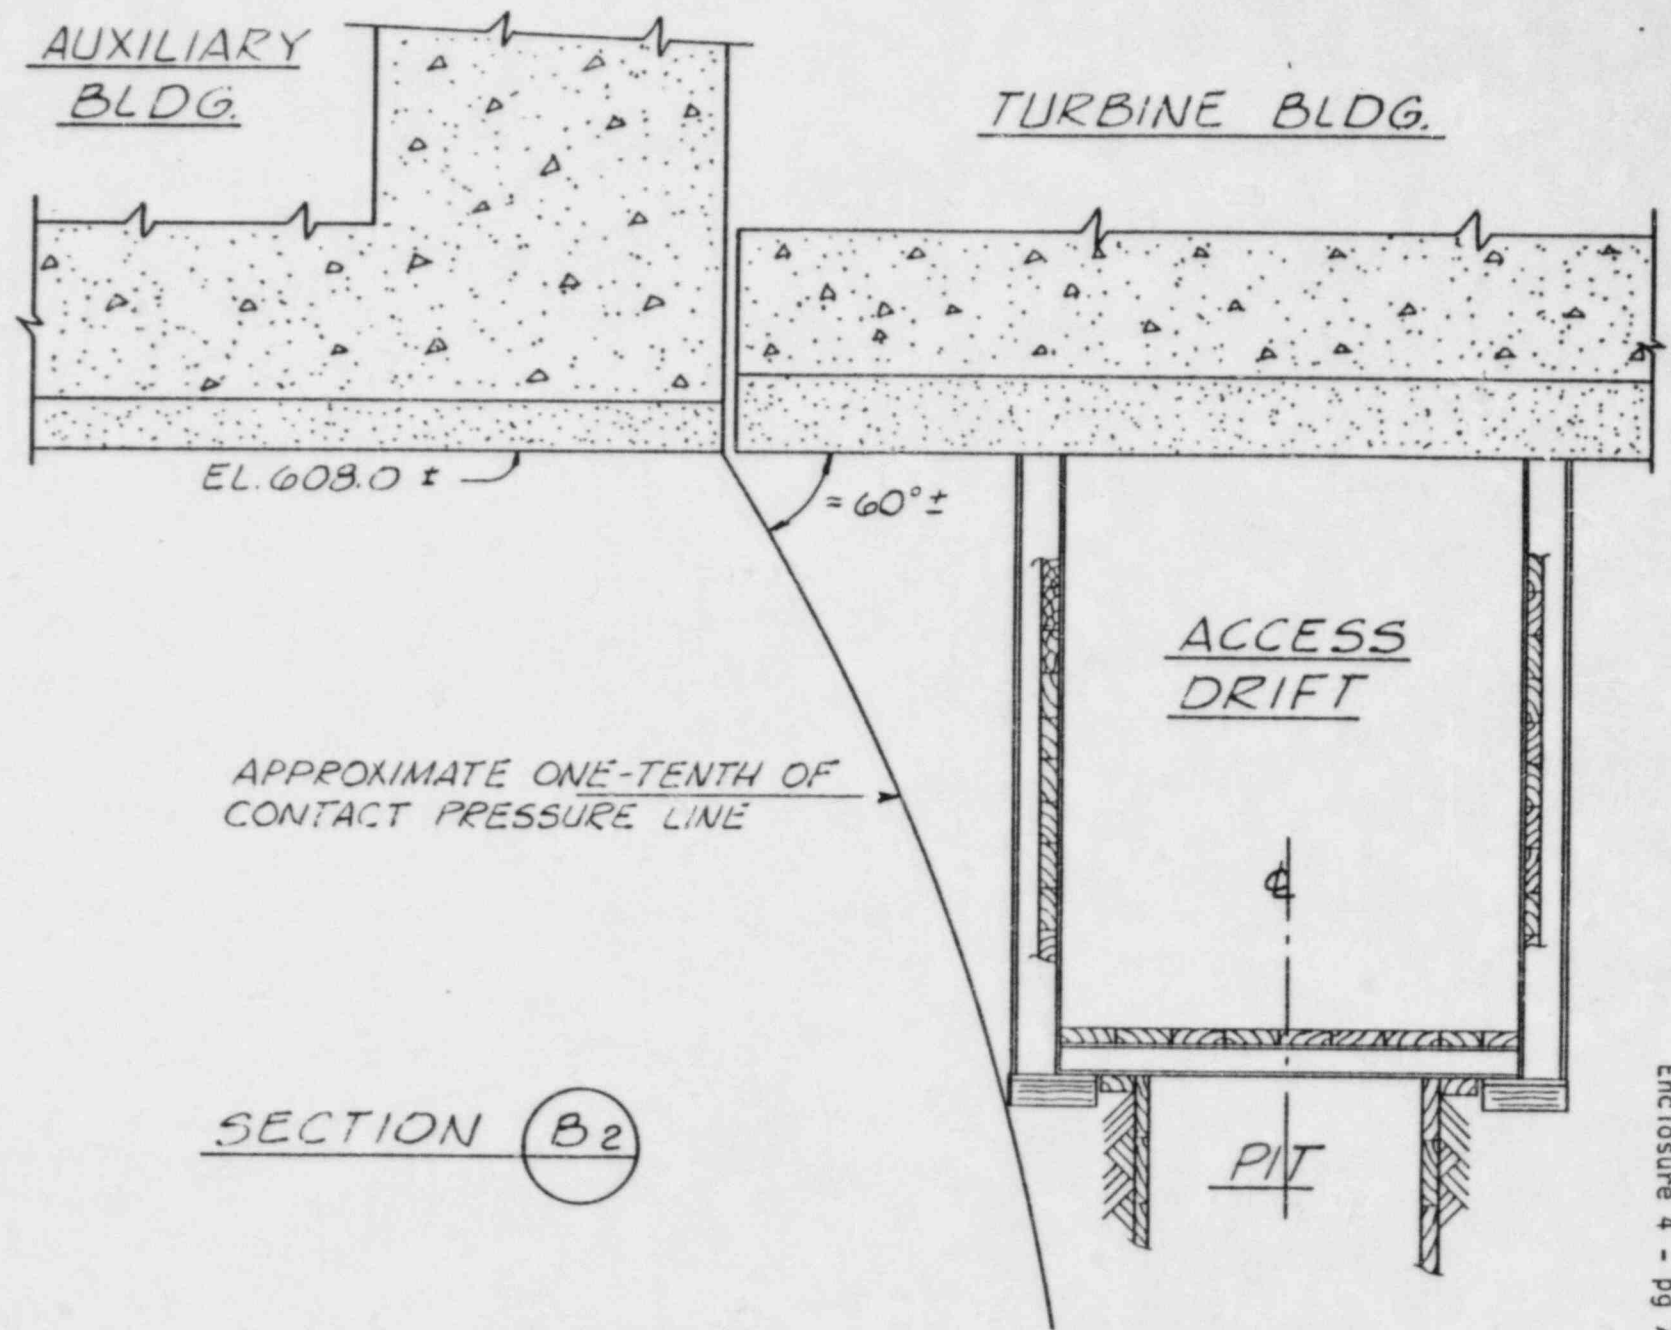
The effect that the excavation will have on the "bulb of pressure" beneath the auxiliary building must also be evaluated. The vertical pressure in the supporting soil reduces with depth. The pressure lines on Figures A2 and B2 represent the bulb of pressure corresponding to one-tenth of the contact pressure beneath the foundation of the auxiliary building. Thus, it is seen from Figures A2 and B2 that this one-tenth ratio line does not intersect the access drifts.
