UNITED STATES
NUCLEAR REGULATORY COMMISSION
REGION III
799 ROOSEVELT ROAD
GLEN ELLYN, ILLINOIS 60137

SUBJECT: SALP III EVALUATION PERIOD

MIDLAND UNITS 1 AND 2

Major Events Ladder

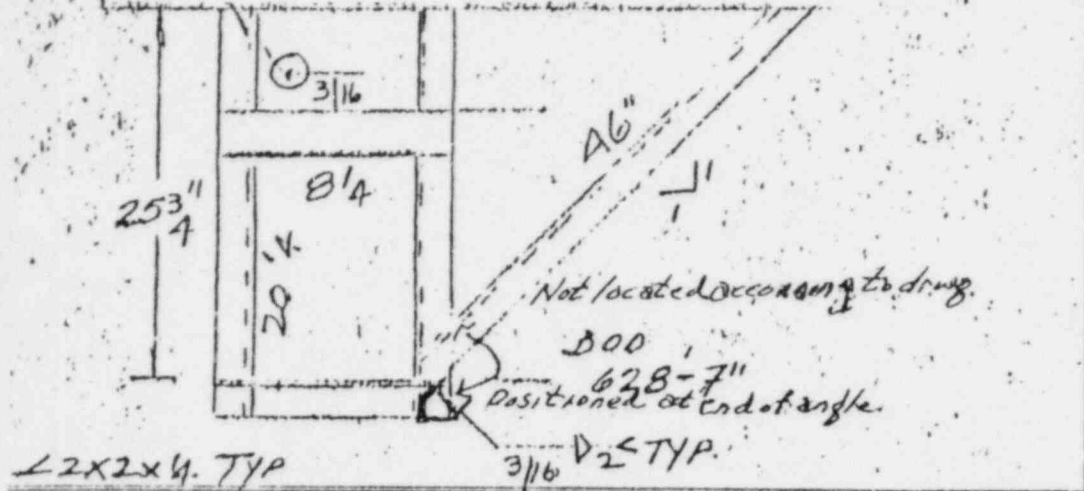
CUTTING LIST		QUANTITIES	
SHEET	ANGLE		
COPY # 3 INCLOSURE			
NOT ACCORDING TO BECHTEL			
DRWG. C-898			
DETAIL 7			
ILLUSTRATION ONLY			
#31

CUSTOMER HOLD POINTS **NONE** DIMENSIONAL TOLERANCES: **+ 1/4"**
 WELDING PROCEDURES: **MA-CCP 1A** **IPCCB**
 NOT ACCORDING TO BECHTEL
 DRWG. C-898
 DETAIL 7
 NOT POSITIONED EXIST. ST.
 ACCORDING TO DRWG. (I-BEAM)

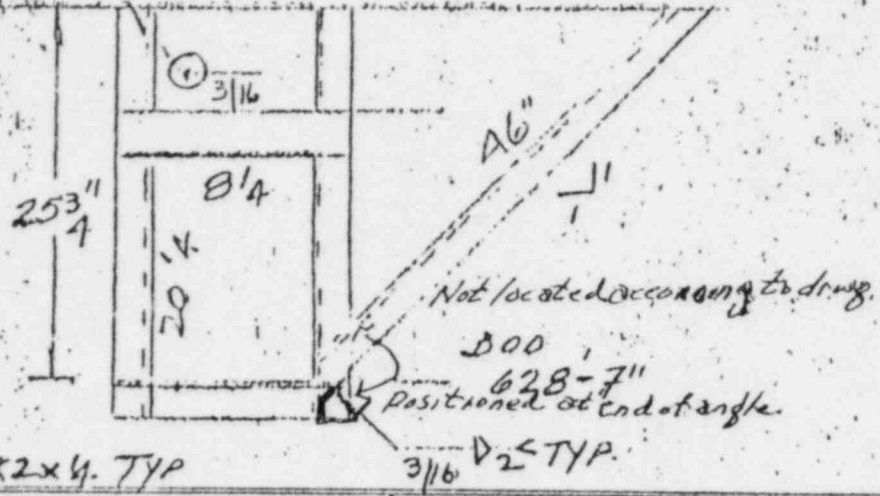
#31

NOT ACCORDING TO BECHTEL
DRWG. C-898
DETAIL 7

NAT POSITIONED EXIST. ST.
ACCORDING TO DRWG. (I-BEAM)
