STRUCTURAL EVALUATION OF THE DIESEL GENERATOR BUILDING -
ASSESSMENT OF THE STRUCTURAL PERFORMANCE
CAPABILITY AND SERVICEABILITY AS POTENTIALLY AFFECTED
BY SETTLEMENT INDUCED CRACKING

TERA CORPORATION

TOPIC TITLE Civil/Structural Design Considerations, Foundations, Concrete/Structural Steel TOPIC NO. 111.5-2, 111.6-2, PAGE 1 OF 3
 ENGINEERING EVALUATION Structural Eval. of the Diesel Generator Bldg CONT. ID. NO. 3201-001-031 REV 0 DATE 12/30/83

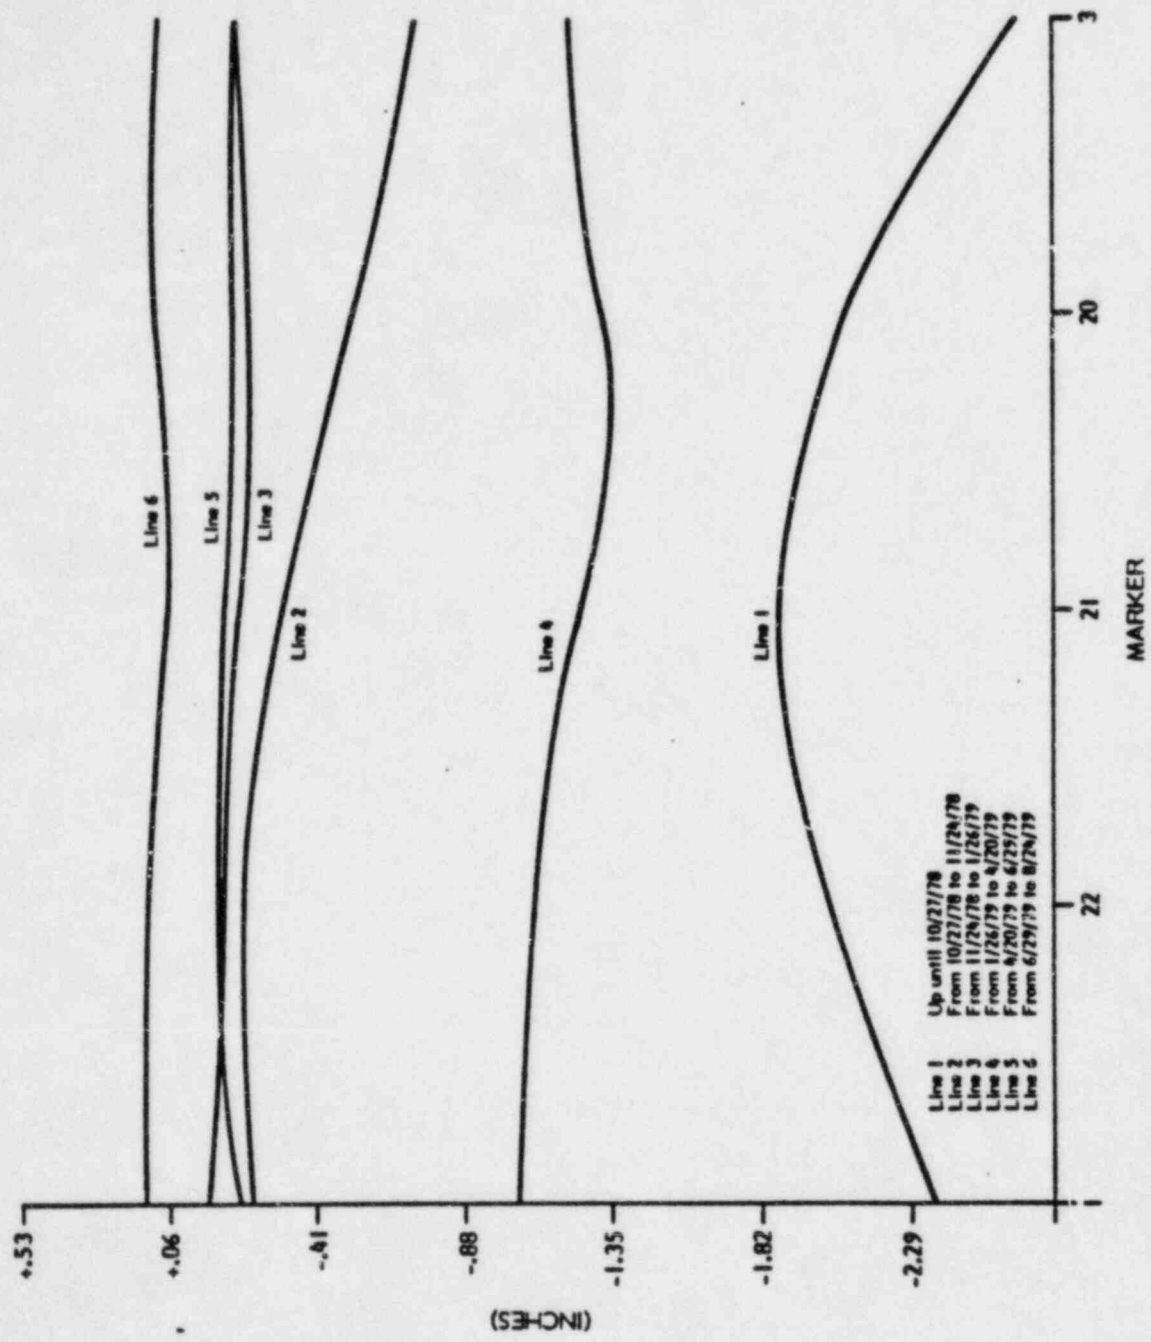
FIGURE 6-3
DIESEL GENERATOR BUILDING
SOUTH WALL
SETTLEMENT INCREMENT

Figure 6-3 shows the incremental settlement for 6 time periods between July 1978 and August 1979 for the south wall of the DGB. The first three measurements show large differential deformations and introduction of curvature in the wall. The latter ones show stabilization of differential settlements implying that the wall is still settling but as a rigid unit, introducing little additional in-plane bending. For more recent recordings the stabilizing trend is even more noticeable. Study of the foundation curvature variation and deformation of the building with respect to its rigid body motion point toward the same trend. This is supported by an evaluation discussed in reference 4, where it was noted that the settlements occurring during the time periods represented by lines c and d (reference 4, figure DGB-7), were those that are expected of a rigid body. In figure DGB-7, line c represents settlement during the surcharging period (1/79 - 8/79) and line d represents estimated settlement during the post-surge period (9/79 - 12/2025). The point here is that the early cracking occurred when the building was only partially completed. Upon completion, the five sided (four walls and a roof) structure is now responding as a stiffer, essentially rigid body as would be expected.

Hence during its construction stage, the building underwent substantial differential settlement that introduced in-plane curvature in the walls with resulting stress and cracking compounded with normal shrinkage cracking. As the building was completed and the concrete aged, its tended to behave more and more as a rigid unit, the whole foundation (or building) moving as a plane (or a unit). The recent data indicates that for the last four years the building has generally settled as a rigid body introducing relatively little additional distortion in the structure. We expect this behavior to persist in time.
