CPL-19-103
Revision 1
July 1984
CPL019.0103

ANALYSIS OF
UNREPAIRED FLAW INDICATIONS
AT
BRUNSWICK STEAM ELECTRIC PLANT
UNIT 2

Prepared for:
Carolina Power and Light Company

Prepared by:
NUTECH Engineers, Inc.
San Jose, California

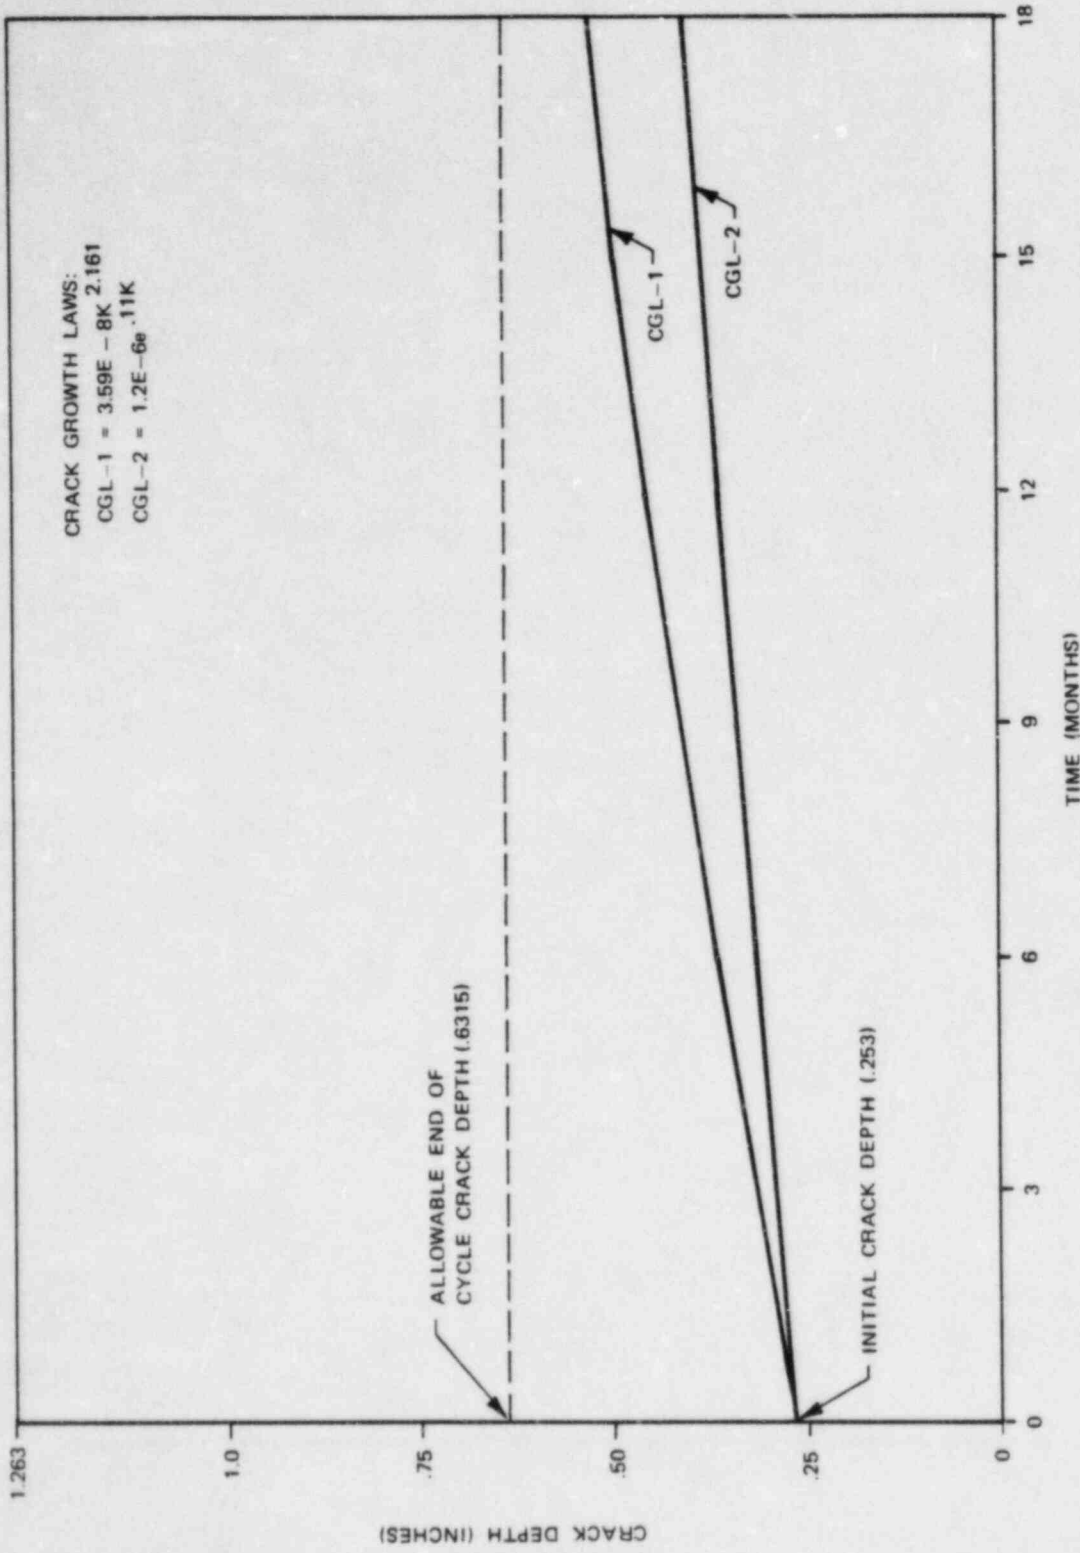
Figure 2.8
 CRACK GROWTH - VS - TIME, WELD 28B5
 (BRUNSWICK 2)

Among the 60° transducer indications that appeared to grow, the flaw that apparently grew the most was on weld 28-B-5 (6.5% growth in 6 months). If the deepest flaw indication grew at this rate over the next 18 months, it would still not exceed the allowable end-of-cycle depth.

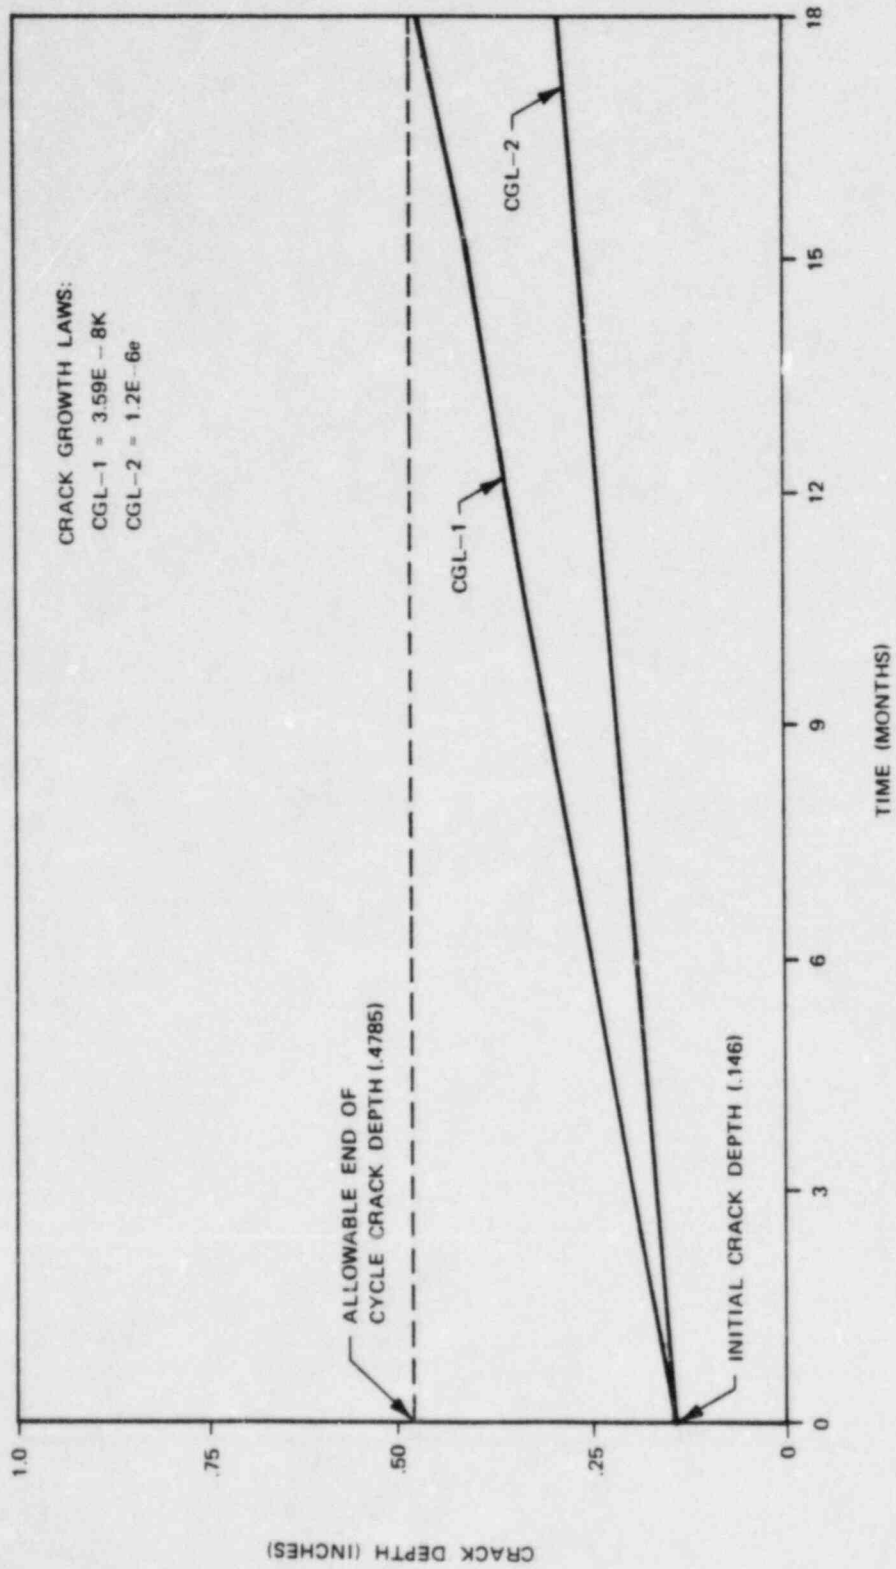
Figure 2.9
 CRACK GROWTH - VS - TIME, WELD 22AM5
 (BRUNSWICK 2)

Two welds (22-AM-5 and 22-BM-1) in the 22" recirculation piping have reportable flaw indications. Weld 22-AM-5 is a cross-to-pipe weld and weld 22-BM-1 is an end cap-to-pipe weld. The majority of the flaw indications are circumferential and all are tabulated in Table 1.0. The allowable end-of-cycle crack depth is 2/3 of the Reference 7 value, in accordance with Generic Letter 84-11.

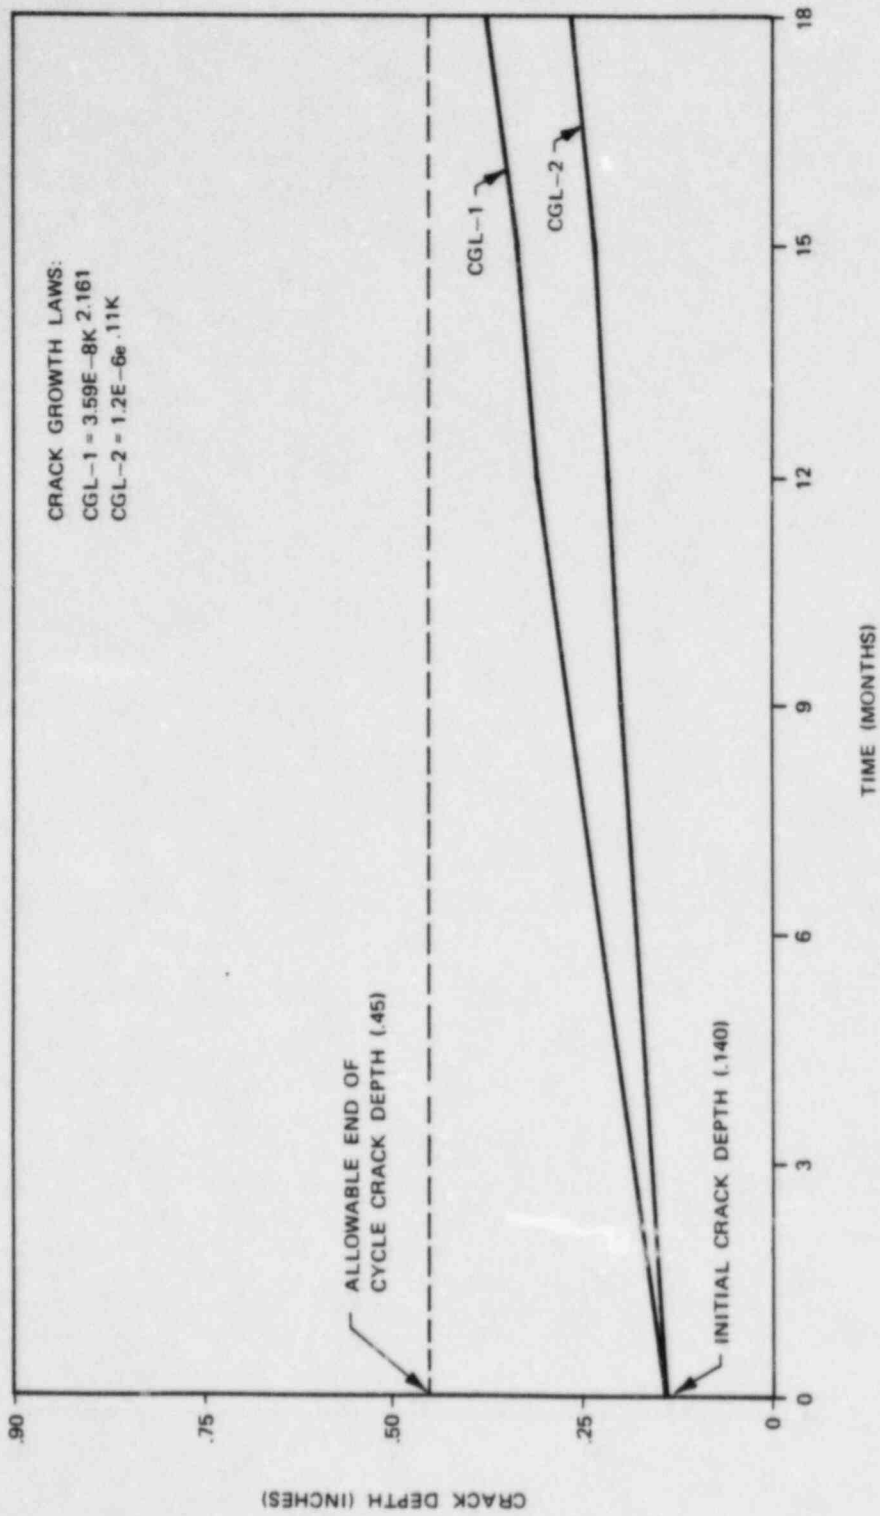
Figure 2.11
CRACK GROWTH - VS - TIME, WELD 20A2
(BRUNSWICK 2)

As previously mentioned, weld 2E11-20"-A2 had no reportable indications in the Spring, 1984 inspection.

However, an analysis was still performed using data from the October-November inspection when indications were found. The indications are tabulated in Table 1, and the allowable end-of-cycle crack depth is 50% from References 6 and 7.
