Environmental Qualification Test Report
of
Raychem Nuclear Cable Breakout and End Sealing Kits
for
Raychem Corporation
Menlo Park, California

In the matter of Alabama Power Company

REPORT NO. 58442-2
OUR JOB NO. NDO 58442
CONTRACT ---
YOUR P. O. NO. A01183

ENVIRONMENTAL QUALIFICATION TEST REPORT
OF
RAYCHEM NUCLEAR CABLE BREAKOUT AND END SEALING KITS
FOR
RAYCHEM CORPORATION
MENLO PARK, CALIFORNIA

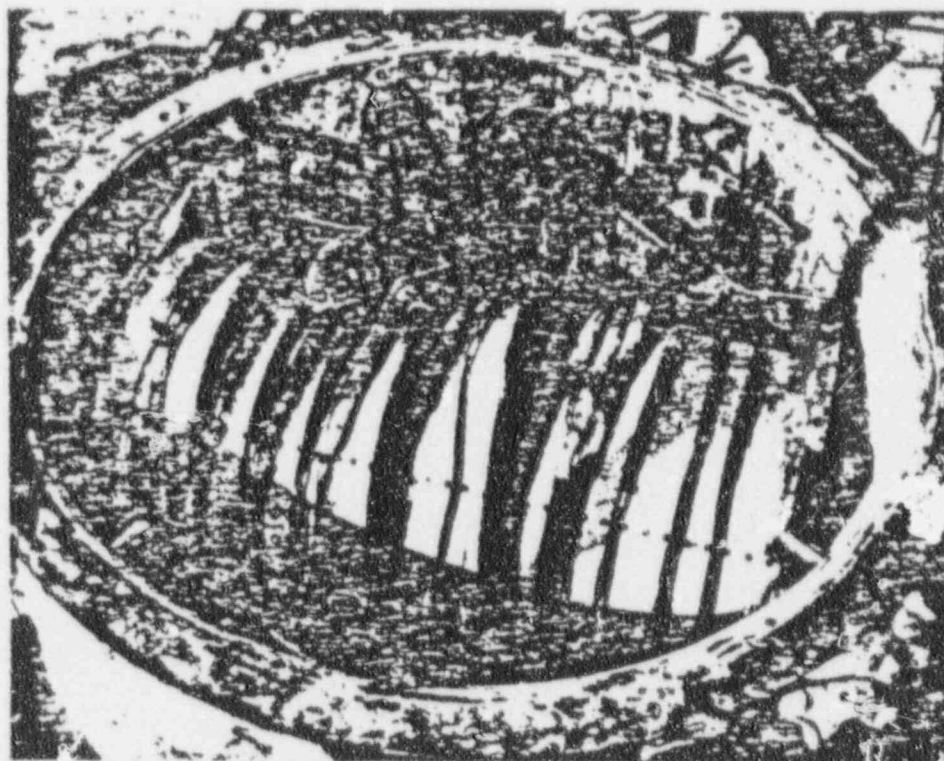
FIGURE 8. Test Chamber and Samples

At the conclusion of the test profile (Figure 5), the test vessel was flooded with tap water. The specimens were then given a voltage withstand test, and the insulation resistances measured. The results of the insulation resistance tests are given in Table 1. The vessel was then opened and the cause for some of the specimens being unable to hold rated voltage investigated. The test vessel with the specimens in place is shown in Figure 8. Figure 9 shows the test specimens after removal from the test vessel.

Some specimens had high values of insulation resistance throughout the simulated LOCA/MSLB test but dropped in insulation resistance or did not pass the voltage withstand test when the vessel was flooded with water. It was found that the low values were caused by cracks in the extension wire insulation away from the mandrel area. The samples again had high insulation resistance values and passed the voltage withstand test when the mandrel was removed from the vessel, the extension wires repaired, and the mandrel re-immersed in water. The insulation values are given in Table 1.

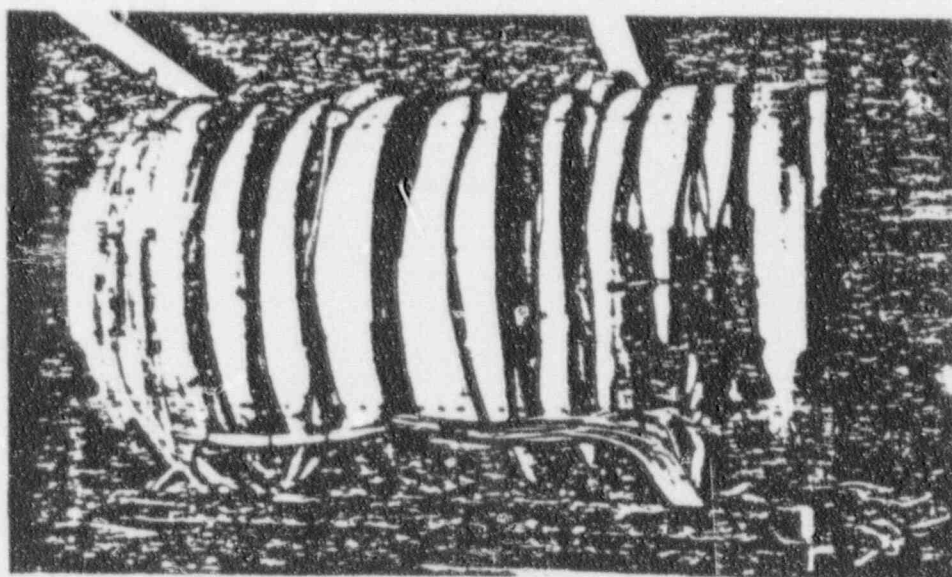
FIGURE 9. Mandrel After Removal from Vessel

The remaining specimens had cracked wire insulation on the test loops around the mandrel. In these cases, the specimens were removed from the mandrel and individually immersed in water for test. In this way, the cracked wire could be isolated. The remaining specimens, except 2-5B, gave high insulation resistance values and passed the voltage withstand tests when tested with the cracked wire insulation out of the water. This could not be done with specimen 2-5B since the crack in the wire insulation was too close to the end of the cable breakout. An insulation resistance value could not be obtained on this specimen because the surface leakage gave an erroneous value. This specimen did, however, pass the voltage withstand test using an aluminum foil ground plane.

Visual examination of the sleeves used over the cable breakouts and end caps showed surface degradation and some superficial crazing. This was most apparent on specimens 2-4 and 2-5.
