Tennessee Valley Authority, Post Office Box 20000, Knoxville, Tennessee 37975

March 27, 1992

SEQUOYAH NUCLEAR PLANT (SQN) - ICE CONDENSER LOWER PLENUM FLOOR MOVEMENT  
AND DEGRADATION

ICE CONDENSER LOWER PLENUM FLOOR  
MOVEMENT AND DEGRADATION

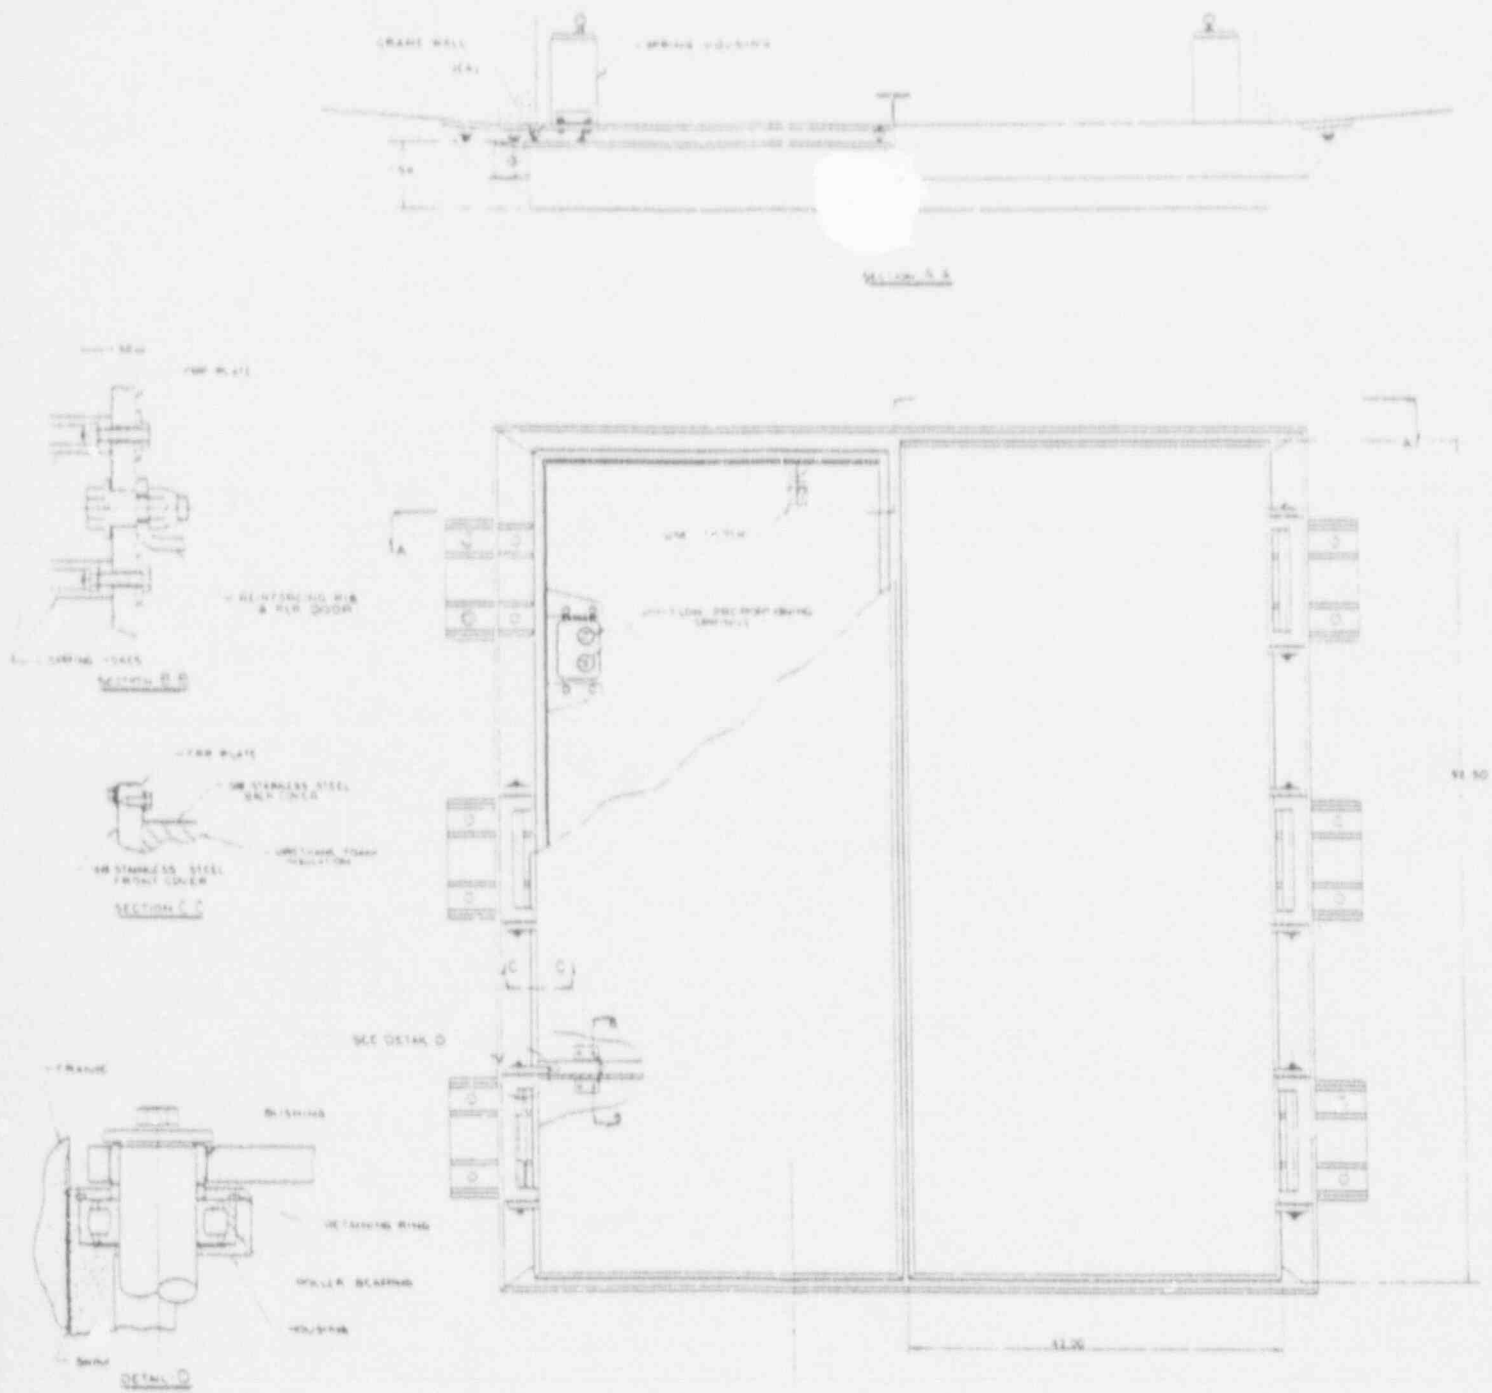
Figure 6.5.9-2 Lower Inlet Door Assembly

The ice condenser is divided into 24 bays, with each bay having a pair of inlet doors in the lower plenum (see Attachments 3 and 4 for the lower elevation door and plan views). These door panels are provided with tension spring mechanisms that produce a small closing torque on the door panels as they open. The magnitude of the closing torque is equivalent to providing approximately 1-psf pressure drop through the inlet ports with the doors open to a position equivalent to the full port flow area. The zero load position of the spring mechanisms is such that, with zero differential pressure across the door panels, the gasket holds the door slightly open. The setting provides assurance that all doors

Upward movement and cracking of the wear slabs were identified in both SQN Units 1 and 2. The cracking is located principally near points of rigid restraint. This upward movement also resulted in mechanical interference with the bottom frames of a number of lower inlet doors, thereby increasing the required opening force beyond the technical specification (TS) limit of 675 inch-pounds. The condition was discovered of the lower inlet doors during the Unit 2 Cycle 5 refueling outage inspections on March 16, 1992, and verified on March 17, 1992, following further engineering inspection and review. The movement of 27 of 48 doors was found to be inhibited, along with localized wear slab cracking and upward displacements of up to several inches. The immediate apparent cause of the wear slab degradation was water intrusion, freezing, and expansion within the floor assembly. A confirmatory inspection of Unit 1 on March 18, 1992, which was operating near 100 percent power three months into Cycle 6 operation, identified similar indications, although to a lesser extent, affecting 11 of 48 doors. TVA conducted an orderly shutdown of Unit 1 to effect resolution to the observed problems, and hot standby was reached at 0247 Eastern standard time on March 19, 1992. The condition resulted in potential operability impacts of the ice condenser from both performance and structural standpoints.

To restore operability to the Unit 1 lower inlet doors, a temporary modification (Reference 1) was performed to remove the lower "L-shaped" sheetmetal flashing and gasket mounted on the wear slab and connected to the flashing piece that forms the jam for the lower inlet doors. This removed the interference with the bottom of the doors and provided physical margin for wear slab growth without interference with the doors. A second temporary modification was implemented to replace the insulation bags installed under the flashing with a double layer of Armaflex rubber insulation fixed in place with adhesive. This provided improved sealing of air-leakage paths and ensured retention under accident conditions. Refer to Attachment 6 for the premodification and postmodification configurations. Following removal of the flashing and gasket described above, a pull-force surveillance test was successfully performed for all of the Unit 1 lower inlet doors, verifying TS operability. The removal of the flashing and gasket provides acceptable configuration during power operation, but would require further alteration to support future outage maintenance activities. As discussed in Sections III and IV, the long-term overall resolution and configuration for Unit 1 will be determined from the ongoing resolution for Unit 2 and subsequent monitoring of the effectiveness of those actions.

To restore operability of the inlet doors, a modification will be implemented to install a sheetmetal flashing configuration that will allow for vertical movement. This will provide a long-term configuration that is acceptable from both operation and maintenance perspectives.

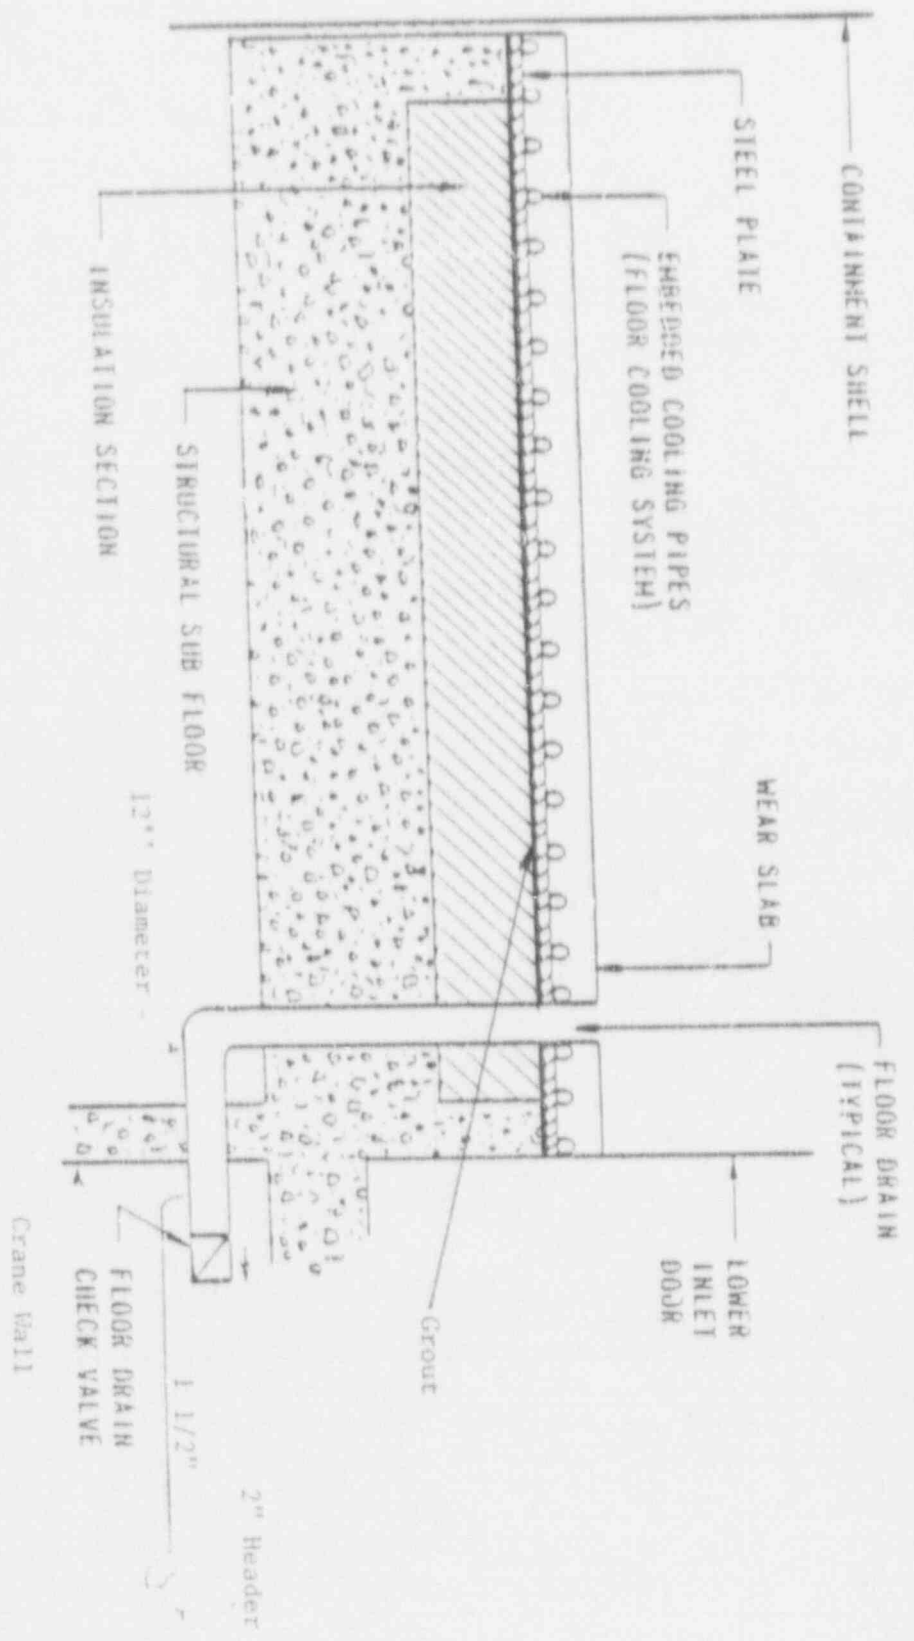
Figure 6.5.1-2 Floor Structure

The ice condenser floor assembly consists of an 18-inch-thick structural slab, spanning between the crane wall and concrete columns at the steel containment vessel (SCV) (see Attachment 5 for the floor assembly details). A vapor barrier (copper armored sisalkraft) is installed on top of the structural slab, with a 15-inch-thick foam concrete layer poured as an insulator. The foam concrete is a very light-weight concrete consisting of portland cement, water, and a foaming agent. On top of the foam concrete, a 1-inch-thick layer of grout was placed to provide a level surface for the placement of a 1/4-inch steel plate that has the glycol piping attached to it. Within each bay, the steel plate consists of two pieces that were "butted" together and spliced with a plate on the top. The splice plate was tack welded to the two bottom plates. The 4-inch concrete wear slab is poured on the top of the steel plate. Reinforcing steel at 6 inches on center in both the radial and circumferential direction was placed with 1/2 inch cover from the top of the slab. Each bay of the wear slab is independent of the next bay and separated with expansion joints. The wear slab is also independent of the crane wall with an expansion joint occurring at the juncture of the crane wall and wear slab. The design required that the expansion joints be sealed with a sealer 1/2 inch deep.

TVA has concluded that the wear slab movement and degradation resulted from water intrusion, freezing, and expansion within the floor assembly. Several paths for floor assembly water intrusion were created by initial construction and design deficiencies. A design change during construction and approved by Westinghouse allowed the removal of the requirement for a sealed metal flashing at the crane wall expansion joint and for elimination of the expansion joint and sealant over two short sides of the middle column support. Additionally, walkdowns have determined that the sealer in the expansion joints, which is required by the designer, is "missing" in several areas. It was also found that the steel plates were warped in some cases at the time of initial installation and were installed on cured hardened grout, leading to gaps within the floor assembly. Subsequent maintenance practices resulted in significant exposure to water during outage maintenance activities (e.g., defrosting and cleaning) and did not establish appropriate controls to prevent water from accumulating or standing on the floor and in the drains during those maintenance activities. Additionally, humid, lower-containment air present in the floor drains during operation would provide a mechanism for condensation and freezing with available gaps and passages.

An additional modification will be implemented before start-up to seal exposed wear slab interfaces and joints at water intrusion paths, and to seal wear slab cracks as appropriate. Possible methods to drain water and/or ice accumulation from the floor assembly are being evaluated. Voids and separation in the floor drains will also be repaired as appropriate.
