UNITED STATES
NUCLEAR REGULATORY COMMISSION
REGION III
799 ROOSEVELT ROAD
GLEN ELLYN, ILLINOIS 60137

Reports No. 50-329/82-07(DETP); 50-330/82-07(DETP)

Docket Nos. 50-329; 50-330

Midland Plant Units 1 and 2
Attachment 3 to
Report on Cable Installation

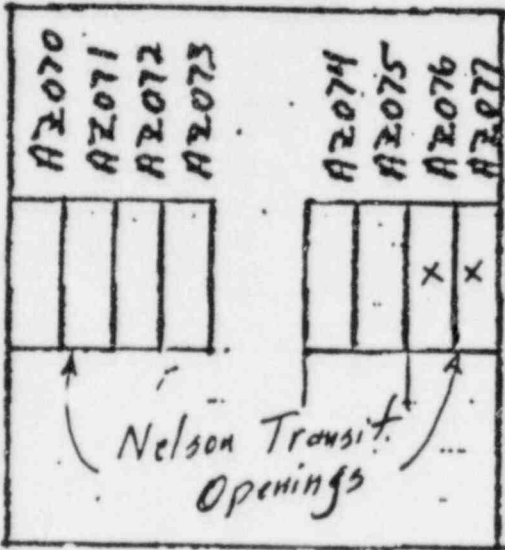
Sec. A

Per E-37 Cable Routing is:
ASD05 AZ077 ASD04

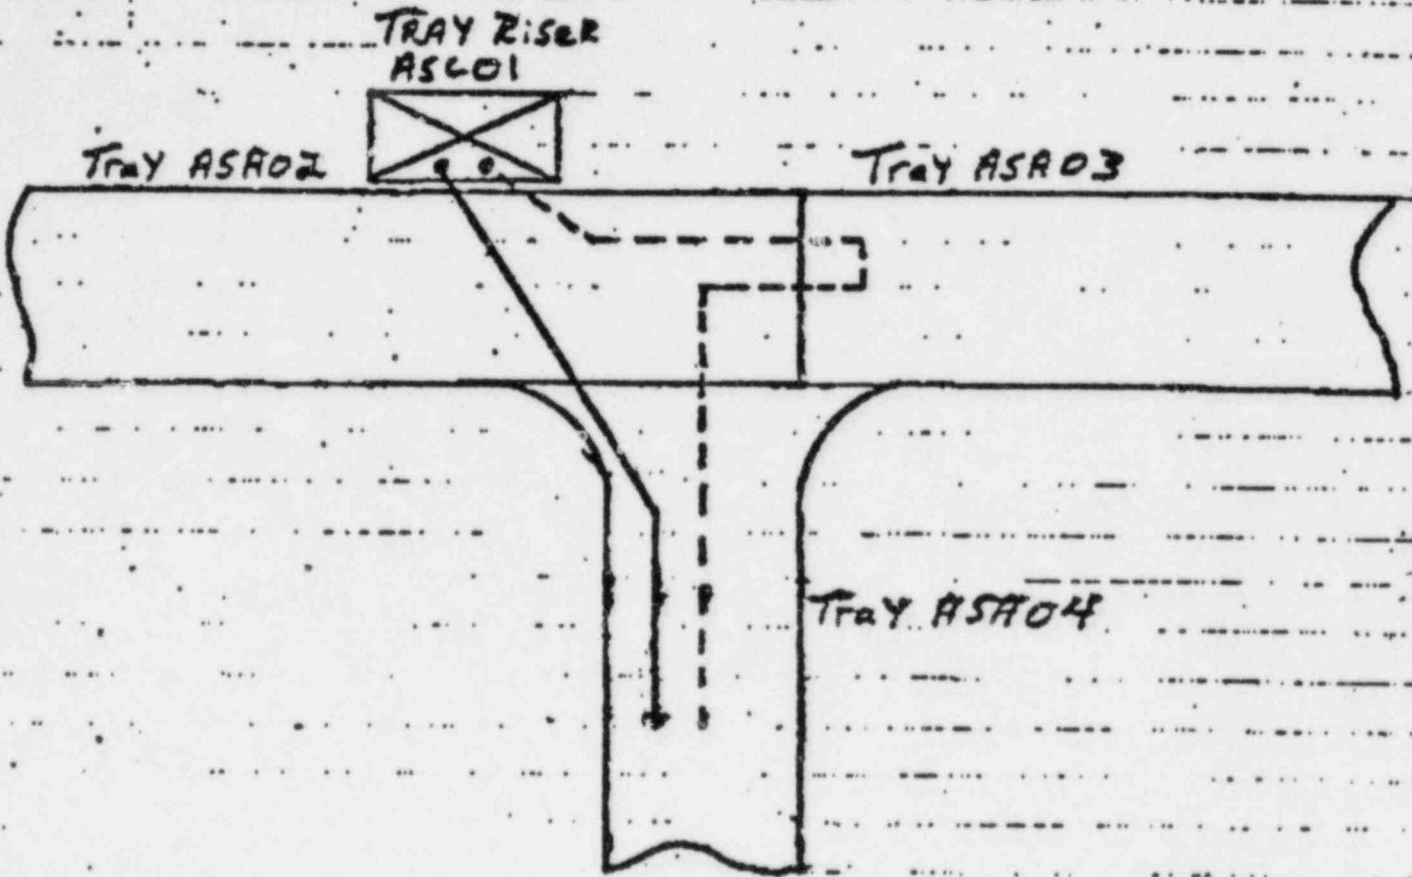
SK 3

—————→ Cable 35^{d7} routed-by field

----- Cable should be - Ter E-37

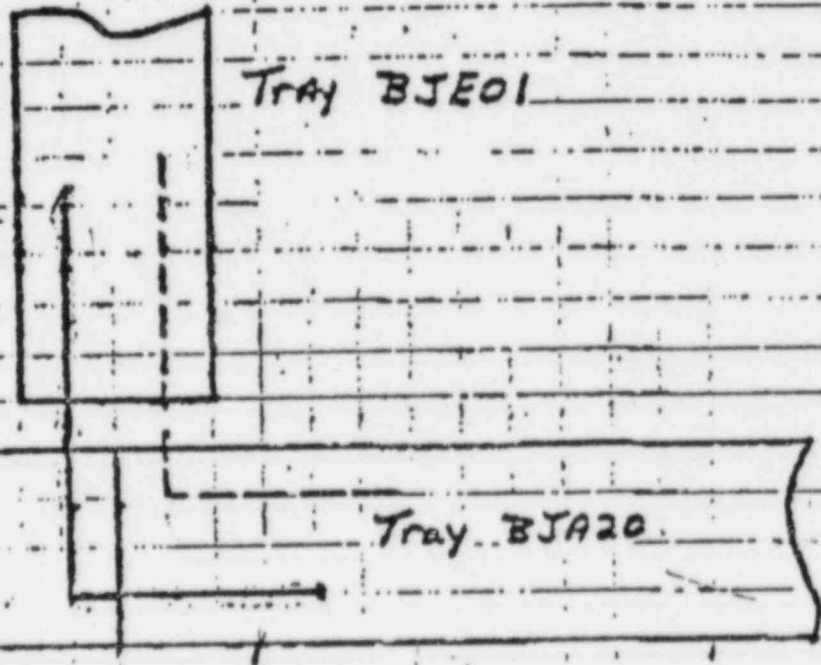
Trays are installed per E-36 and layout dwgs.

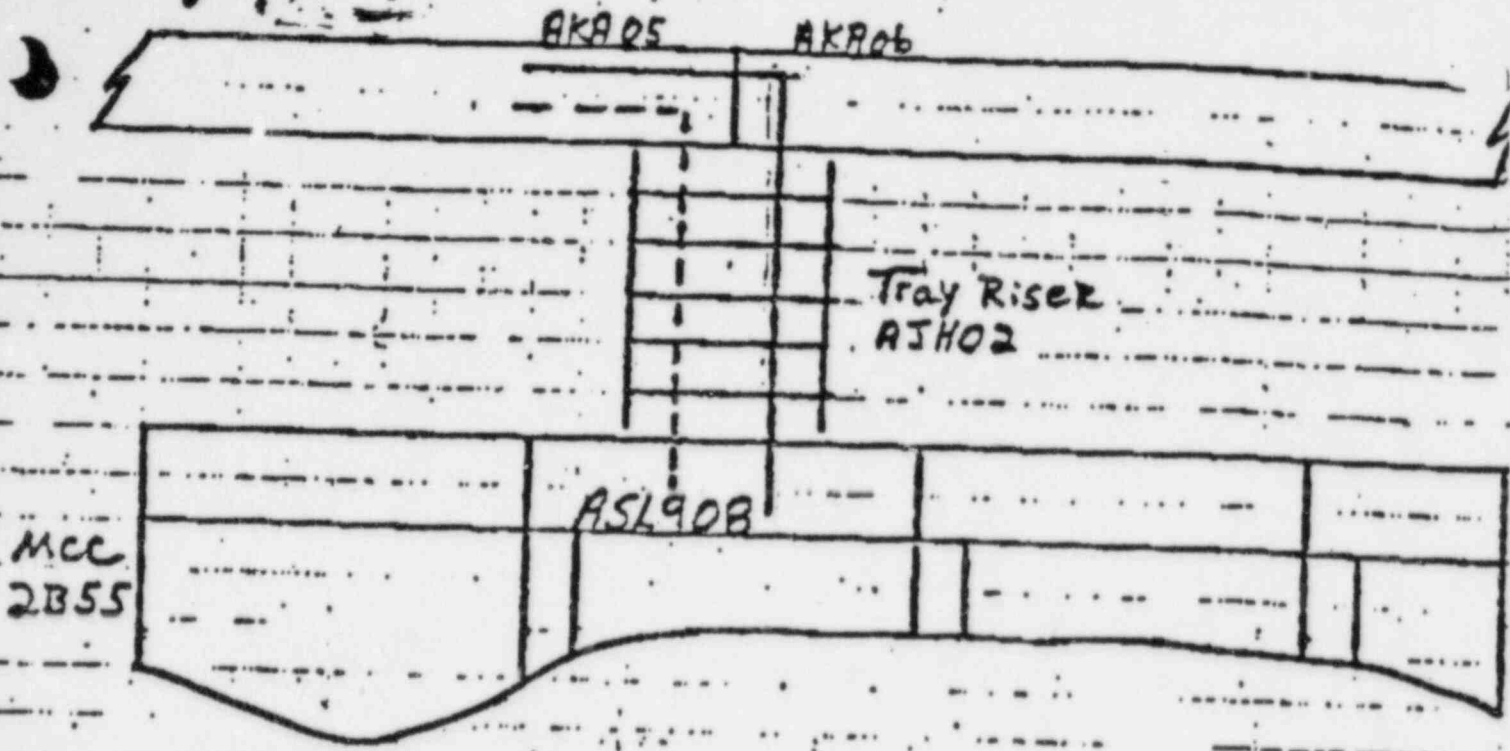
SK-5-A
Midland Plant Units 1 and 2
Attachment 3 to
Report on Cable Installation

"TO" End of cable

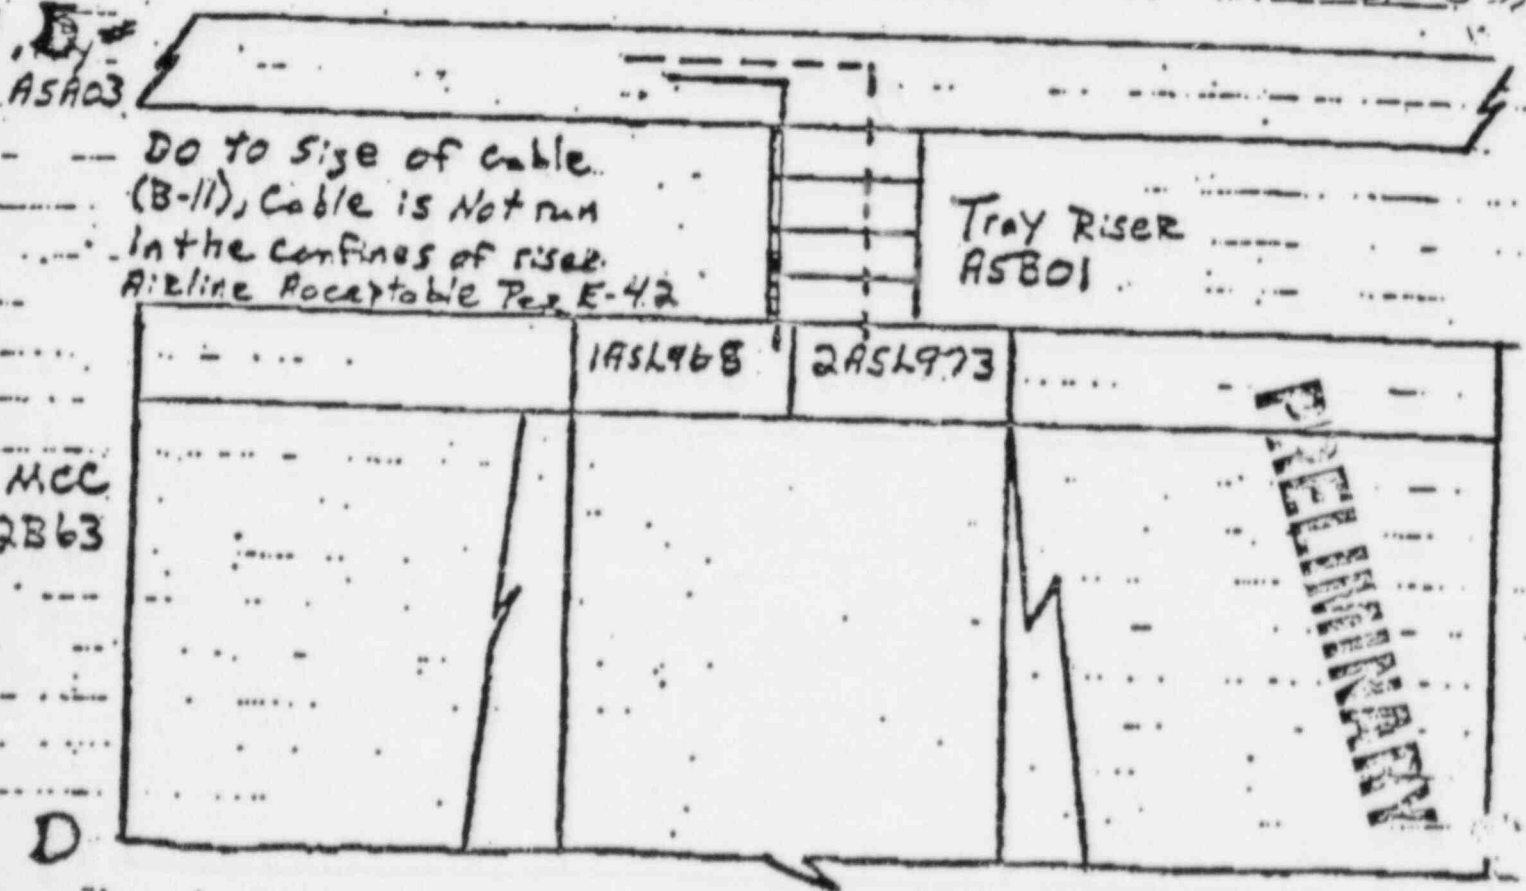
SK-5A and 5B

Cable is routed-by field
Cable should be routed-per E-37

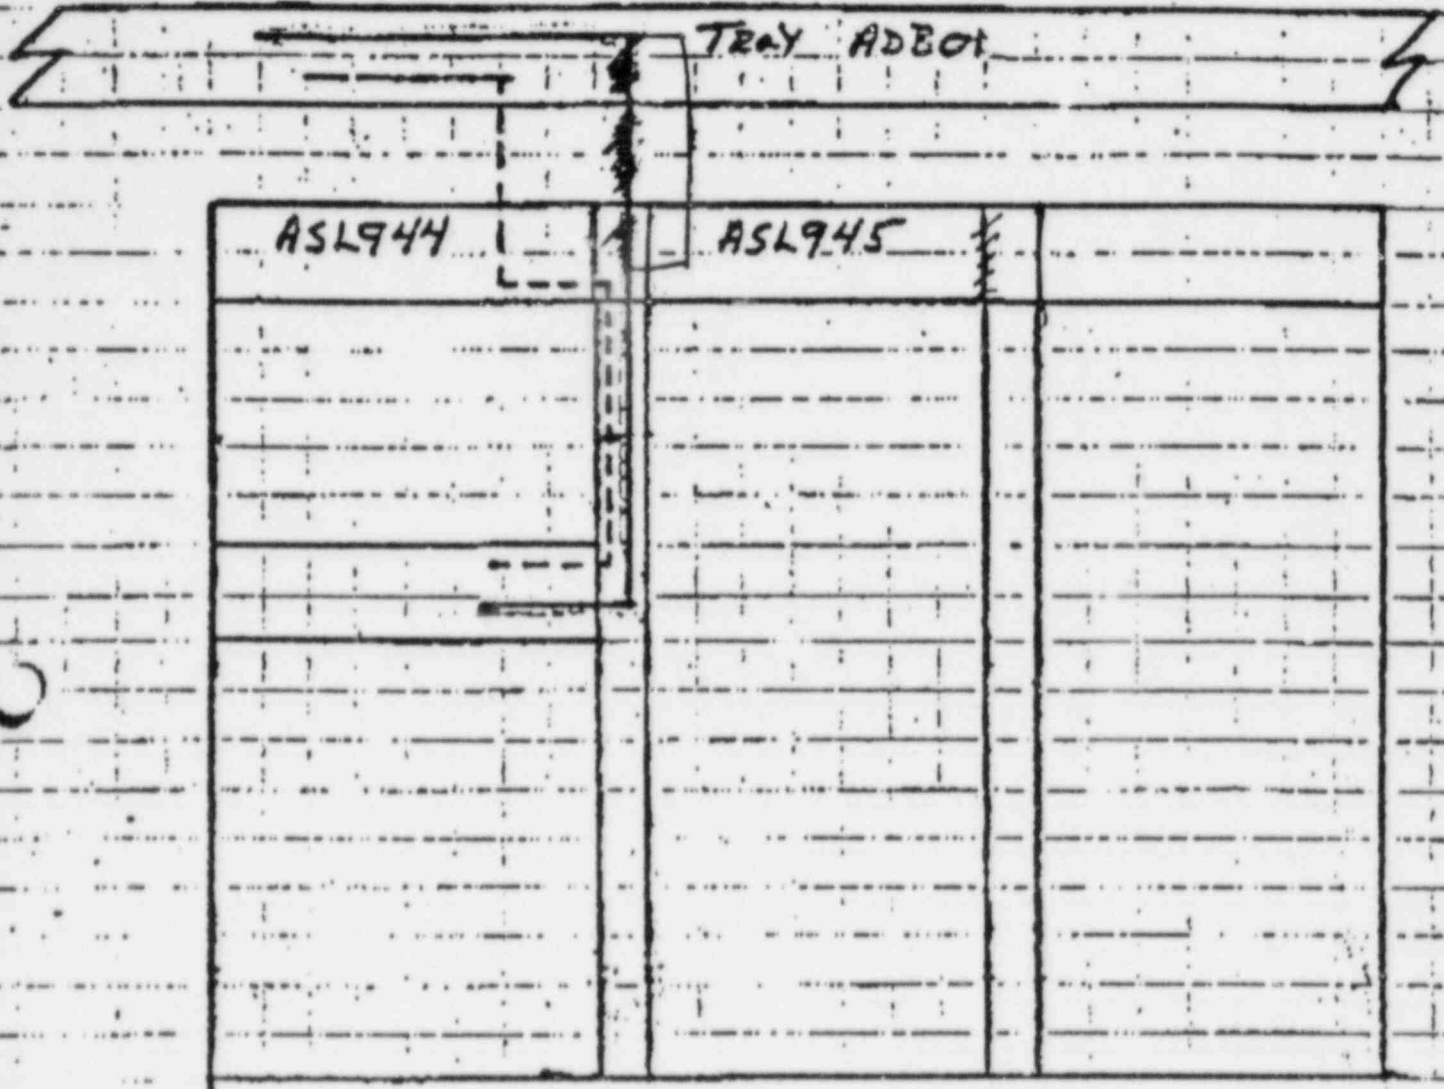
SK-6

Cable is routed by field
Cable should be routed per E-37

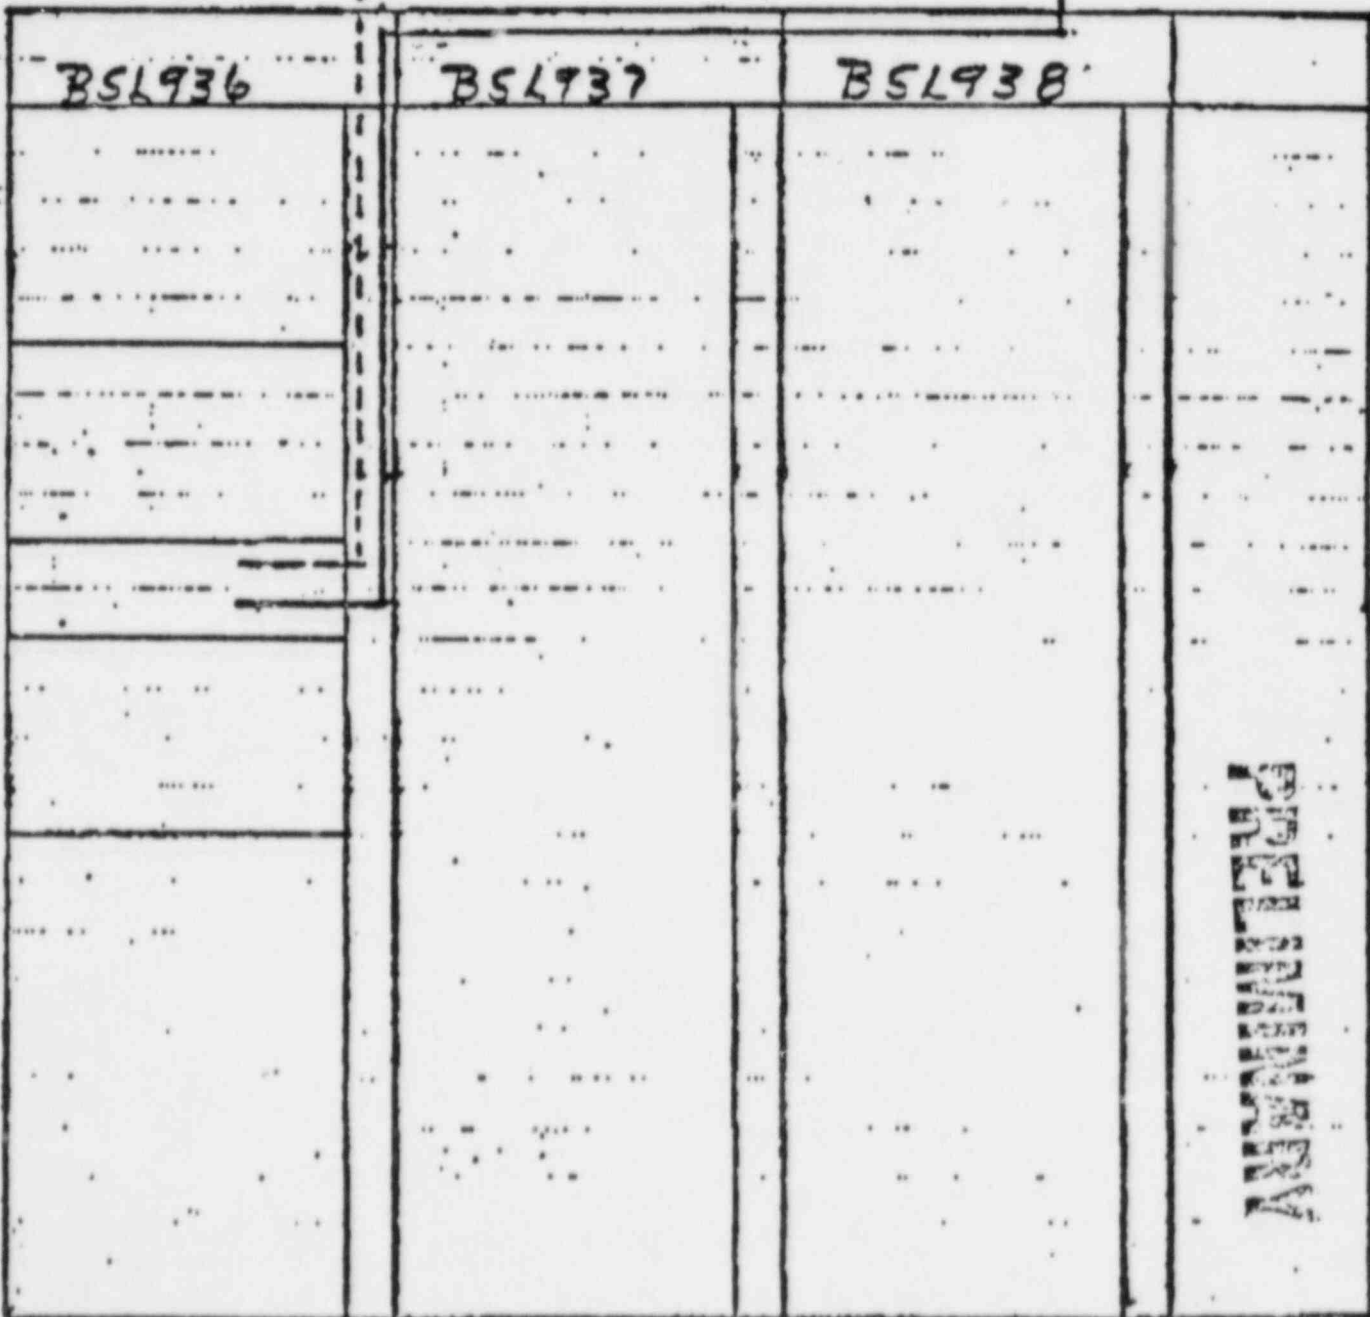
SK-7

Cable is routed by field
Cable should be routed per E-37

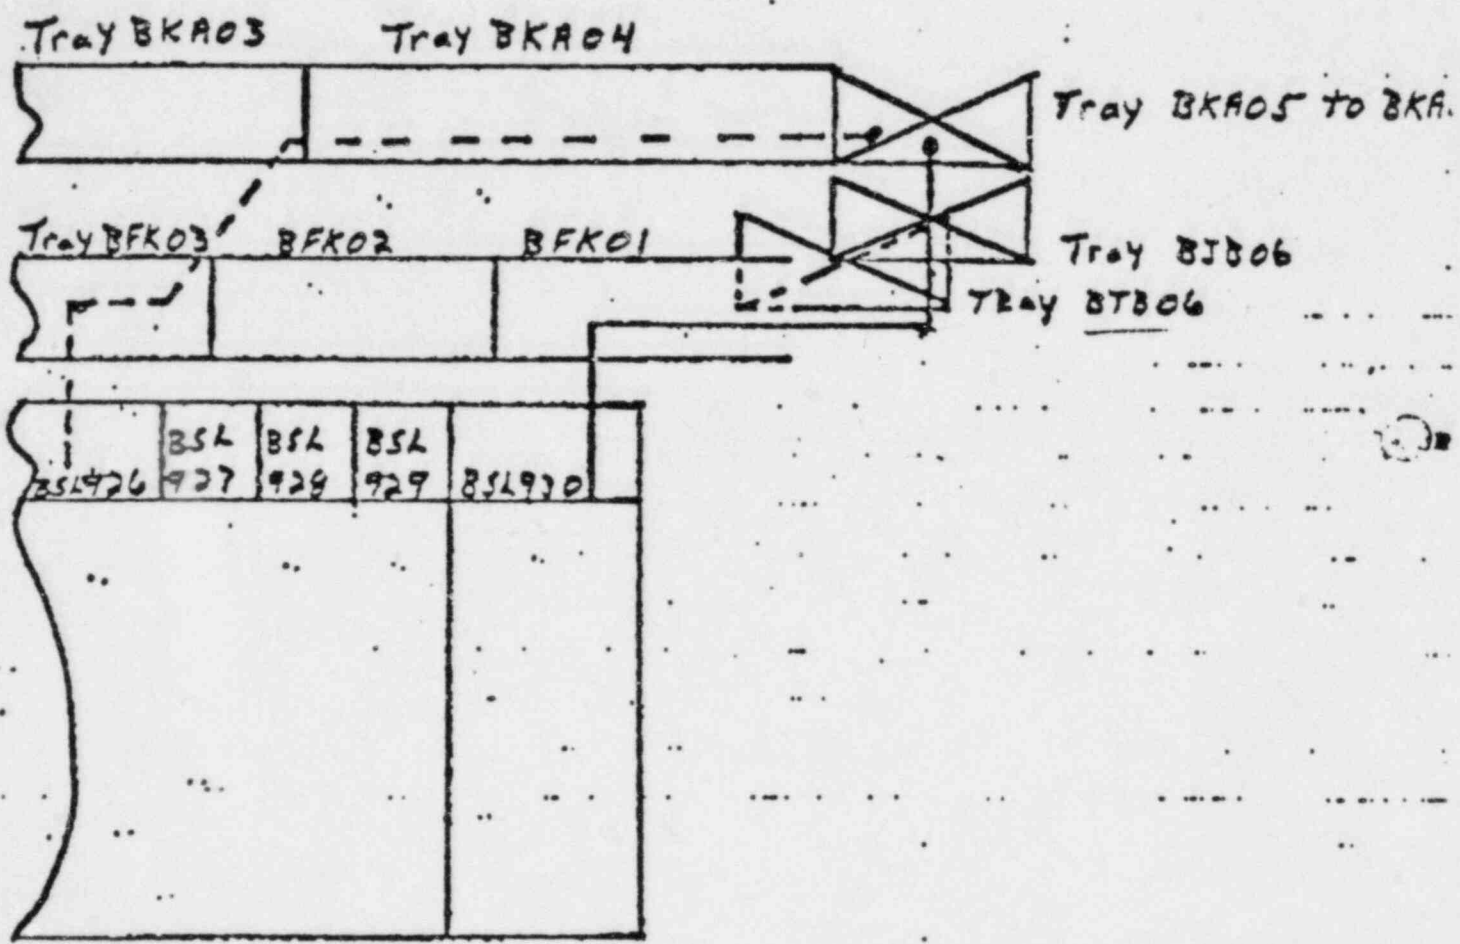
SK.12

— Cable is Routed - by field
 - - - Cable should be - Per E-37

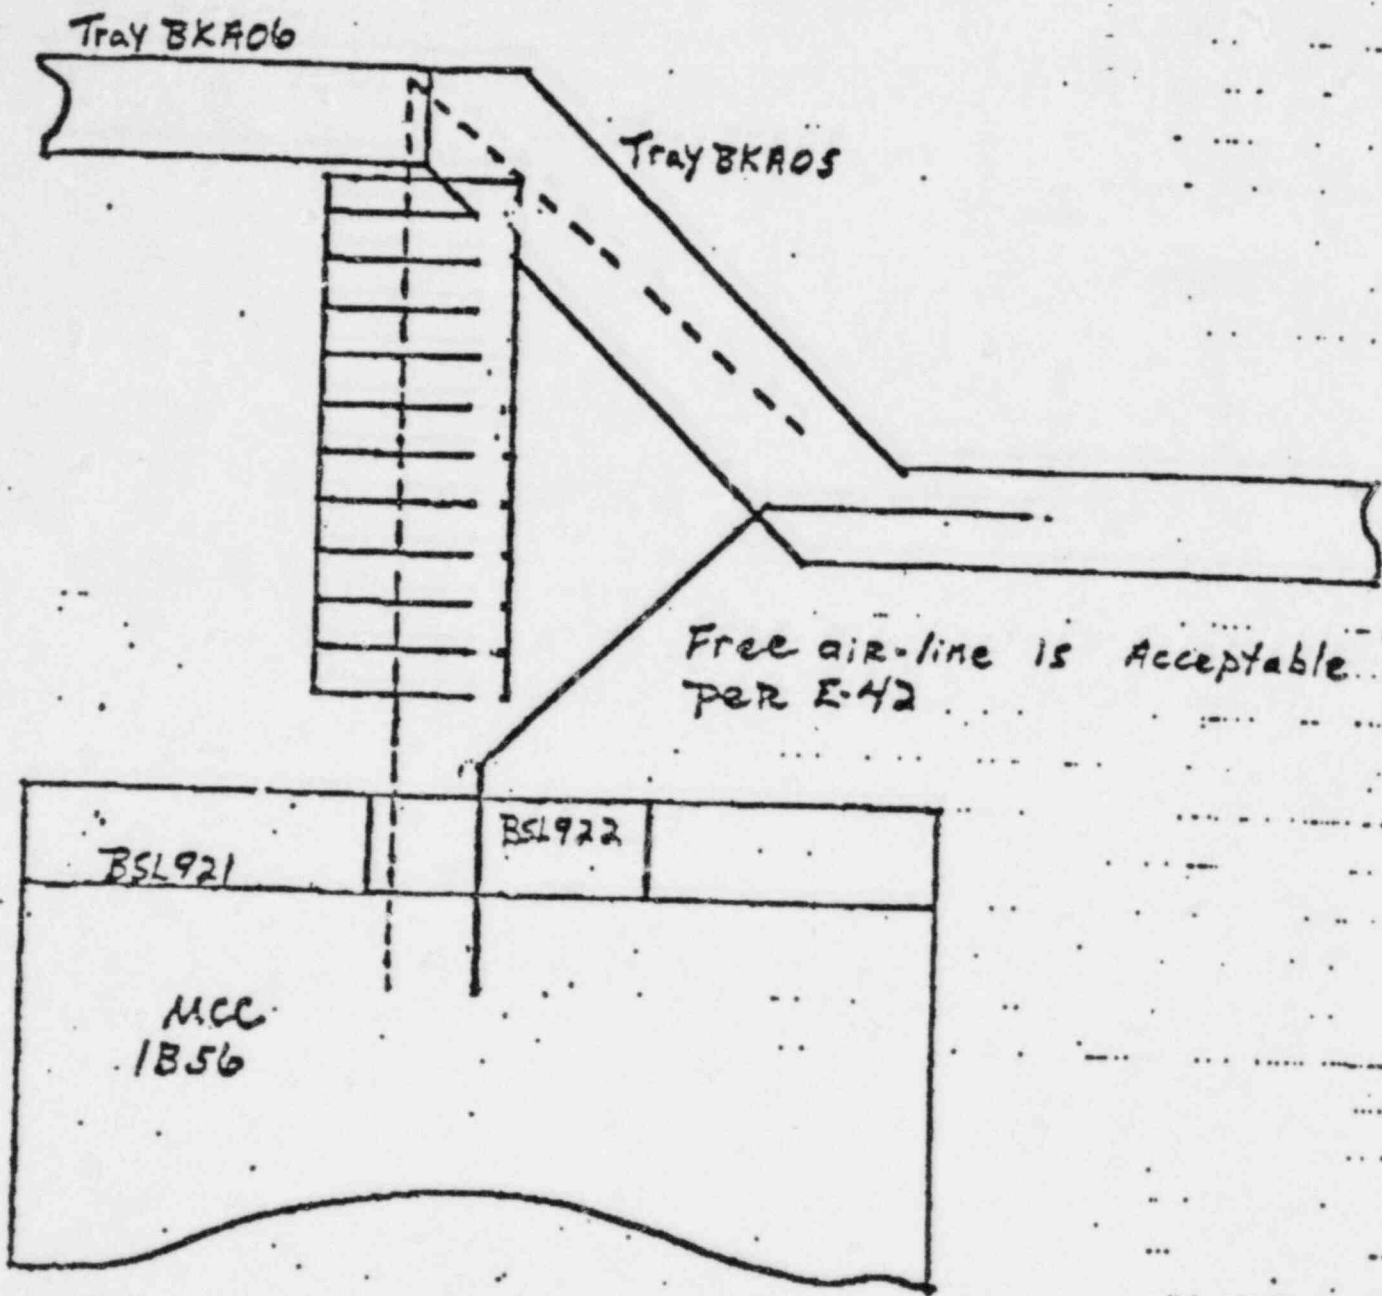
Code = 1003610C
D-1
Design

Free air-line is acceptable
PER E-42

Quality control will inspect all cable transitions from one raceway to another; this inspection will eliminate this concern.

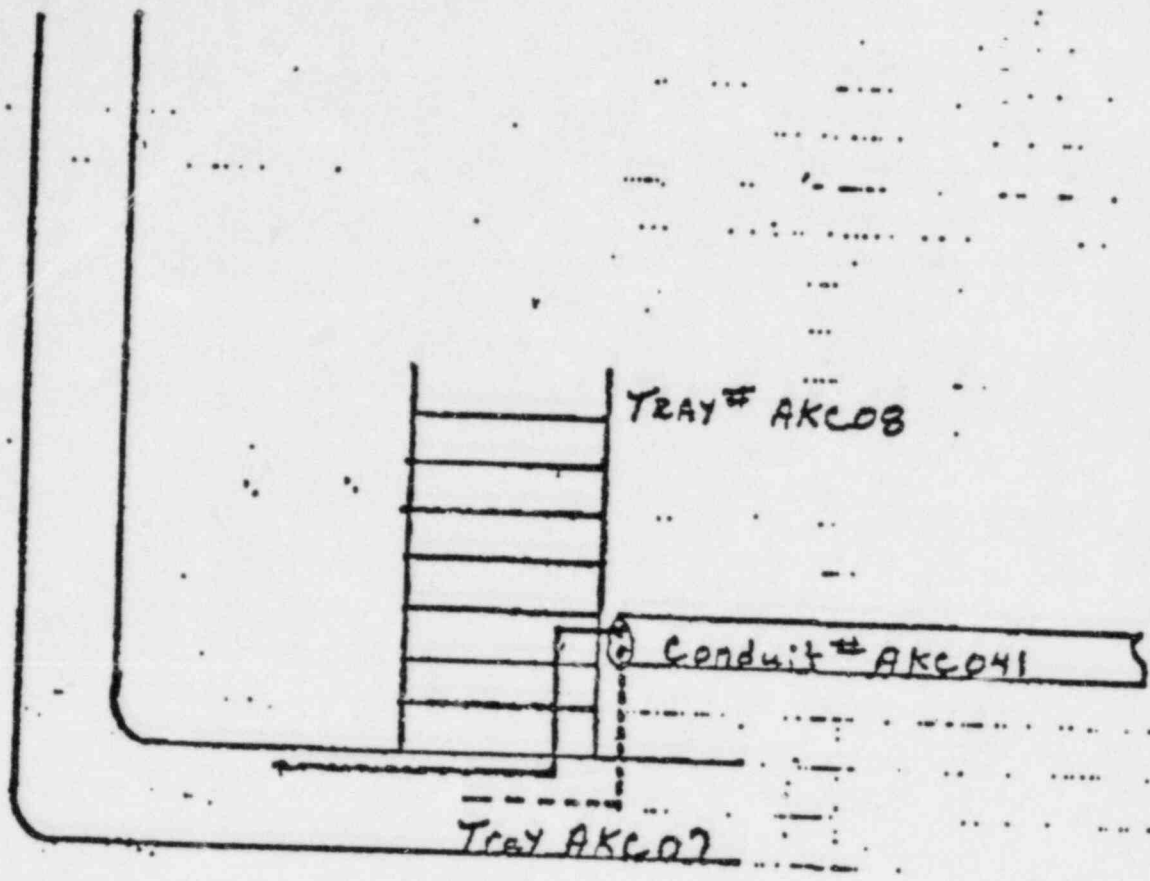
SK.14

———— Cable is routed by field
- - - - - cable should be - Tar E-37

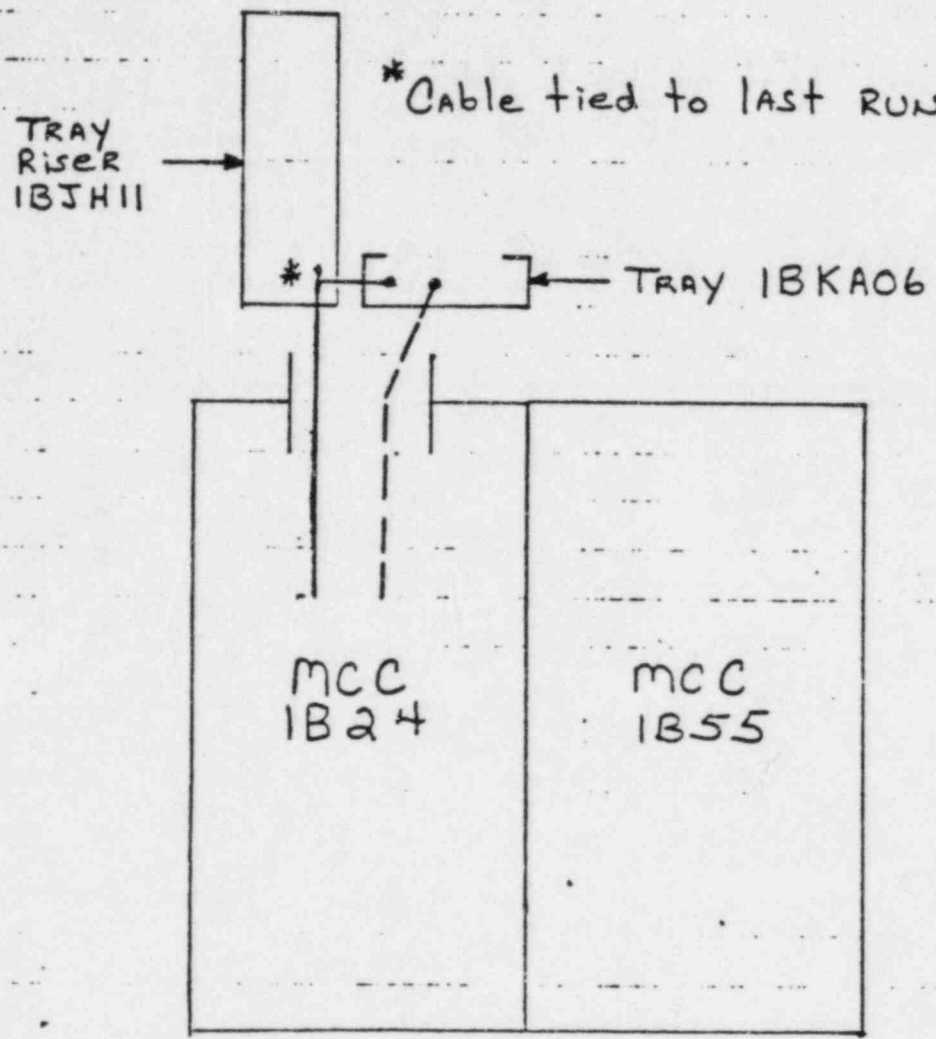
SK#15
Midland Plant Units 1 and 2
Attachment³ to
Report on Cable Installation

————— Actual cable route in field
----- Cable route per E-37

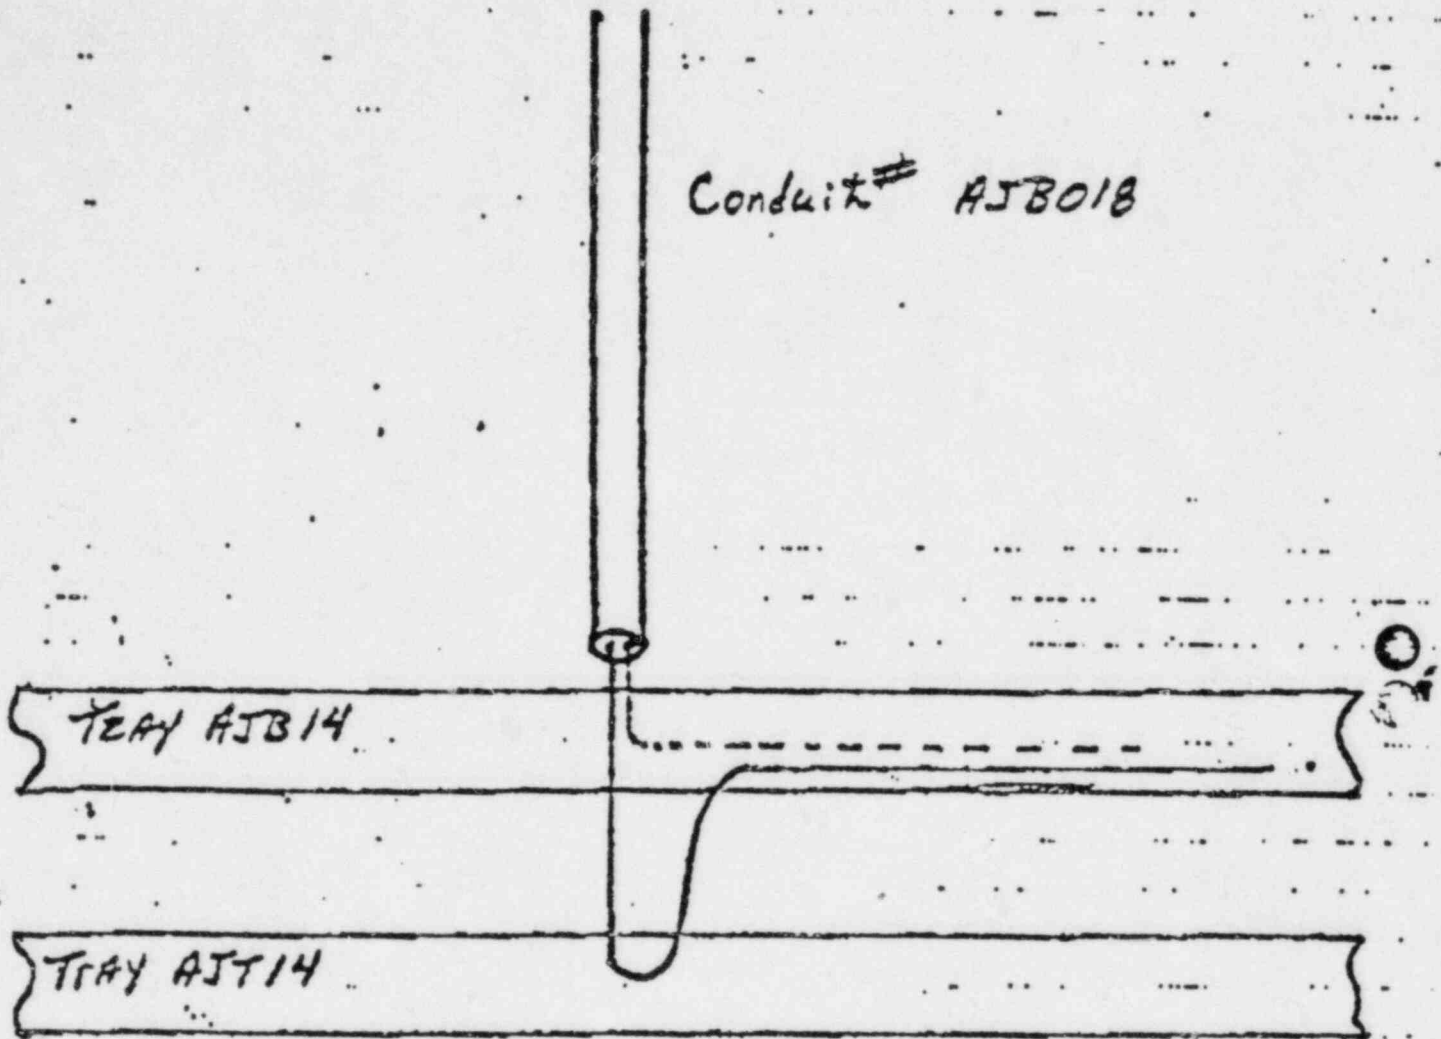
JK-16

———— Cable is routed - by field.

----- Cable should be - Per E-37

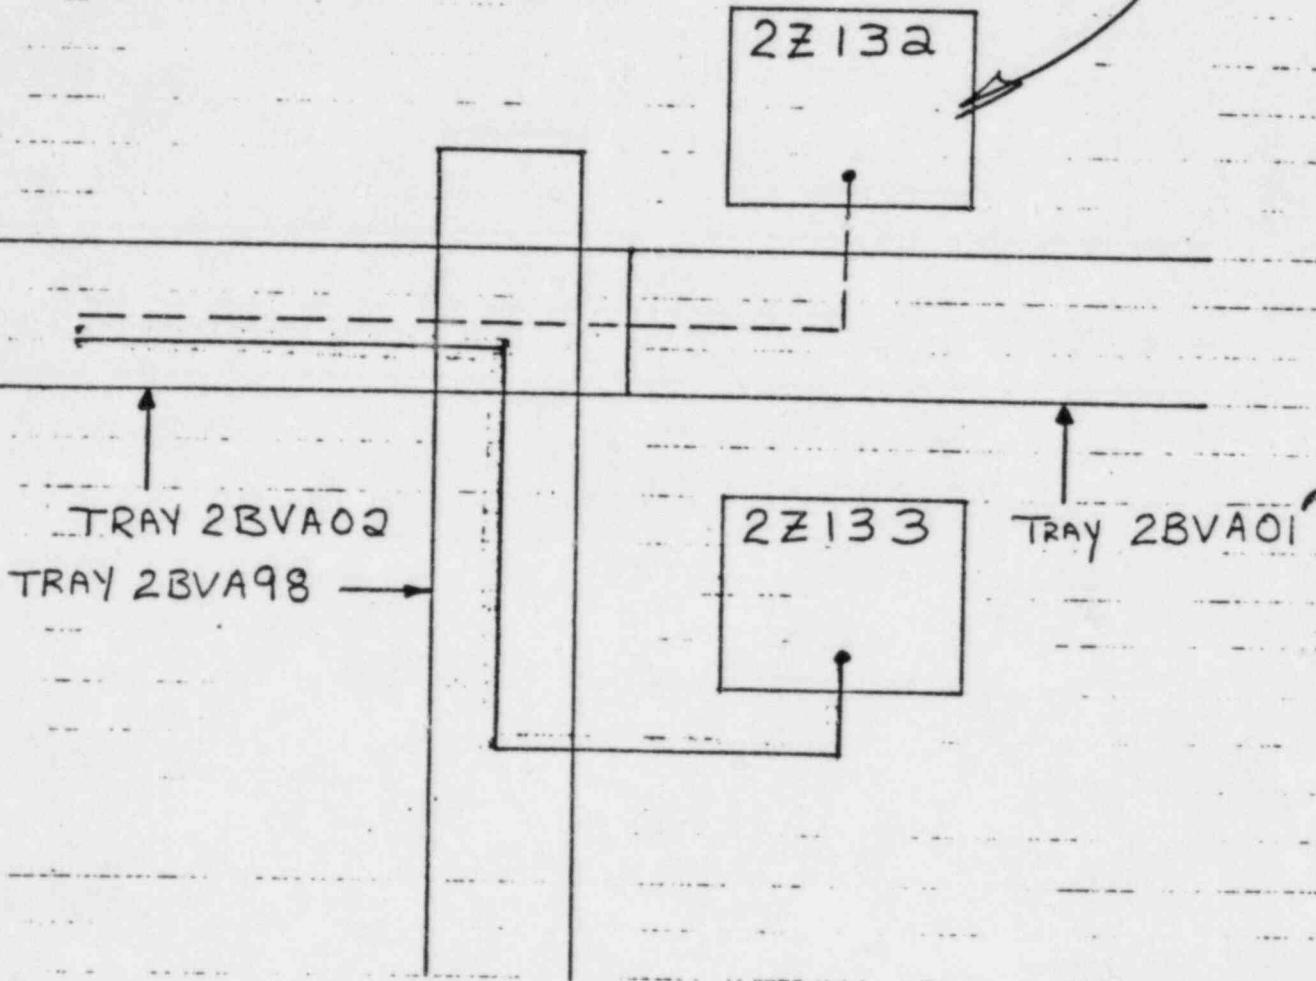
Cable # 2B1067 A
Code # D-1
(CONSTRUCTION)

----- Cable route per E-37

====> Actual Route of cable in field

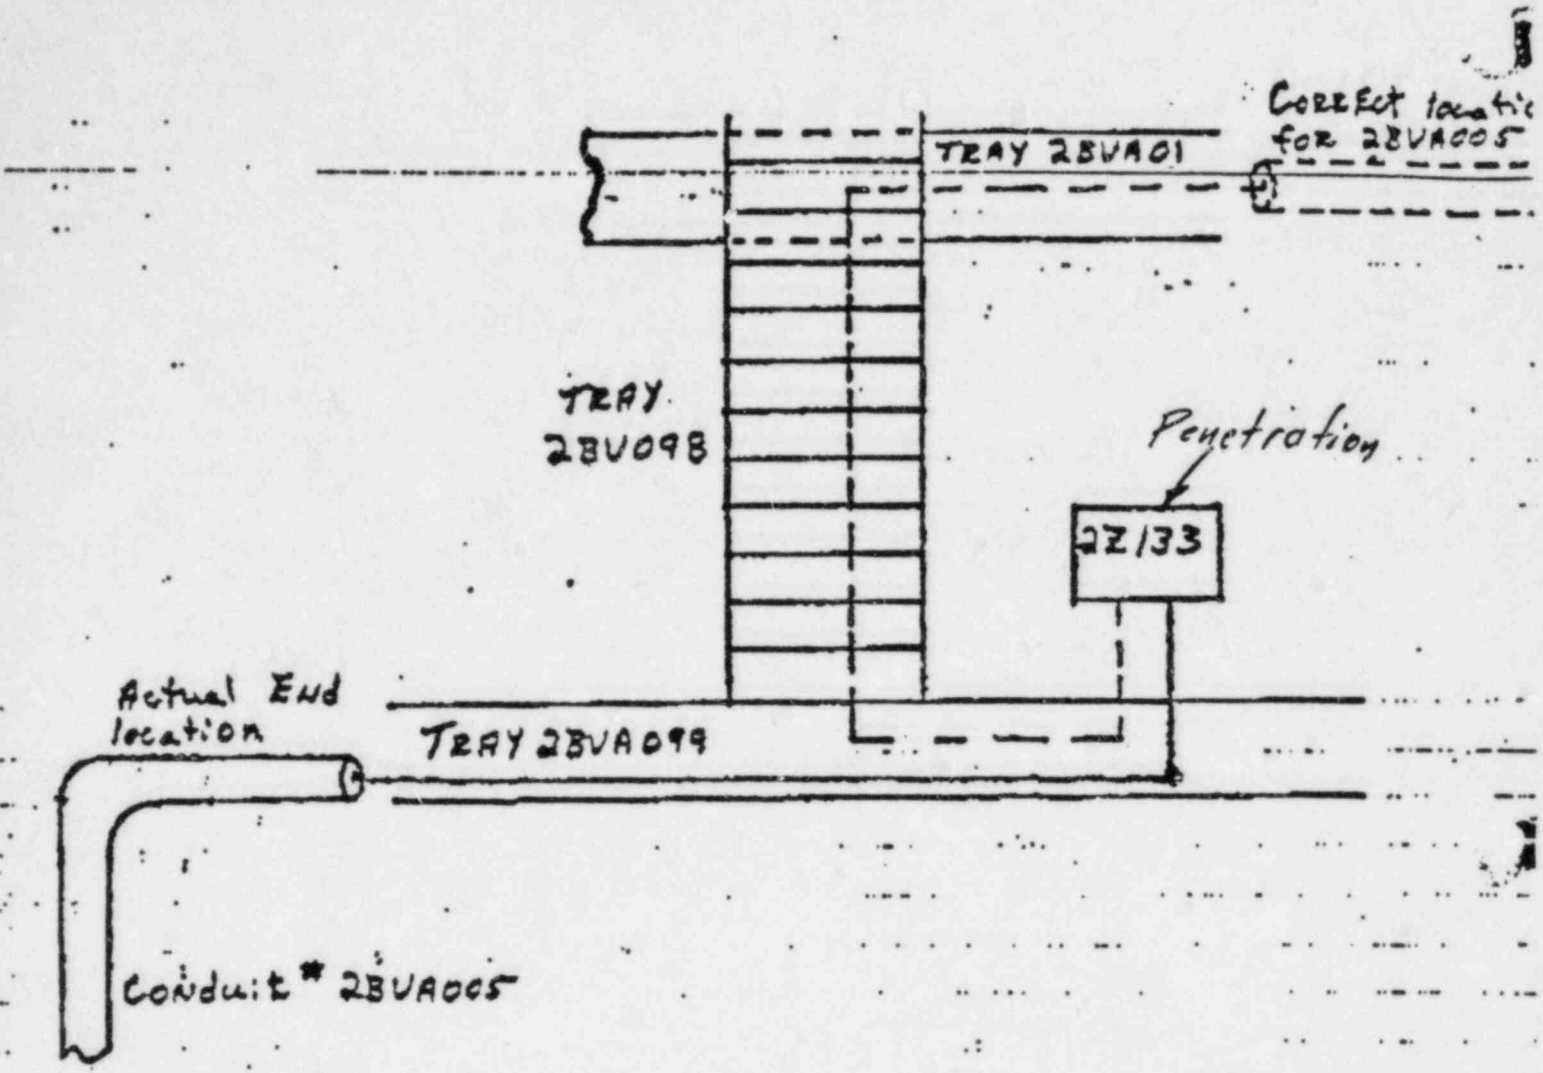
SK 18

CONDUIT # 2BVA005 installed at incorrect. End locat
 should run to 2BVA01 ± 18" into adjoining TRAY section

Cables vias per K-37 ARE: BVA005 BVA01 BVA98 BVA99

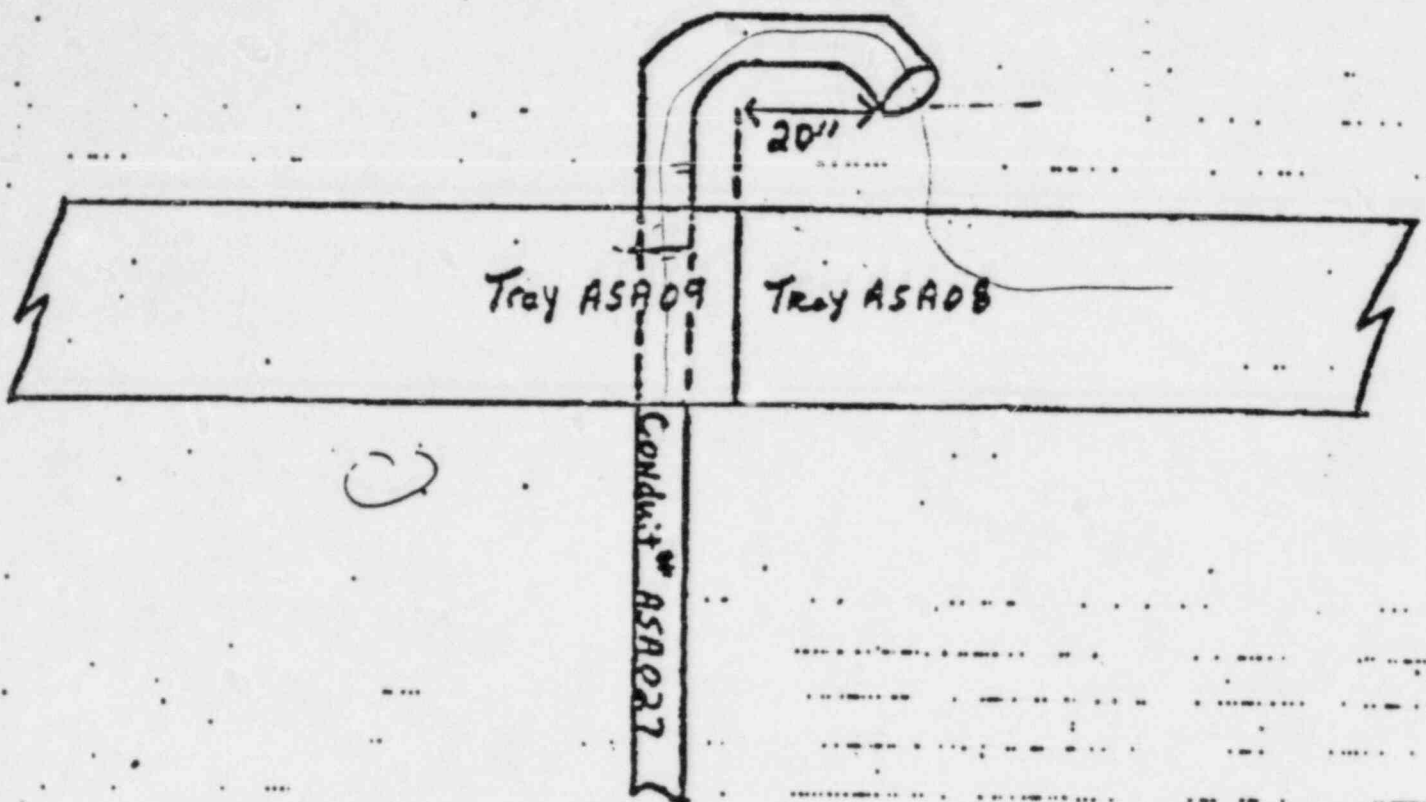
SK. 19
Midland Plant, Units 1 and 2
Attachment 3 to
Report on Cable Installation

CONDUIT # ASA027 installed at incorrect END location.
Should run to ASA09 ± 18" into adjoining tray section.
Cable Vias per R-37 are: ASA027 ASA09 ASA08
Due to incorrect END location: ASA027 — ASA08

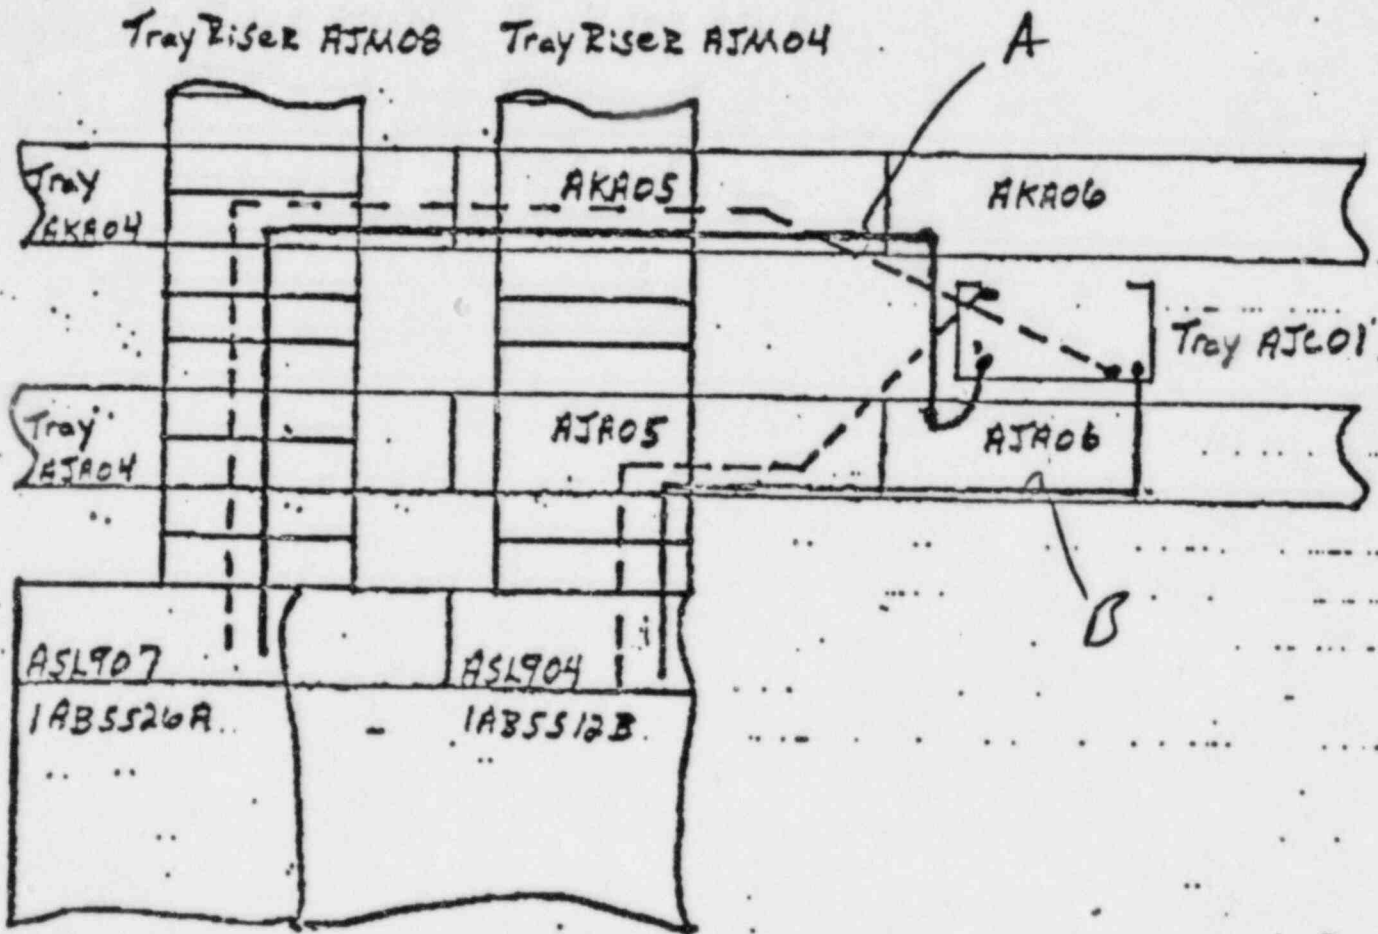
SK 20
Midland Plant Units 1 and 2
Attachment 3 to
Report on Cable Installation

———— Cable is routed - by field
----- Cable should be - Per E-37

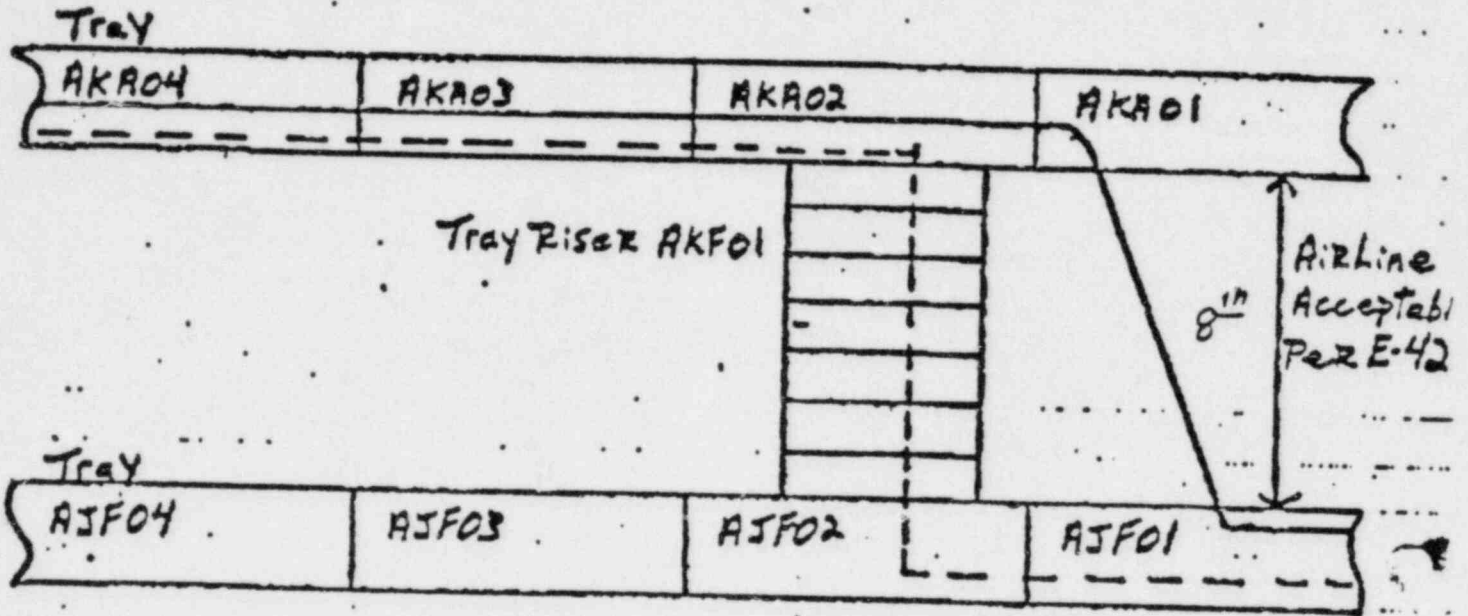
SK.22

————— Cable is Routed - by field

- - - - - Cable should be - Per E-37

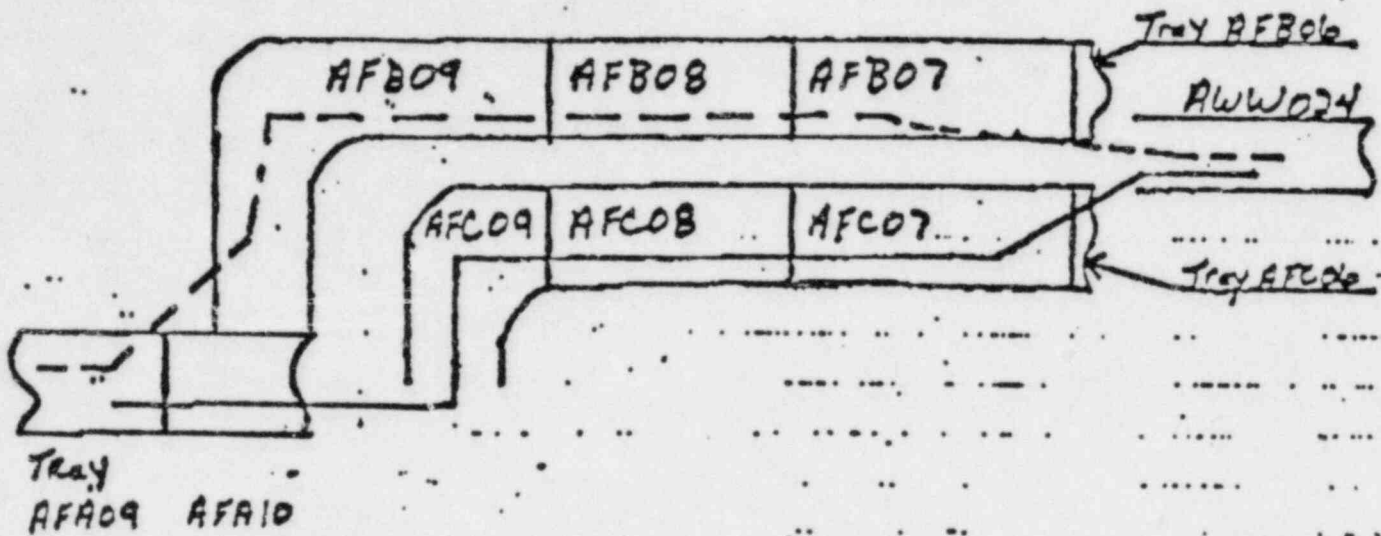
SK. 23

———— Cable is routed - by field
----- Cable should be - Per E-37
