UNITED STATES
NUCLEAR REGULATORY COMMISSION
REGION III
799 ROOSEVELT ROAD
GLEN ELLYN, ILLINOIS 60137

Reports No. 50-329/82-07(DETP); 50-330/82-07(DETP)

Docket Nos. 50-329; 50-330

Midland Plant Units 1 and 2
Attachment 3 to
Report on Cable Installation

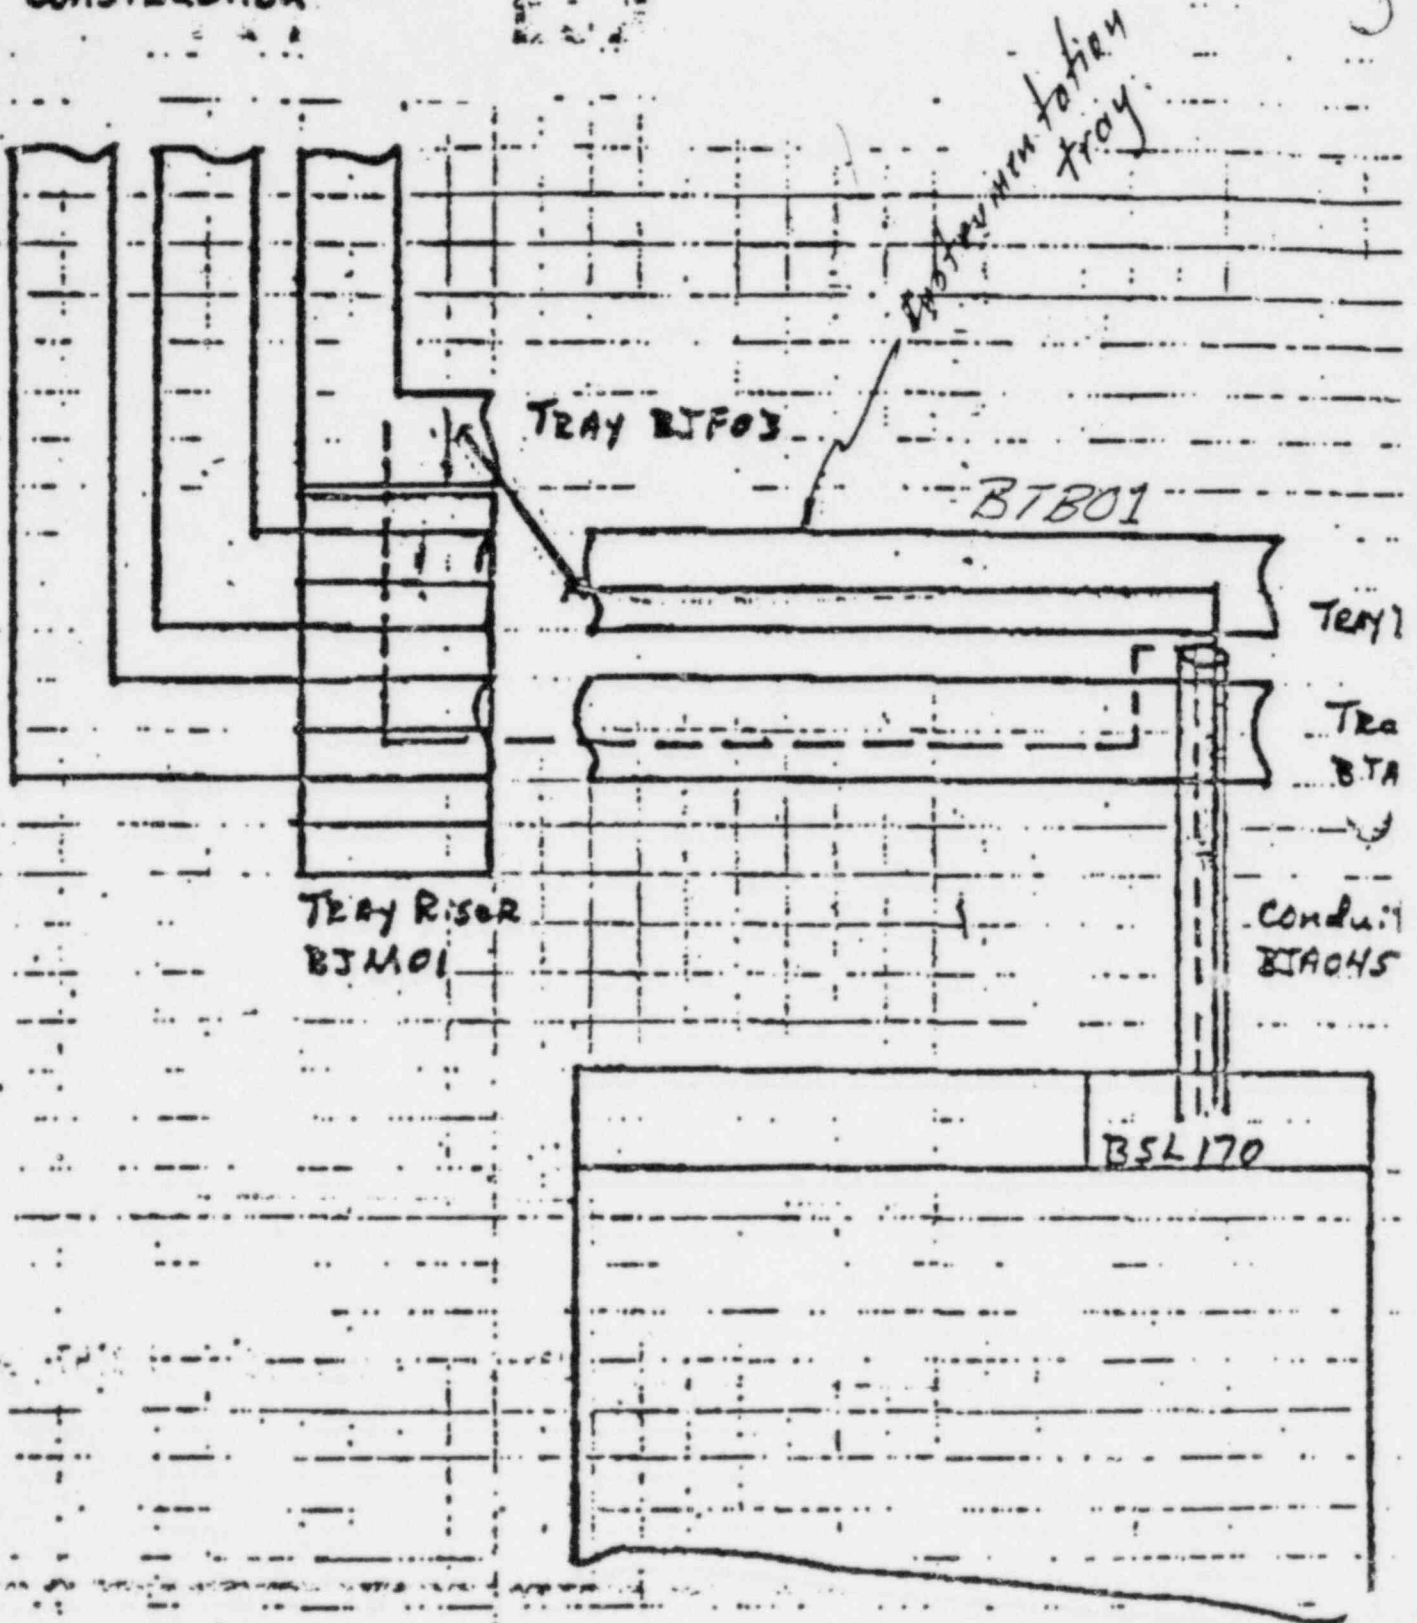
SK-24

— Cable is routed - by field

- - - Cable should be - per E-37

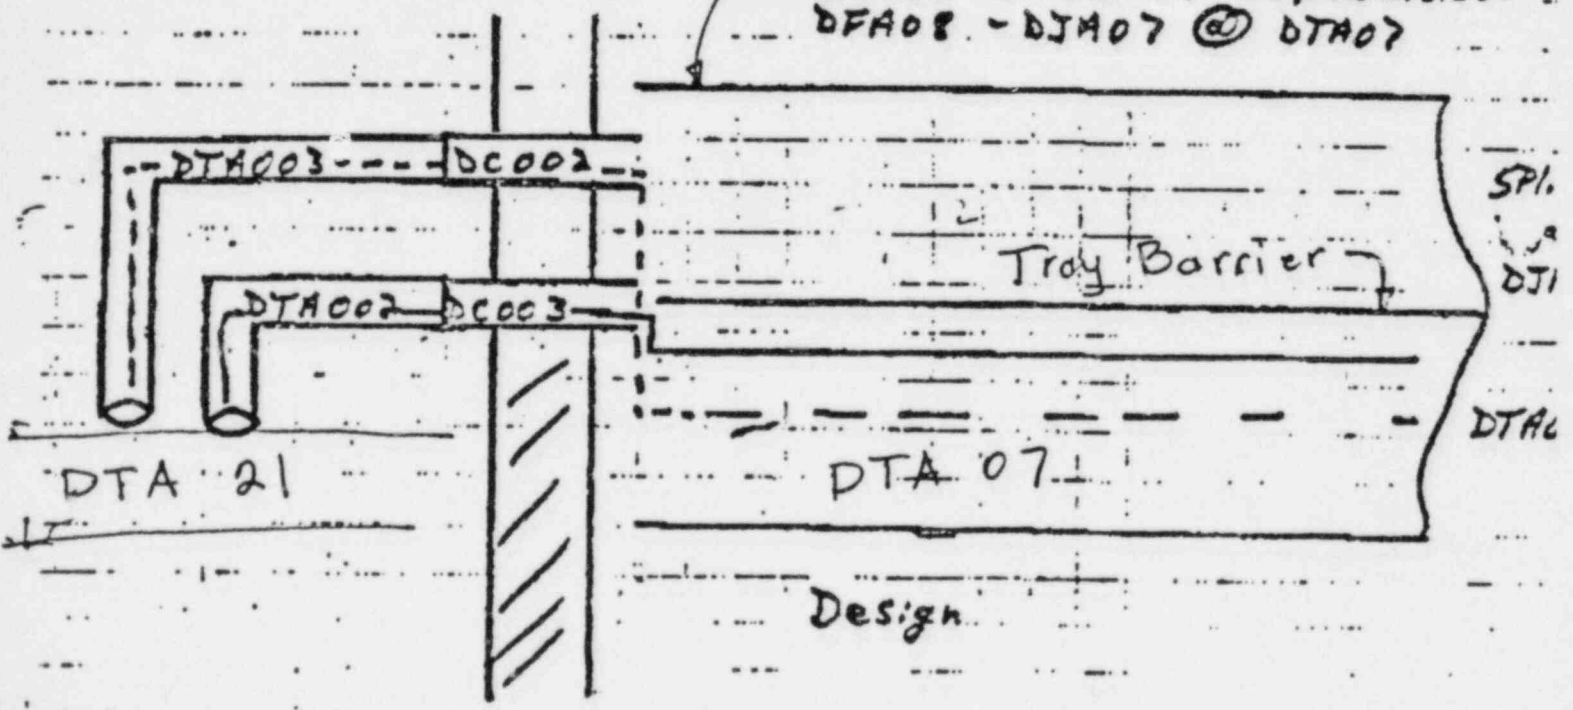
Troy Construction
CROSS OVER OF SEPARATORS.
DFA08 - DJA07 @ DTA07

Cable routed by field

Cable should be per E-37

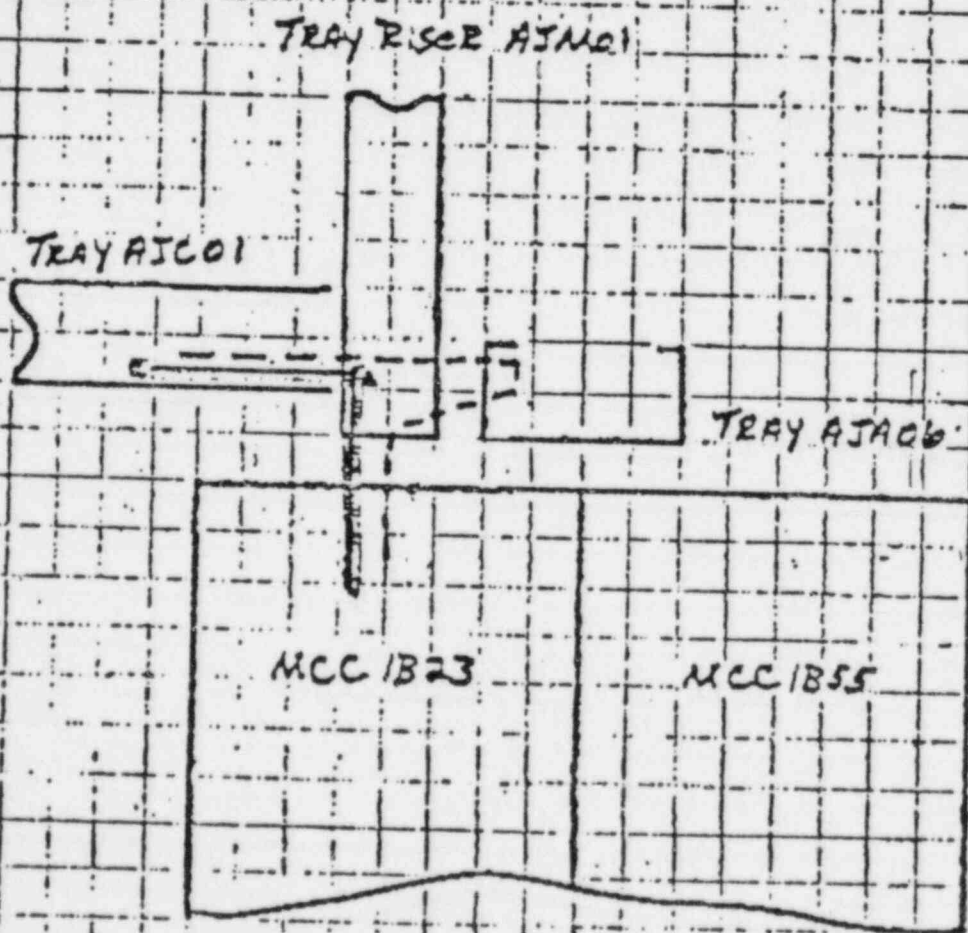
Cable # 1AB2341B
Code # D-1
Design

————— Cable is Routed - by field
- - - - - Cable should be - Per E-37

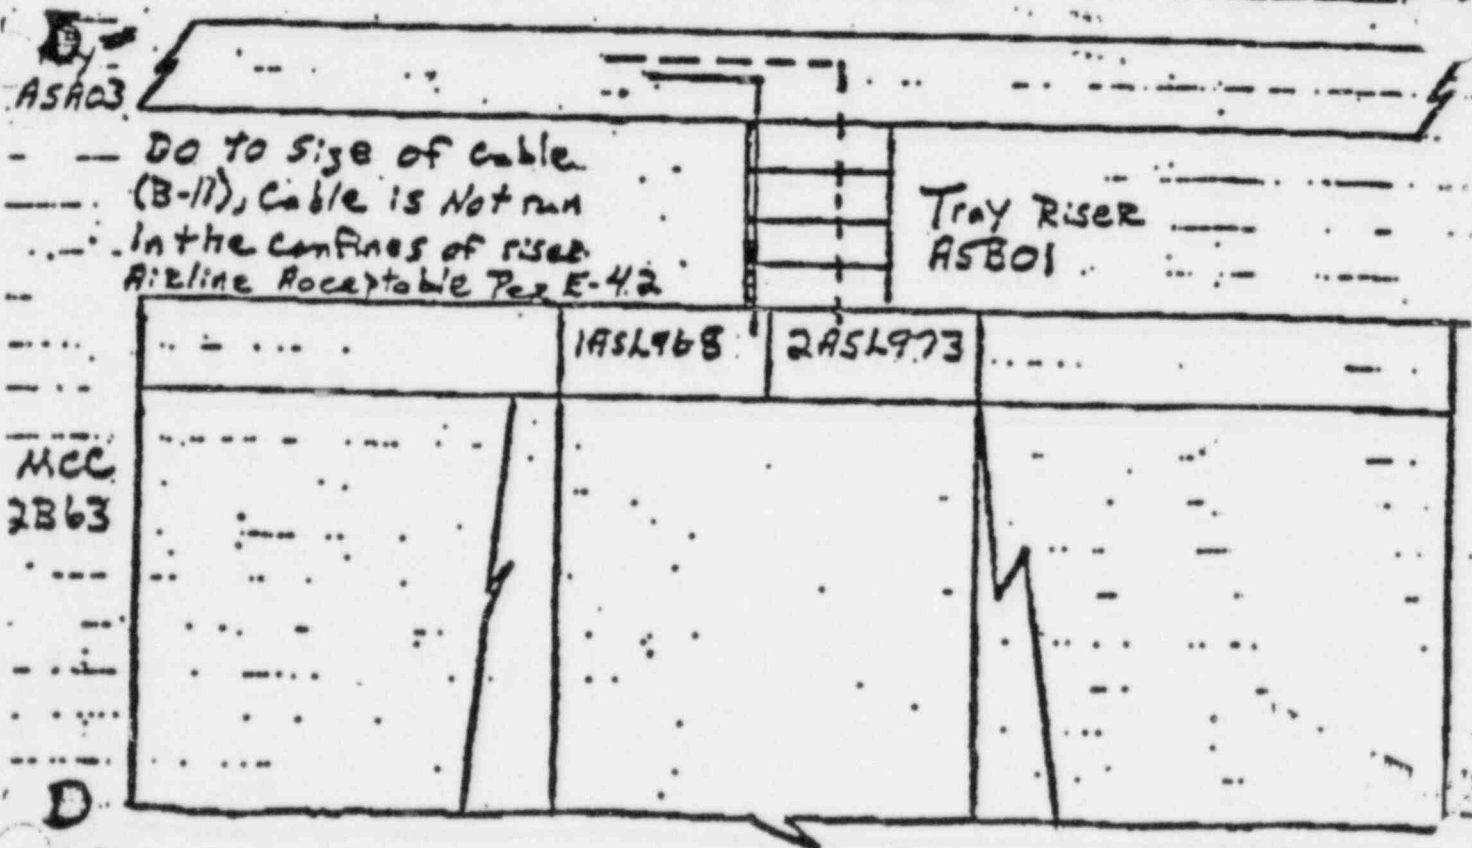
SK-5-B

DO TO size of cable
(B-11), Cable is Not run
in the confines of riser.
Airline Acceptable Per E-4.2

Cable is routed-by field
Cable should be routed-per E-37

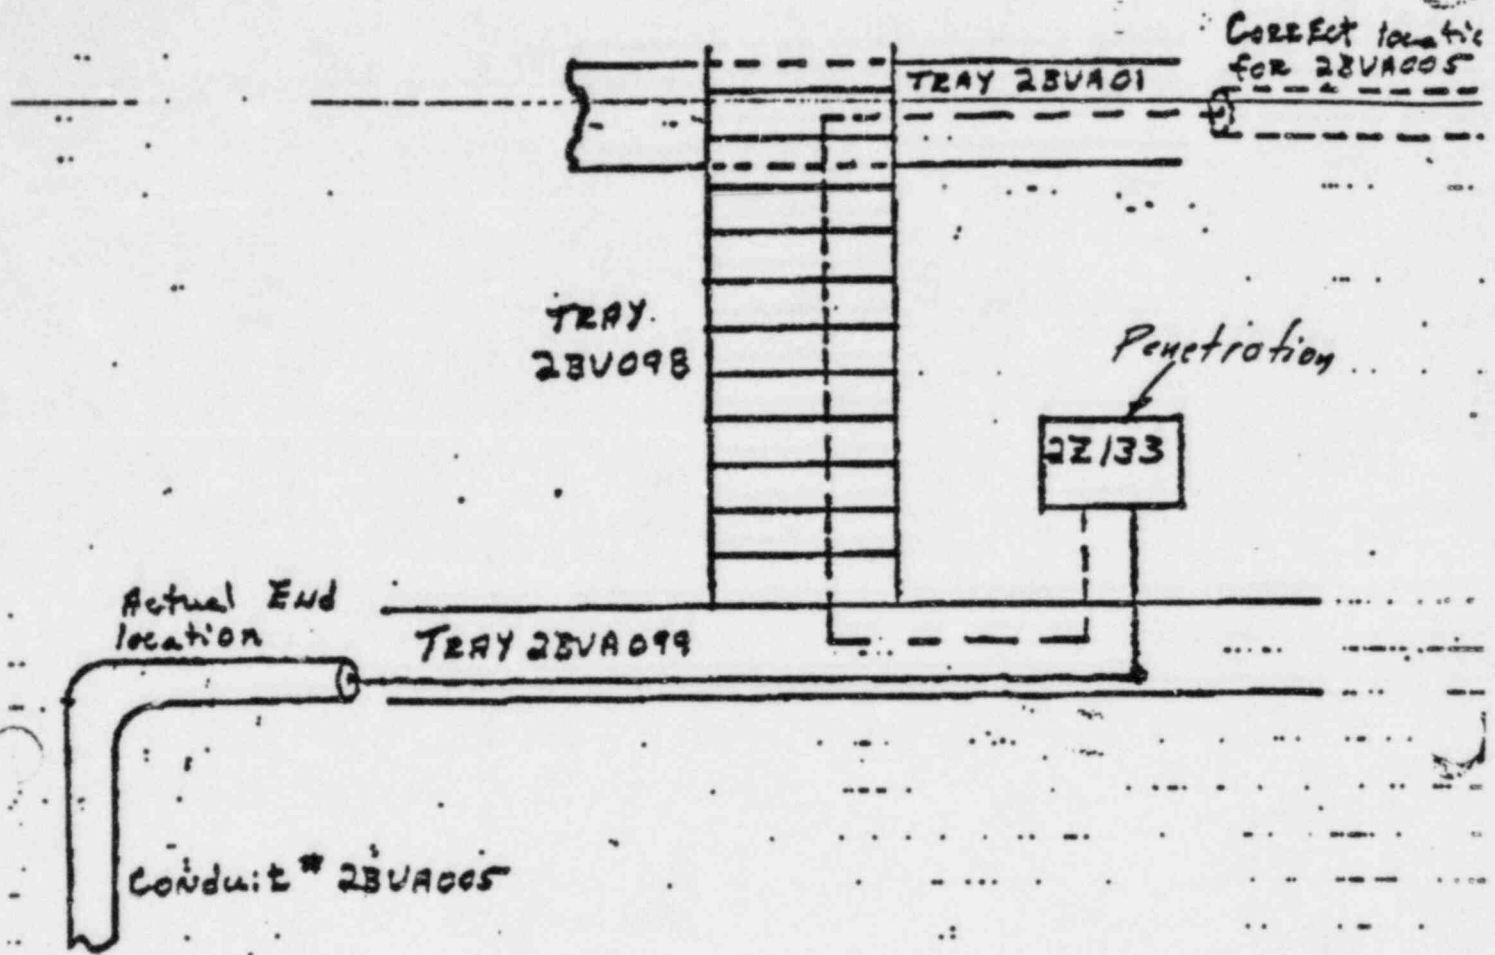
SK 18

CONDUIT # 2BVA005 installed at incorrect. End location should run to 2BVA01 ± 18" into adjoining tray section

Cables vias per E-37 ARE: BVA005 BVA01 BVA98 BVA99

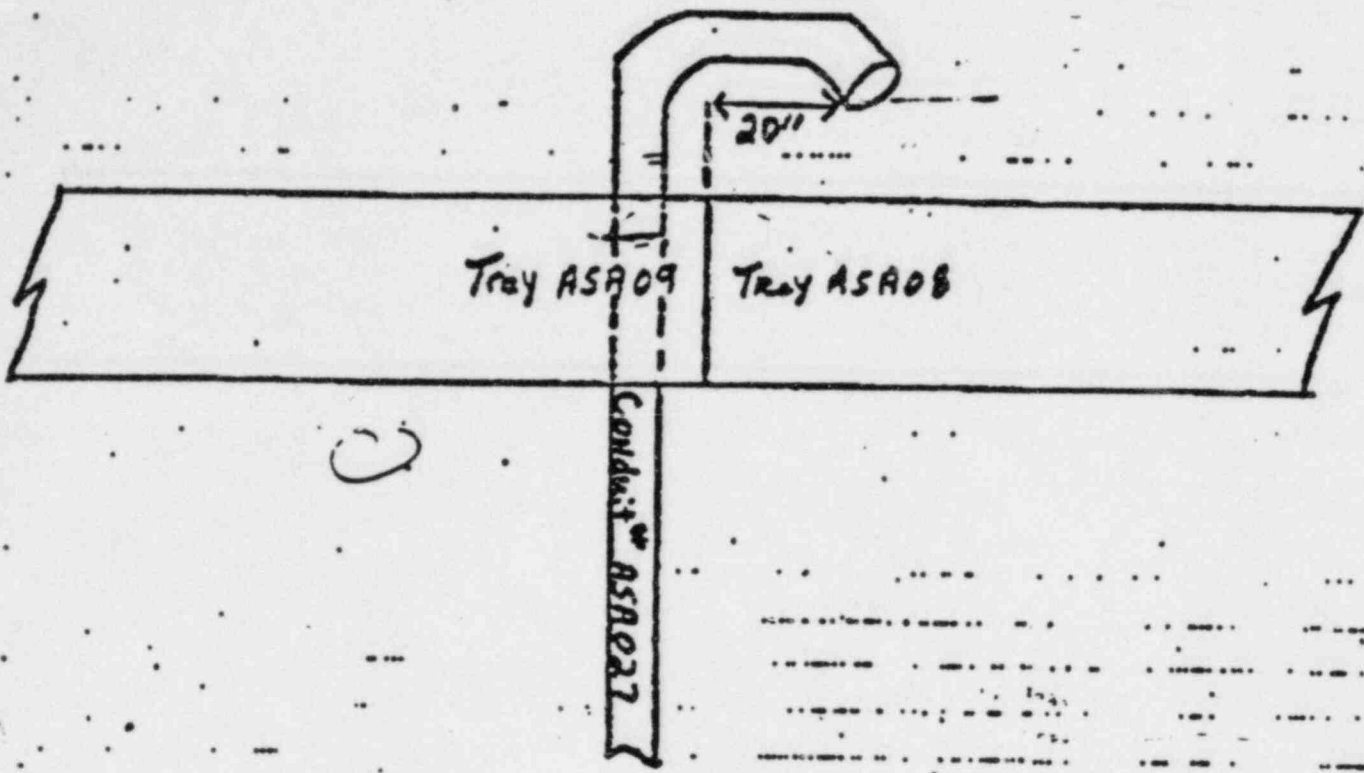
SK.19
Midland Plant Units 1 and 2
Attachment 3 to
Report on Cable Installation

CONDUIT # ASA027 installed at incorrect END location.
Should run to ASA09 ± 18" into adjoining tray section.
Cable vias per K-37 are: ASA027 ASA09 ASA08
Due to incorrect END location: ASA027 — ASA08

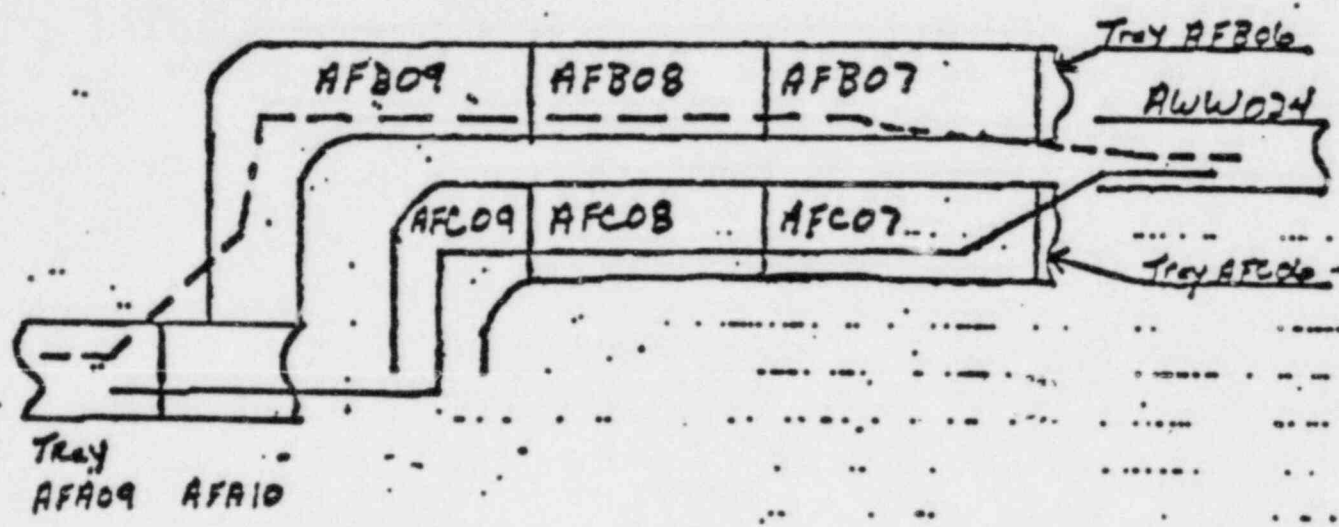
SK. 23
Midland Plant Units 1 and 2
Attachment 3 to
Report on Cable Installat:

Cable is routed - by field
Cable should be - Per E-37

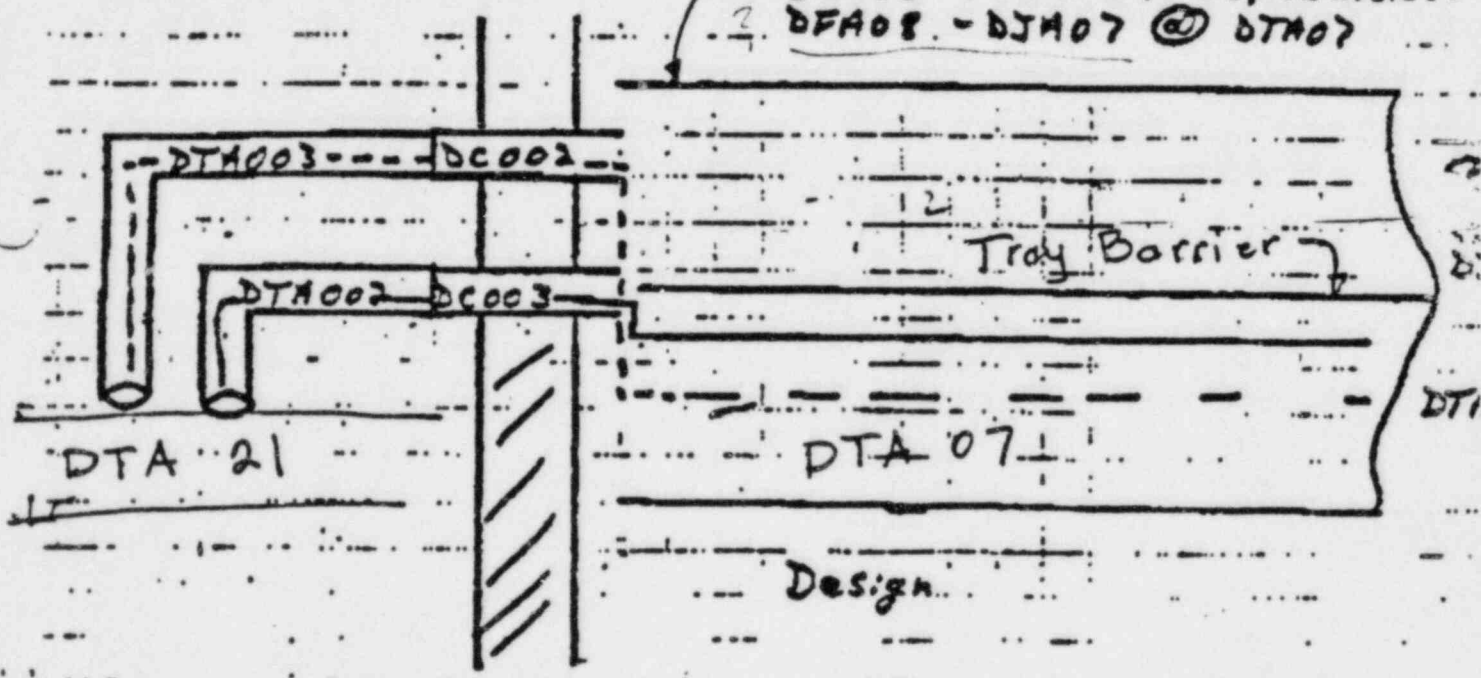
SK-25 Unique Case

Troy Construction
CROSS OVER OF SEPARATORS.
DTA 08 - DTA 07 @ DTA 07

Cable routed by Field
Cable should be per E-37
