SDW Public Meeting
Jan 13, 1984

MIDLAND ENERGY CENTER GWO 7020
AUXILIARY BUILDING CRACK EVALUATIONS
File: 0485.16 UFI: 42*05*22*04 Serial: CSC-7074

AUXILIARY BUILDING
CRACK MAPPING EVALUATIONS
FOR
GRILLAGE 8 INITIAL JACKING & REJACKING

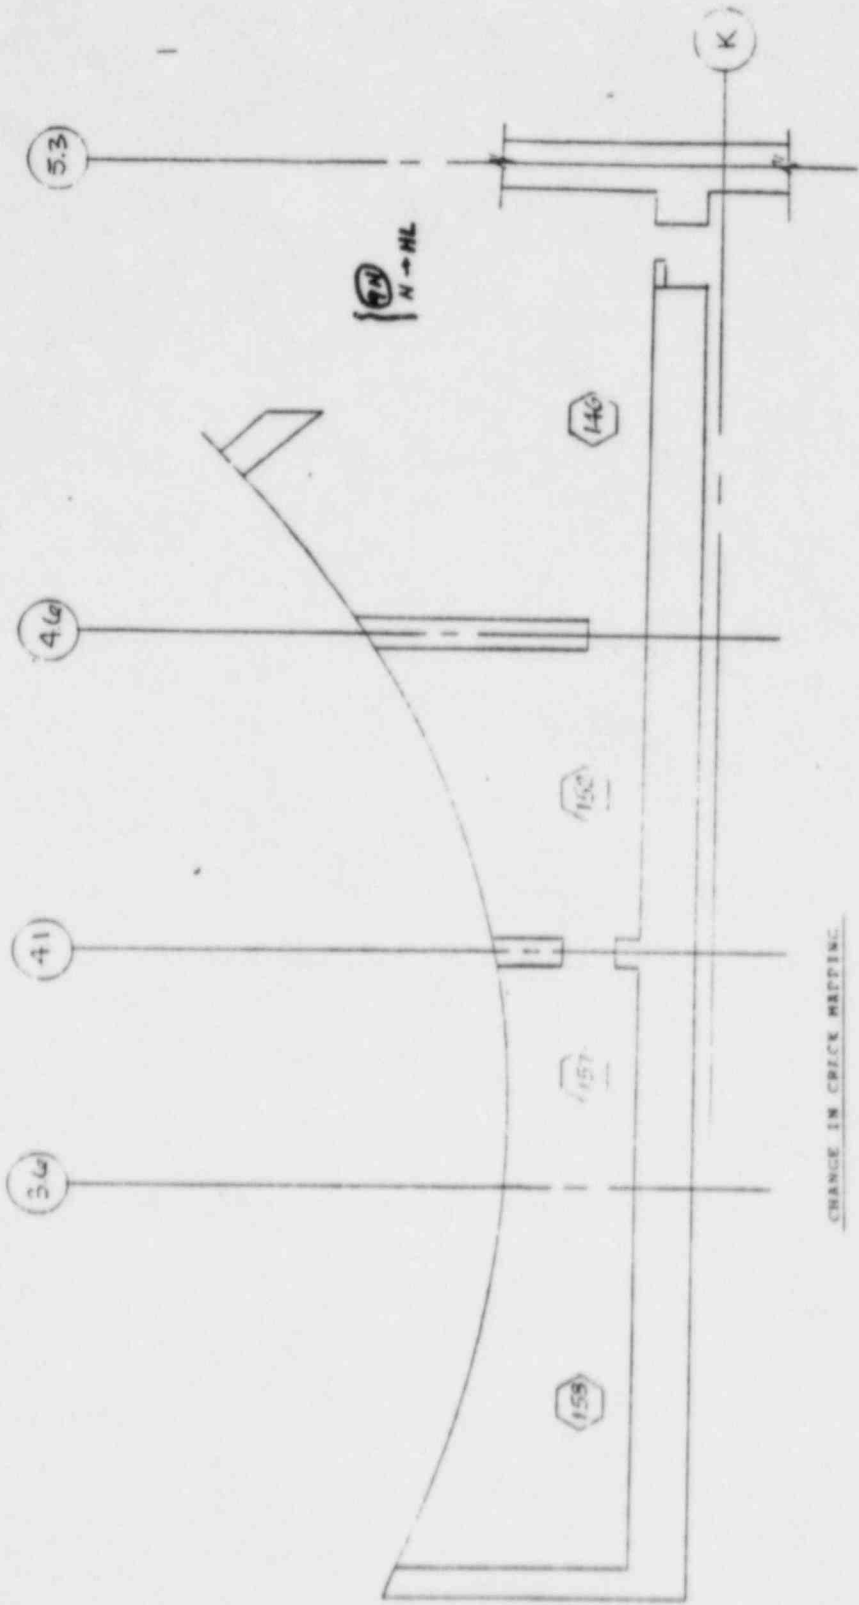
ARBITRARY DIMENSIONS - WEST ELECTRICAL FINISHING AREA AT ELEVATION 628'-6"

CHANGE IN CRACK MAPPING.

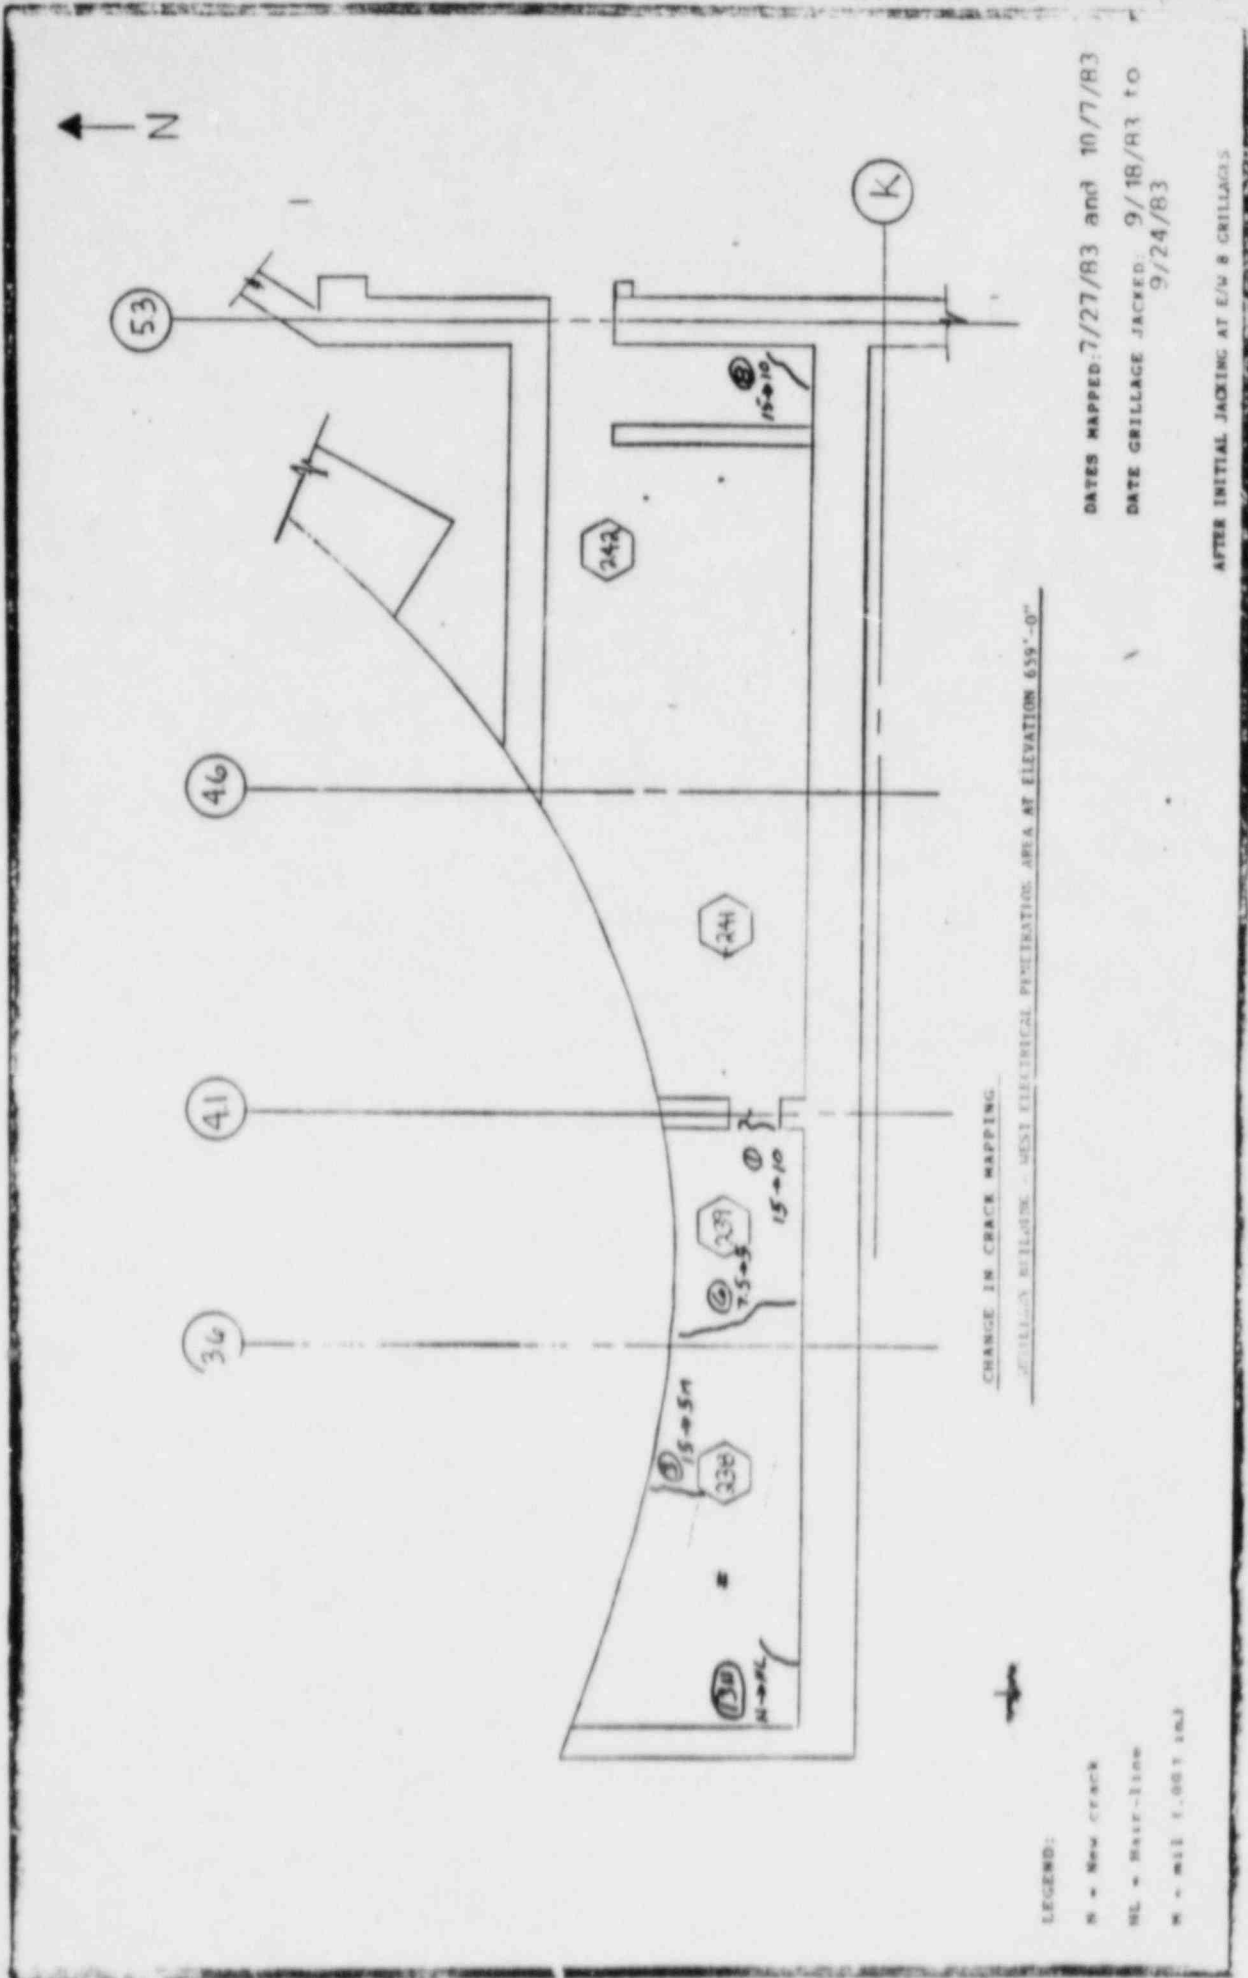
CHANGE IN CRACK MAPPING
 WEST ELECTRICAL PENETRATION AREA AT ELEVATION 659'-0"

AFTER INITIAL JACKING AT E/W 8 GRILLAGES

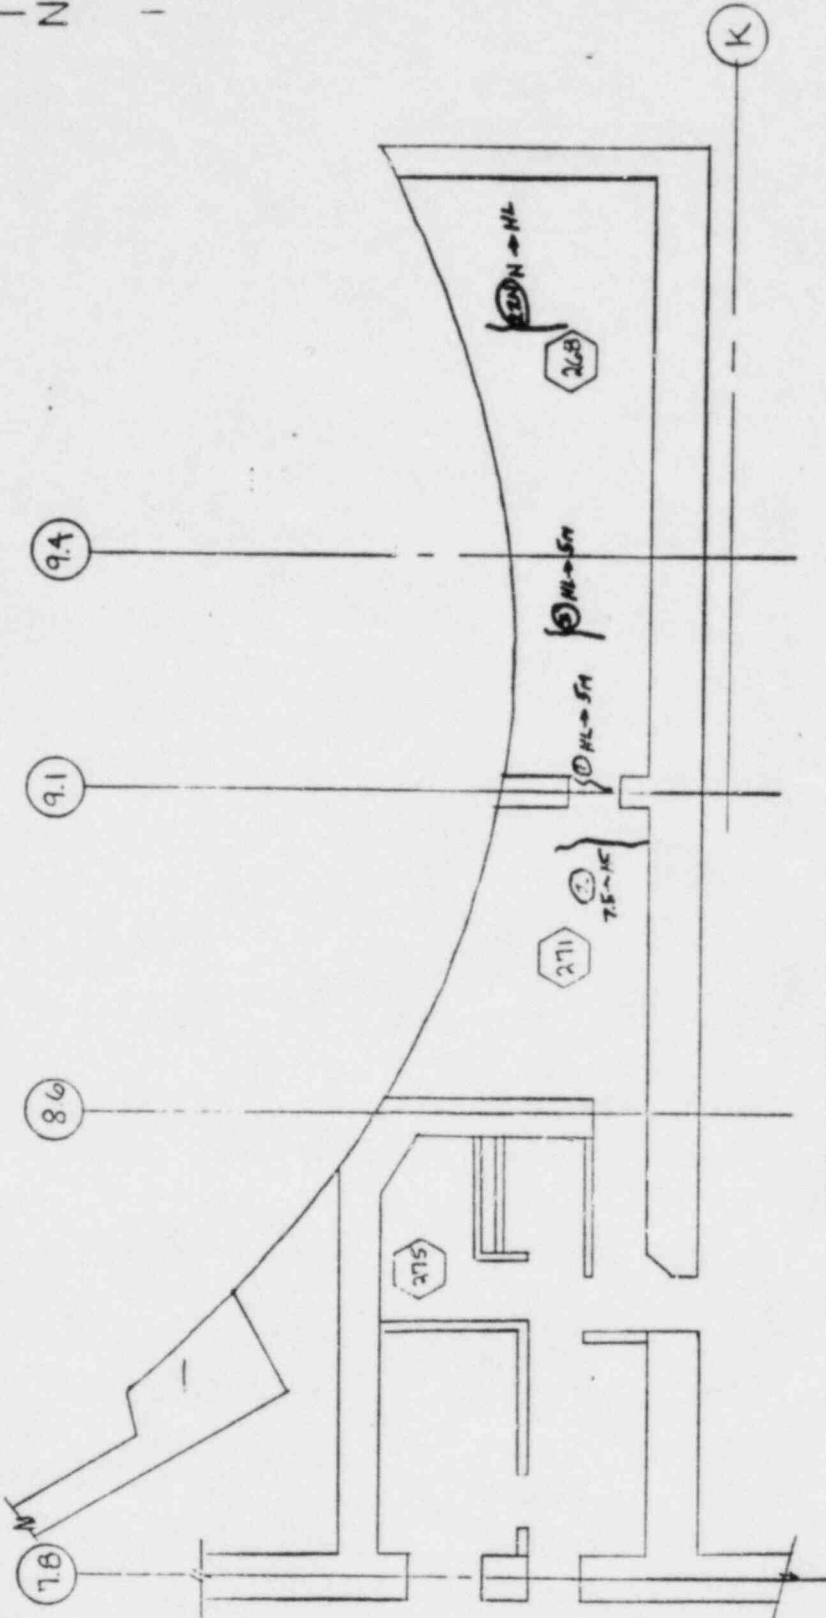
WELLS BUILDING - EAST ELECTRICAL PENETRATION AREA AT ELEVATION 659'-0"

CHANGE IN CRACK MAPPING

AFTER INITIAL JACKING AT E/W 8 GRILLAGES

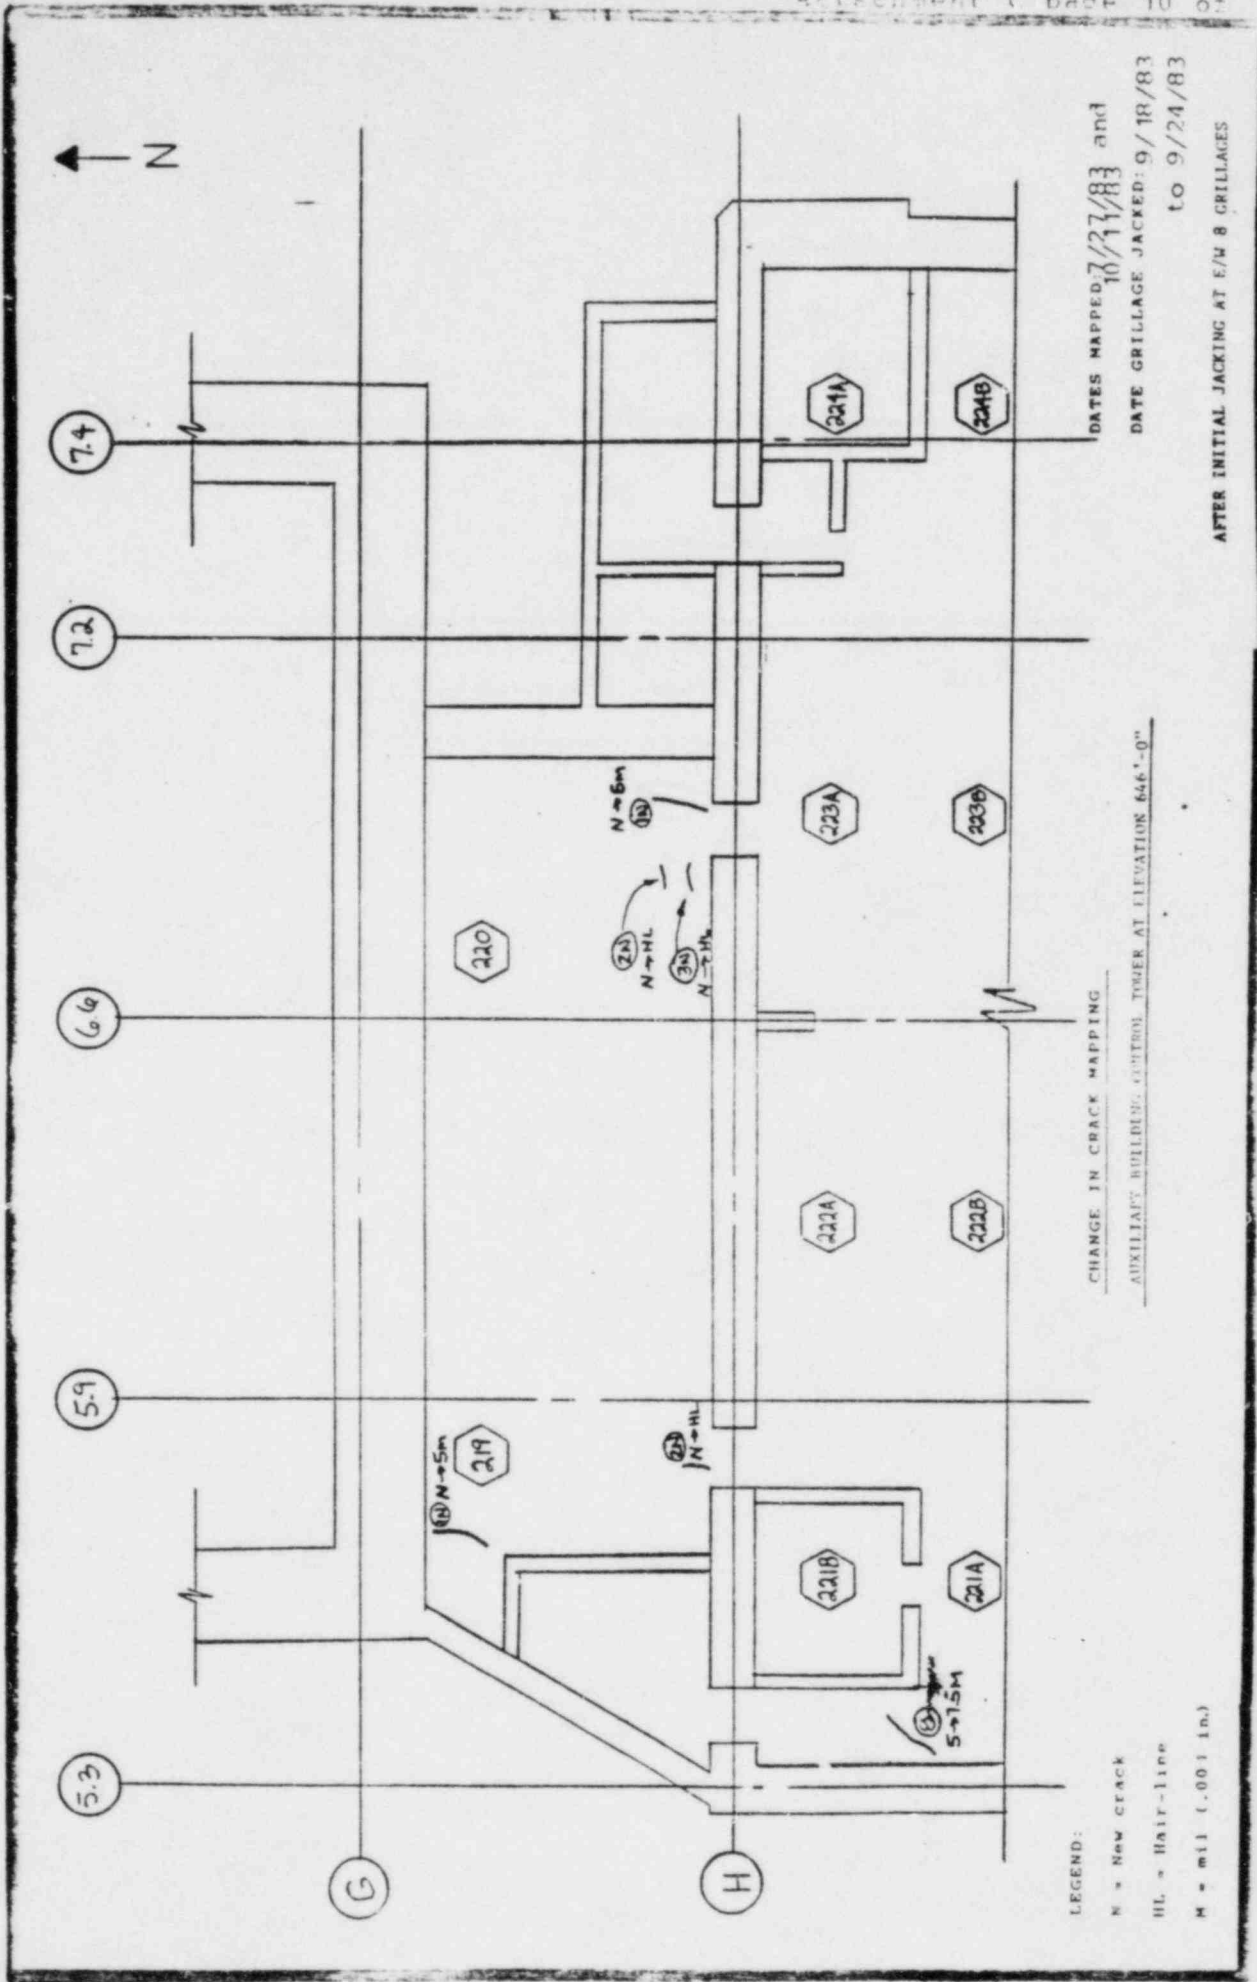
CHANGE IN CRACK MAPPING
 AUXILIARY BUILDING CENTER TOWER AT ELEVATION 646'-0"

DATES MAPPED 7/27/83 and 10/17/83
 DATE GRILLAGE JACKED: 9/18/83 to 9/24/83
 AFTER INITIAL JACKING AT E/W 8 GRILLAGES

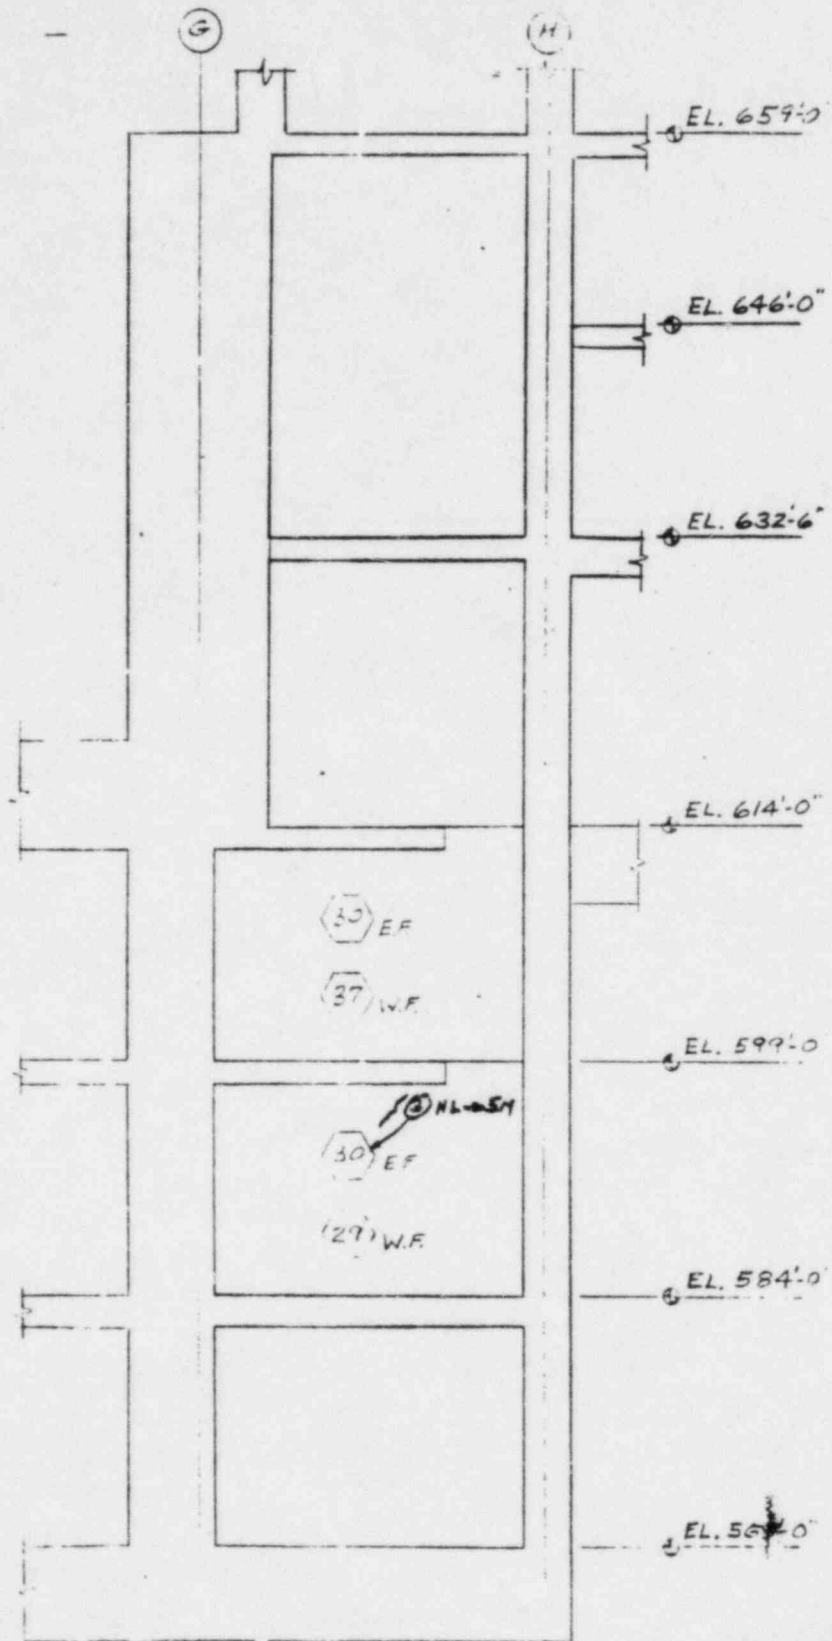
CHANGE IN CRACK MAPPING
AUXILIARY BUILDING
PAST ELECTRICAL PENETRATION AREA
WEST FACE OF WALL AT COLUMN LINE 7.9

AFTER INITIAL JACKING AT E/W 8 GRILLAGES

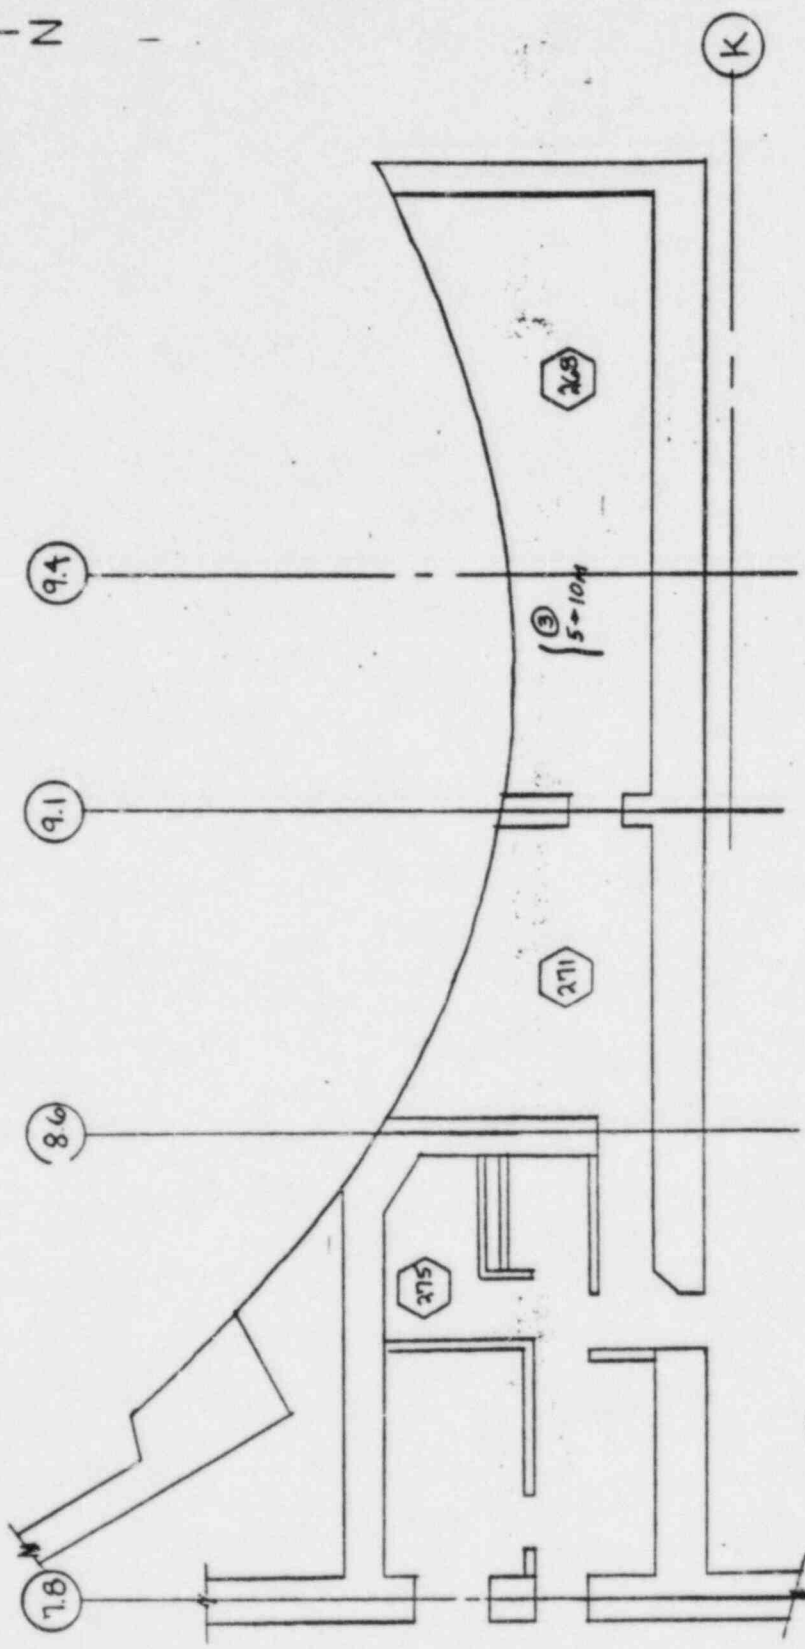
CHANGE IN CRACK MAPPING
 AUXILIARY BUILDING - EAST ELECTRICAL PENETRATION AREA AT ELEVATION 658'-0"

FROM JACKING AT E/W 8 TO 11-28-83

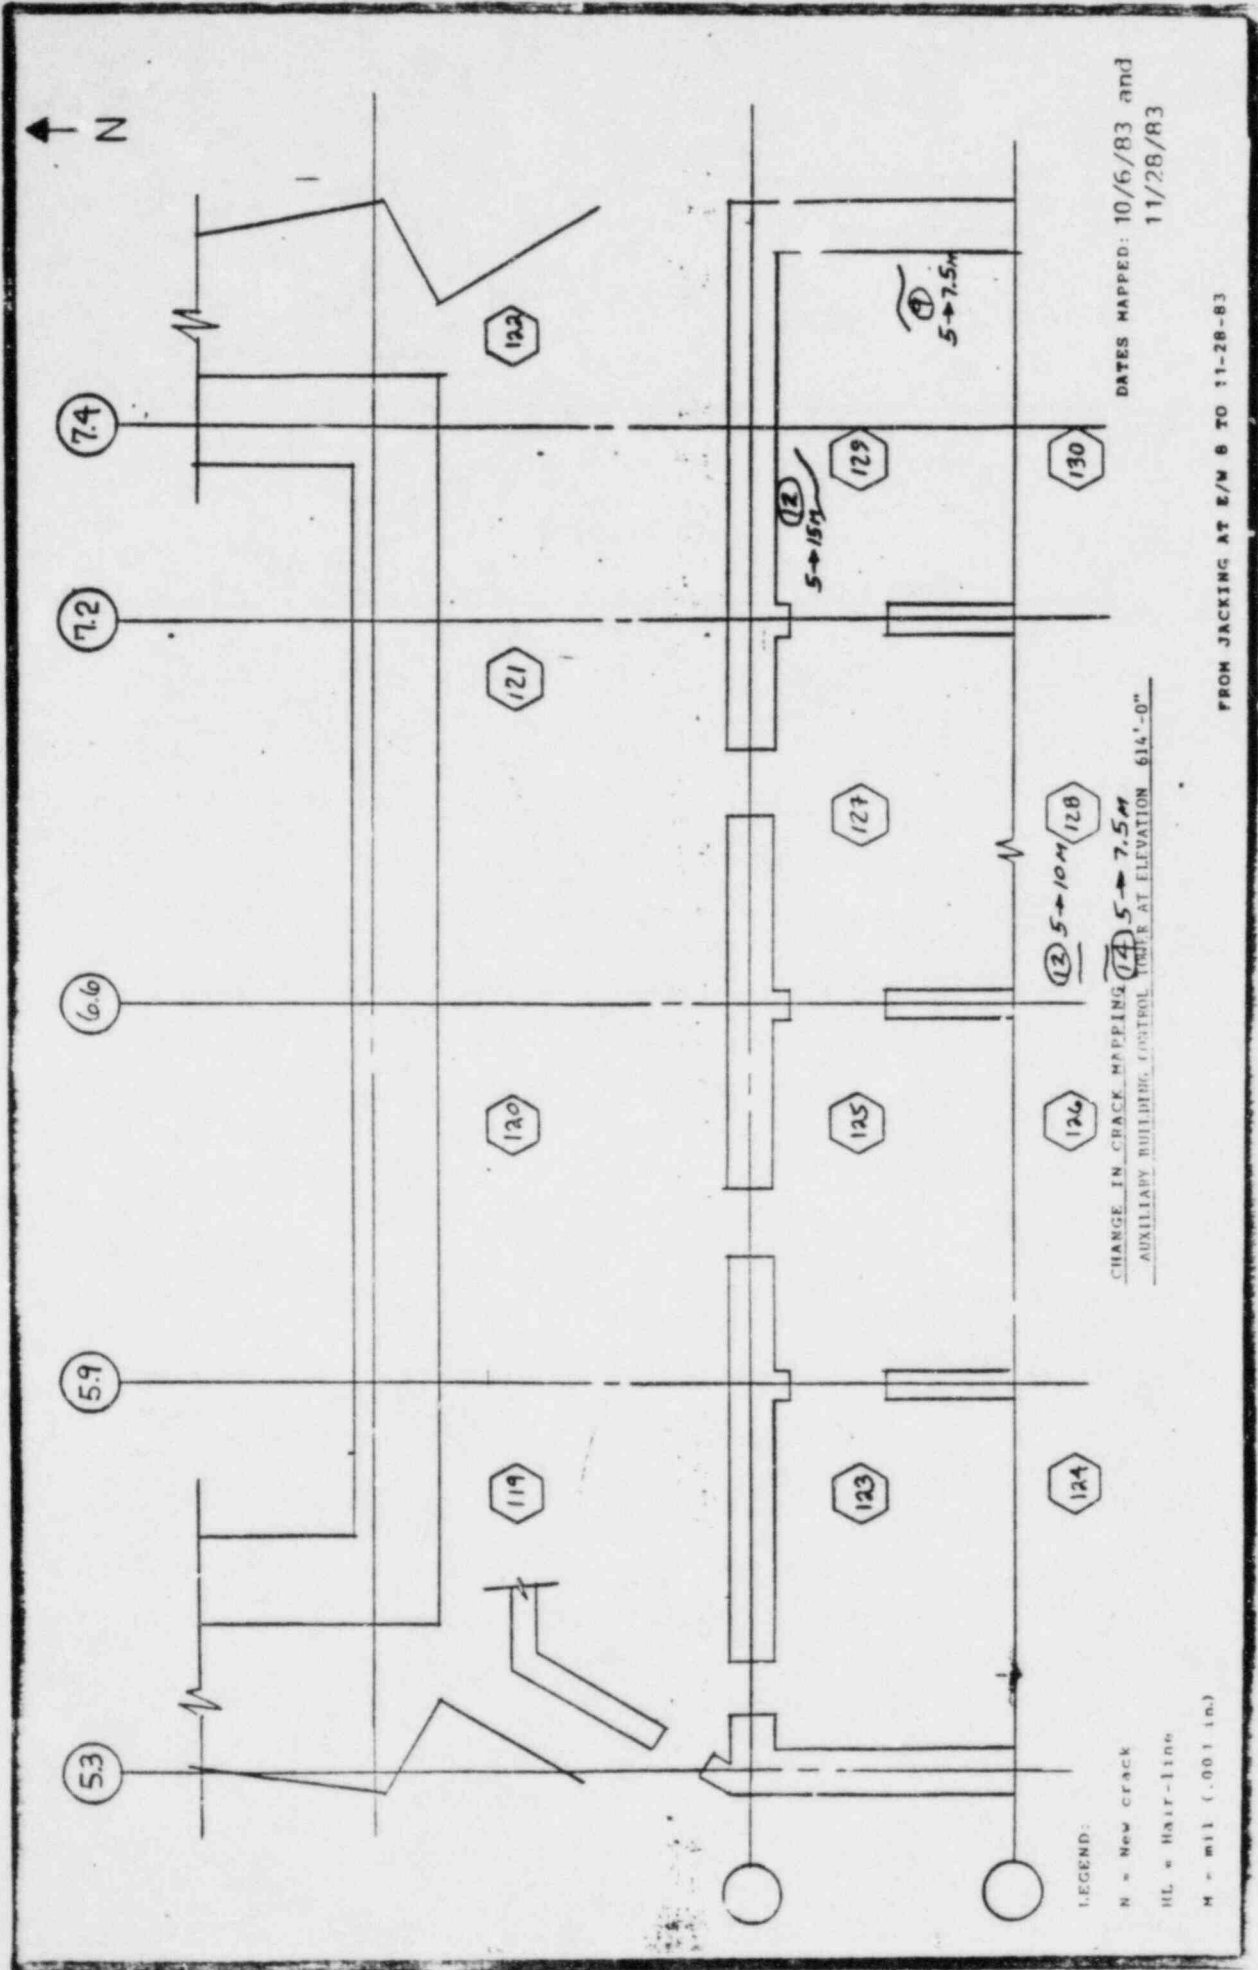
CHANGE IN CRACK MAPPING (7.4) 5 → 7.5M
AUXILIARY BUILDING CONTROL JUMP AT ELEVATION 614'-0"

FROM JACKING AT E/W 6 TO 11-28-83

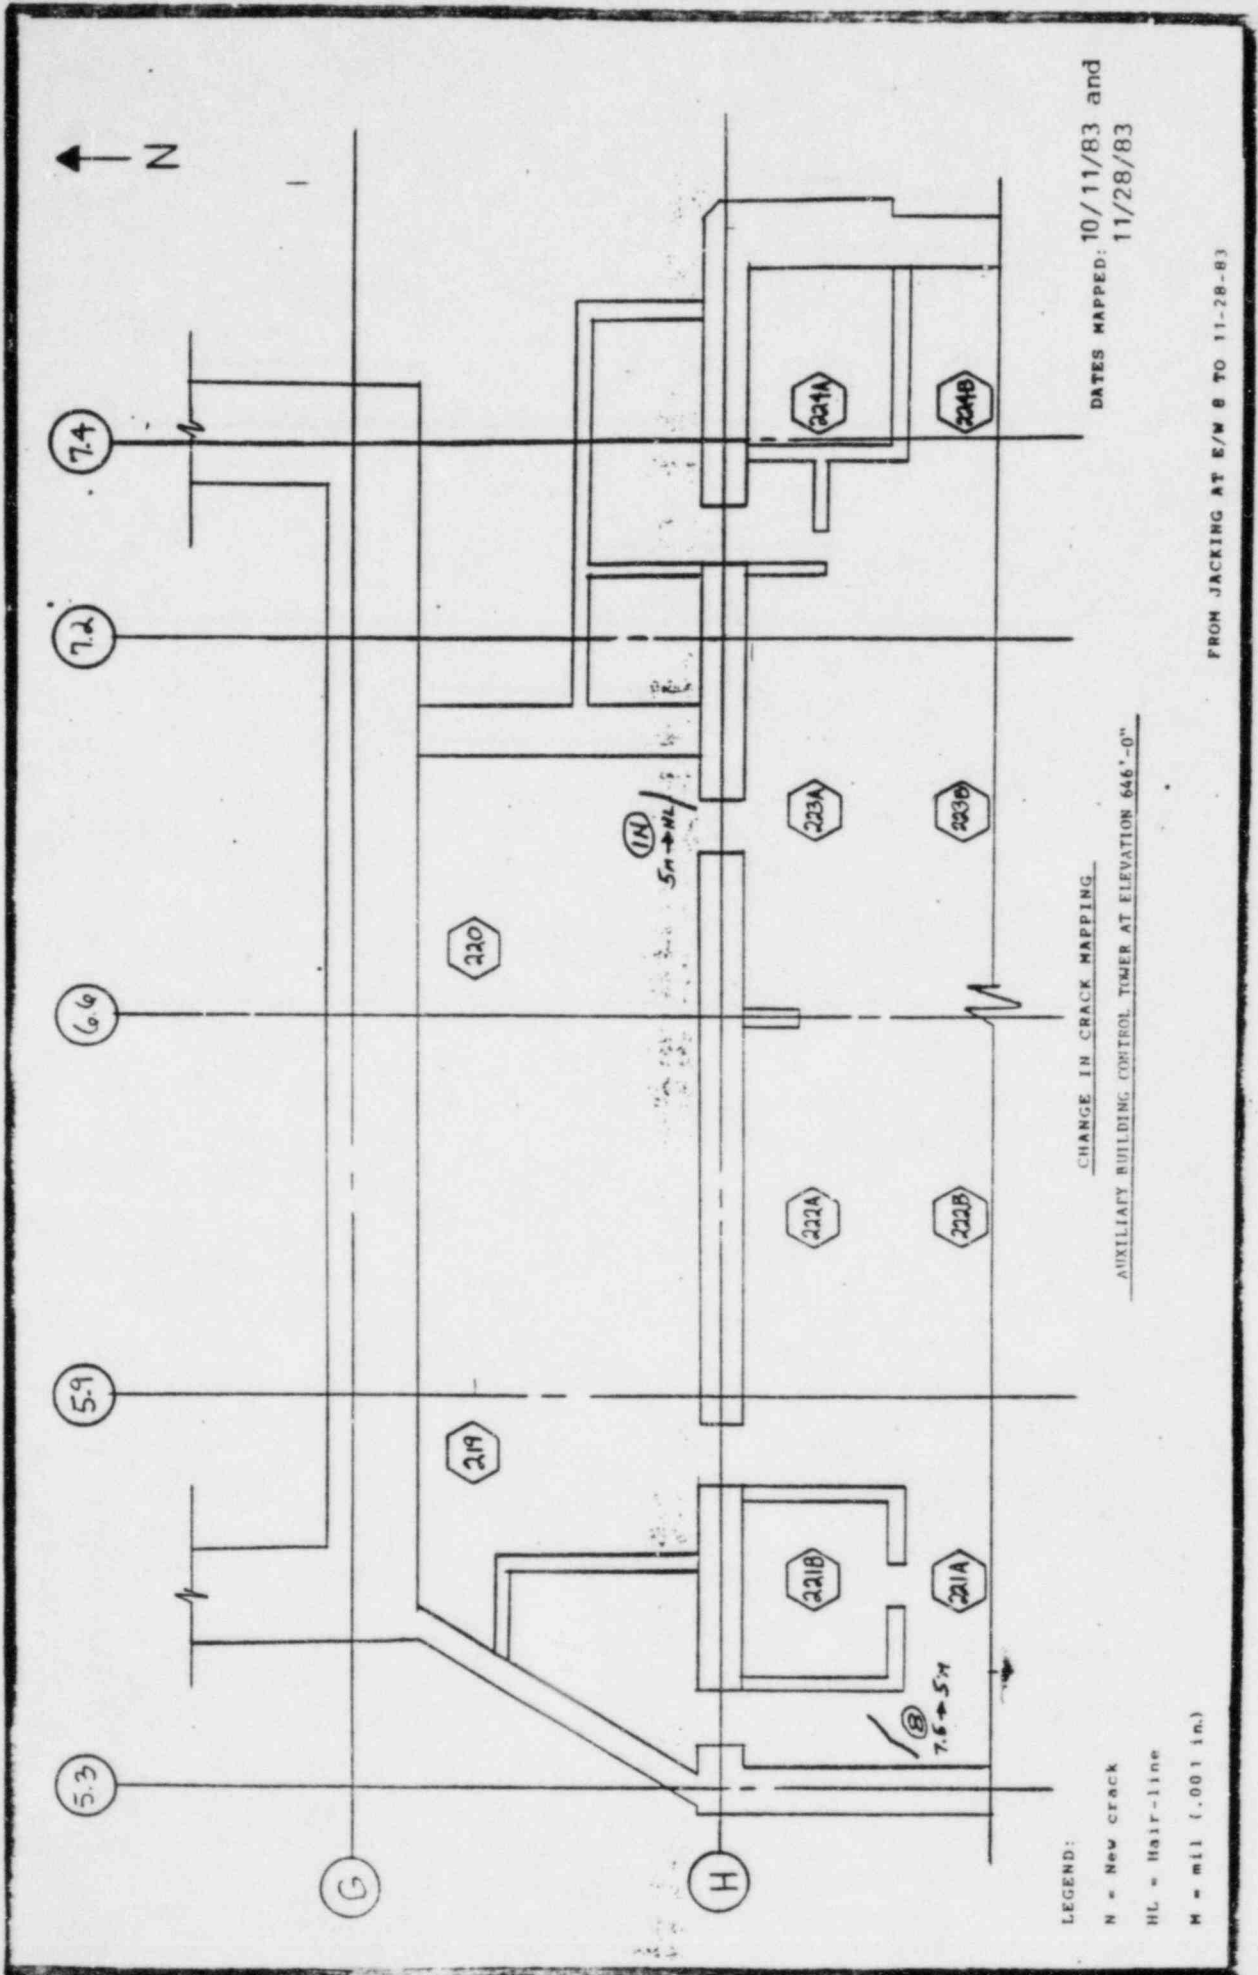
CHANGE IN CRACK MAPPING
AUXILIARY BUILDING CONTROL TOWER AT ELEVATION 646'-0"

FROM JACKING AT E/W 8 TO 11-28-83
