UNITED STATES NUCLEAR REGULATORY COMMISSION

FACILITY: North Anna Power Station, Unit No. 1 (NA-1)

SUBJECT: MEETING SUMMARY OF MARCH 2, 1992

Steam Generator Mid-Cycle Inspection Outage NRC Startup Approval Meeting

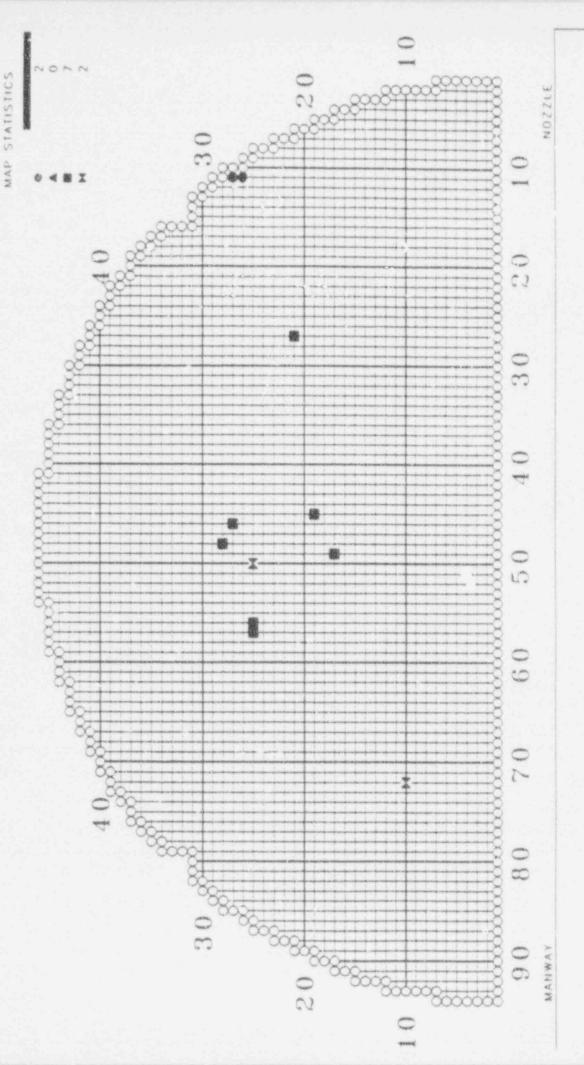
NORTH ANNA UNIT 1 ALL S/G's WEXTEX CIRCUMFERENTIAL INDICATIONS

STEAM	GENER	ATOR
# TUBES	Α	В	С
SINGLE AXIAL	3	0	2
MULTIPLE AXIAL	0	0	0
SINGLE CIRCUMFERENTIAL	10	9	7
MULTIPLE CIRCUMFERENTIAL	2	1	2

THERE WERE Q TUBES WITH MIXED MODE DEGRADATION IDENTIFIED IN THE WEXTEX TRANSITIONS.

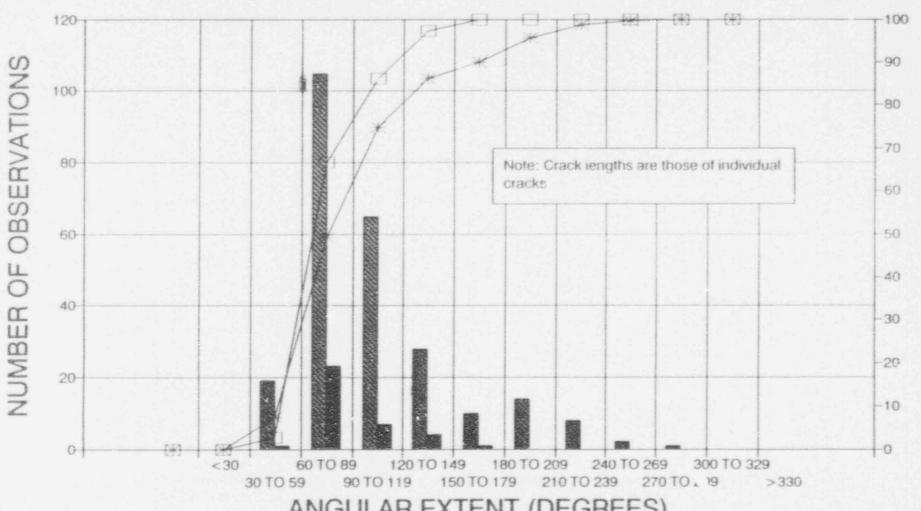
No single circumferential indications located at the WEXTEX transitions exceeded the limiting crack size for meeting the criteria of RG 1.121. Also, crack indications at the TSPs were determined to be enveloped by the criteria of RG 1.121 with two exceptions. VEPCO stated that these two exceptions will not recur in January 1993 because tubes inspected during the mid-cycle inspection used the more sensitive RPC probe with a lower threshold of detection than used during the previous inspection. Re-examination of probe data (8x1 and RPC) from the previous inspection now indicate that circumferential cracks detected at TSPs during the mid-cycle inspection were present during the previous inspection, but below detection thresholds. The licensee and Westinghouse stated that maximum end-of-cycle (EOC) crack sizes are expected to be significantly less than that seen during the mid-cycle inspection due to the extent of repairs made and due to the reduction in hot leg temperature for the remainder of the operating cycle.

Multiple circumferential indications were found at both the WEXTEX transition area and the TSP during the mid-cycle SG inspection. The licensee and Westinghouse stated that all of these multiple indications meet the criteria of RG 1.121. Each crack had a ligament which exceeded the minimum ligament size required to meet the three-times-normal operating pressure differential.

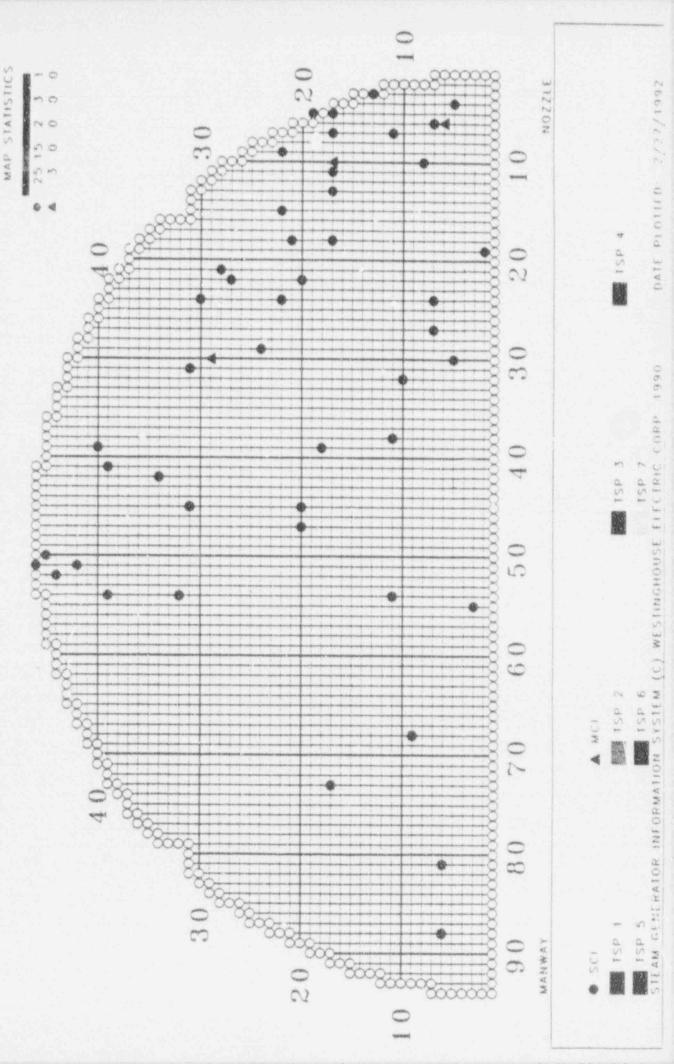
SUPPORT PLATE CIRCUMFERENTIAL INDICATIONS (RPC 2/27 PLUG LIST NORTH ANNA UNIT I S/G A

ELEVATION	S	TEAM GENERATOR	
	A	В	C
	SCI/MCI	SCI/MCI	SCI/MCI
1H	25/3	22/0	27/0
2H	15/0	33/3	42/3
3H	2/0	7/2	19/1
4H	3/0	0/0	3/0
5H	1/0	0/0	1/0
6H	0/0	0/0	0/0
7H	0/0	0/0	0/0

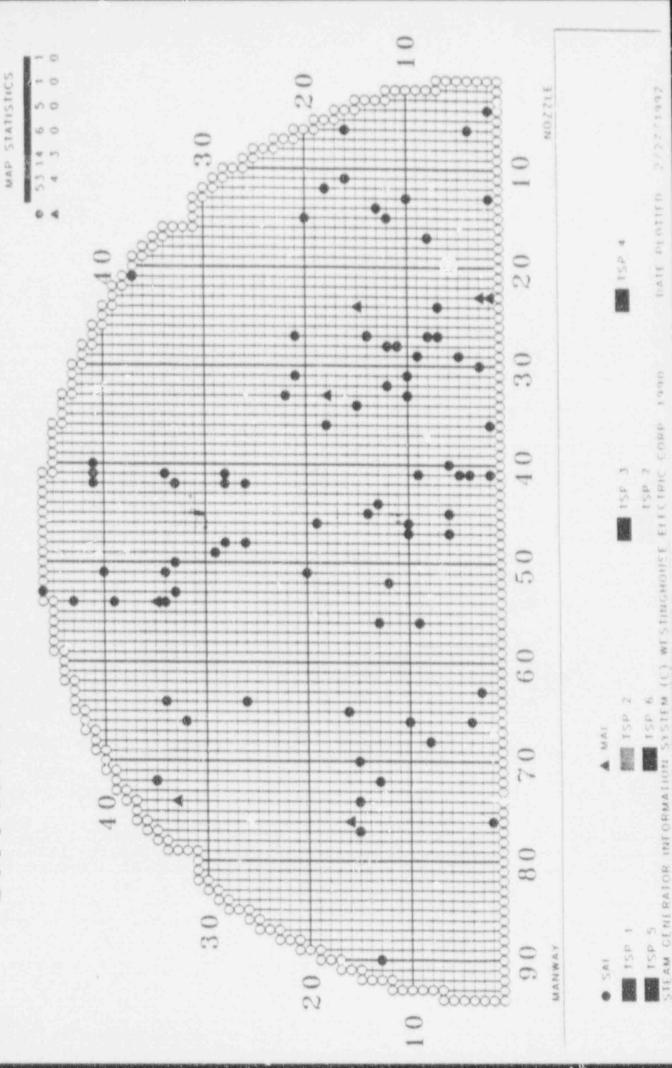
NORTH ANNA UNIT 1 S/G B 2/27 PLUG LIST SUPPORT PLATE AXIAL INDICATIONS (RPC)

ELEVATION	STEAM GENERATOR		
	Α	В	С
	SAI/MAI	SAI/MAI	SAI/MAI
1H	36/0	53/4	37/5
2H	24/2	14/3	41/1
3H	7/0	6/0	5/1
4H	5/0	5/0	8/0
5H	21/0	1/0	1/0
6H	3/0	1/0	2/0
7H	0/0	0/0	0/0

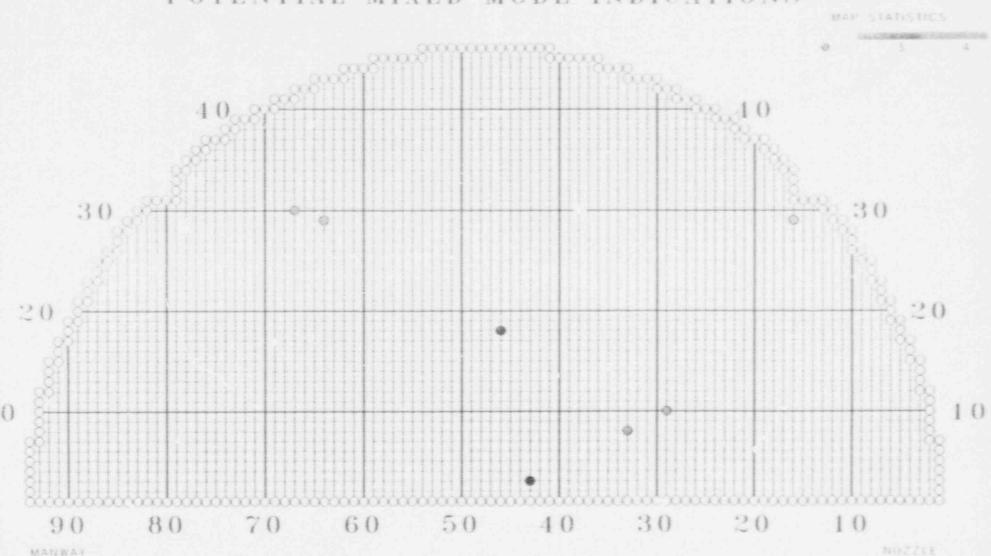
NORTH ANNA UNIT 1 S/G C FEB 1992 INSPECTION POTENTIAL MIXED MODE INDICATIONS

SEVEN (7) LOCATIONS WITH MIXED MODE DEGRADATION AT THE SAME TSP EDGE WERE OBSERVED IN S/G C.

ELEVATION	TUBE EDGE*	CIRCUM.	MINIMUM SEPARATING LIGAMENT	
TSP #1:	R29C16 +	750	> 250	
	R3C43 +	730	> 390	
	R18C46 +	690	> 690	
TSP #2:	R10C29 -	1190	>113°	
	R8C33 +	760	> 37°	
	R29C64 -	910	> 27°	
	+	630	> 17°	
	R30C67 +	1330	> 20°

ALL THESE INTERSECTIONS WERE JUDGED TO BE ACCEPTABLE AGAINST TUBE BURST CRITERIA.
