Draft
Radiological and Engineering
Assessment

Vicinity Property No. SLC 050

THE RADIOLOGICAL AND ENGINEERING ASSESSMENT

SALT LAKE CITY PROPERTY

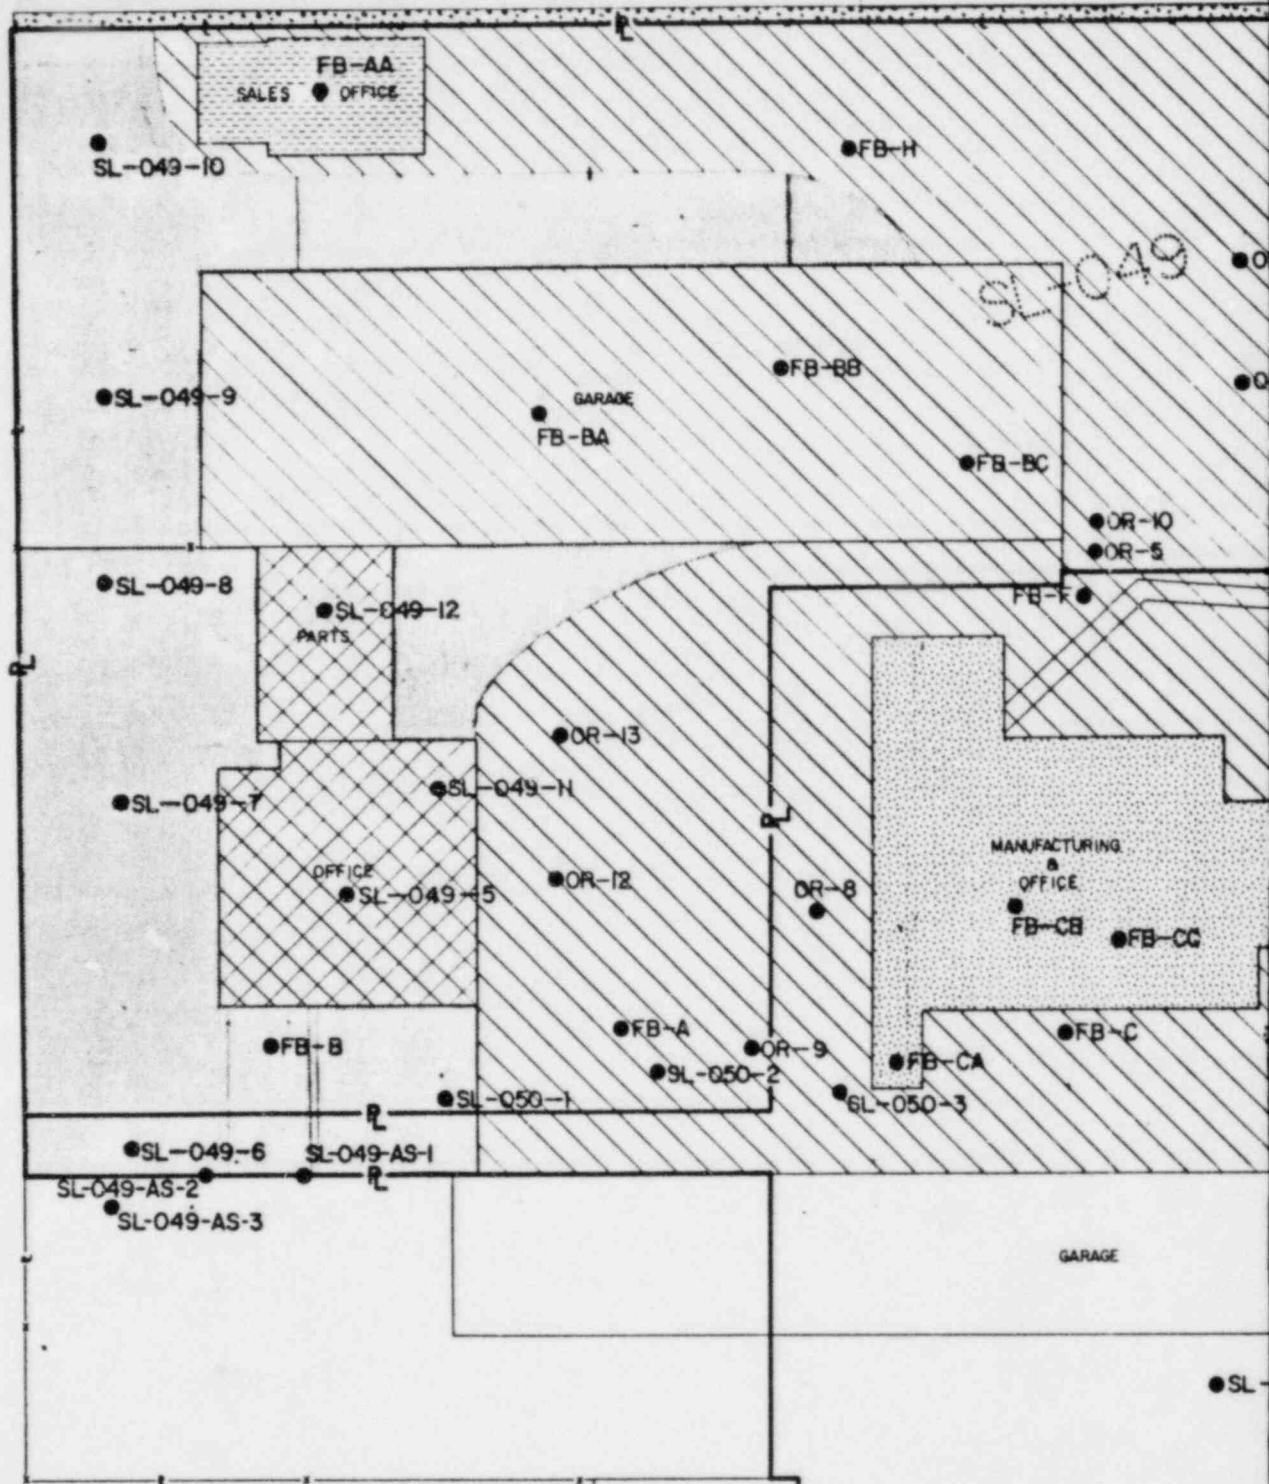
The entire area of SL-050 is contaminated. Figure 3.1 shows the estimated depth of contamination in various areas. In this figure, borehole locations marked "OR__" were drilled by ORNL; "FB__" were by FB&D; and "SL-050-__" were by MK/CNSI.

ESTIMATED
DEPTH OF CONTAMINATION

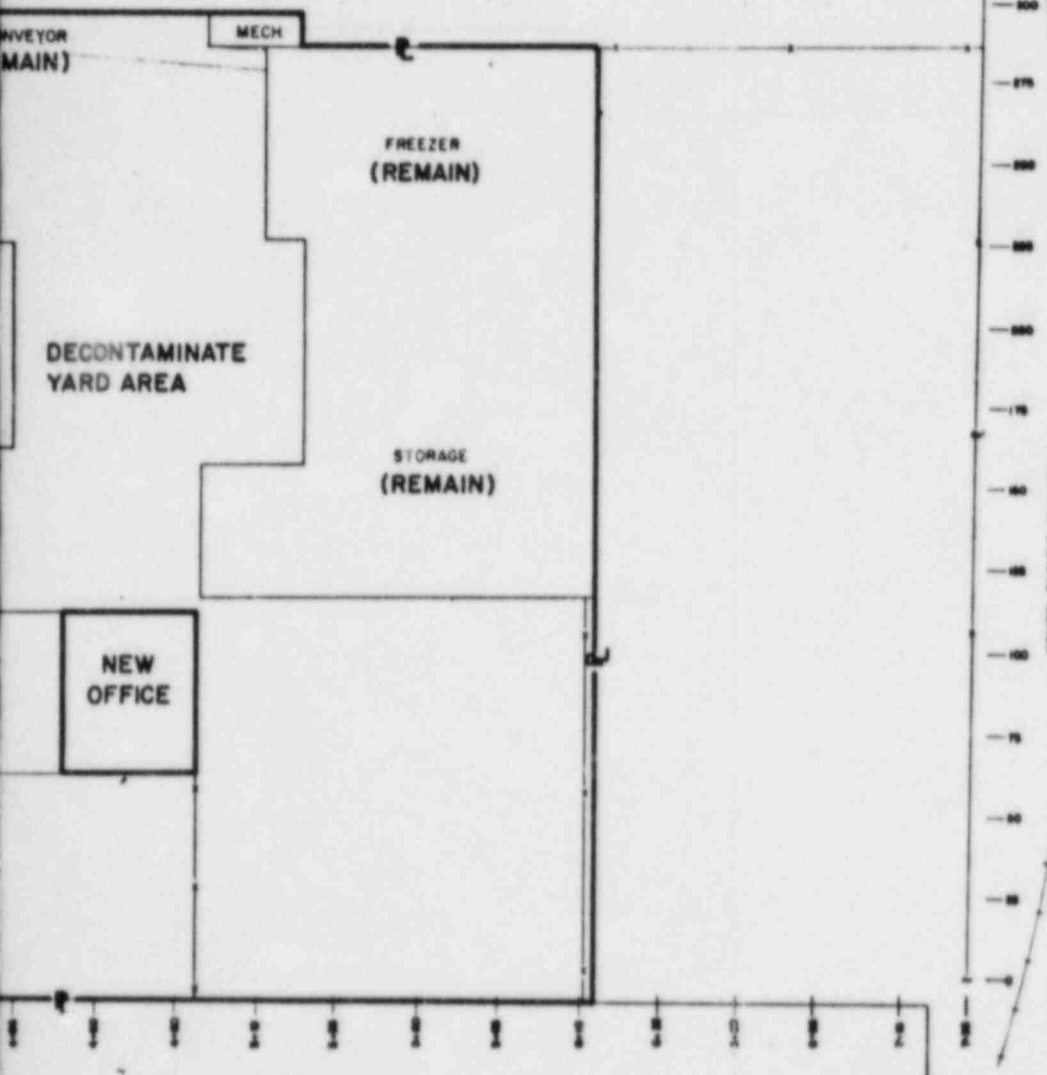
Option 3 - See Figure 4.2 for the conceptual layout of this option. Partially decontaminate the property. This includes exterior decontamination and construction of a new office building at the east end of the existing Dairy garage.

Remove all asphalt and concrete surfacing in yard areas. Excavate all contaminated soil in yard areas. Fill, compact and grade with clean backfill. Replace asphalt and concrete per original limits. Remove 40 feet from the east end of the Dairy garage. Construct a single story concrete block building (40' x 50') for office use adjacent to the Dairy garage. Upgrade existing ventilation systems to reduce radon gas concentrations in the manufacturing building.

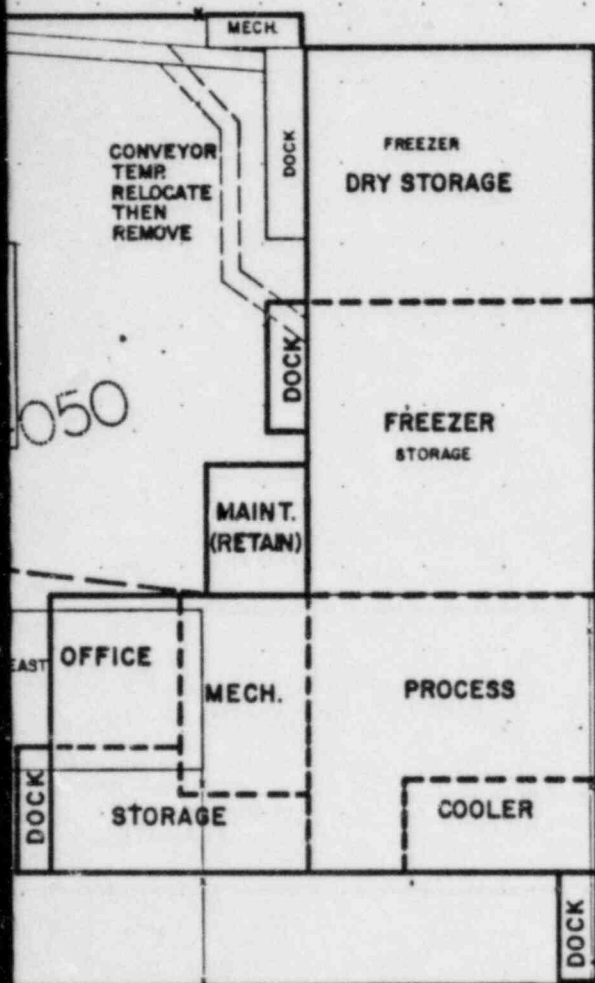
Option 5 - See Figure 4.3 for a conceptual layout of this option. This option provides complete decontamination of the property in stages, while maintaining the property owner in business and on his own property. Remove all asphalt and concrete surfacing in yard areas. Remove the east end of the Dairy garage building. Excavate all contaminated soil in yard areas then fill, compact, grade with clean backfill, and then replace asphalt and concrete. Construct a new two-story concrete block building in the area south of the freezer and storage building. The new building will replace the existing office and manufacturing building. Relocate the office equipment and move the inventory from the storage building into the new storage building. Decontaminate the freezer and storage building in two phases, reversing their positions. Excavate storage area slab and contaminated soil, then replace with insulated/ventilated foundation and slab. Excavate original freezer foundation and contaminated soil, then replace with a ventilated foundation and slab, thus converting it to storage area. Relocate loading dock. Transfer refrigeration equipment to new freezer area. Relocate refrigerated conveyor temporarily. The relocated conveyor will be utilized temporarily until the new manufacturing building is ready for production work. At that time, the conveyor will be removed permanently.

Re-route underground well piping from existing location to new building. Move storage inventory from new building to new storage area. Move manufacturing equipment to new building. Provide additional equipment and materials as required to establish the new facility. Demolish the existing office and manufacturing building. Excavate and remove all foundation concrete and floor slabs. Excavate all contaminated soil, fill, compact, grade with clean backfill and asphalt.
