Technical Report on the Findings of Task 4

Southwest Research Institute

Sealed Source and Device Design Safety Testing

Investigation of Failed Radioactive Stainless Steel
Troxler Gauges

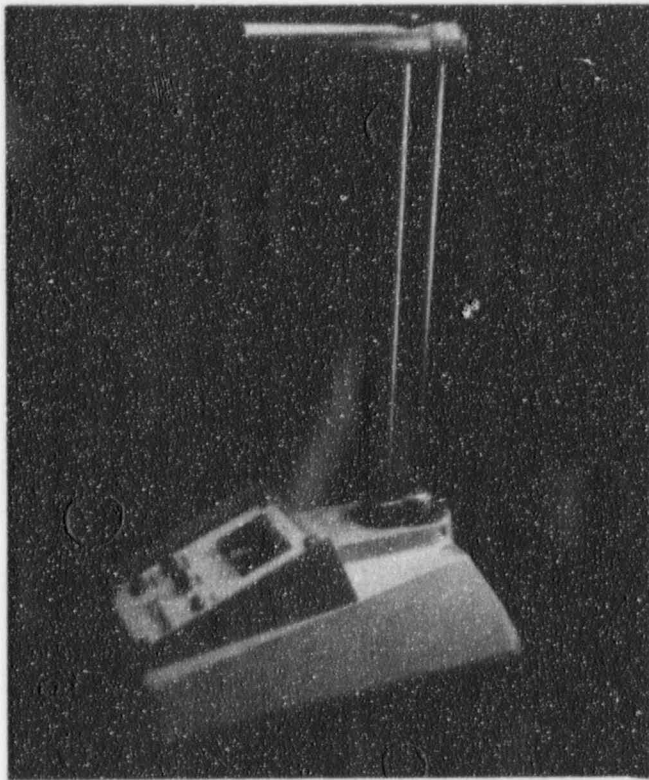
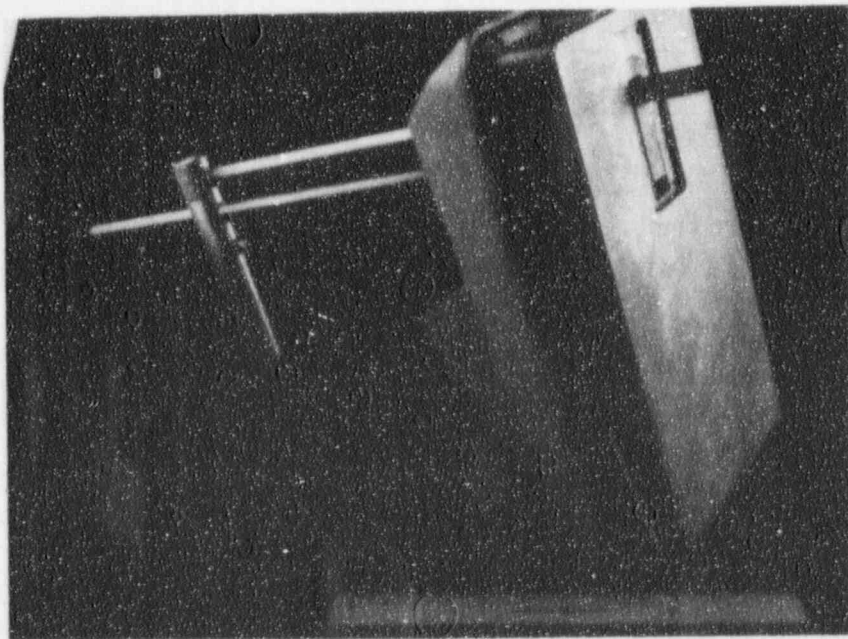
FIGURE 1-1. PHOTOGRAPHS OF THE AS-RECEIVED TROXLER GAUGE NO. 12711 (a) AND THE EXTENDED FRACTURED ROD (b).

On August 8, 1993, the Ohio Department of Transportation reported that during routine use of a Troxler Model 3401 nuclear gauging device, the cesium 137 radioactive tip fell off. The gauge is used to measure density of asphalts, soils or other mediums. It was determined by the Ohio Department of Transportation that the break occurred in the vicinity of the weld that secured the encapsulated source to the probe. Southwest Research Institute was furnished the broken rod and four other rods to determine the cause for failure and the extent of the problem.

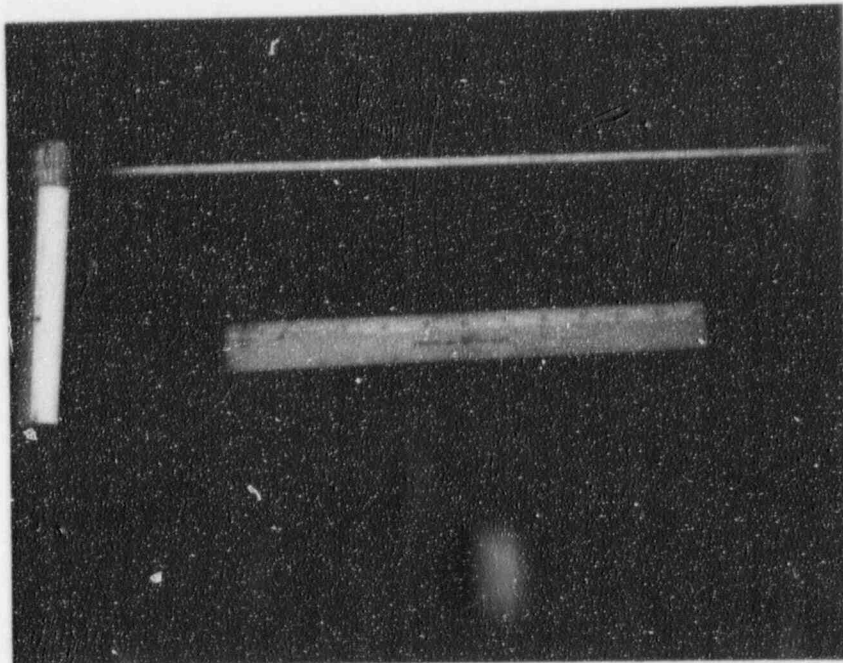
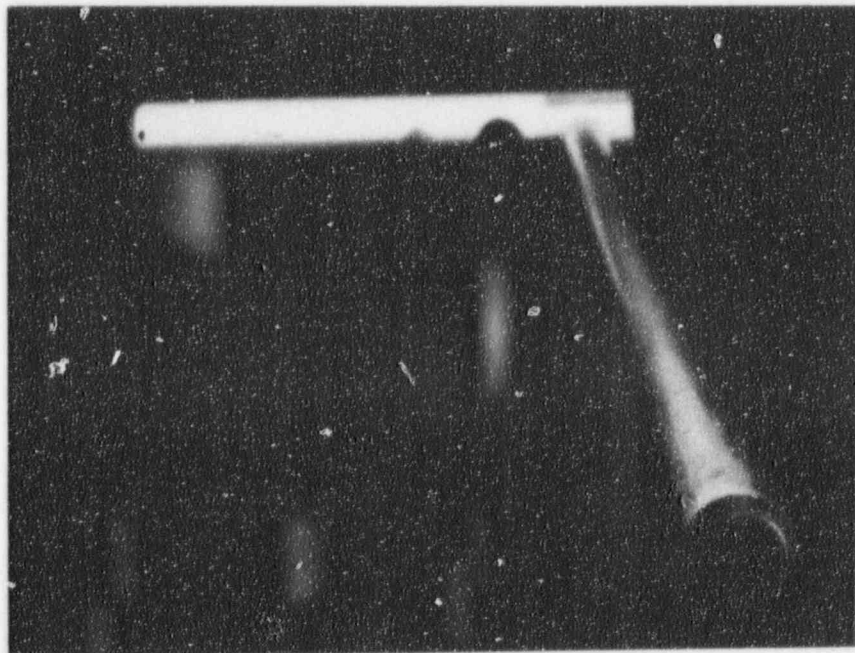
FIGURE 1-2. PHOTOGRAPHS OF THE FAILED ROD.

Southwest Research Institute concluded that the broken rod failed in a brittle manner due to a hard zone in the heat affected zone of the weld. Because the rod material, Type 440C, has poor weldability, it developed a hard zone that was not relieved with a post weld heat treatment. The fractographic evidence and surface abrasion marks indicated that the rod was subjected to a bending condition at the hardened zone which initiated a crack. After the crack had initiated, it gradually propagated during multiple uses.

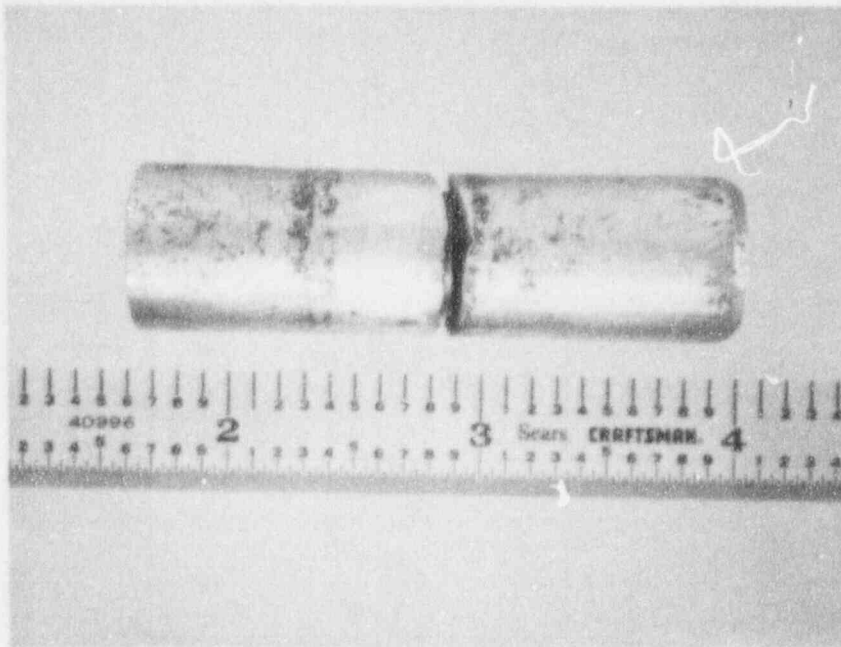
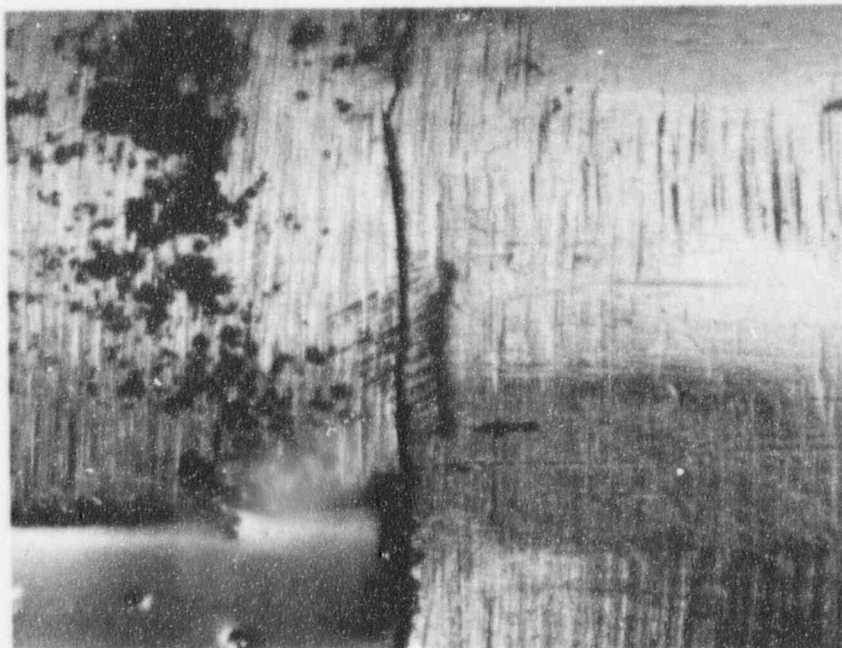
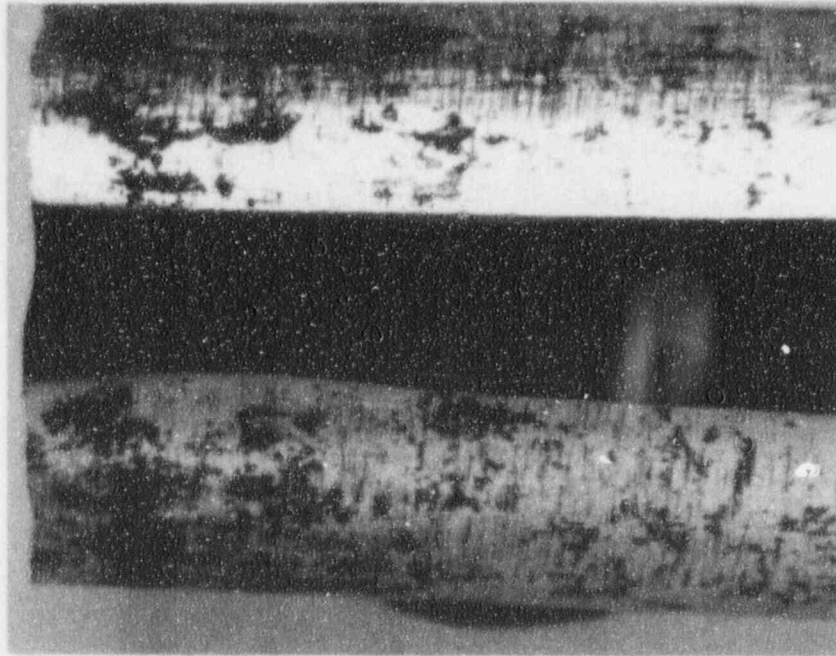
FIGURE 3-1. PHOTOGRAPHS OF THE TIP AND LOCATION OF FAILURE.
Arrow shows abrasive mark on OD surface.

- (2) At some time during usage of the gauge in the field, the rod was impacted as indicated by abrasive markings. This caused a bending condition on the rod at the hard zone which resulted in a crack.

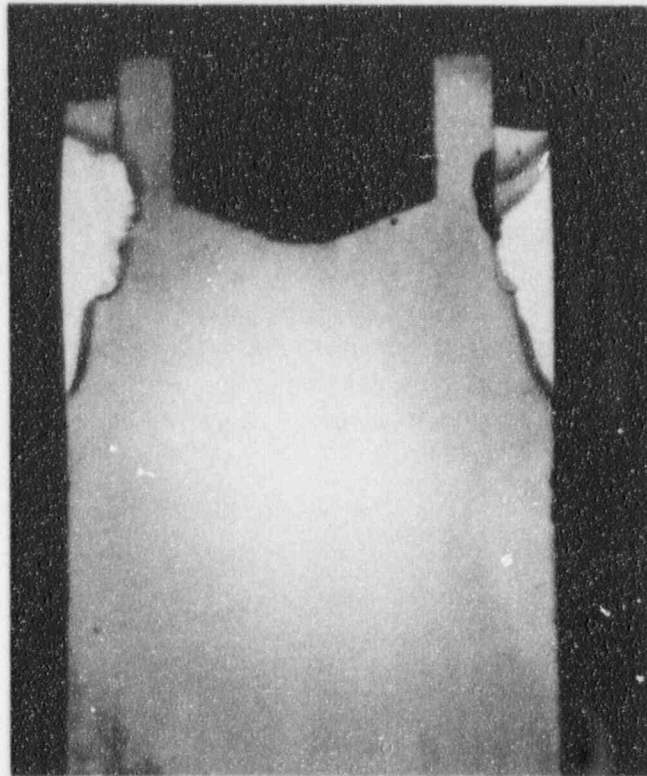
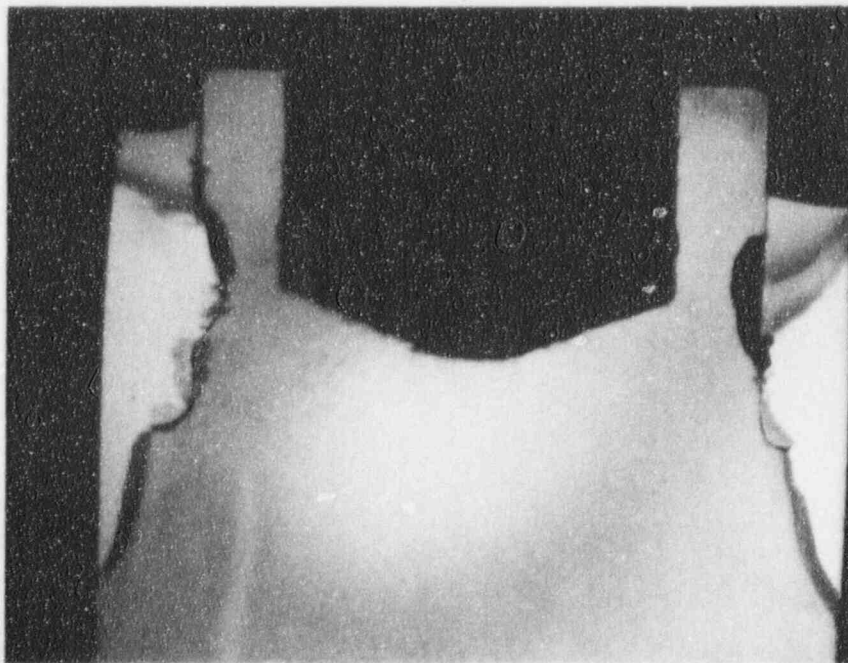
FIGURE 5-1. PHOTOMICROGRAPHS OF THE ROD CROSS SECTIONED AT THE FRACTURE.

Both halves of the fracture surface were sectioned in the vicinity of the origin to examine the weld and to determine if any microstructural anomaly caused the failure. Figure 5-1 shows the position of the weld relative to the fracture. Figure 5-2 shows a close-up of the weld heat affected zones (HAZ) and hardness indentations. The fracture plane was about 0.034 inch from the edge of the weld metal at the surface of the rod. The fracture origin location had no anomaly, however, the base metal was more typical of an untempered martensite, which is hard. The weld had a lack of fusion between the weld metal and the rod. But, this did not contribute to failure, see Section 8 - Weld Evaluation, for more details. Figure 5-3 shows the OD surface had corrosion pits. The corrosion pits were about 0.0025 inch deep. No cracks extended from the pits.

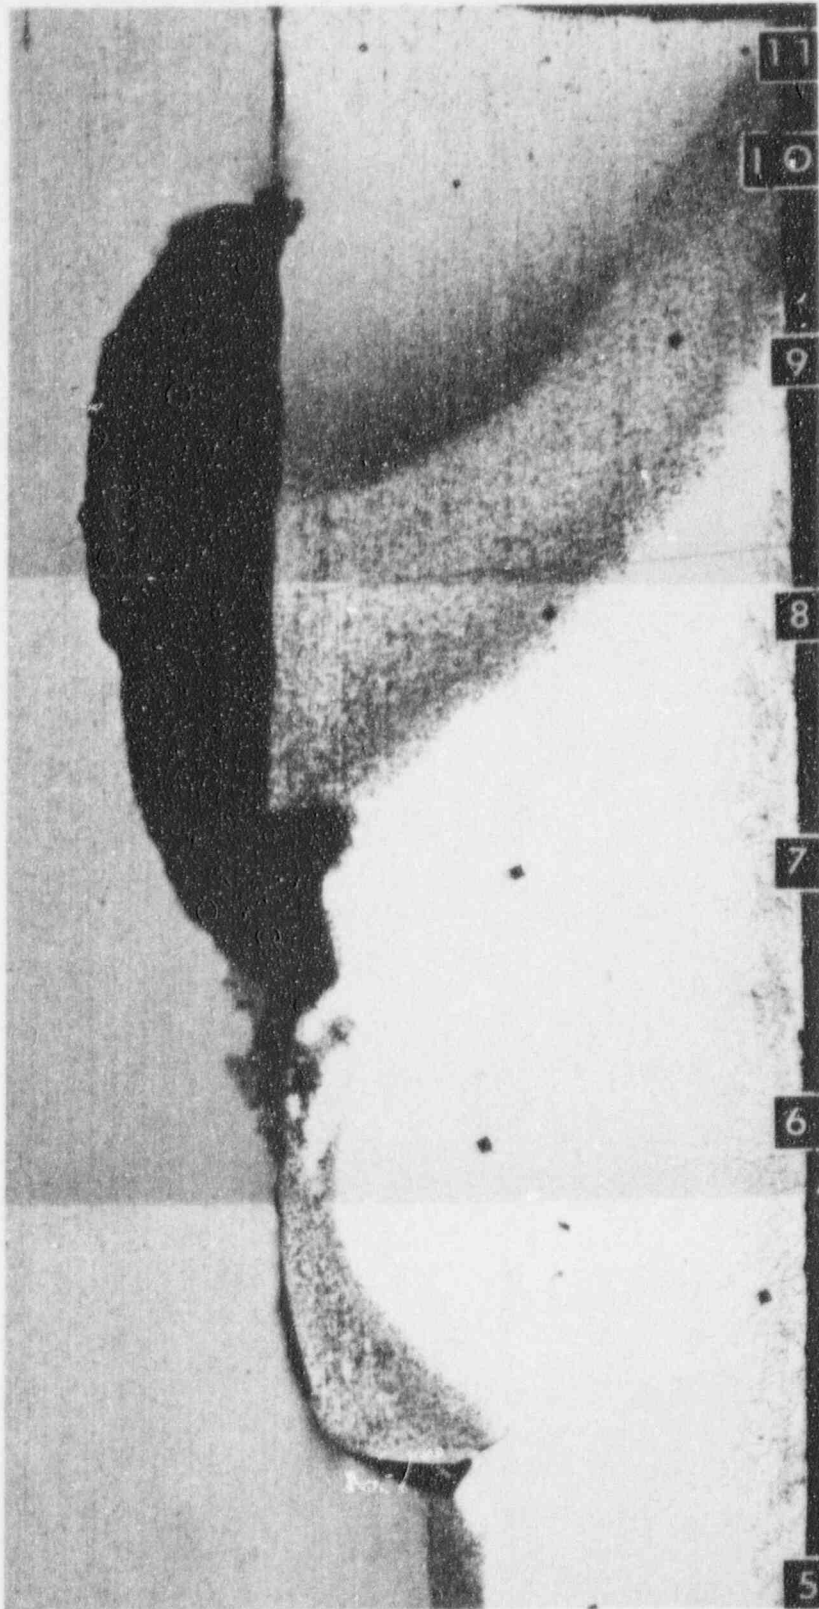
FIGURE 5-2. PHOTOMICROGRAPHS OF THE ROD CROSS SECTIONED SHOWING THE WELD AND MICROHARDNESS LOCATIONS.

Table 4-3 shows the microhardness values for the failed Troxler Gauge No. 12711. The fracture plane was about 1.0 inches from the end of the rod. The fracture did not occur in the weld, but at the toe of the weld in the HAZ. Hardness measurements were made on either side of the fracture. The hardness results showed that at the location of crack initiation, the hardness was the highest. It was interesting to note that the weld was extremely soft. A weld usually is not as soft as shown in this rod. In fact, the hardness survey indicated that all of the rods had an extremely soft weld.

- Heat Treatment** Because the source cup and rod parts were hardened before welding, a sharp microstructural transition was produced by the weld as indicated by the heat affected zone shown in Figure 5-2.

- Weld Root** Inadequate penetration of the weld root also is shown in Figure 5-2, was probably caused by misalignment of the joint over the backing groove.

An improved welding procedure could reduce the high hardness. The heat treatment recommended should be included with the welding procedure requirements for the purpose of reducing the hard brittle transition of the HAZ. A minimum of 500°F preheat is recommended for carbon contents over 0.50% before welding. Maintaining this preheat as a minimum interpass temperature through to post weld heat treat is recommended by tempering immediately after welding without cooling to room temperature. Typical tempering for this alloy for stress relieving is done from 300 to 800°F. Post weld heat treatment in the form of a localized stress relief might soften this zone. Using the temper bead technique to deposit the cover-pass weld beads also might produce sufficient softening of the HAZ to minimize the "brittle notch" condition.

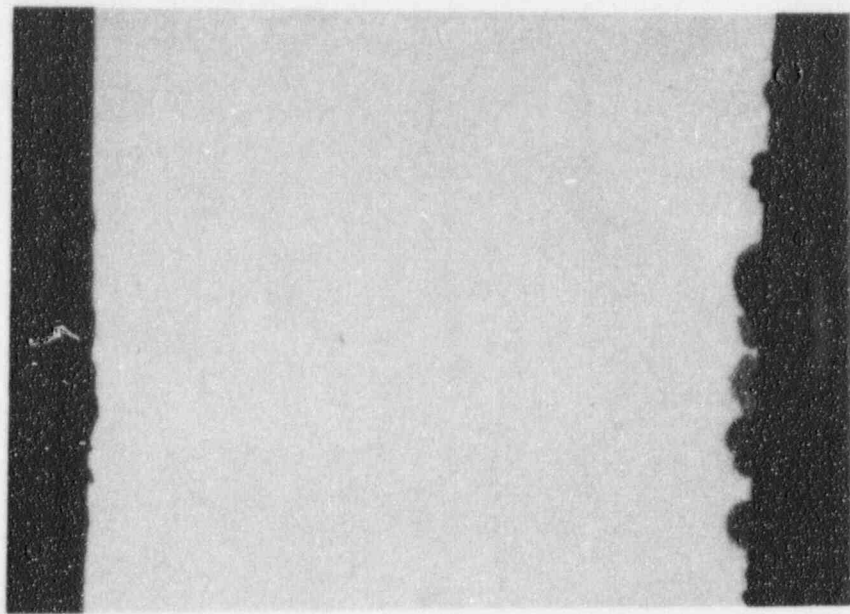
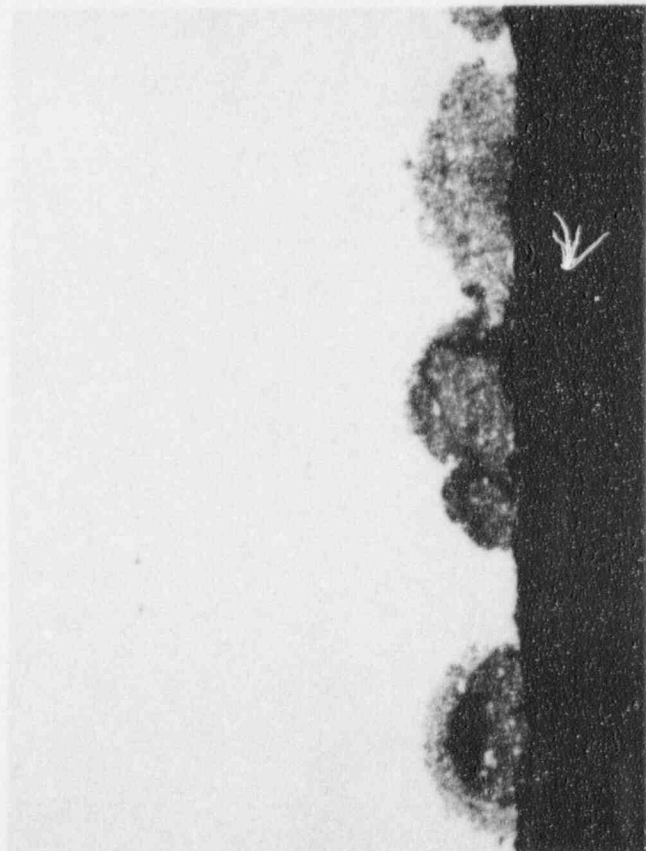
FIGURE 5-3. PHOTOMICROGRAPHS OF THE OD SURFACE SHOWING CORROSION ATTACK. Notice no microcracks extend from the pits.

A stress concentration was present because of two factors. First, the large differential in hardness between the HAZ and the weld metal caused a microstructural stress concentrator. Second, the superficial pitting was found on the surface and was evident at the origin. Corrosion of Type 440C is not unusual. Although pitting was present, it is believed that the pits alone were not a cause for failure. The reason is because pits were evident at other locations, but no cracks were found extending from the pits.

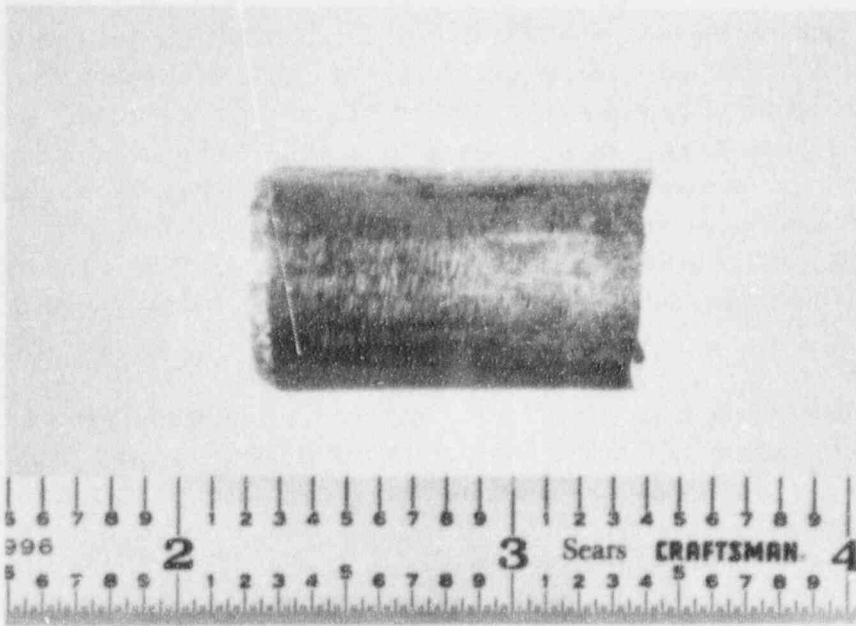
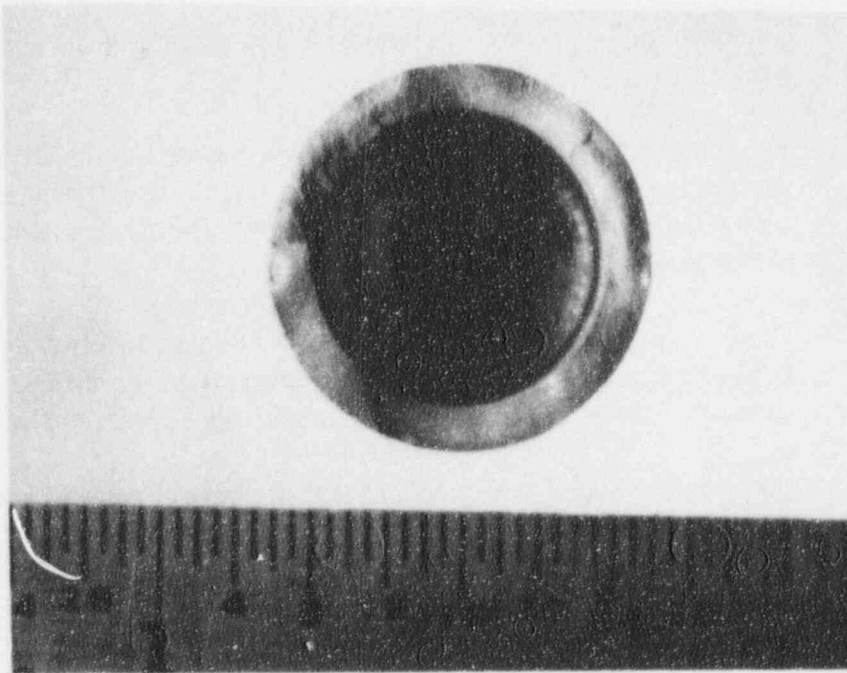
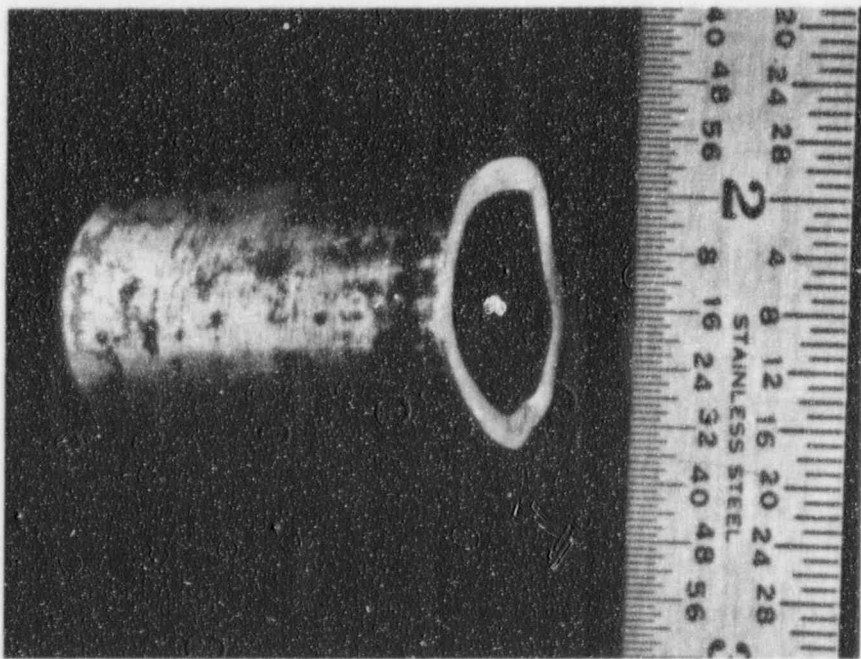
FIGURE 6-1. PHOTOGRAPHS OF THE FRACTURED TIP.

The fracture surface from Gauge No. 12711 was examined using the stereomicroscope and the scanning electron microscope (SEM). Figure 6-1 shows the fracture surface viewed towards the end of the rod. Figure 6-2 shows the fracture surface viewed towards the housing. The fracture plane was nearly transverse to the axis of the rod. A unique feature found on the fracture surfaces was a discolored zone, shown in Figures 6-2 through 6-4. The discolored region extended about 0.25 inch around the circumference. The clamshell features and radial markings, shown in Figure 6-4, indicate this region was the origin. Crack initiation occurred on one side of the rod coinciding with the elliptical region. The transverse crack extension and the initiation on one side suggests that the rod was loaded in a bending condition.

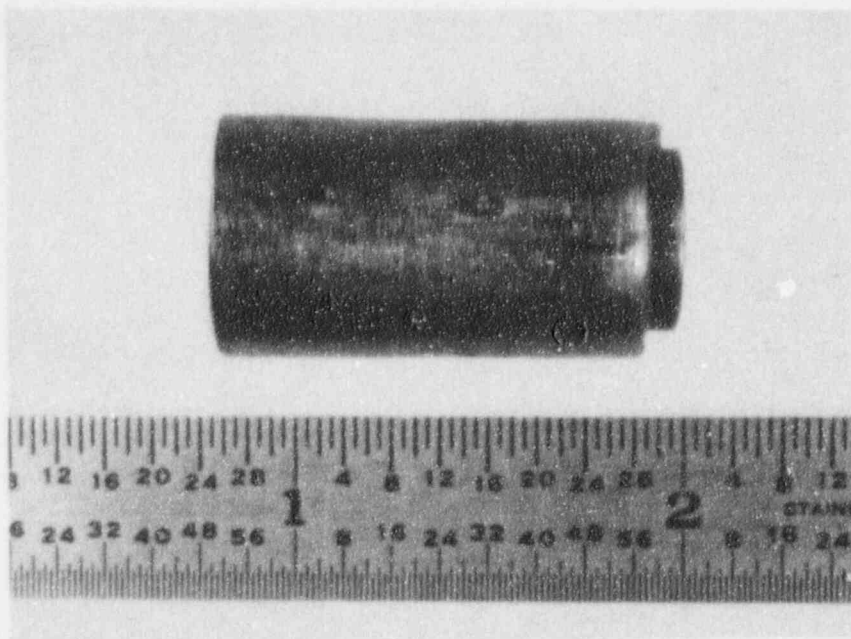
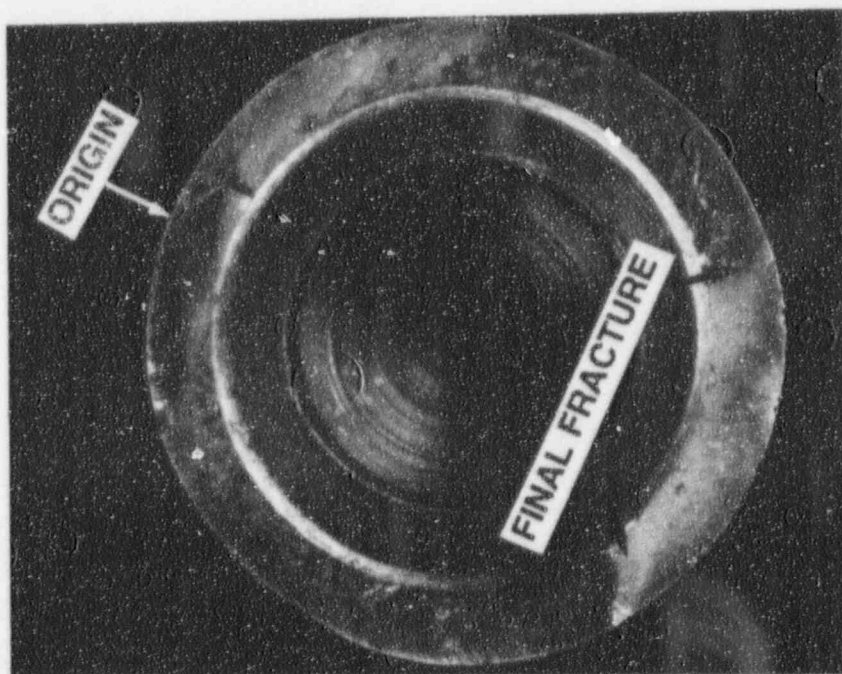
FIGURE 6-2. PHOTOGRAPHS OF THE FRACTURED SURFACE TOWARDS THE GAUGE. Arrow shows discolored region.

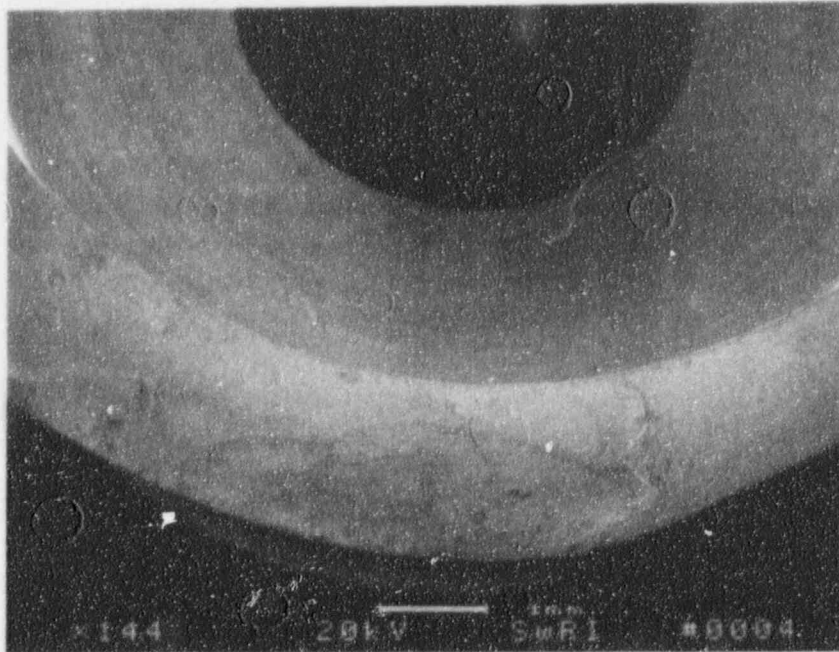
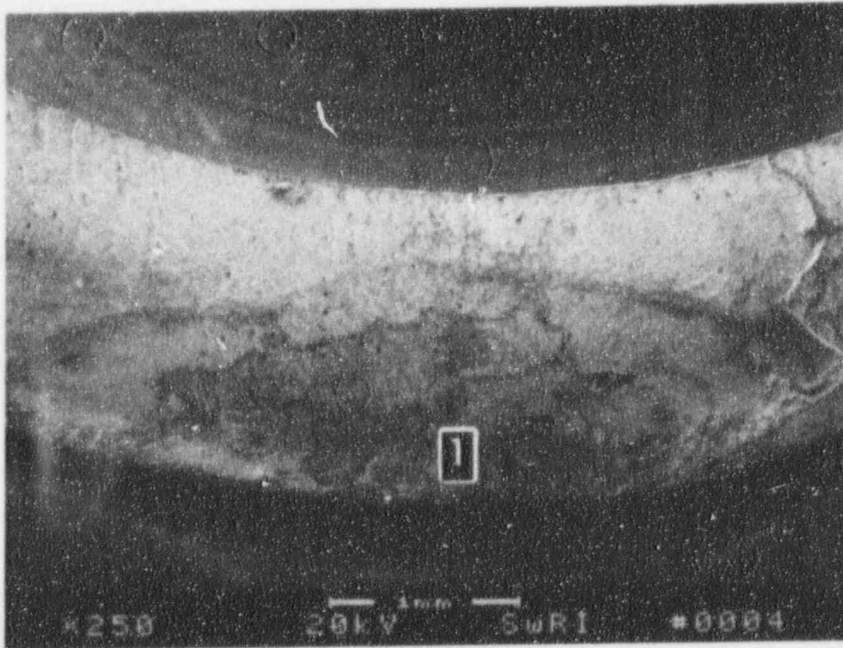
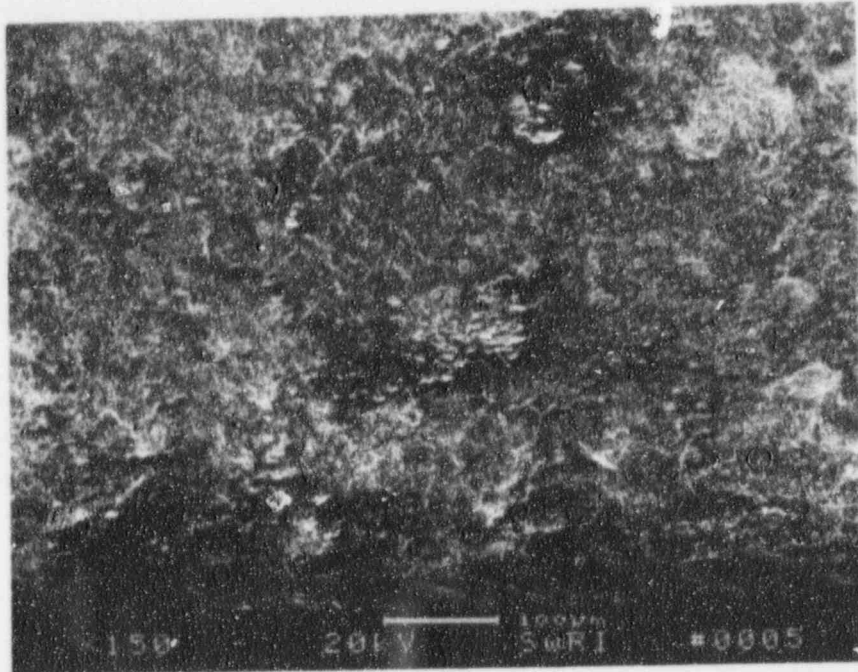
FIGURE 6-3. SEM FRACTOGRAPHS OF THE TIP END SHOWING ELLIPTICAL REGION.

- 1) The discolored region was elliptical in shape and had a heavy oxide present, see Figure 6-3.
- 2) Corrosion pits were evident in the vicinity of the origin, see Figures 6-4 and 6-5, however, pitting was not limited to the origin.

- 3) Fractographic features in the discolored region consisted of a heavily oxidized fracture surface and crack arrest bands. These features indicate that a small crack had existed for some time. The surface corroded, then during usage the crack extended, then arrested until the next usage.

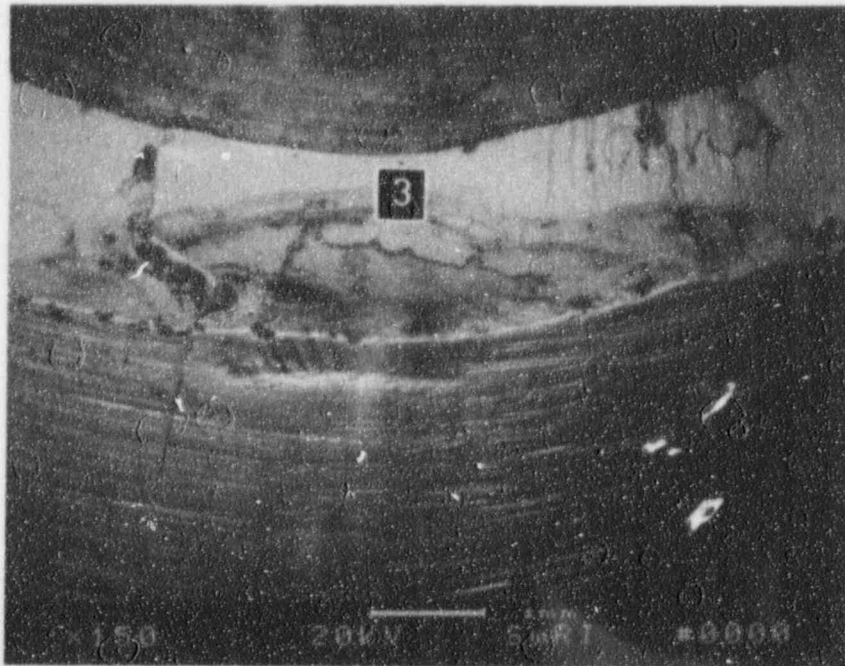
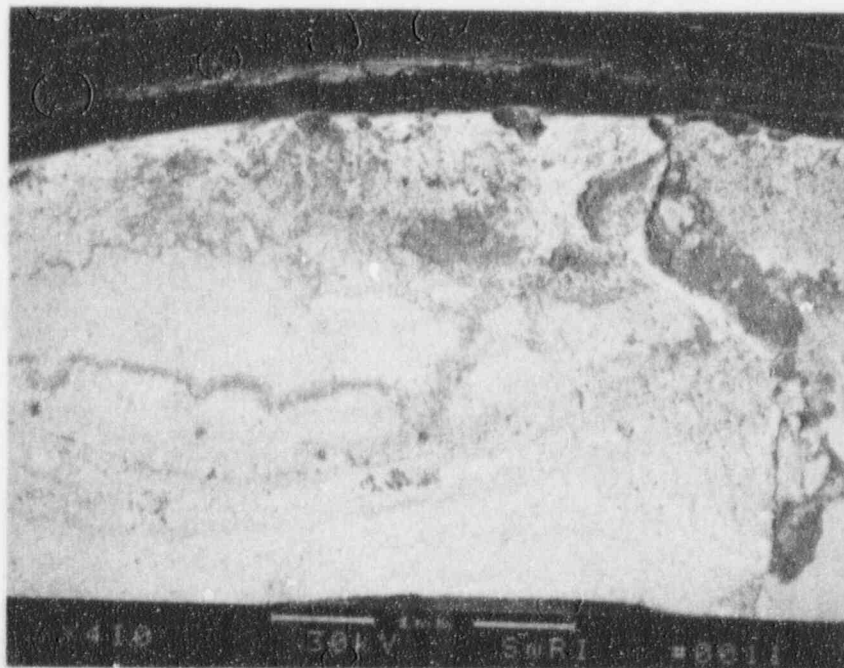
FIGURE 6-4. SEM FRACTOGRAPHS OF ORIGIN ON GAUGE SIDE. Notice corrosion pits on the OD surface. Arrow indicates clamshell pattern.

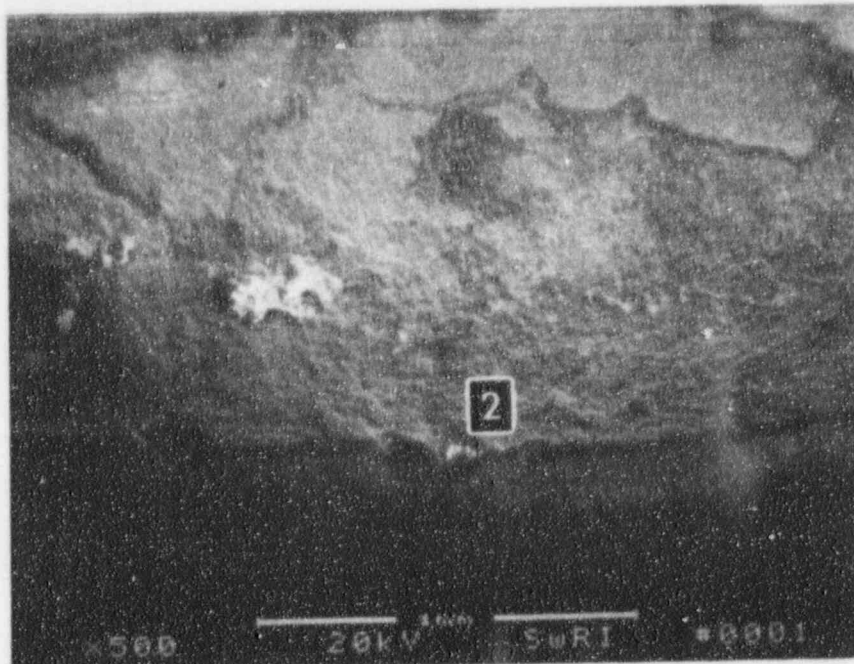
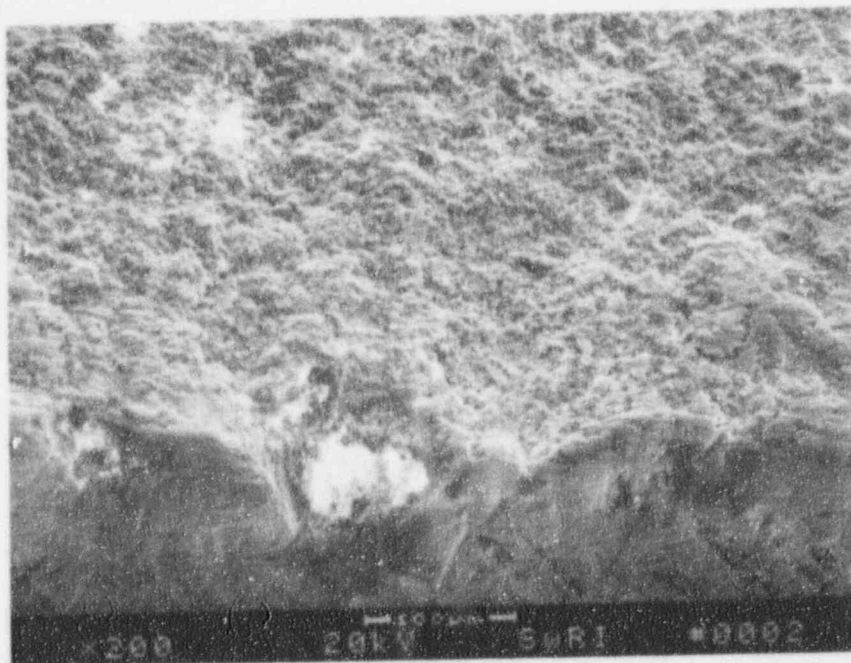
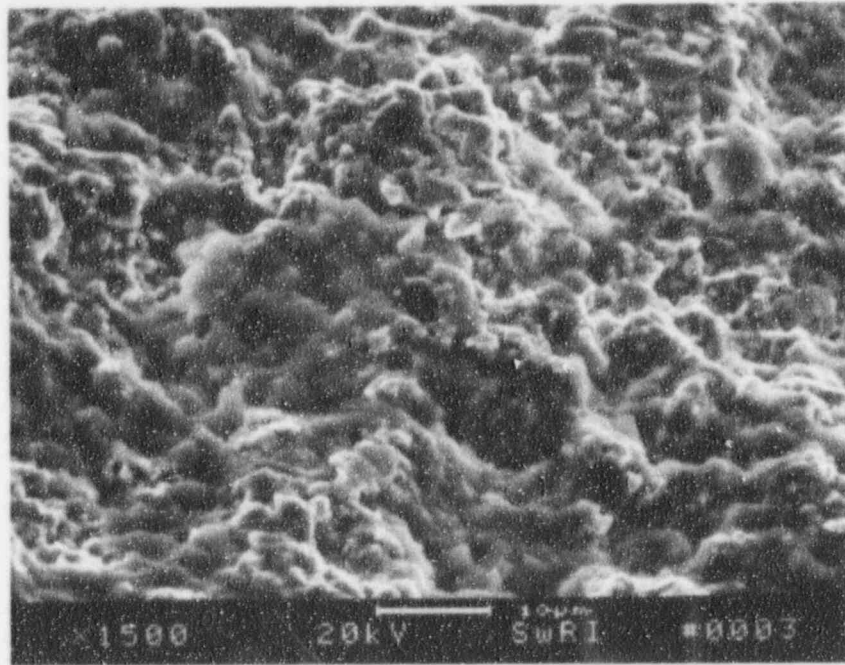
FIGURE 6-5. SEM FRACTOGRAPHS IN THE ELLIPTICAL REGION, LOCATION 2.

- 5) There were no signs of tensile overload dimples, or cleavage facets in the origin location indicative of brittle impact overload, or even intergranular facets indicative of environmental attack, see Figures 6-5 and 6-7.

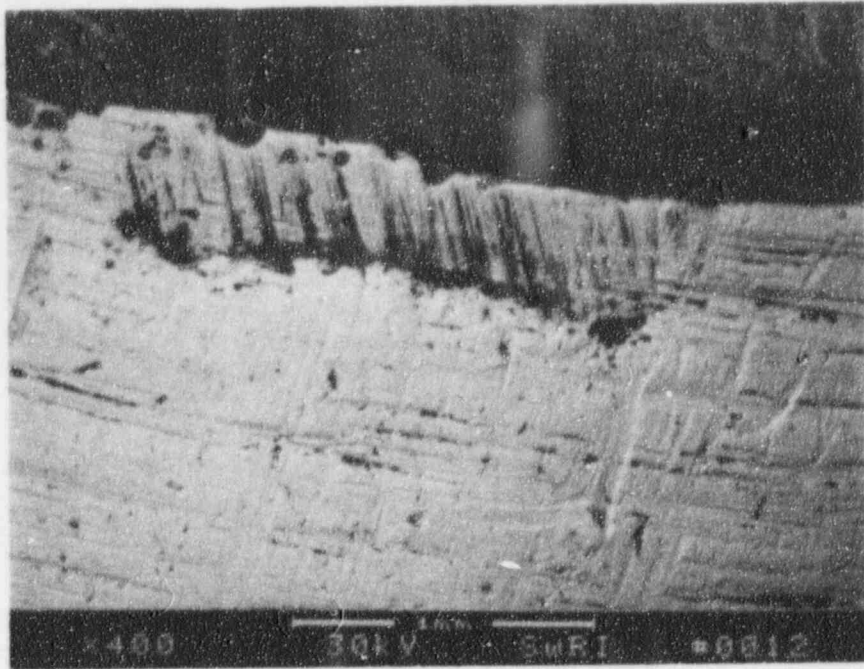
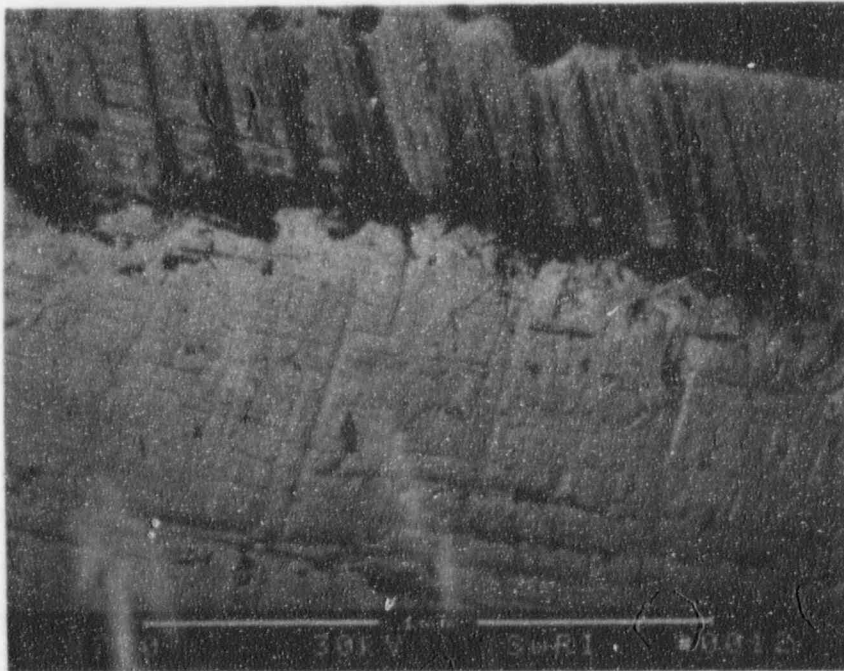
FIGURE 6-6. SEM PHOTOGRAPHS OF ABRASIVE SCRATCH ON THE SURFACE.

- 3) An abrasive-like scratch was evident in the vicinity of the origin, see Figure 6-6.
- 4) The fracture features in the elliptical region were flat. Although there were no obvious signs of fatigue striations, crack arrest bands were present indicative of progressive crack propagation. The crack extended about 290° before final fracture occurred.

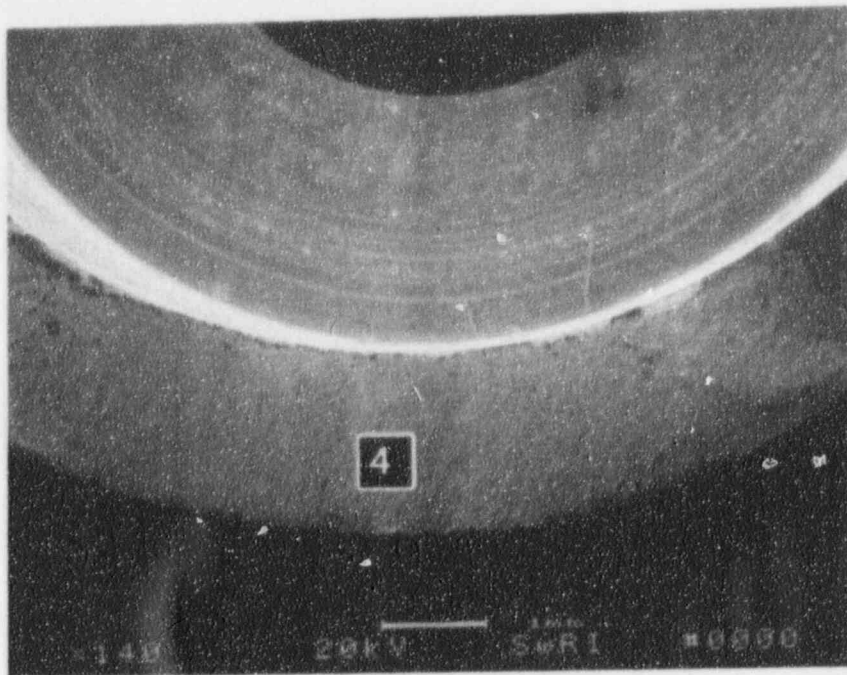
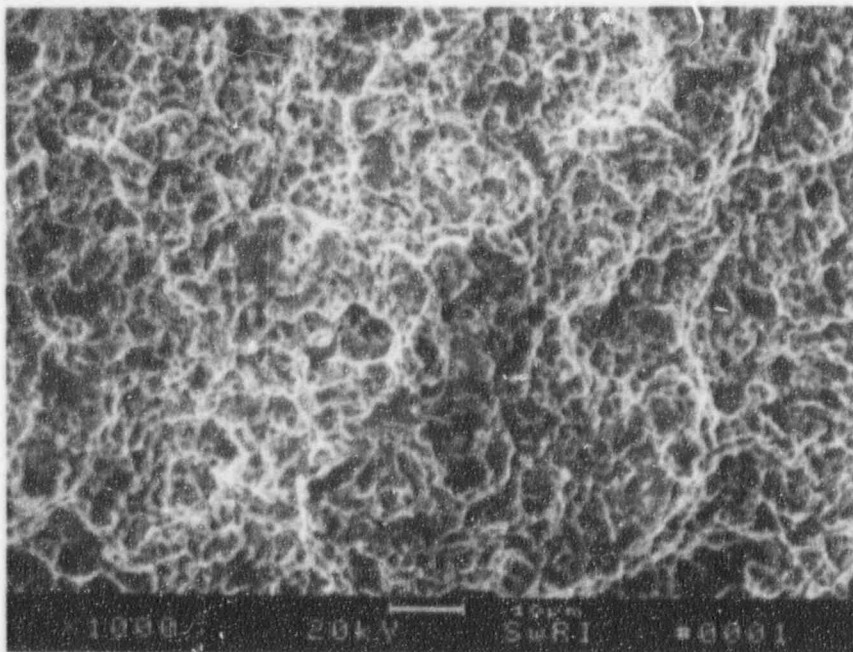
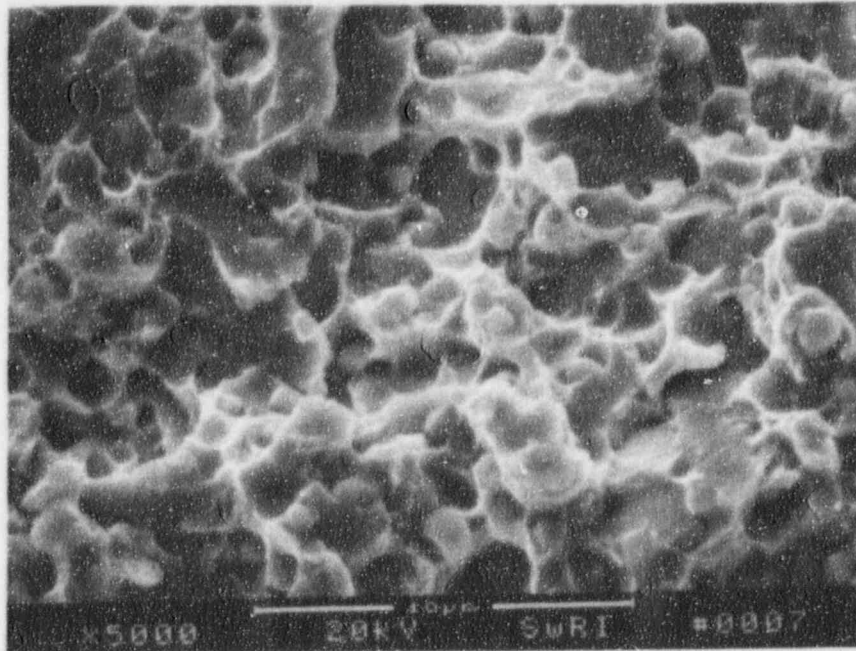
FIGURE 6-8. SEM FRACTOGRAPHS OF FINAL FRACTURE REGION AND LOCATION NO. 4.

- 6) The fracture features in the final fracture region were primarily of brittle cleavage failure indicated by the facets (occasional dimples were also evident), see Figure 6-8.

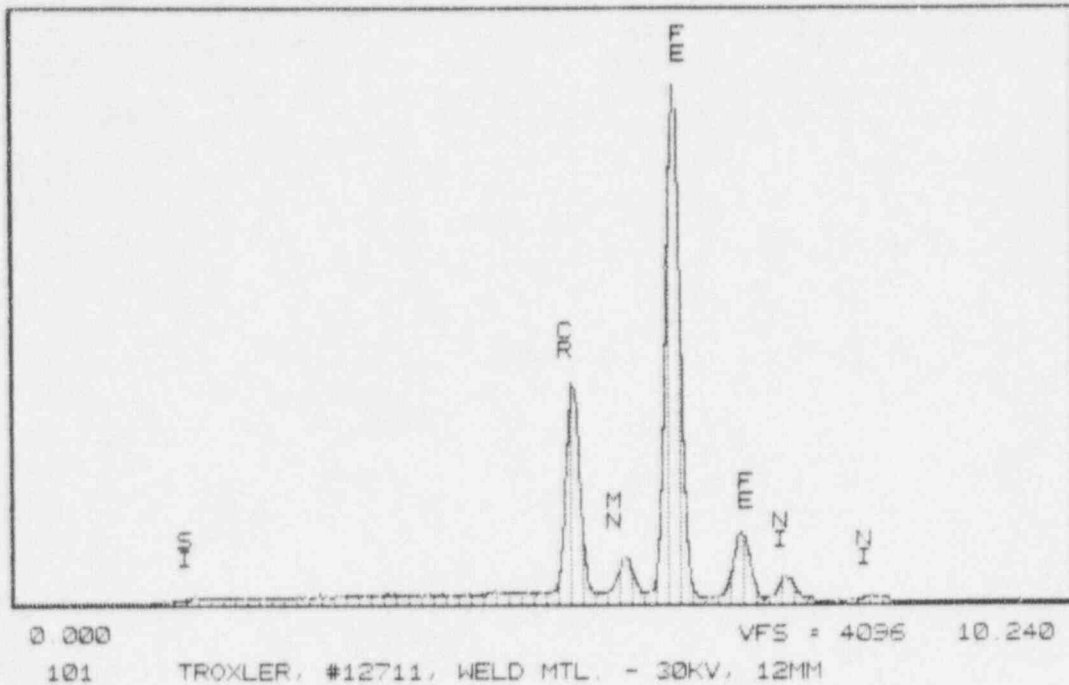
FIGURE 7-4. ENERGY DISPERSIVE X-RAY SPECTRA FOR THE WELD.

However, the weld metal was not the same metal as the rod. The weld metal was comparable to an austenitic stainless grade (probably Type 308).

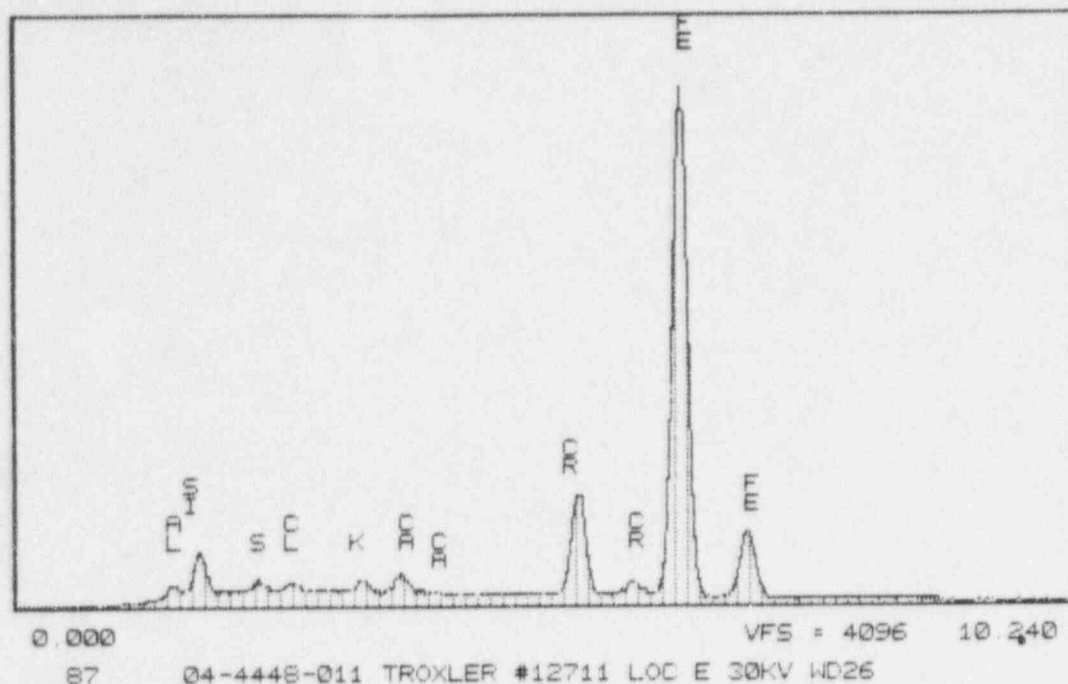
FIGURE 7-5. ENERGY DISPERSIVE X-RAY SPECTRA FOR THE ROD CORROSION.

The corrosion product analysis identified elements of calcium, chlorine, and potassium. These elements are typical for the application of the rod.
