NUREG/CR-6074
04-4448-012
Vol. 4

Sealed Source and Device Design Safety Testing

Technical Report on the Findings of Task 4

Investigation of Sealed Source for
Paper Mill Digester

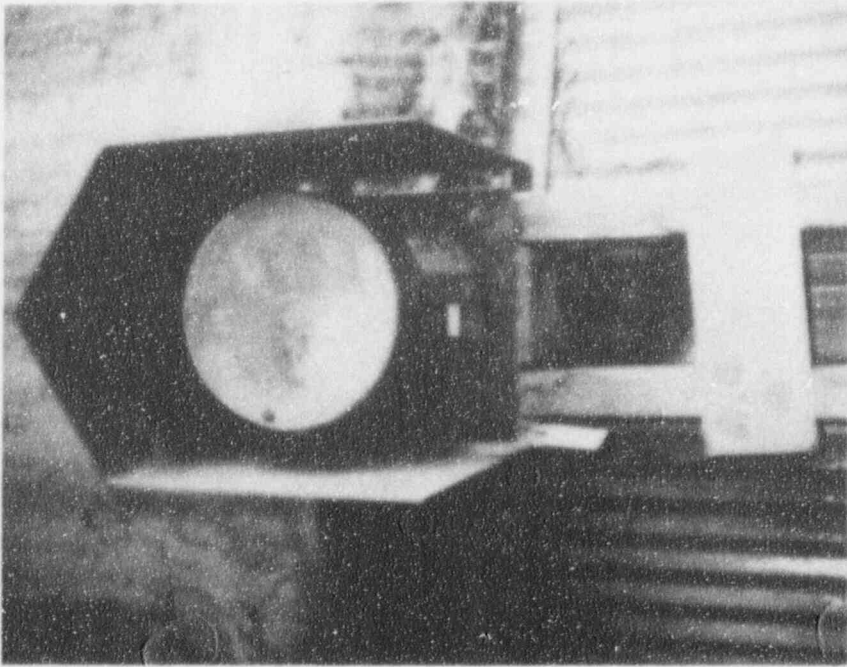
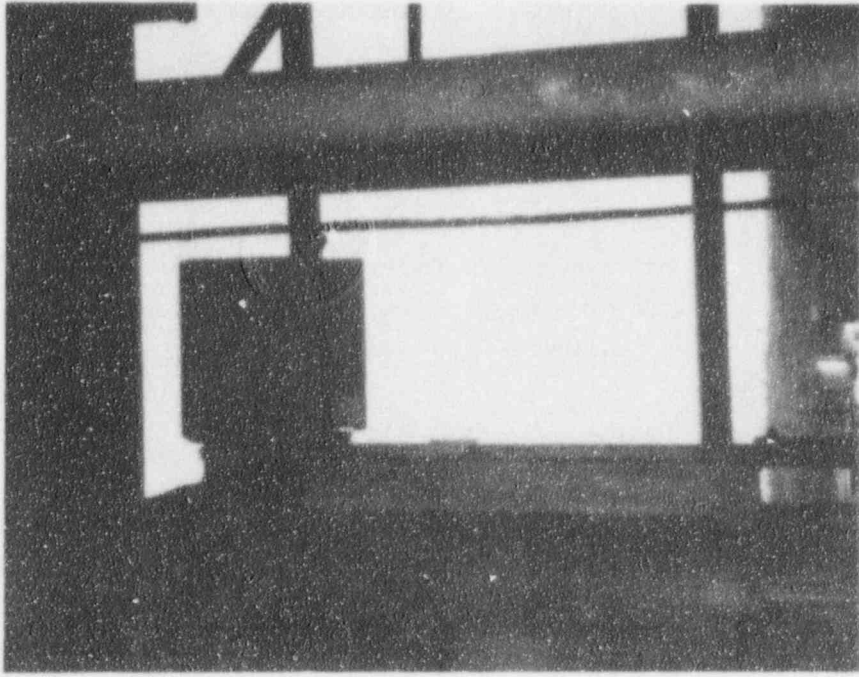
FIGURE 1. PHOTOGRAPHS OF THE LOCATION OF THE HOUSING (a) ON THE DIGESTER.

According to the RSO at the Georgia facility, the gauge SwRI obtained was located in the most harsh atmosphere (even worse than the gauge in which the suspected leaking source was installed) in which these gauges are mounted at the plant. Huge tanks containing liquid caustic which are approximately 40 feet in diameter and 10-20 feet tall are located approximately 75 feet to the north of the location where the digesters and fixed gauges were located. Winds carry smelly, corrosive atmosphere to the fixed gauge locations. The digesters to which the gauges are mounted are approximately four stories tall. The fixed gauges are protected from some overhead and side precipitation by a metal shield ("birdhouse") fashioned over the top and sides of the fixed gauge housing, see Figure 1. These "birdhouses" were installed approximated two years ago. The received gauge has a service history closely matching that of the gauge containing the suspected leaking source.

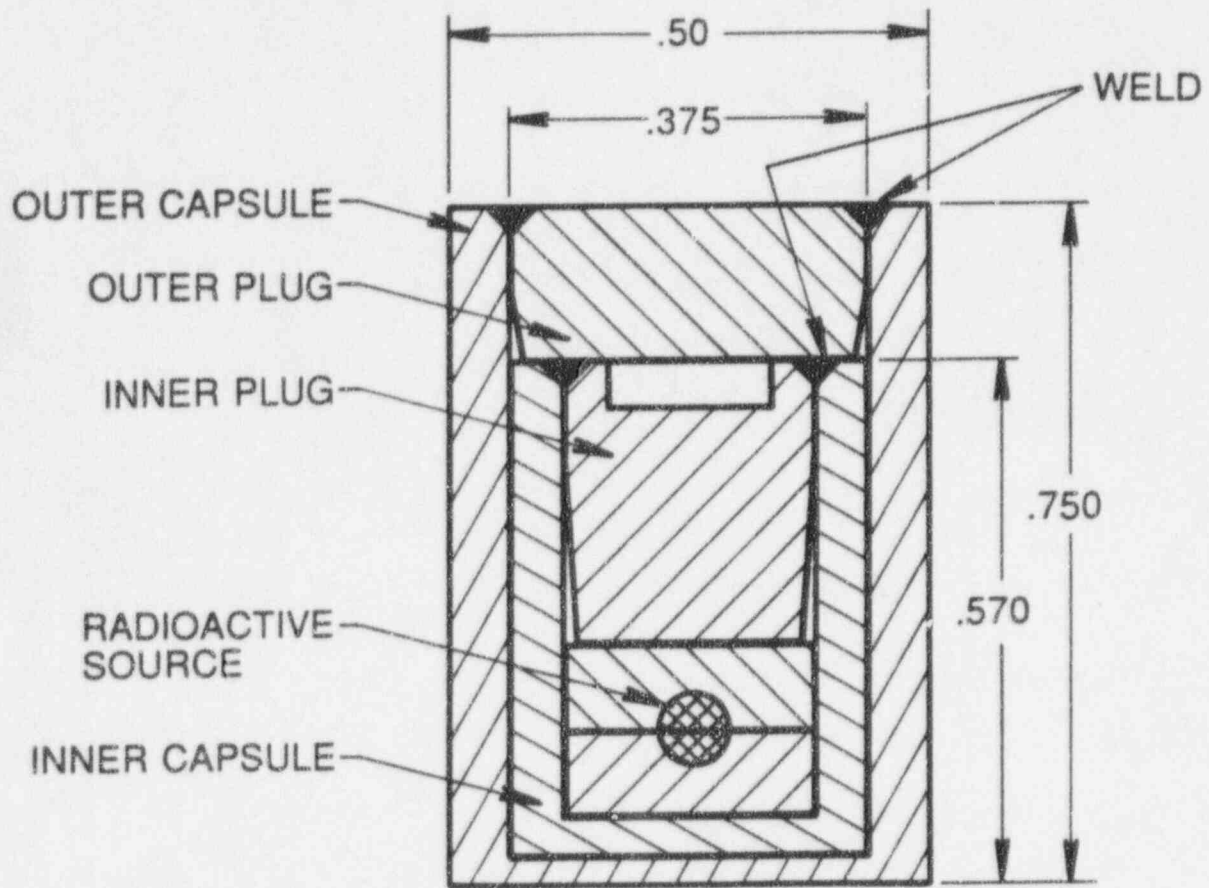
FIGURE 2. ILLUSTRATION OF THE ENCAPSULATED SOURCE.

SwRI investigated the feasibility of acquiring the sealed source for analysis. It was determined that it would be necessary for SwRI to take receipt of the entire disposal container since it was possible that the source had contaminated the contents of the container. Also, SwRI learned that the source had been removed from its source holder using a mandrel, which could have damaged the source containment further. It was felt that the damage could compromise the ability of SwRI to determine the actual cause of the leakage. The composition of the disposal container was determined and a drawing showing that the source was doubly encapsulated was supplied by Kay-Ray/Sensall, see Figure 2.

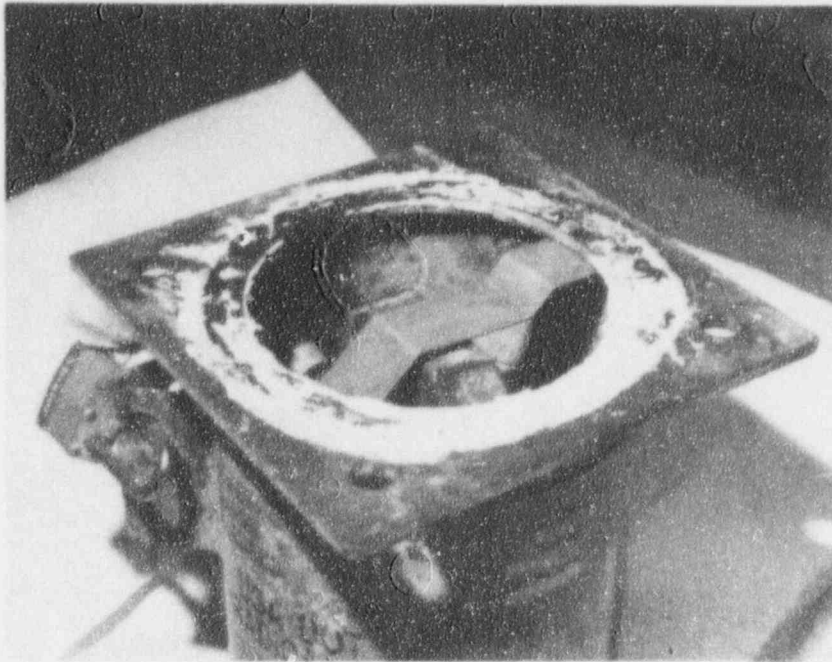
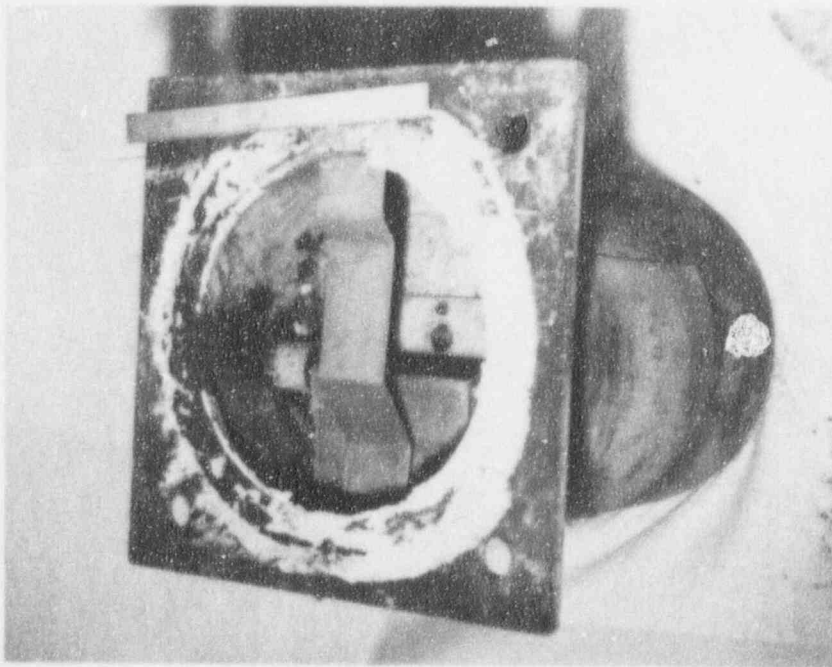
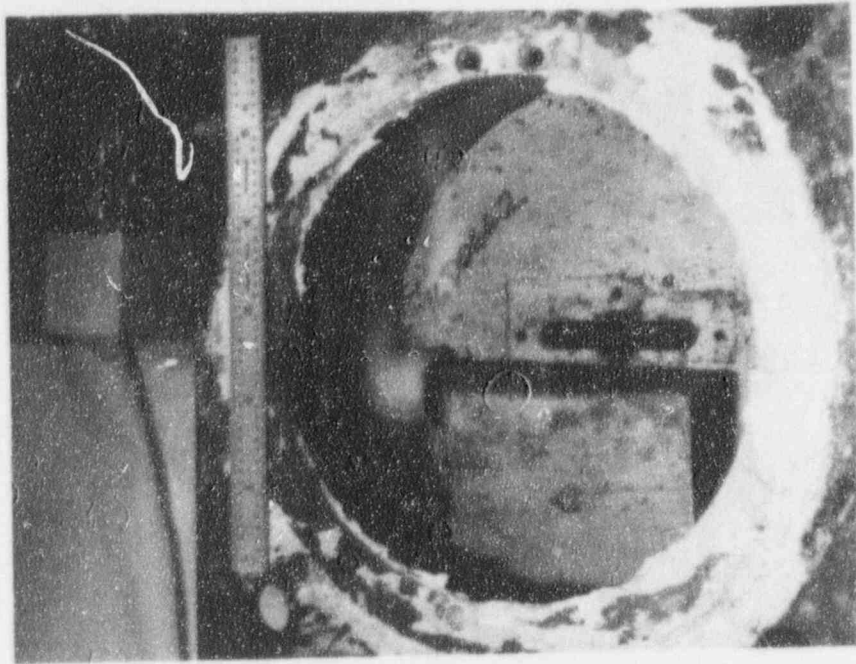
FIGURE 4. PHOTOGRAPHS OF THE LEAD SHIELDING (a) THE HOLDER (b) AND THE HOLDER REMOVED (c).

The three screws which fastened the source holder to the housing were removed, and then the holder was removed, see Figure 4. Figure 5 shows the as-received condition of the holder. The source end is shown in Figure 6. The wipes were taken down the source holder tube, using Q-tips. It was confirmed that the radiation X-rays were Cs-137, using gamma spectrometry. The instrument used was the Canberra Series 100 Multichannel Analyzer with a Ge detector.

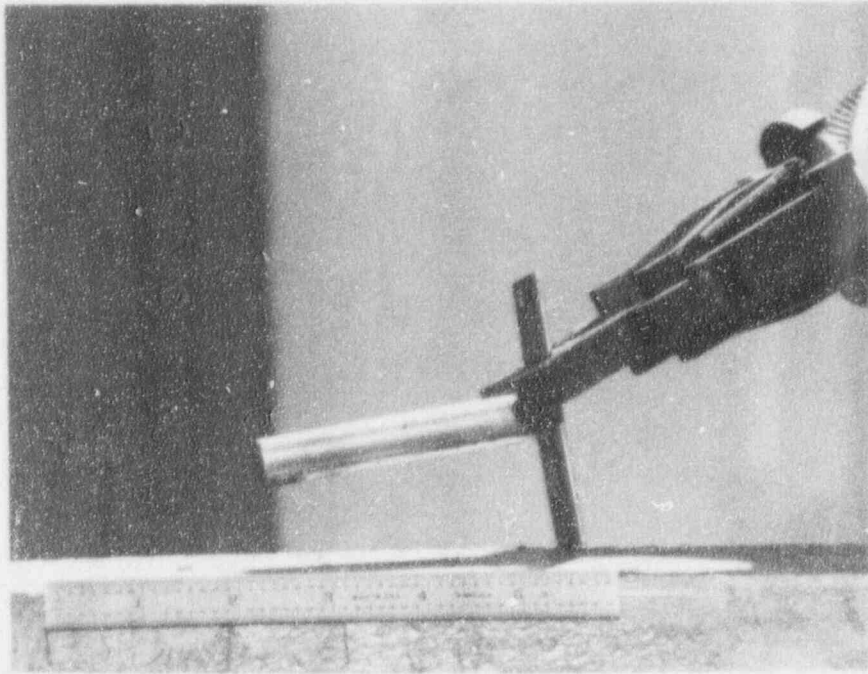
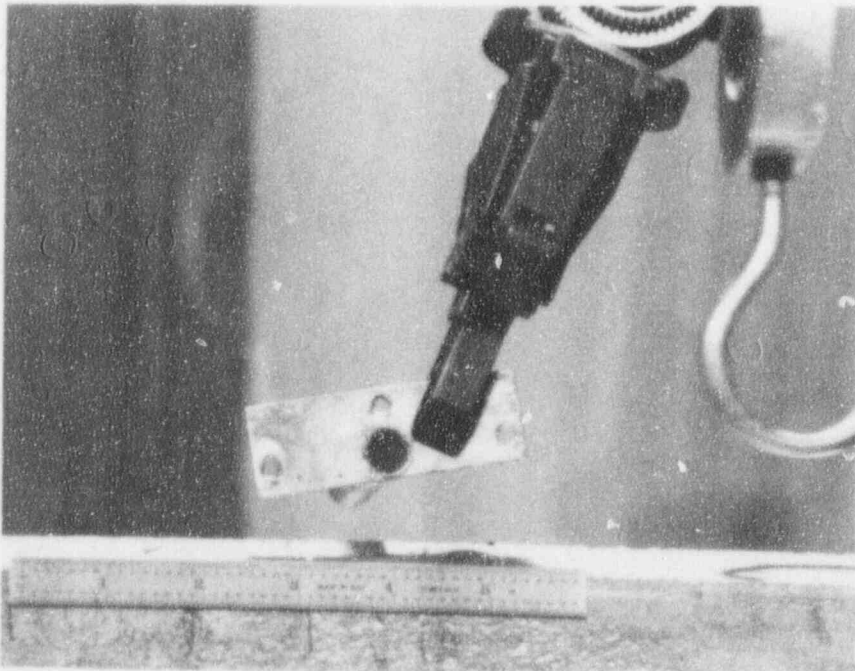
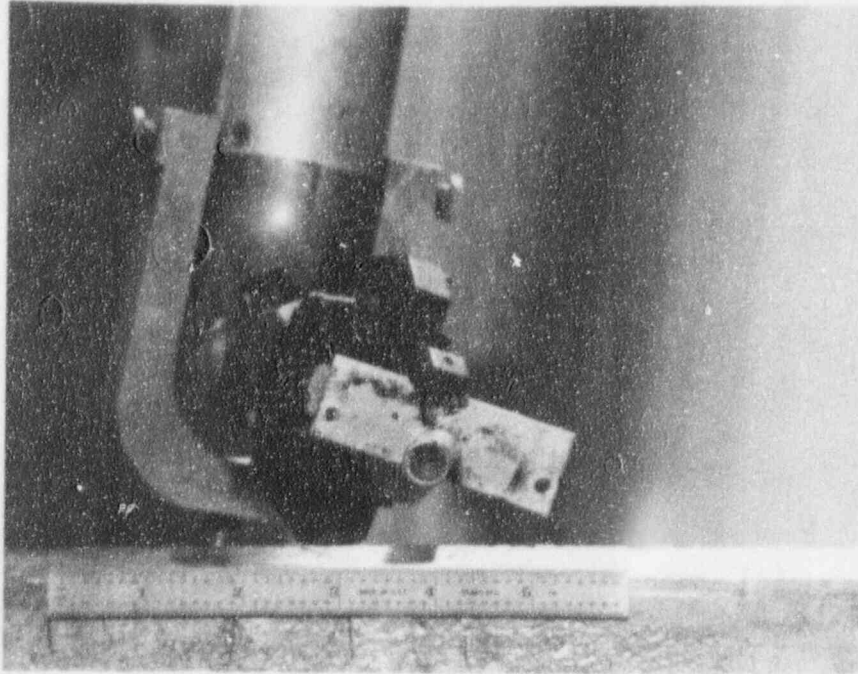
FIGURE 5. PHOTOGRAPHS OF THE ALUMINUM HOLDER AND SOURCE.

It was reported to SwRI that the source holder was stainless steel or aluminum, but it was obvious based on the color and weight that the holder was an aluminum alloy. The OD measured 0.563 inch while the ID measured 0.438 inch. The holder tube was cut using a jewelers saw and hack saw, then split in half, as shown in Figure 7, exposing the double encapsulated source. The inside of the tube measured 40,000 cpm (1.82 μ curies).

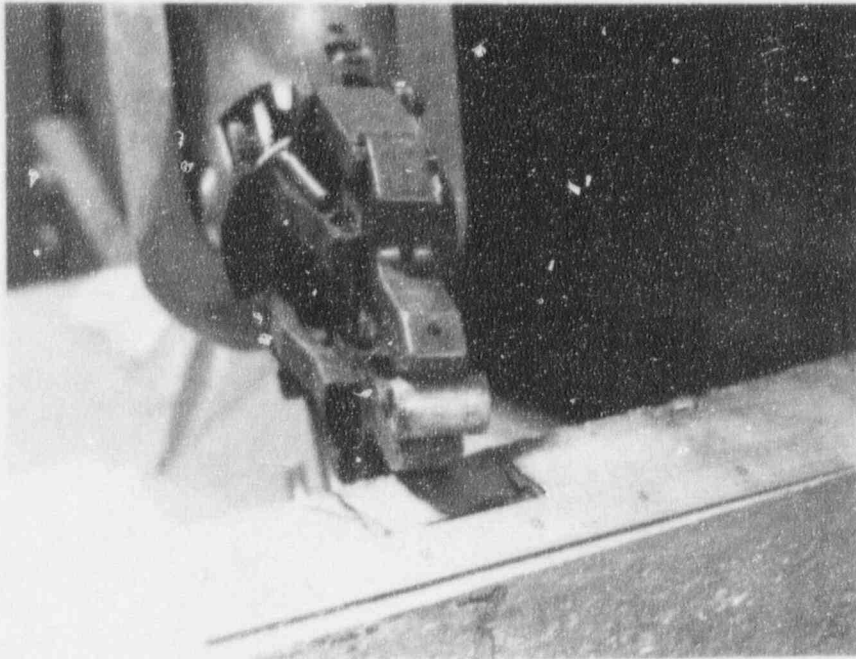
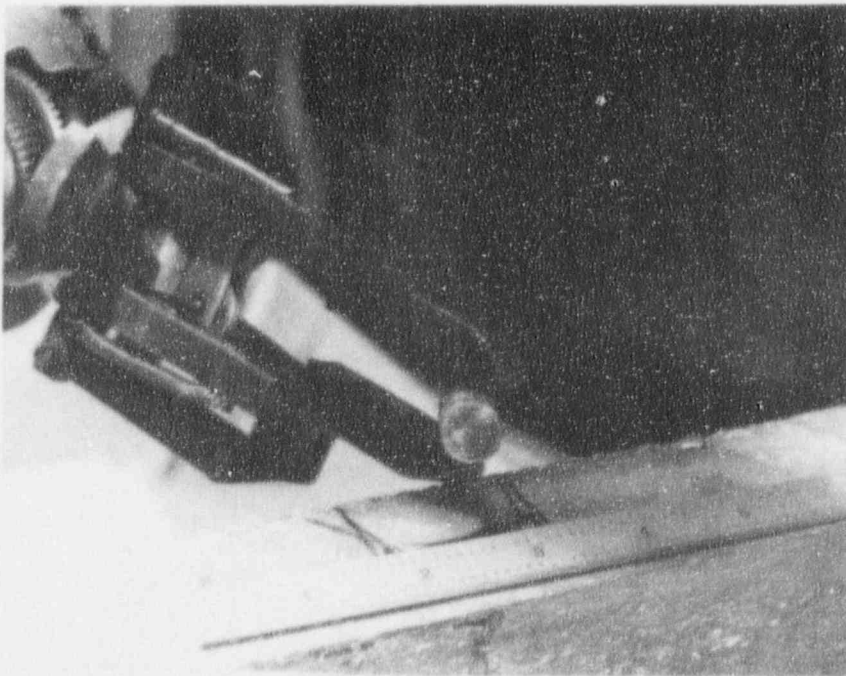
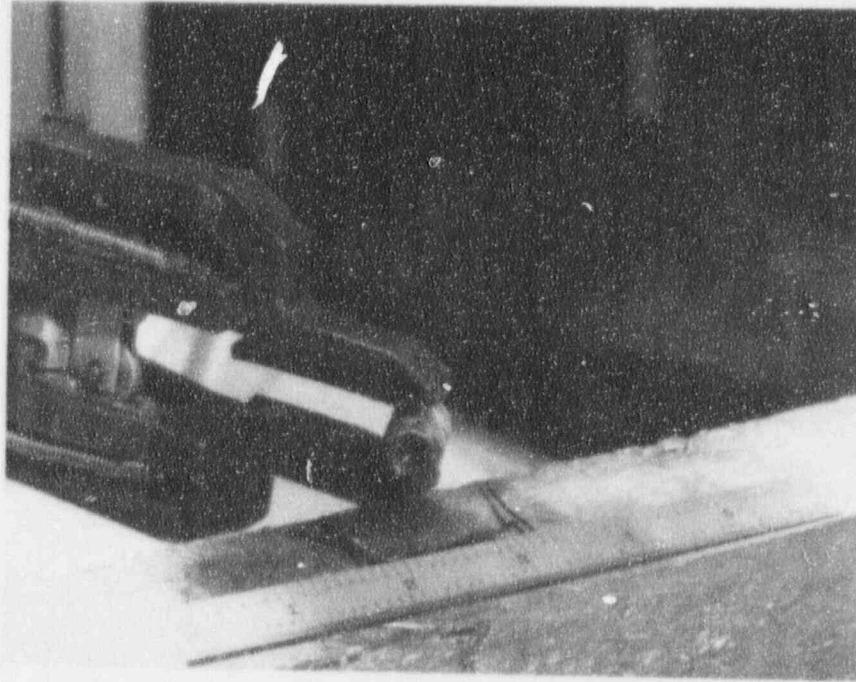
The exposed double encapsulated source, shown in Figure 8, shows very slight corrosion and the weld region was darkened, likely due to heat input. There was no evidence of stains or obvious cracks since the stainless steel encapsulated source was unattacked. It is possible that some of the corrosion was transferred from the aluminum holder. When the source was exposed, it was noticed that the S/N on the source was stamped with the alpha-numeric SR626 Mar70. The test certificate received with the housing and source stated SR625.

FIGURE 8. PHOTOGRAPHS OF THE DOUBLE ENCAPSULATED SOURCE.
Notice Stamped No. SR 626 shown in Figure (a).

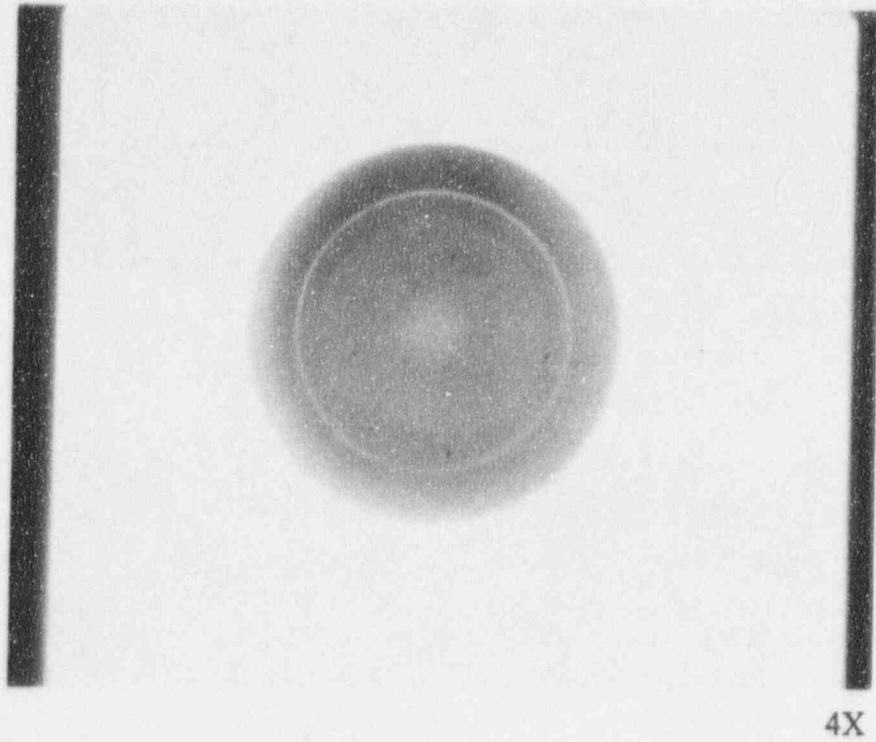
The top portion of the cap that had the weld was fluorescent dye penetrant and X-ray inspected. No indications of cracks were found. Figure 11 shows the radiograph of the weld.

FIGURE 11. RADIOGRAPH OF THE WELD IN THE OUTER ENCAPSULATION.
Notice no evidence of cracking.

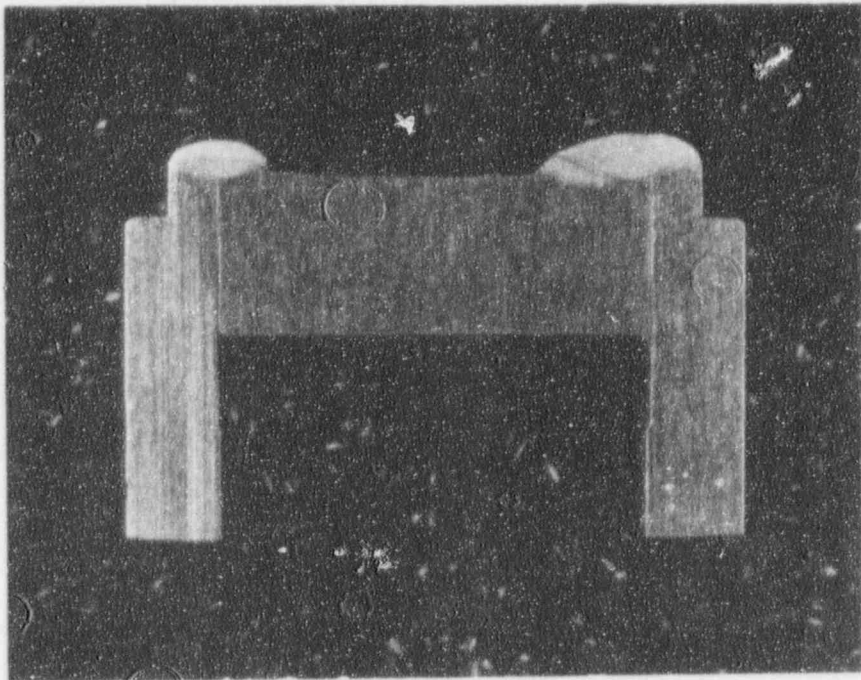
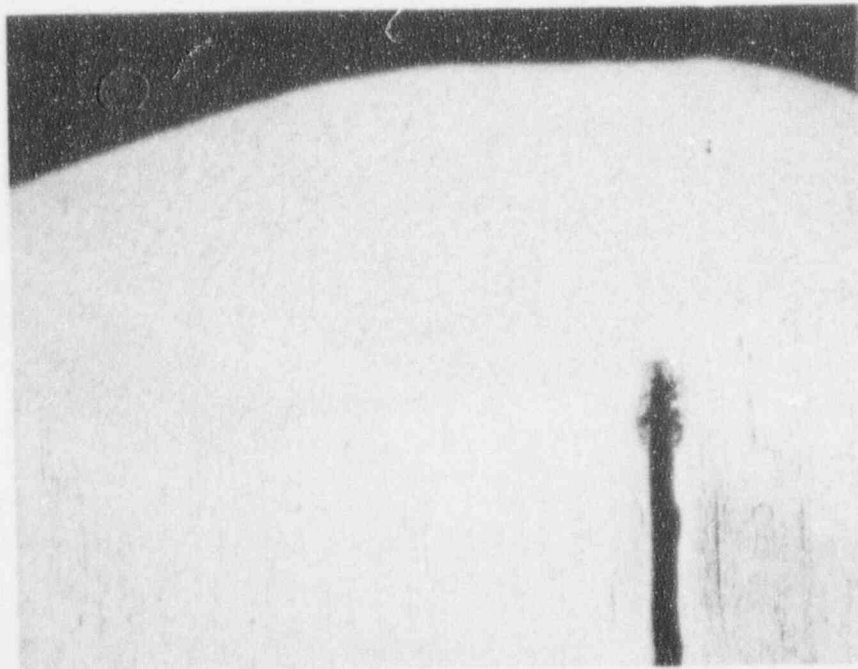
Finally, the portion with the weld was sectioned in half to examine the quality of the weld. Figure 12 shows the welds had adequate fusion with no signs of cracking.

A likely place for cracking to occur would be in the heat affected zones of the welds. In the HAZ, often high residual stresses and sensitization² can result in preferential attack. However, the encapsulated source, S/N 626, had good weld quality with good fusion and not a large HAZ. A sensitization etch on this weld indicated the HAZ was not sensitized.

FIGURE 12. PHOTOMICROGRAPHS OF THE CROSS SECTION OF THE OUTER CAPSULE AND THE WELD. Notice no cracks evident.

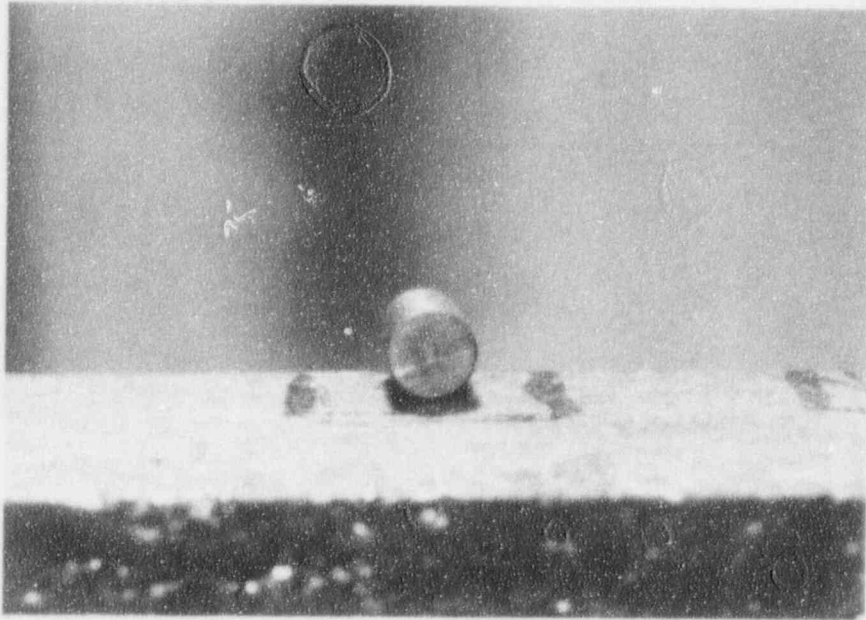
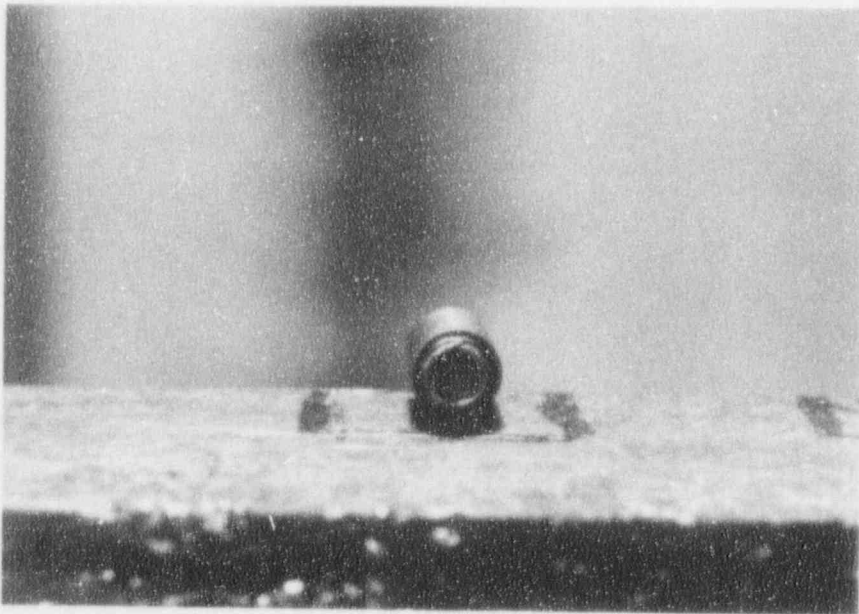
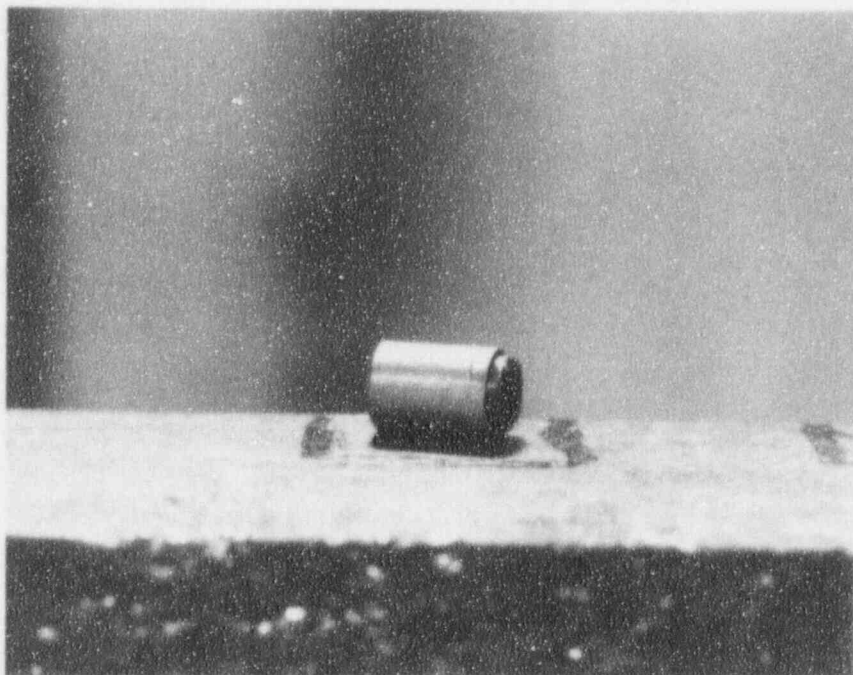
FIGURE 13. PHOTOGRAPHS OF THE INNER ENCAPSULATION.

The inner capsule was wipe tested. It was found that the radiation level was below typical background and was less than 100 cpm. The source was wiped with Q-tips after 24 hours and found to have no change in the radiation level. Figure 13 shows the condition of the inner capsule. Again, there were no signs of discoloration, corrosion, or cracking. To further evaluate if the capsule was cracked, a helium leak test was performed. Like before, the capsule was subjected to 100 psi of helium for 1 1/2-hour. Then, the encapsulation was dumped into a bath of water. No bubbles formed indicating no helium had migrated into the encapsulated source. Therefore, it is reasonable to believe the inner encapsulation was not cracked.
