November 28, 1995
MP-95-342

Reference: Facility Operating License No. DPR-65
Docket No. 50-336
Licensee Event Report 95-041-00

FACILITY NAME (1) Millstone Nuclear Power Station Unit 2	DOCKET NUMBER (2) 05000336	PAGE (3) 1 OF 4
---	-------------------------------	--------------------

TITLE (4)
Potential for EDG Overload With 2 HPSI Pumps Aligned to 1 Facility

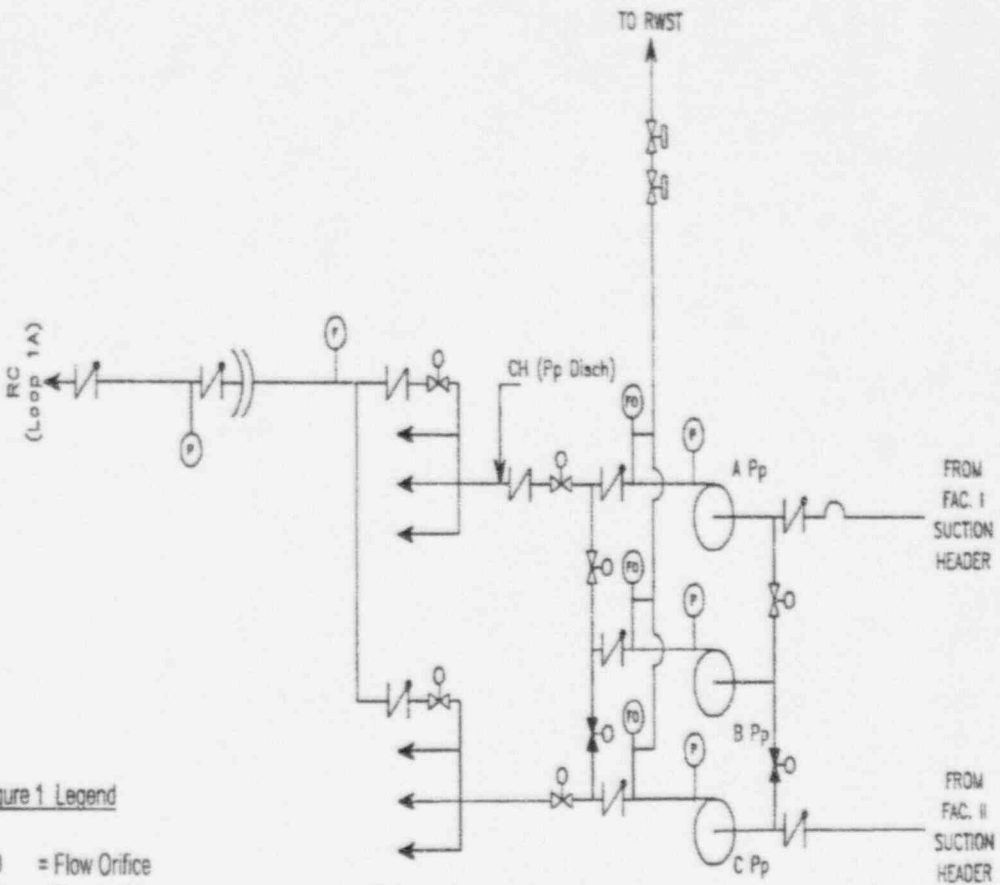
**Figure 1
HPSI SYSTEM**

Millstone Unit 2 is designed with 3 High Pressure Safety Injection Pumps (HPSI), see Figure 1. For power operations two HPSI Pumps are required. The third pump or "B Pump" is an installed spare that can be aligned (both electrically and mechanically) to either facility 1 or facility 2. This configuration is desirable because it allows the normally aligned pump to be removed from service for maintenance or testing.

In the postulated event of a LOCA concurrent with an LNP, all the loads on the emergency bus are shed, then the EDG starts. The loads are then sequenced onto the EDG in 5 load blocks. (sequences 0 thru 4) if two HPSI pumps are aligned electrically to one facility (a condition which is realized when performing SP 21136 procedure) both pumps will restart at sequence 1 of the event. The additional load on the EDG from the second HPSI pump will cause the generator output voltage to dip to approximately 72% of its rated voltage. This is outside the design value of 75% established in Safety Guide 9 and the Final Safety Analysis Report (FSAR). Additionally because the additional pump is now on the safety related bus the peak load added at sequence 3 and 4 of the loading sequence will be above the 300 hour rated load of the engine. Sequence 3 peak load increases to 3384 KW, sequence 4 peak load increases to 3604 KW versus 3250 KW 300 hour rated loading of the EDG.
