# VERMONT YANKEE NUCLEAR POWER CORPORATION

December 1, 1995  
BVY 95-126

Subject: Temporary Non-Code Repair of Service Water Piping

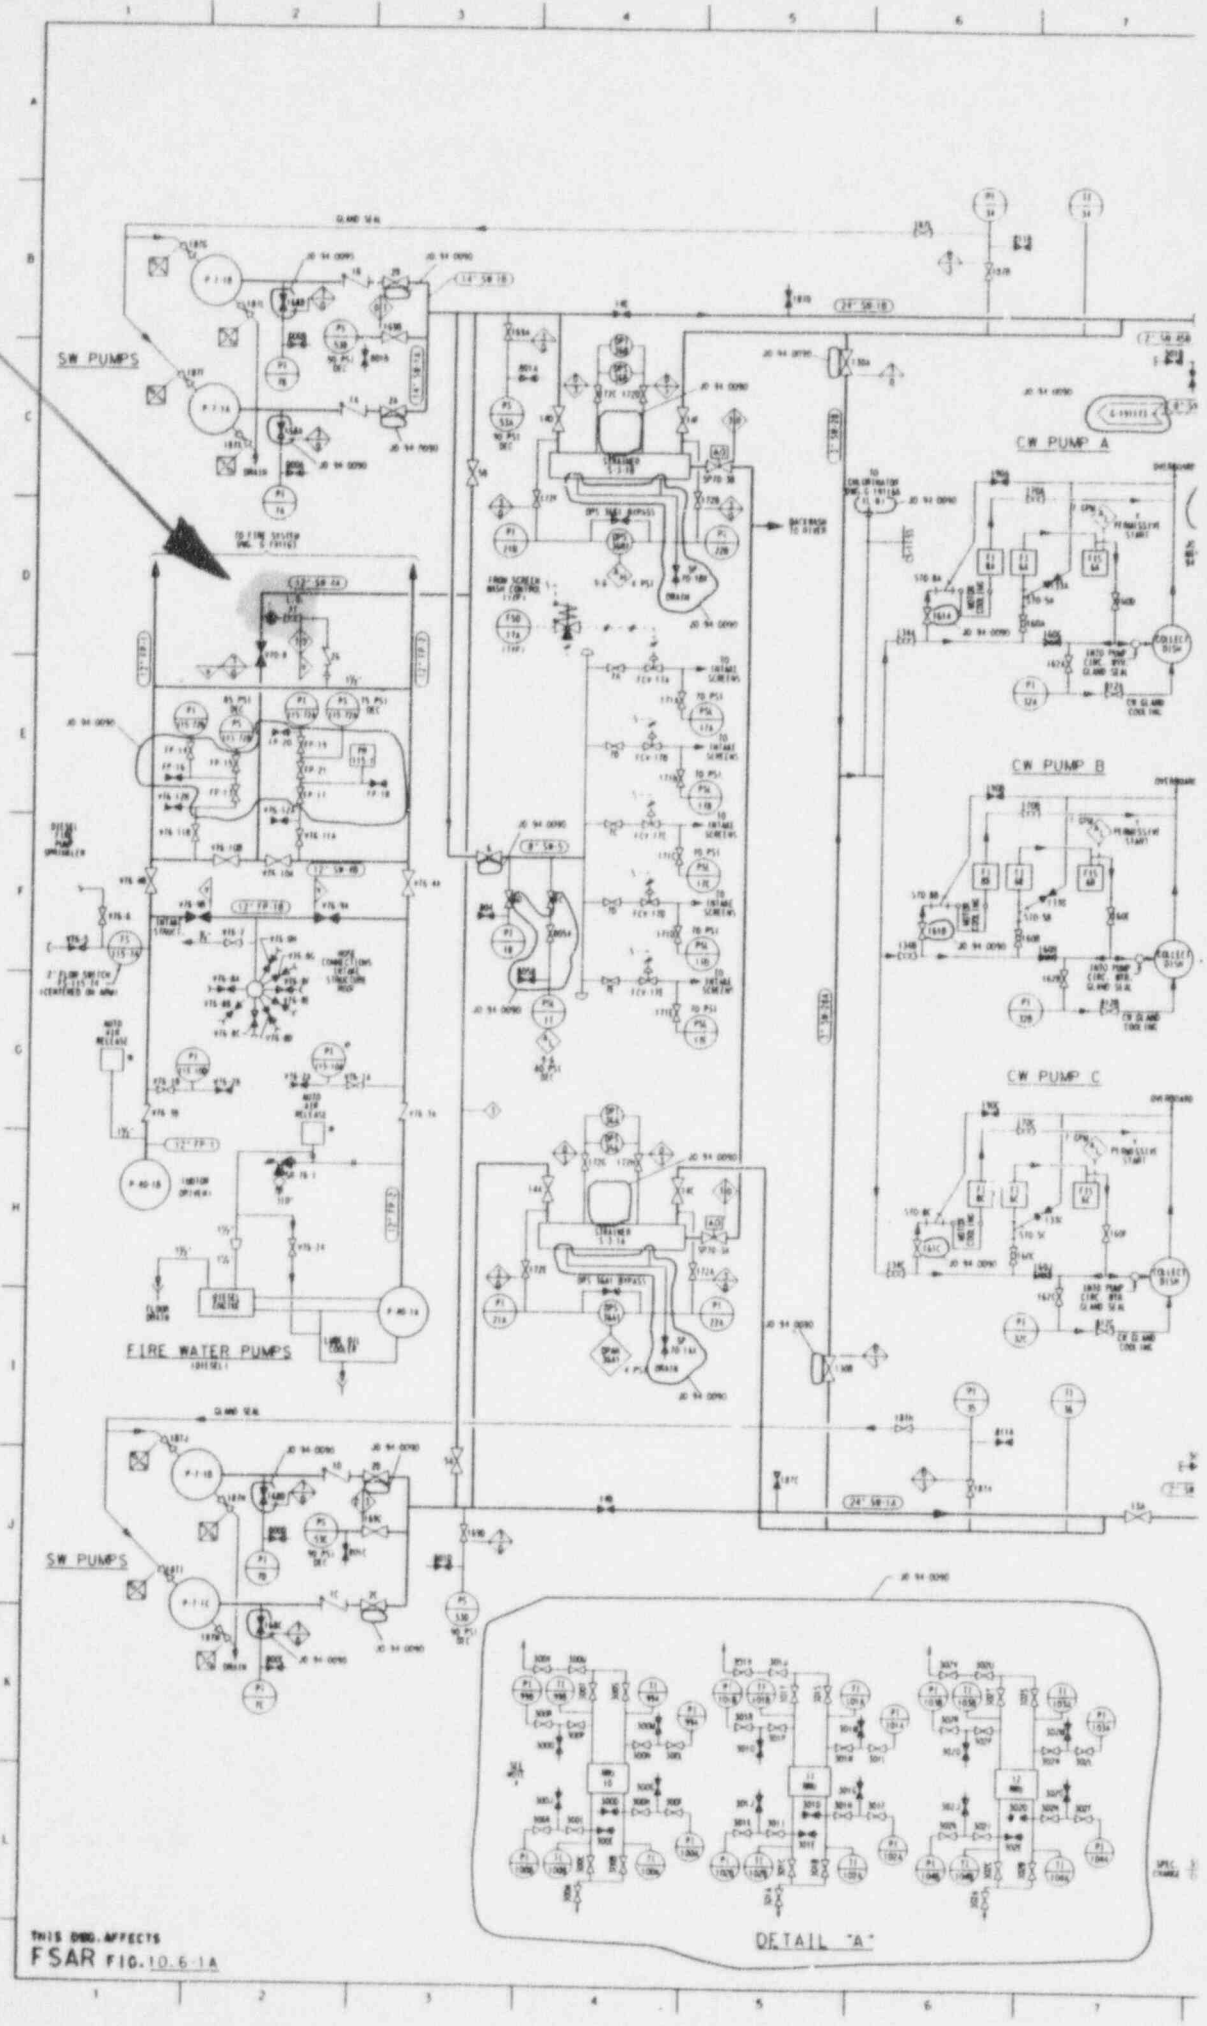
Figure 1  
BVV 95-126

On November 2, 1995, during a routine tour of the plant, the Operations Department reported minor leakage from a 1.5 inch service water line located in the Intake Structure. The leak rate is approximately 1 drop every 10 minutes. The leak is located in a 1.5 inch diameter, 2.5 inch long spool piece upstream of valve V70-27 in the Safety Class 3 portion of the piping which is used to maintain a static pressure in the fire water system when the fire water system is in standby. Attempts to isolate and repair the leak were unsuccessful due to a small amount of leakage past the isolation boundary valves. See Figure 1 (attached) for identification of the leak location.

The leak is in a moderate energy, Safety Class 3 pipe which has a design pressure of 125 psig and design temperature of 32°F to 85°F. The piping is 1.5 inch, schedule 80 carbon steel with a nominal thickness of 0.2 inches. The code-required minimum wall thickness for this piping is 0.008 inch.

Ultrasonic examination (UT) of 100% of the surface of the 2.5 inch length of pipe between fittings containing the leak was performed. The inspection data indicate pipe wall thinning with a remaining wall thickness ranging from 0.045 inch to 0.075 inch over approximately a 0.5 inch radius around the leak. The data characterizes the leak as a localized "pitting" type flaw which appears to be indicative of microbiologically induced corrosion (MIC). Vermont Yankee

The inspection data for the remaining 2.5 inch long pipe surface indicate that the pipe wall thickness ranges from 0.1 inch to 0.19 inch with the exception of an additional localized flaw with a remaining wall thickness ranging from 0.069 inch to 0.072 inch. This additional localized flaw was of sufficient distance from the leak location so as not to require connecting them for analytical purposes.

A local flaw evaluation was performed in accordance with reference (b). The through-wall flaw evaluation approach was used to calculate the allowable flaw size. This evaluation resulted in a single allowable flaw size of 0.375 inch in diameter, which bounds the UT data described above. In addition, a piping analysis was performed which conservatively modeled the remaining safety class portion of this line using a reduced wall thickness of 0.1 inch. The piping stresses met acceptance criteria.

In summary, engineering evaluations have demonstrated that the structural integrity of the piping system remains unaffected in the as-found condition. To ensure that the structural margin of the pipe is not reduced below an acceptable limit, Vermont Yankee will perform UT inspections once every three months until a wall loss rate can be established which supports less frequent inspection of the leak area. Also the effects of the leak on service water system performance are deemed acceptable. Therefore, Vermont Yankee concludes that relief from immediate code repair will present no undue risk to the health and safety of the public. We request that the NRC grant relief to allow deferral of a code repair until no later than startup from the next refueling outage, currently planned for September 1996.
