Edwin I. Hatch Nuclear Plant - Unit 2
Reactor Vessel Inventory Loss Results in
Unplanned Engineered Safety Feature System Actuations

Enclosure: LER 50-366/1995-008

Edwin I. Hatch Nuclear Plant - Unit 2

Reactor Vessel Inventory Loss Results in Unplanned Engineered Safety Feature System Actuations

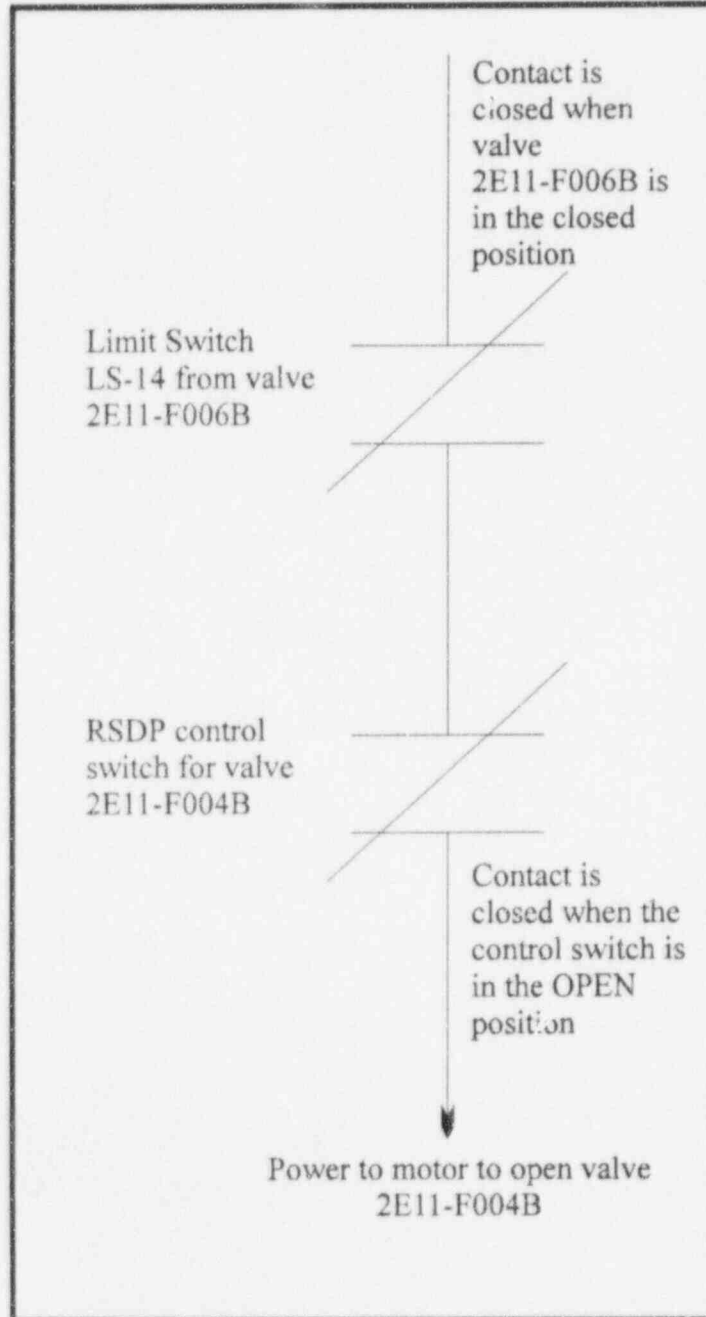
Figure 1: As-Designed RSDP Opening Circuit for Valve 2E11-F004B

When RSDP switch S-10 was placed in the "EMERG" position, valve 2E11-F004B should have started to open. This is because its RSDP control switch was in the "OPEN" position and the interlock between valves 2E11-F004B and 2E11-F006B, which prevents the opening of one valve when the other is not fully closed, should have been satisfied with valve 2E11-F006B fully closed (see Figure 1). However, valve 2E11-F004B did not open when the PEO placed switch S-10 in the "EMERG" position because Limitorque operator limit switch LS-14 for valve 2E11-F006B was set to operate opposite from design. This limit switch, which provides the interlock permissive to open valve 2E11-F004B from the RSDP only, was improperly set to provide a permissive signal to open valve 2E11-F004B when valve 2E11-F006B started to open (see Figures 2 and 4). This was a problem only when control was at the RSDP, however. The Main Control Room control and interlock logic functioned properly because a different Limitorque operator limit switch (LS-6) is used to provide the position of valve 2E11-F006B. This limit switch was, and is, set correctly.

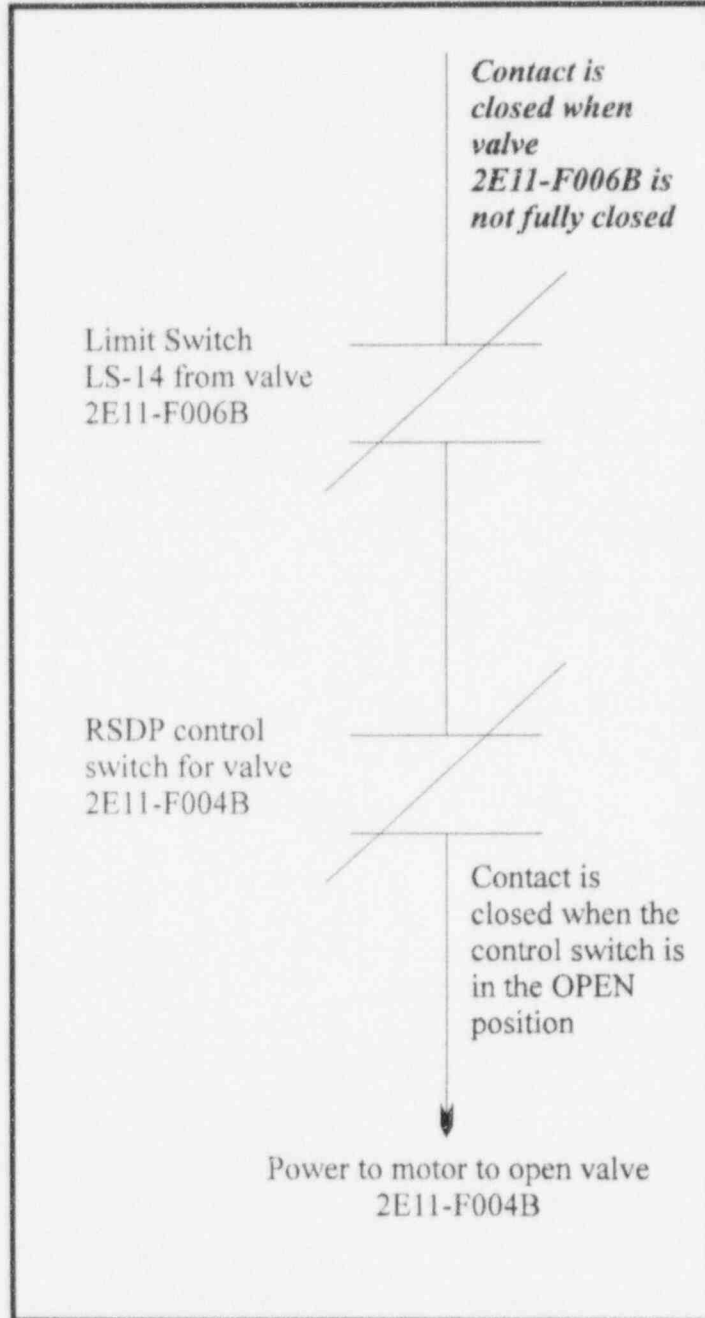
Figure 2: As-Found RSDP Opening Circuit For Valve 2E11-F004B

RHR System elementary drawings were not clear regarding the limit switch set-up for valve 2E11-F006B. The limit switch setting diagram which applies to this valve does not explicitly state this. Furthermore, below this diagram is a note which references another drawing whose limit switch setting diagram could be interpreted to apply to valve 2E11-F006B. This latter limit switch setting diagram is formatted in such a way as to be confusing regarding limit switch set-up and therefore could have led to LS-14 being set to operate in the manner found on 11/3/95 (see Figure 2).

Limit switch LS-14 was found labeled "LS-15." Additionally, limit switch LS-15 (an unused switch) was found set to operate as LS-14 should have been set, i.e., to close only when valve 2E11-F006B was fully closed. Consequently, it is possible the interlock logic wiring for LS-14, at some time, had been incorrectly connected to LS-15 as a result of the aforementioned labeling error. Had the interlock logic been wired to LS-15, the valves and interlock logic would have functioned correctly. However, had this wiring error been corrected at a later date, that is, the logic wiring for LS-14 connected correctly to LS-14, the RSDP valve interlock would have been defeated because LS-14 was not set to operate per design.

The applicable RHR System elementary drawings will be clarified to indicate clearly which limit switch setting diagram applies to RHR System valves 2E11-F004A-D and 2E11-F006A-D. Additionally, the note which does not apply to the limit switch setting diagram will be removed or relocated. Similar changes will be made to the applicable Unit 1 RHR System elementary drawings as appropriate.

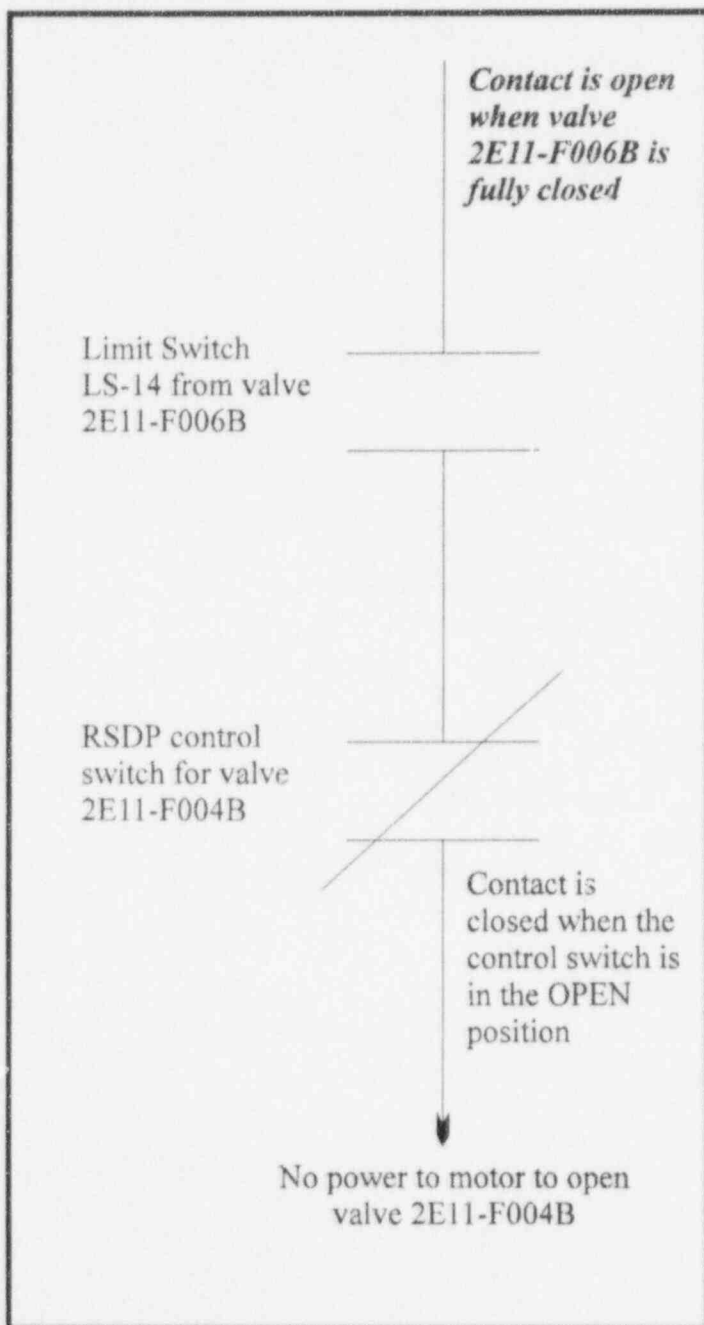
Figure 3: Status of RSDP Opening Circuit For Valve 2E11-F004B Prior to Opening Valve 2E11-F006B

to report to the operator that he had confirmed both valves were closed. This evolution took approximately 20 to 30 seconds to complete. The operator failed to ask specifically about valve control switch position and no one noted valve 2E11-F004B was not opening during this time, as it should have been if limit switch LS-14 for valve 2E11-F006B had been set properly (see Figure 3).

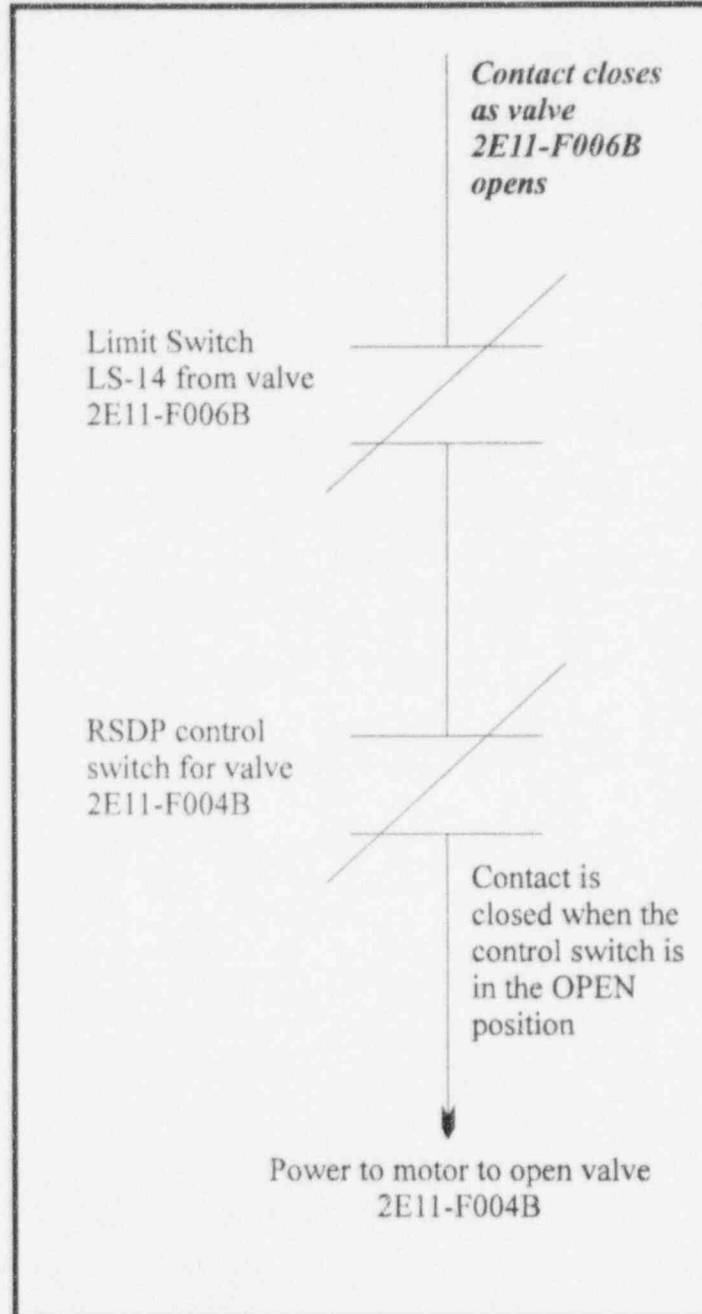
Figure 4: Status of RSDP Opening Circuit For Valve 2E11-F004B After Valve 2E11-F006B Began to Open

The operator then instructed the PEO at the RSDP, via the PEO on the telephone, to place the RSDP control switch for valve 2E11-F006B to the "OPEN" position. The PEOs did as instructed at which time both valves 2E11-F006B and 2E11-F004B began to open (see Figure 4). This created a flow path from the reactor vessel through SDC valves 2E11-F008 and 2E11-F009 and valves 2E11-F006B and 2E11-F004B to the Unit 2 suppression pool. Unit 2 reactor vessel water level began to decrease from its pre-event level of about 58 inches above instrument zero. The PEO at the RSDP noted that valve 2E11-F004B was opening unexpectedly and took the control switches for valves 2E11-F004B and 2E11-F006B to the "CLOSE" position as he had been told previously that both valves were not to be open at the same time. Both valves are designed to stroke fully open or fully closed once they start in the respective direction; therefore, placing the control switches in the "CLOSE" position did not stop the valves from continuing to open.
