Subject: McGuire Nuclear Station Unit 1
Docket No. 50-369
Licensee Event Report 369/92-01, Revision 1

TITLE(4): A Technical Specification Violation Occurred Because Of Failure To Remove A Steam Generator Tube From Service, As Necessary, During the Unit 1 End Of Cycle 7 Refueling Outage.

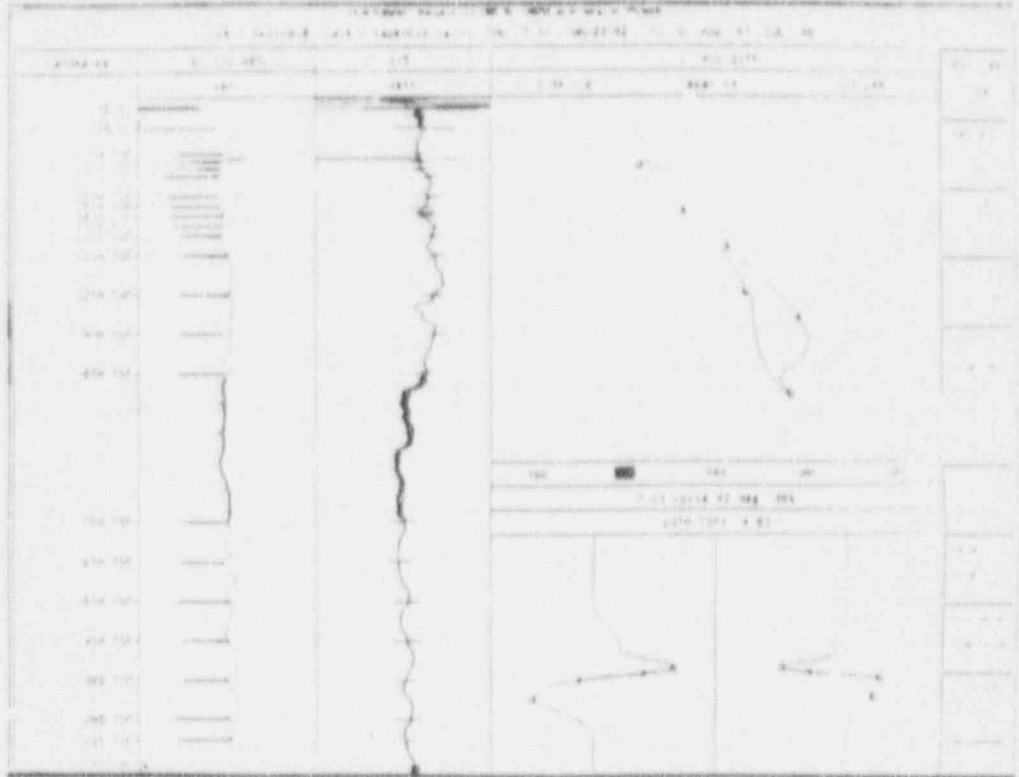
SG TUBE 47-46
BOBBIN COIL DATA
JANUARY, 1992

ECT of tube 47-46 revealed that the tube indication which caused the leak was a 1 inch long axial indication located approximately 5 inches above the 20th TSP. The SG Team initially identified 77 tubes in the 4 SGs which would need to be plugged. These tubes were identified as having indications in the free span area, the same as the indication on tube 47-46. MRPC testing was performed on 63 randomly selected tubes in the general vicinity of the leaking tube, 47-46. The MRPC testing was performed up to the 19th TSP. A review of the bobbin coil data gathered during this outage, revealed additional tube indications on tube 47-46, between the 14th and 15th TSPs. MRPC testing was performed on the tube indications, and the results revealed the indications to be similar to the leak defect. MRPC testing of the largest indication sized it to be 60 percent through wall (TW). A review of the 1991 EOC 7 ECT data for SG 1D revealed some evidence of the tube indication was present at that time, however, the amplitude was small, and was characterized as NDD (no detectable defect). Another 25 tubes located on the Cold Leg side were selected for full length MRPC testing. Thirteen tubes were from the same heat (same manufacturing group) as tube 47-46. Twelve tubes were from the same heat as tube 18-25 (from the tube leakage outage in March, 1989). During the

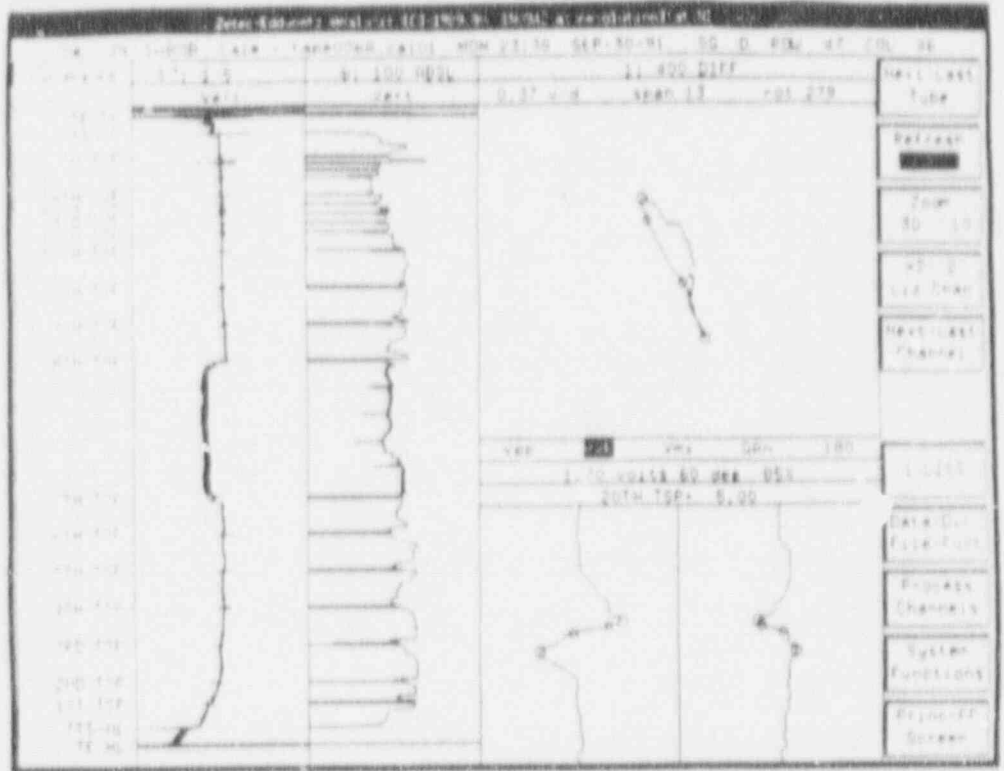
SG TUBE 47-46
BOBP™ COIL DATA
SEPTEMBER, 1991

A cause of Inappropriate Action is assigned because the resolution of the tube indication was not the best alternative. During Unit 1 EOC 7, in 1991, the data analysts were reviewing the bobbin coil data on the SGs. An indication on SG 1D, tube 47-46 was flagged by a primary reviewer. The same indication was independently flagged by a secondary reviewer. The primary reviewer classified the indication as signal to noise (S/N), and additionally classified it as an MEM. A classification of S/N contends there is degradation, however, the S/N ratio is so small, the depth of the degradation cannot be quantified. Further classifying the indication as an MBM was based on the characteristics of the signal, and the primary analyst felt the phase angle was not a true representation of the depth of the indication. The secondary reviewer classified the indication as 85 percent TW. This was also based on the characteristics of the signal. As a result of the differing classifications, the indication was sent for resolution by a resolution team. The resolution team consists of a lead person from the primary and secondary data analysts. Ideally, these persons would be different from the original primary and secondary analysts. The resolution team evaluating the same data as the primary and secondary analysts, misclassified the indication as an MBM. The signal from the tube indication is very similar to the signal generated from an MBM. However, an MBM can be traced back to previous ECT data and normally

the voltage on an MBM is less than 1 volt. The voltage on this indication was 1.7 volts. During the investigation, a review of previous data did not indicate the presence of an MBM. It is reasonable to believe the indication would have been correctly classified if it had received closer scrutiny.

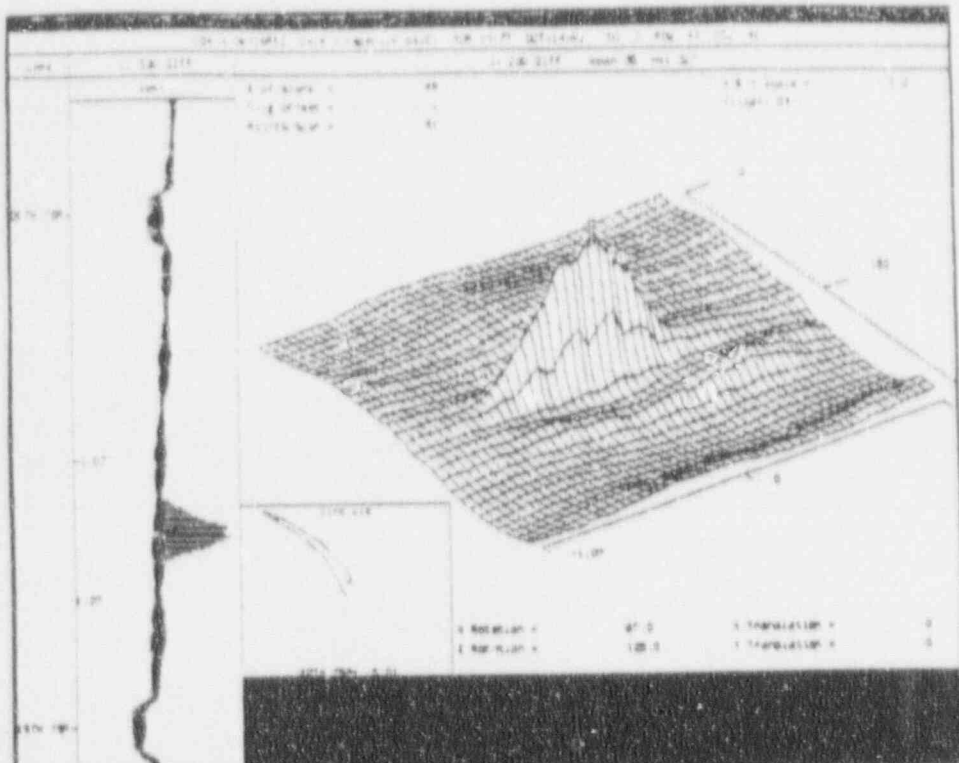
SG TUBE 47-46
MRPC DATA
OCTOBER, 1991

MRPC testing, however, the results of the MRPC testing were not fully evaluated and the tube remained in service. ECT Management and Support Engineering personnel, after evaluating MRPC test data acquired on tube 47-46 during this outage, have determined that the indication from October, 1991, was incorrectly classified. As a result, the SG Team personnel developed the action plan listed below:

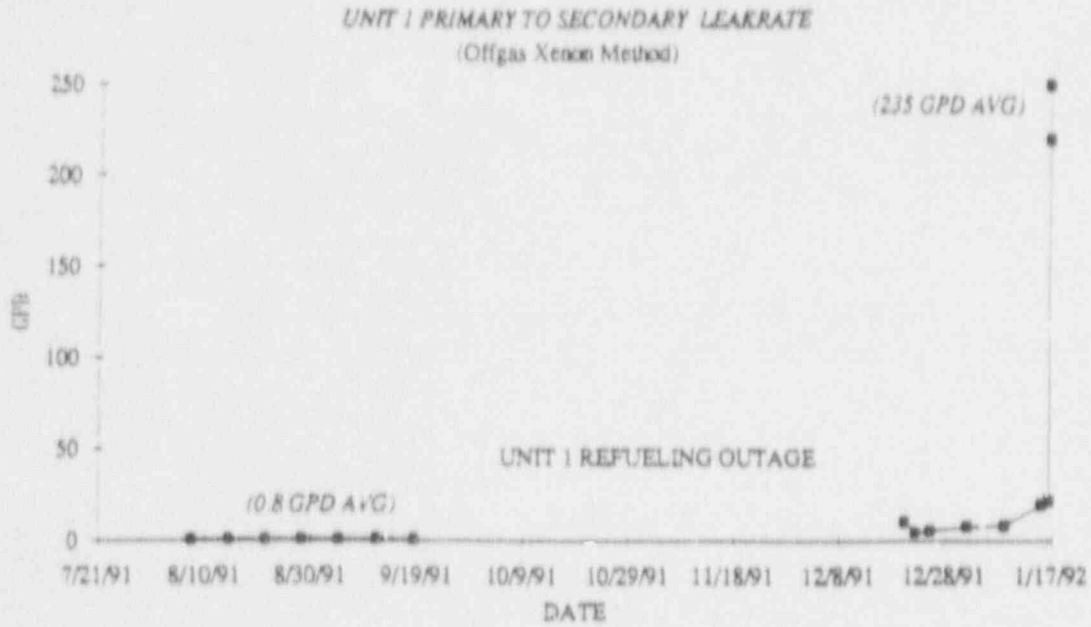
Prior to the Unit 1 shut down on January 16, 1992, Chemistry personnel performed several normal surveillance primary to secondary leak rate calculations as directed by procedure CP/O/B/8100/45, Chemistry Procedure for Calculation of Primary to Secondary Leak Rate (Enhanced Leak Rate Monitoring Program). The results of these calculations showed an increase in primary to secondary leakage from January 8, 1992, to January 15, 1992. The leakage on SG 1D had increased from 8.3 GPD to 20 GPD. Accelerated sampling and leak rate calculations revealed that the leak had increased to 22 GPD on the morning of January 16, 1992.
