Trojan Nuclear Plant  
Docket 50-344  
License NPF-1

**TROJAN NUCLEAR PLANT**  
**Loose Parts Safety Evaluation**

SAFETY EVALUATION FOR TROJAN NUCLEAR PLANT  
POSSIBLE LOOSE PARTS IN REACTOR COOLANT SYSTEM  
AUGUST 1984

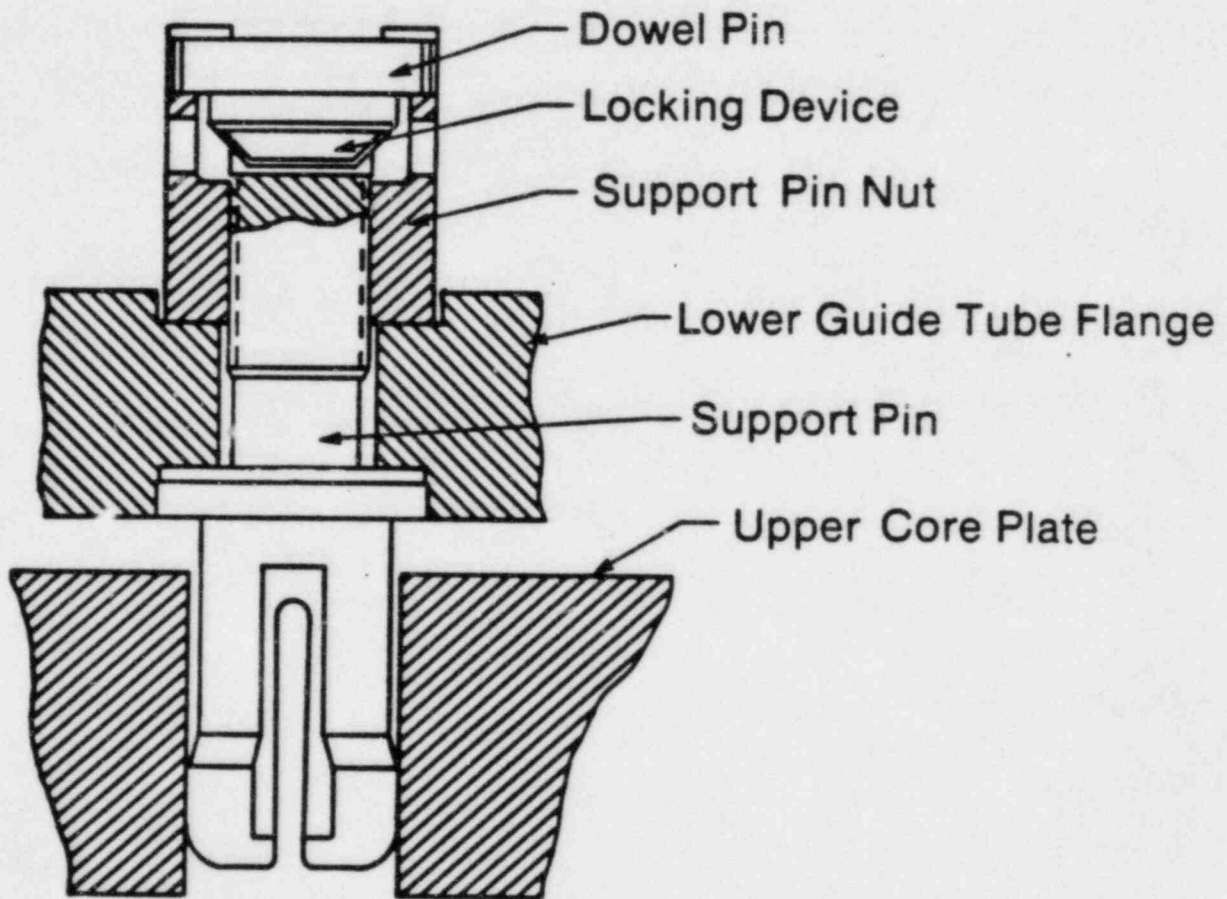
**Figure 1**  
**Cross Section of a Support Pin Assembly**

This report addresses the potential effects of the loose parts resulting from failed guide tube support pins (Figure 1). The potential effects of loose parts on the Reactor Coolant System (RCS), Chemical and Volume Control System (CVCS) and Residual Heat Removal System (RHRS) are considered. The RHRS is addressed since it is open to the RCS during cooldown and therefore creates a path for the loose parts to enter the RHRS.

Table 1 contains a description of the potential loose parts resulting from support pins. The loose parts evaluation for Trojan addresses a core with 17 x 17 standard fuel.

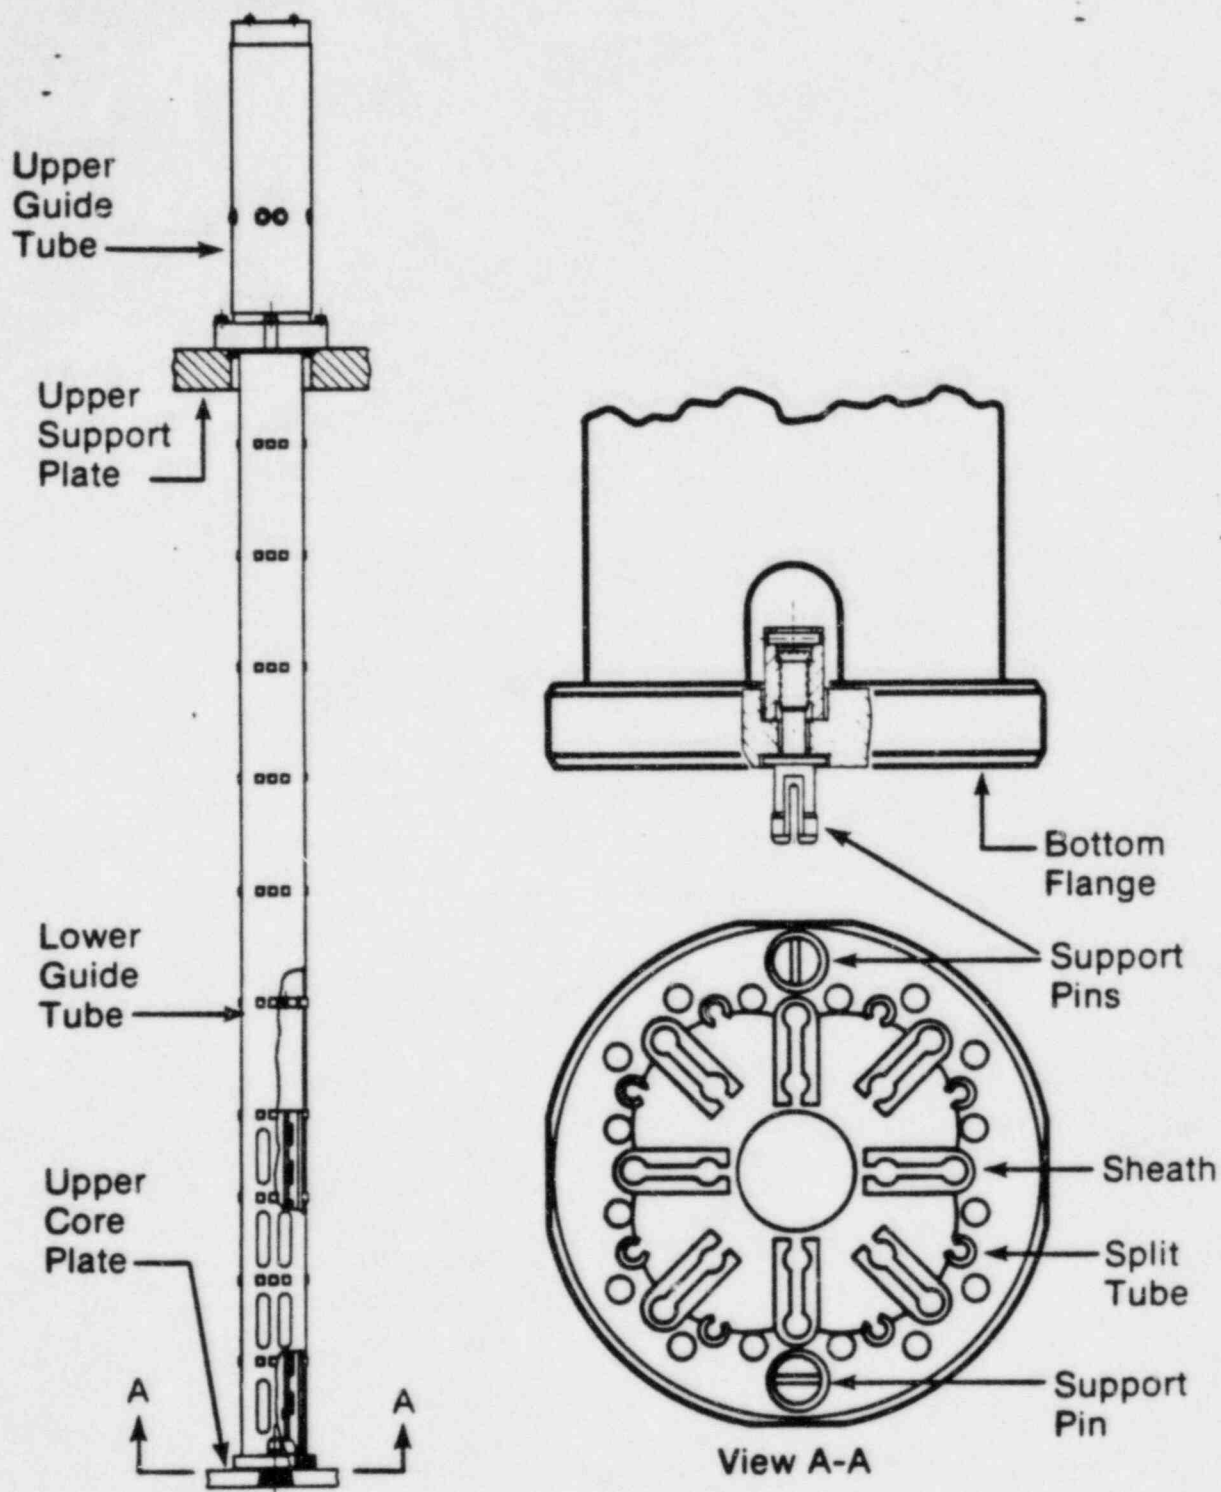
Figure 2  
Control Rod Guide Tube Assembly

The potential for a loose part, resulting from a broken guide tube support pin, to adversely affect RCCA operation is extremely remote. For RCCA operation to be affected, a loose part would have to enter a guide tube through one of the flow openings in the lower guide tube area or through the bottom flange of the RCC guide tube. Once inside the guide tube the loose part would have to move between the rod channels into the center of the guide tube and rise approximately

34 inches above the continuous guide tube region (refer to Figure 2). Once above the continuous region, the loose part would then have to orient itself in such a way as to lay across a guide plate and block the spider channel. It is considered an extremely remote possibility that any loose part could effect all the movements and placements necessary to affect RCCA movement.
