UNITED STATES
NUCLEAR REGULATORY COMMISSION
WASHINGTON, D. C. 20555

SUBJECT: FOIA 83-449 -- REQUEST FROM BILLIE GARDE FOR DOCUMENTS
SUBMITTED BY CONSUMERS POWER CO. FOR CONSIDERATION OF
CANDIDATE COMPANIES OR METHODOLOGIES TO PERFORM THE CON-
STRUCTION IMPLEMENTATION OVERVIEW OF THE CONSTRUCTION COMPLETION
PLAN

MIDLAND UNITS 1 AND 2 - JCS 7220
RESIDENT GEOTECHNICAL ENGINEER REPORT

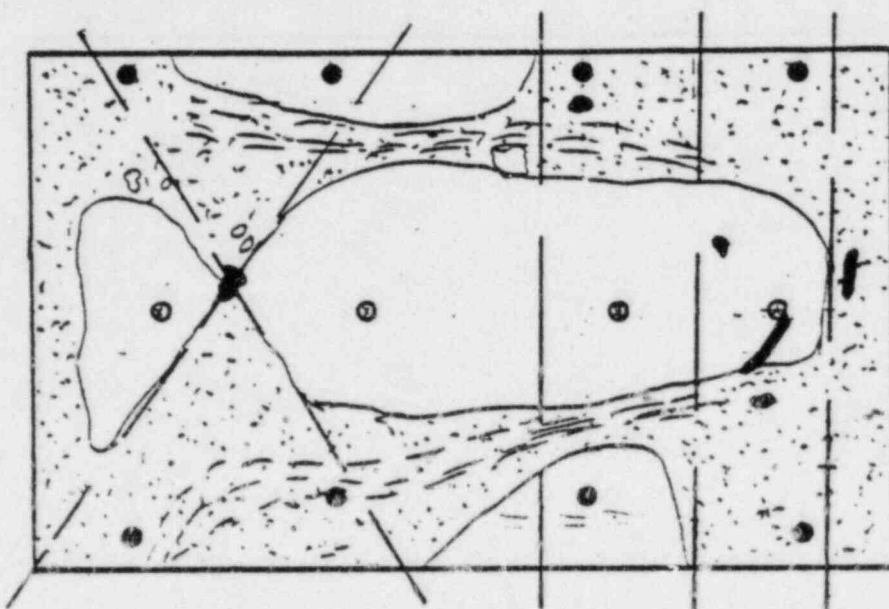
No (Peripheral bubbles from #2 over hole) #3	No
#2	Yes - Towards #1 #4 (North)	No
2. Air noted in underslab notch grout projections? Yes
3. Grout leakdown at air vent holes? No, but lead wool hole plugs extending into grout slab 3/4" past plate edge.
4. Noticeable general air bubble pattern? Yes

5. Calculated void area in excess of 1/4" Ø nominal sizing = 0.9% percent of surface area.

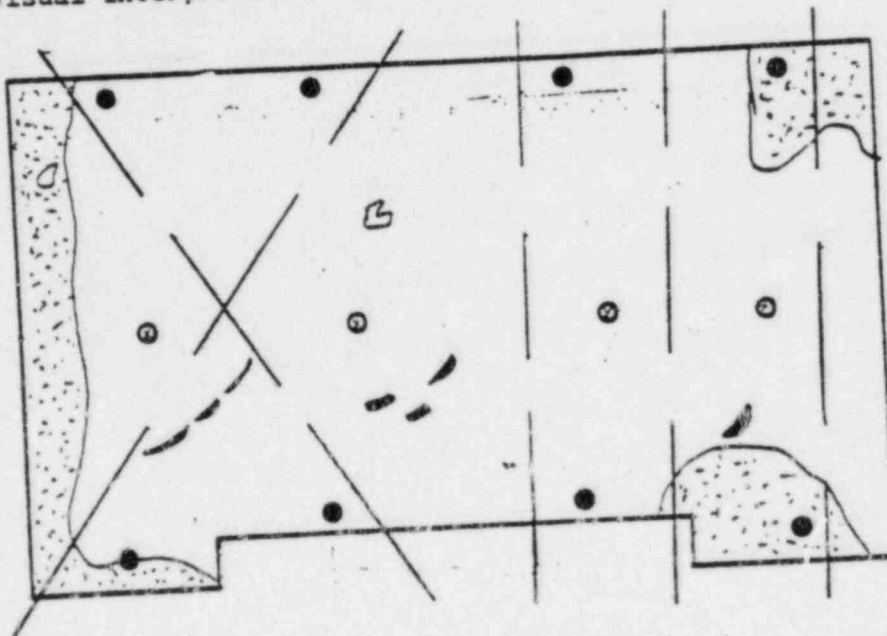
1. Peripheral bubbles about nipples?
 - #1 (South) No #3 Yes, 4 deep approx. 1 1/2" long
 - #2 Yes, one (2 1/2" x 1 1/2") #4 (North) Yes, shallow & minor
2. Air noted in underslab notch grout projections? Yes, minor
3. Grout leakdown at air vent holes? n/a
Lead wool/Exp. metal bulkhead
4. Noticeable general air bubble pattern? Yes, minor

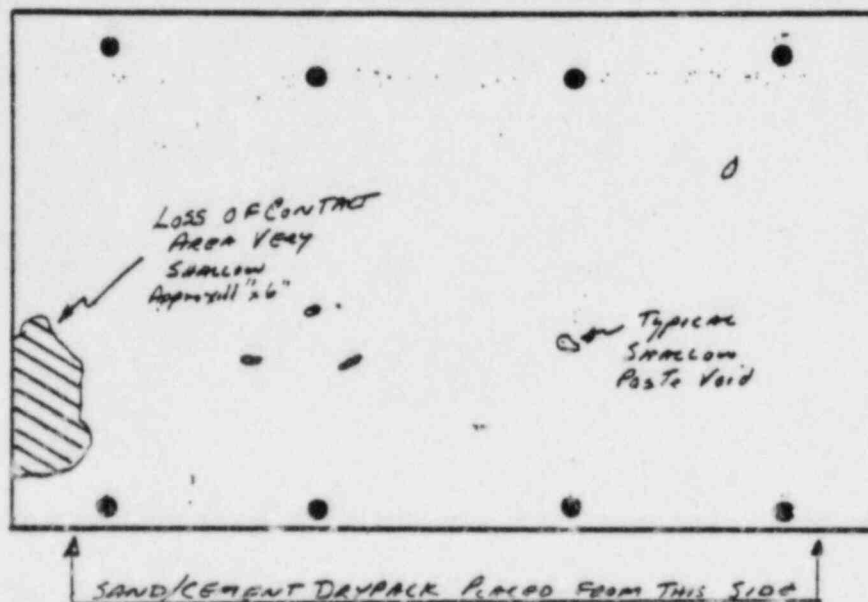
4. Noticeable general void pattern? No

5. Calculated void area in excess of 1/4" ϕ nominal sizing = 2.49%
 percent of surface area. Neglecting lost contact area = 0.1%

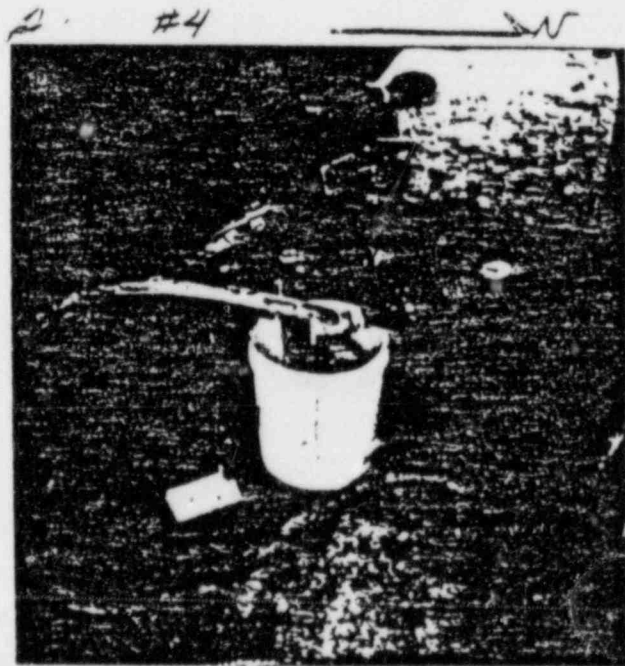
6/28/83 GROUT PUMP SET UP
PUMP = AIRPLACO MODEL #HG-5,
S.N. - 821121, Pressure Gauge 0-60F
2 1/2" Ø DIAL
ALL APPEAR TO BE IN GOOD CONDITION.

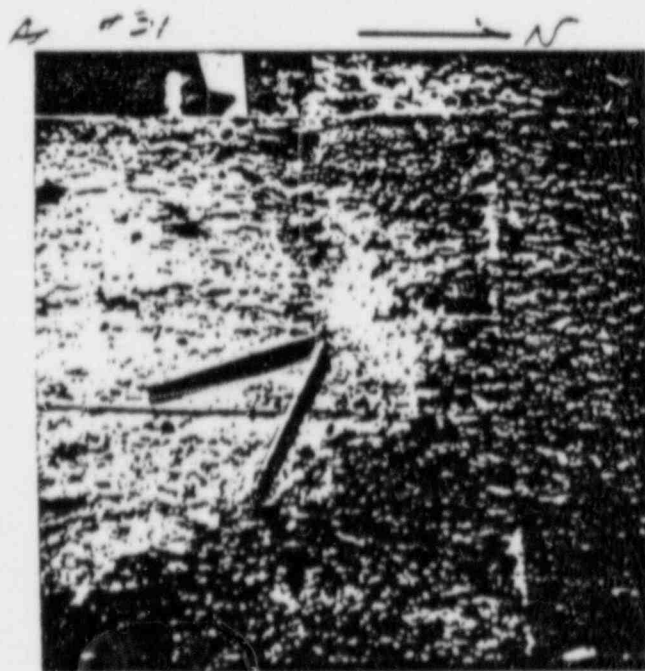
7/11/83 RATE No. 5B (NORTH WEST CORNER)
APPEARANT LOSS ON CONTACT AREA
211" x 6". THE M.B. APPEAR TO HAVE SLIPPED
ON THE WEST SIDE (1 1/2" TO 2" GROUND IN)
