Subject: Supplemental Information Regarding Proposed Alternative for Compliance with
10CFR50.55a Regarding RPV Cladding Indications

Vermont Yankee
Reactor Pressure Vessel
Clad Indications
1992 Refueling

**Report on Ultrasonic Evaluations
of
Reactor Vessel Cladding Indications
at the
Vermont Yankee Nuclear Power Station**

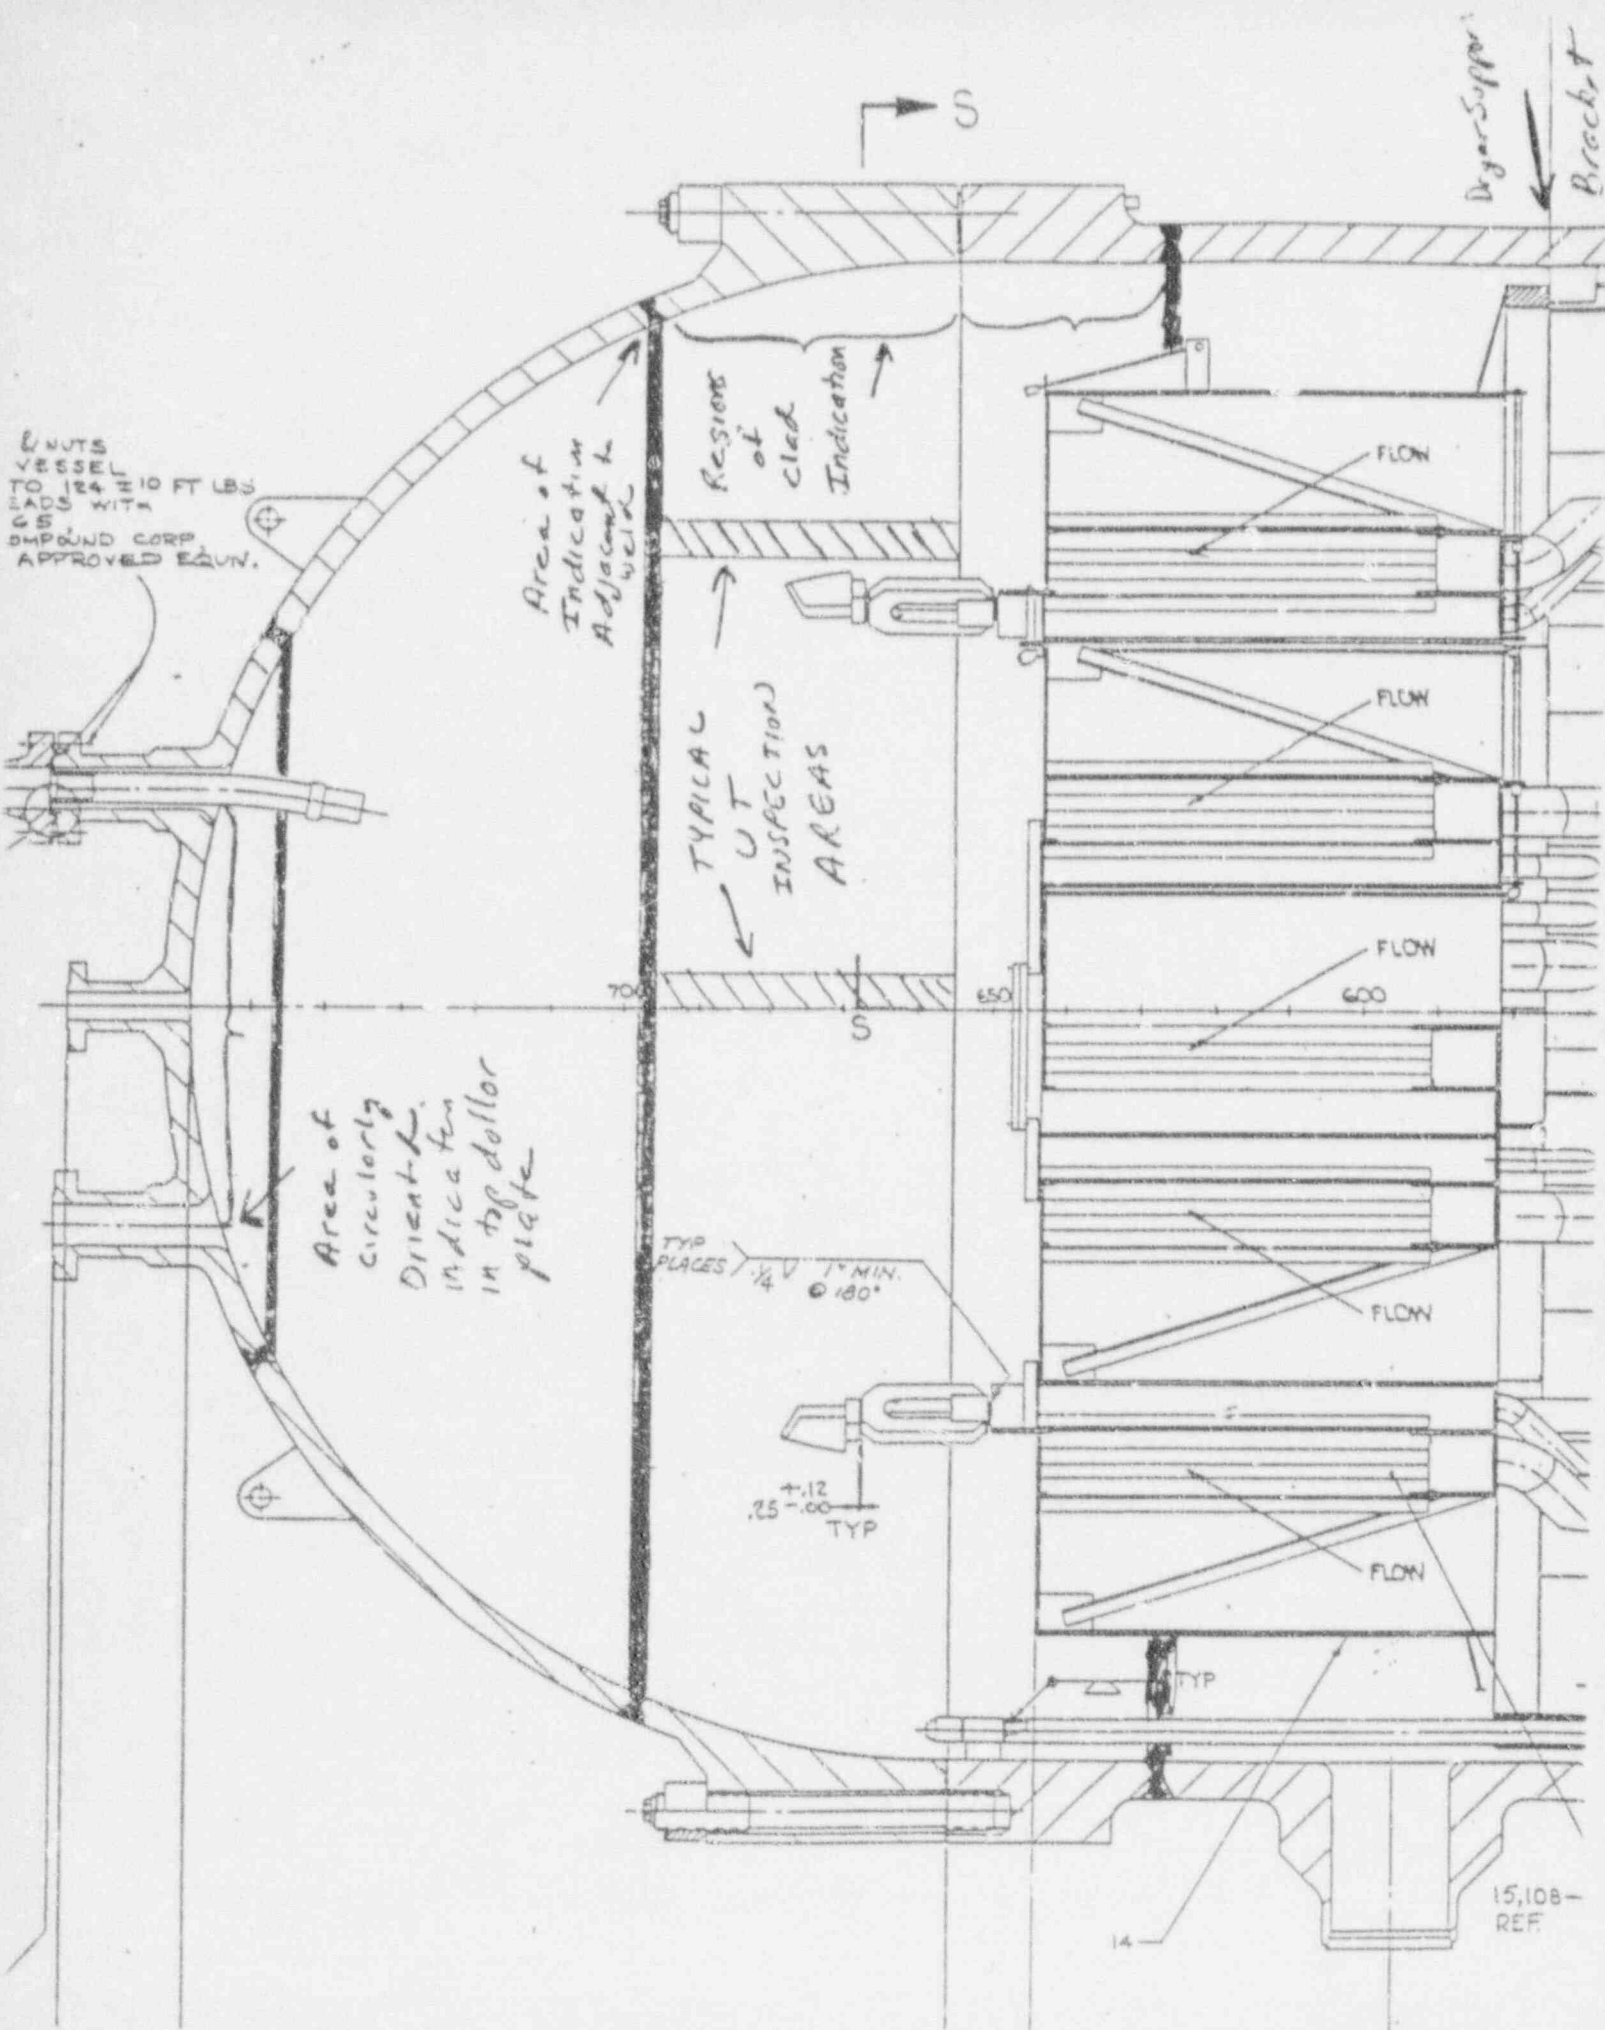
TYPICAL UT INSPECTION AREAS

Area of Circularity Indication in top dorr plate

Area of Indication Adjacent to Weld

Regions of clad Indication
