SUBJECT: BOARD NOTIFICATION - UPDATE ON MIDLAND STOP WORK STATUS
AND NRC STAFFING CHANGES

The attached memorandum, Norelius to Eisenhut dated April 9, 1984, provides an updated status on the Midland Stop Work Status previously reported in BN-84-023 and discusses the NRC Region III staffing plans for the Midland review.

The Diesel Generator Building (DGB) at the Midland Nuclear Power Plant (NPP) is a reinforced concrete structure which has undergone excessive unequal settlement since its construction. The concrete walls of the DGB have been more extensively cracked than usually expected of such a concrete structure. On the basis of review and evaluation of the Applicant's (Consumer Power Co.) various analytical studies, remedial measures taken, and the commitments made and of the staff's own assessments, the original structural engineering staff reviewer came to the conclusion that the DGB was acceptable. However, an NRC regional inspector disagrees with the conclusion as to the acceptability of the DGB and has expressed his concerns in a hearing before a Congressional Government Oversight Committee.

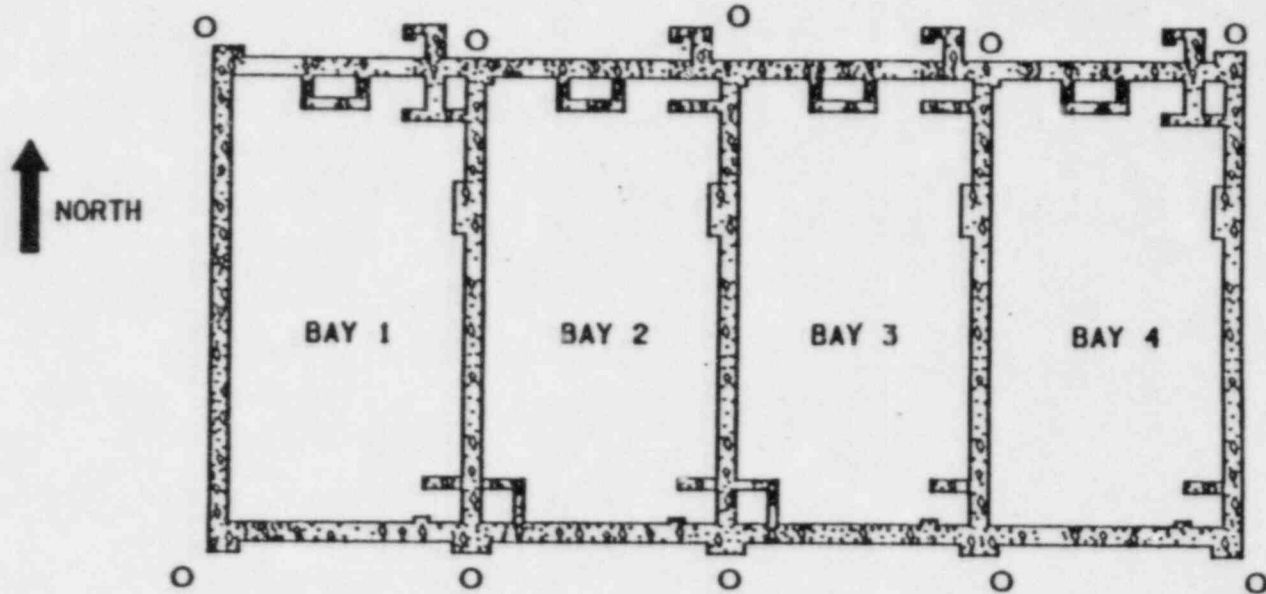
FIGURE 2

The effects of the remedial measures taken can be observed from the amount of settlement which the DGB has gone through as indicated in Figure 2 and also from the crack sizes and crack patterns of the walls as shown in Figure 3. Details of both settlement and cracking issues are discussed in the following sections.

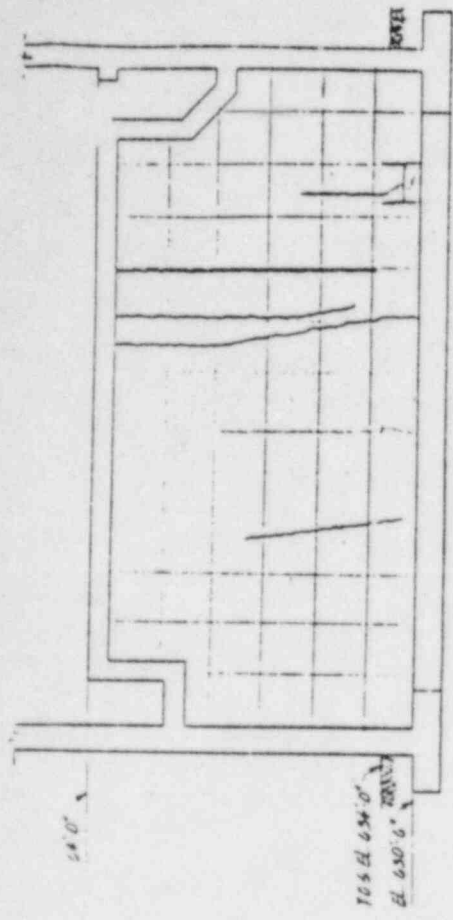
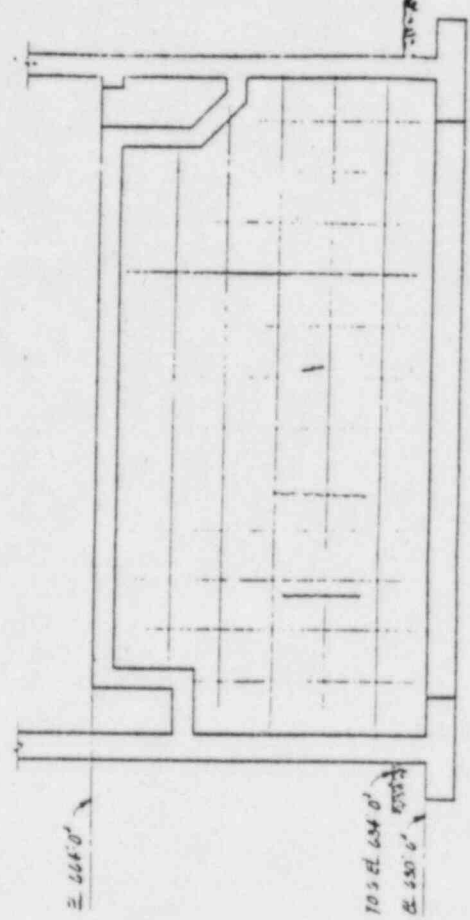
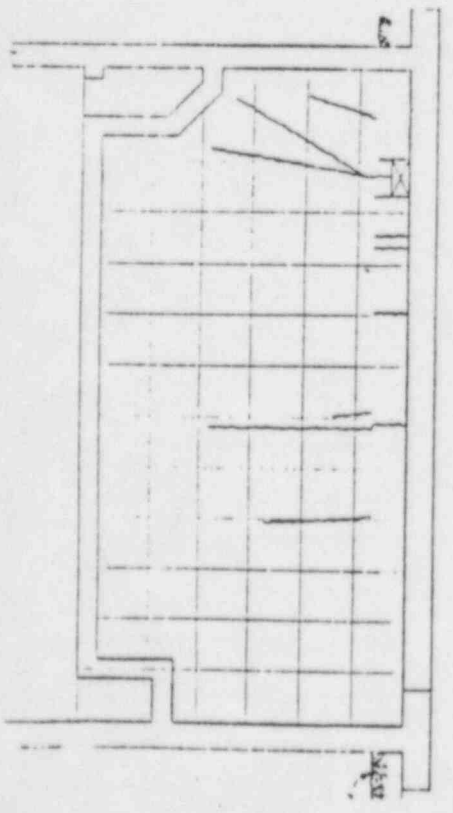
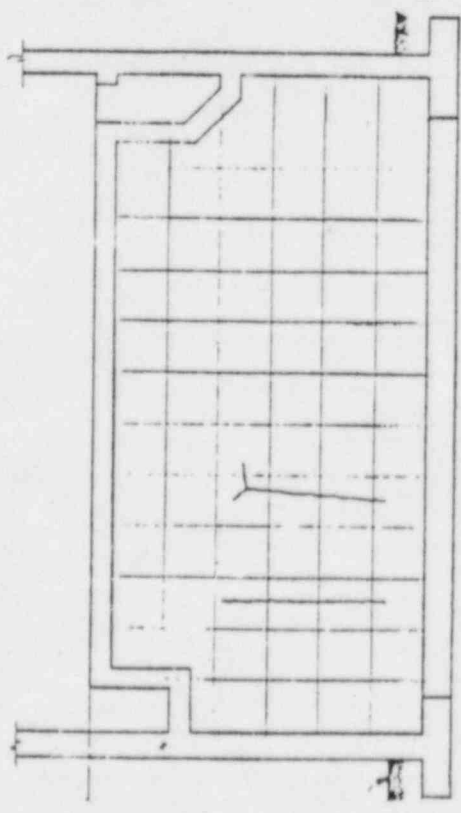
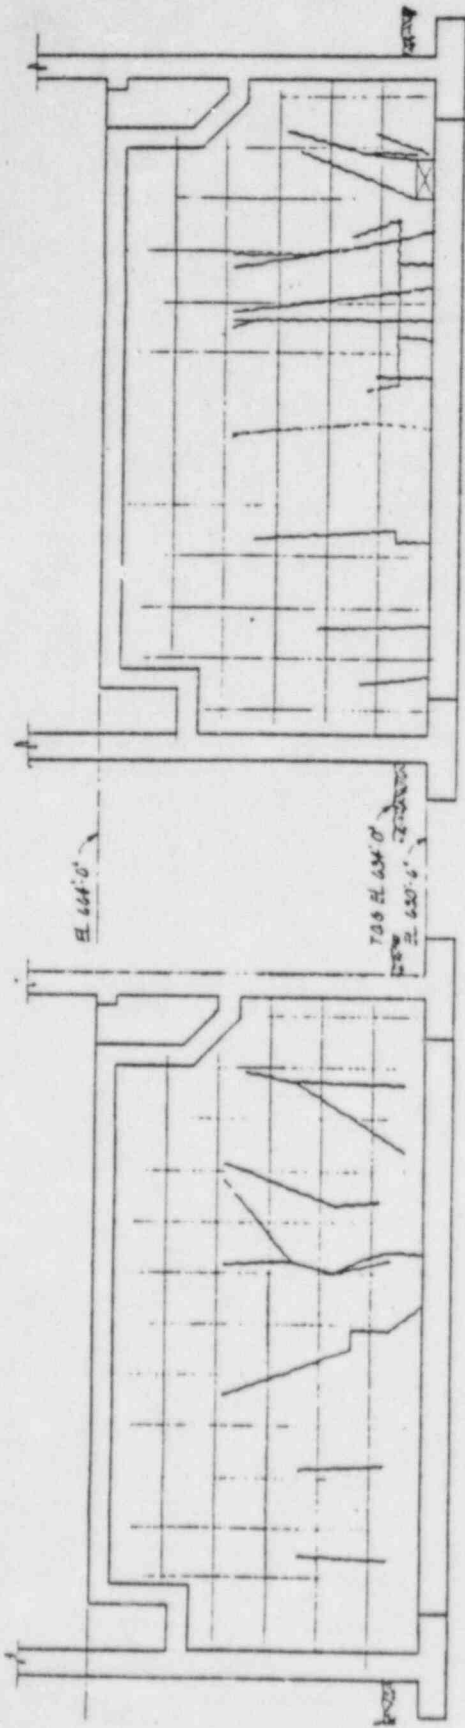
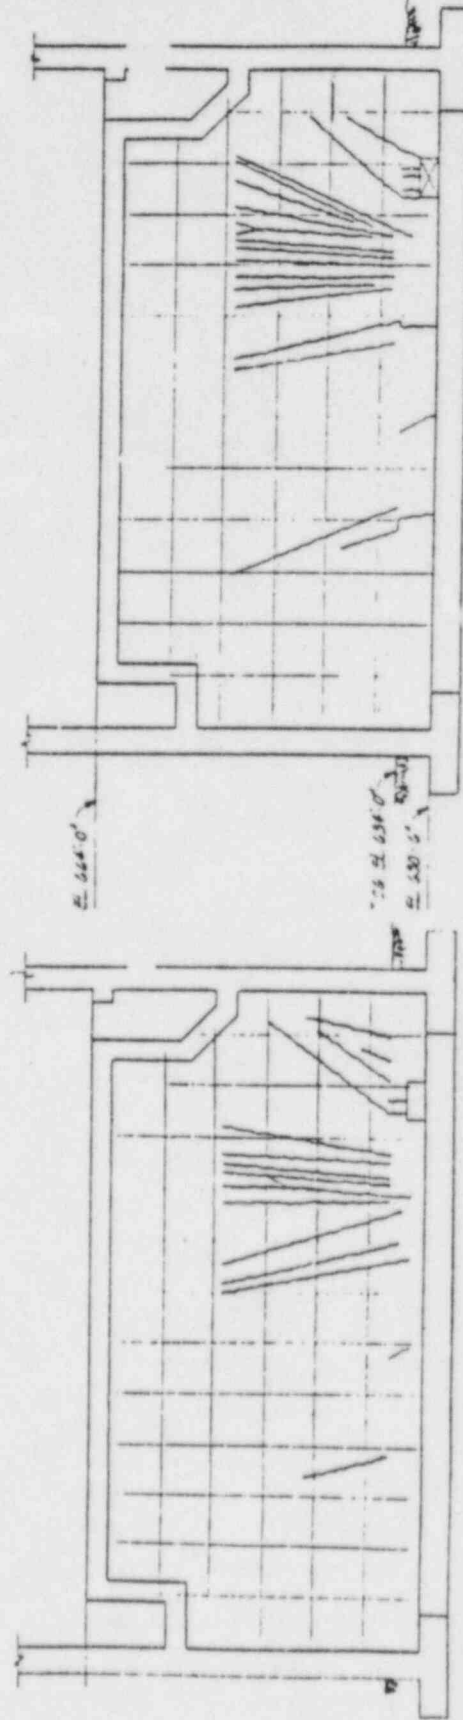
FIGURE 3 A - 2

1. CRACK SHOWN WERE MAPPED PRIOR TO PLACING THE PRELOAD (12-13-78 TO 12-18-78).
2. NORTH & SOUTH WERE NOT MAPPED SINCE NO SIGNIFICANT CRACKS WERE OBSERVED.
3. IN GENERAL, ALL CRACKS WERE PARALLEL WITH SOME CRACKS WITH A THICKNESS OF 28 MILS AS OF 7-2-79.

In order to assure the structural integrity of the DGB, the Applicant has proposed a crack monitoring and evaluation program to be used during the life of the DGB, in addition to an initial repair program. Specific acceptance criteria (i.e. alert limits and action limits) for crack width and crack width increases have been specified by the structural engineering staff reviewer and agreed to by the Applicant.

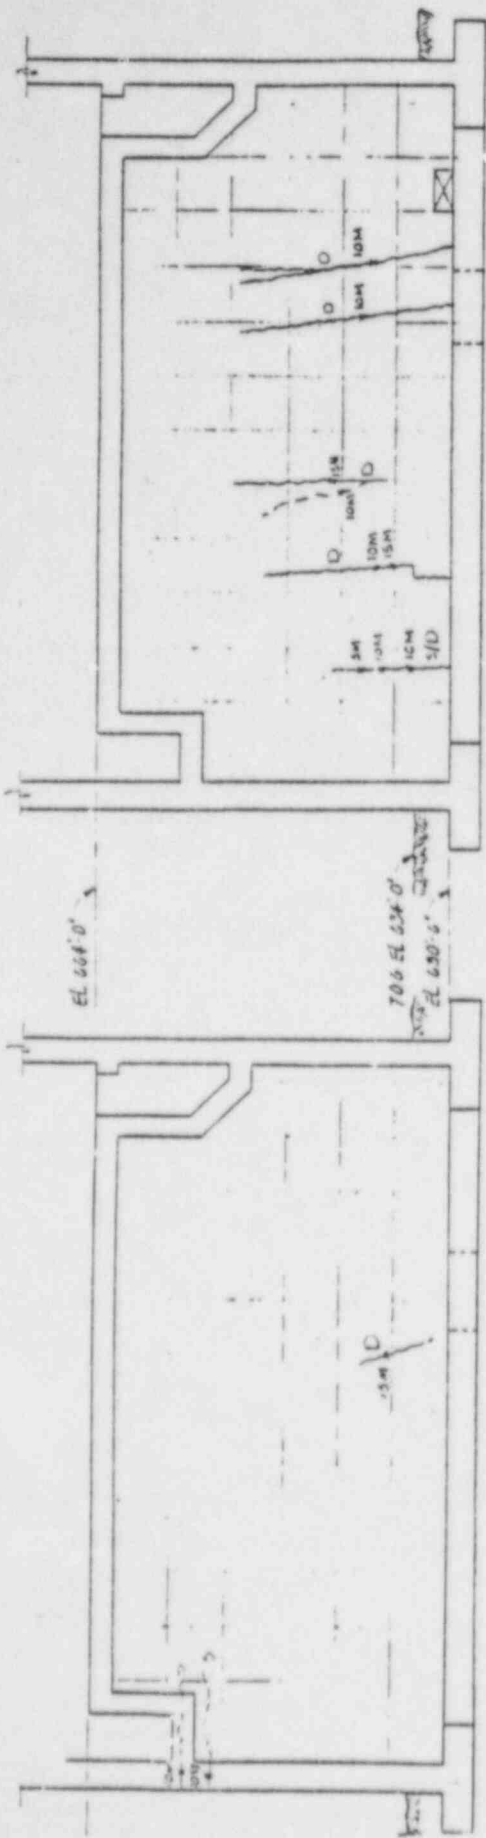
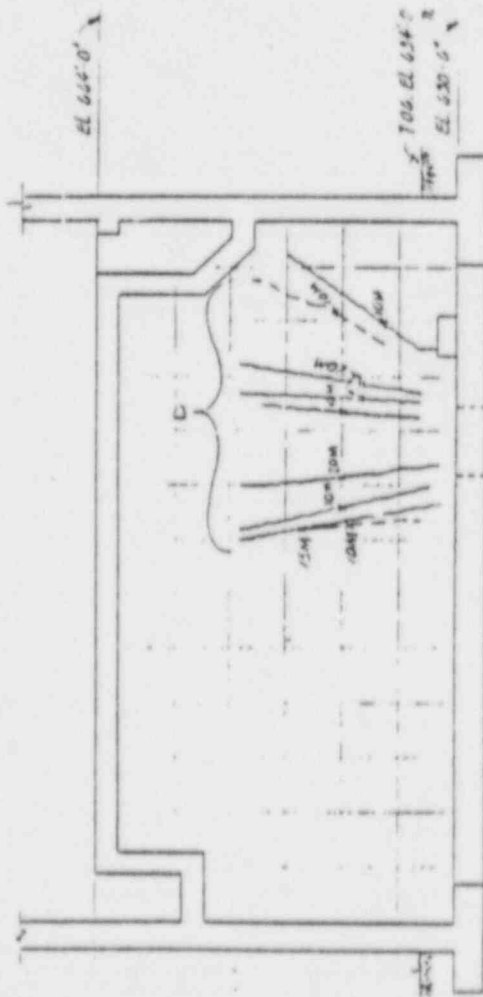
FIGURE 3 B - 2

1. IN GENERAL ALL CRACKS MAPPED IN DEC 1978 WERE HORIZONTAL. SOME CRACKS HAD A THICKNESS OF 28 MILS AS OF 7-7-79.
2. FOR CRACK MAPPING OF WALLS FROM EL. 664'-0" TO EL. 681'-6" SEE F/S. 28-3
3. CRACKS LESS THAN 10 MILLS IN SIZE ARE NOT MAPPED.
