UNITED STATES
NUCLEAR REGULATORY COMMISSION
WASHINGTON, D. C. 20555

APPLICANT: Consumers Power Company
FACILITY: Midland Plant, Units 1 and 2
SUBJECT: SUMMARY OF FEBRUARY 2-5, 1982 MEETING AND AUDIT ON AUXILIARY
BUILDING UNDERPINNING

Enclosure 1 is a summary of this meeting and audit.

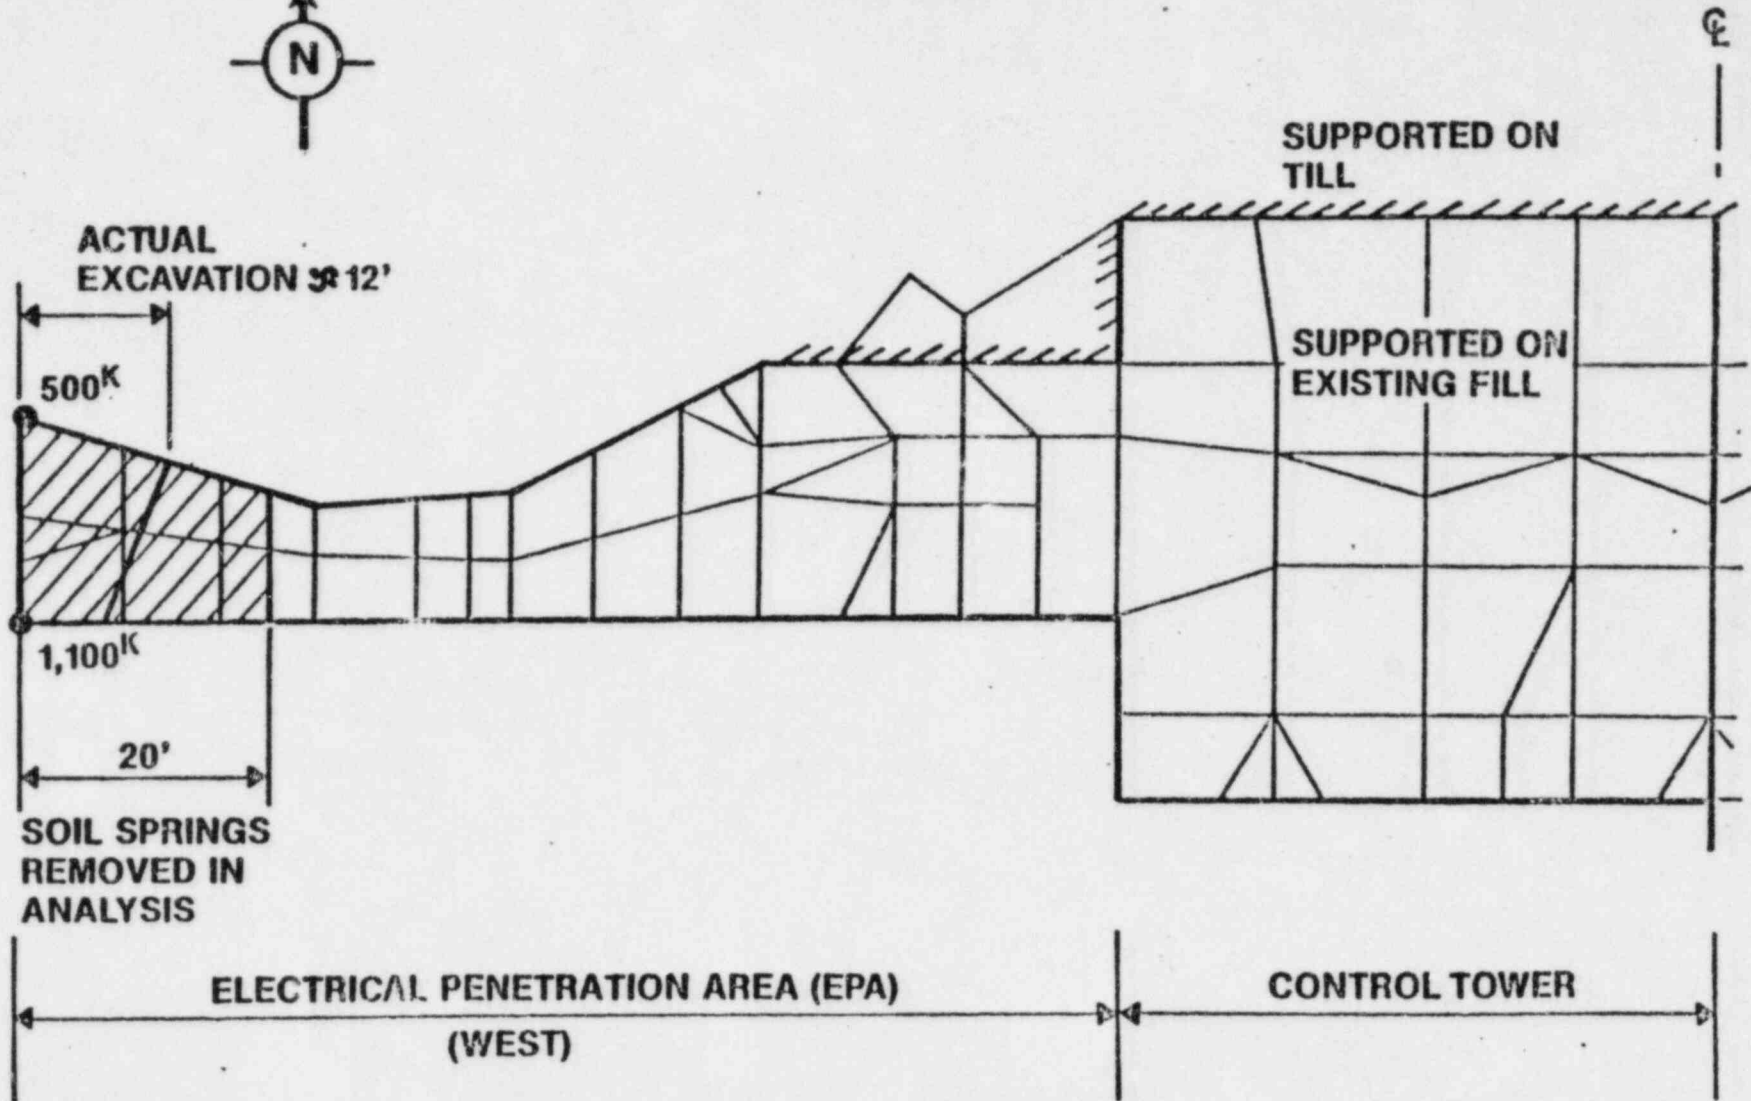
AUXILIARY BUILDING UNDERPINNING CONSTRUCTION SEQUENCE STAGE - 1

**AUXILIARY BUILDING UNDERPINNING
CONSTRUCTION CONDITION ANALYSIS
MAXIMUM STRESS (Tension)
CONSTRUCTION STAGE 1**

<u>Existing Stress</u>	<u>Change in Stress</u>	<u>Total Stress</u>
• DUE TO SOIL REMOVAL	30 K/FT	7 K/FT	37 K/FT
• DUE TO SOIL REMOVAL AND JACKING	30 K/FT	-2 K/FT	28 K/FT

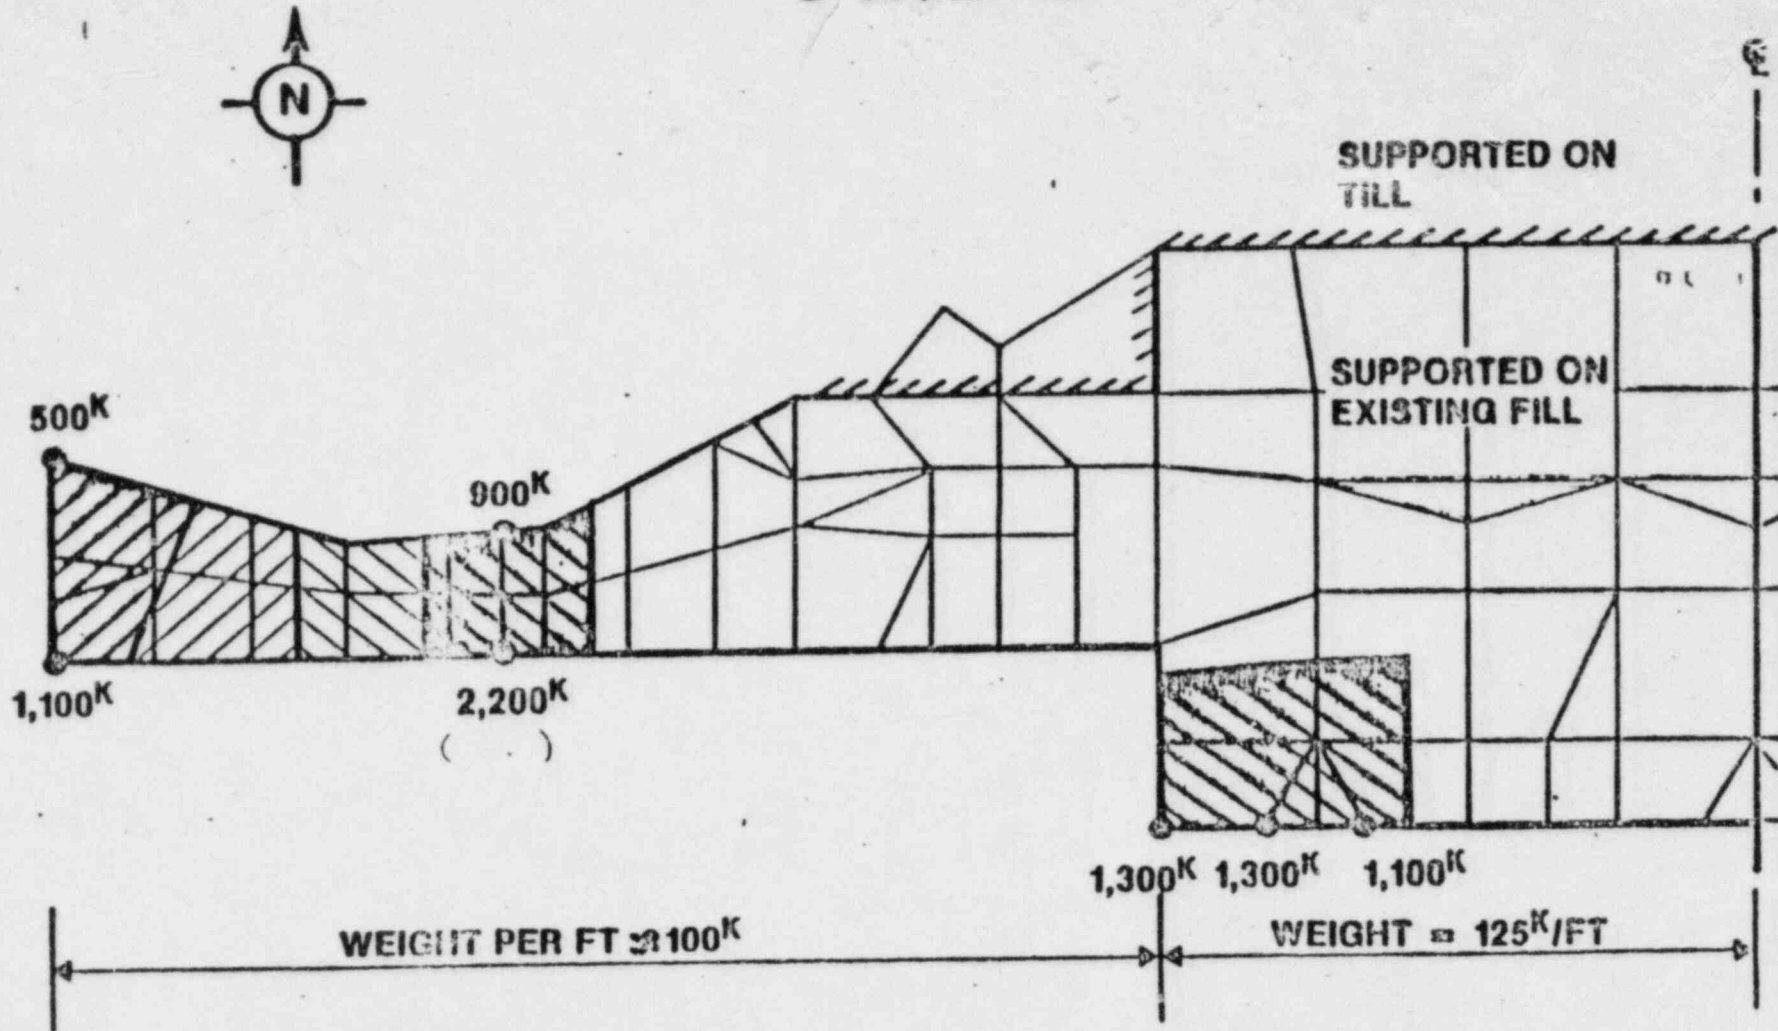
AUXILIARY BUILDING UNDERPINNING CONSTRUCTION SEQUENCE STAGE - 2

**AUXILIARY BUILDING UNDERPINNING
CONSTRUCTION CONDITION ANALYSIS
MAXIMUM STRESS (Tension)
CONSTRUCTION STAGE 2**

<u>Existing Stress</u>	<u>Change in Stress</u>	<u>Total Stress</u>
• DUE TO SOIL REMOVAL	30 K/FT	1 K/FT	31 K/FT
• DUE TO SOIL REMOVAL AND JACKING	30 K/FT	-65 K/FT	-35 K/FT

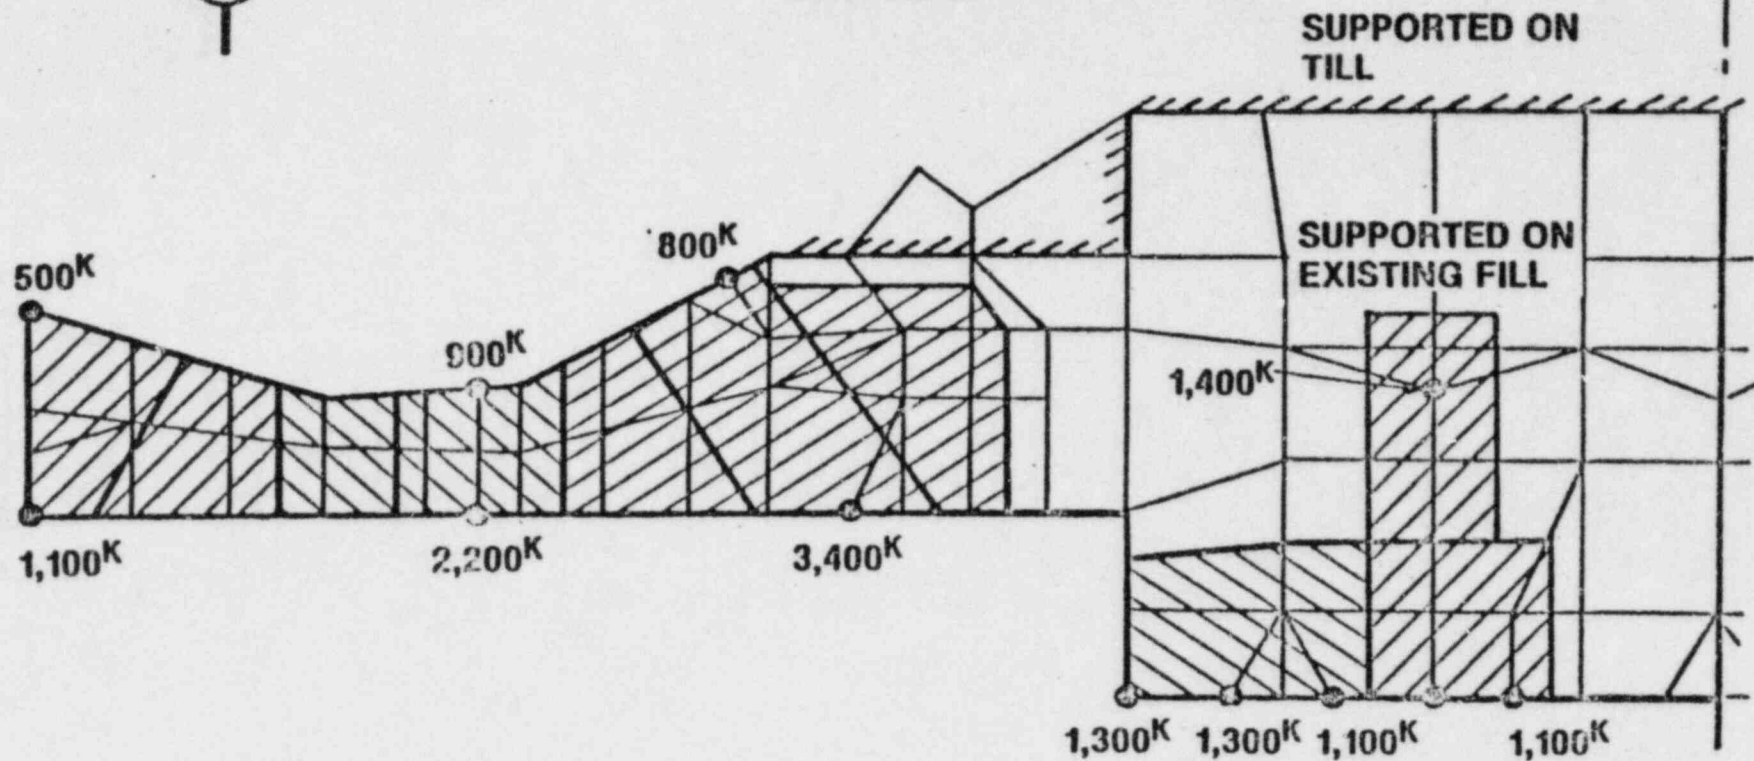
AUXILIARY BUILDING UNDERPINNING CONSTRUCTION CONDITION ANALYSIS CONSTRUCTION SEQUENCE STAGE - 3

**AUXILIARY BUILDING UNDERPINNING
CONSTRUCTION CONDITION ANALYSIS
MAXIMUM STRESS (Tension)
CONSTRUCTION STAGE 3**

<u>Existing Stress</u>	<u>Change in Stress</u>	<u>Total Stress</u>
• DUE TO SOIL REMOVAL	30 K/FT	-20 K/FT	10 K/FT
• DUE TO SOIL REMOVAL AND JACKING	30 K/FT	-95 K/FT	-65 K/FT

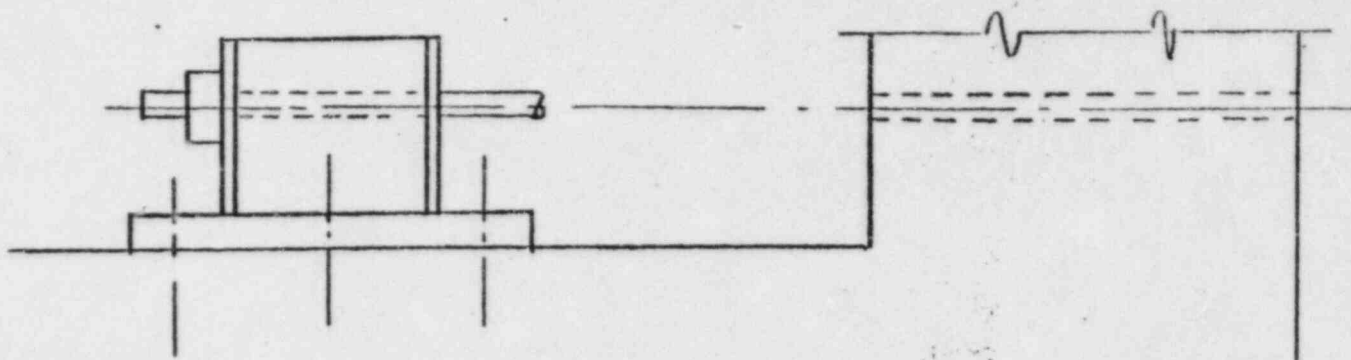
EXISTING BRACKET CONDITION

AS BUILT CONDITION

- BEARING PLATE UNDER ANCHOR HEAD OMITTED
- NO UNUSUAL DISTORSION OF BRACKET OBSERVED
- CAPACITY OF BRACKET IS 470 Kips BASED ON LIMIT ANALYSIS
- FACTOR OF SAFETY AGAINST BRACKET FAILURE IS 1.5

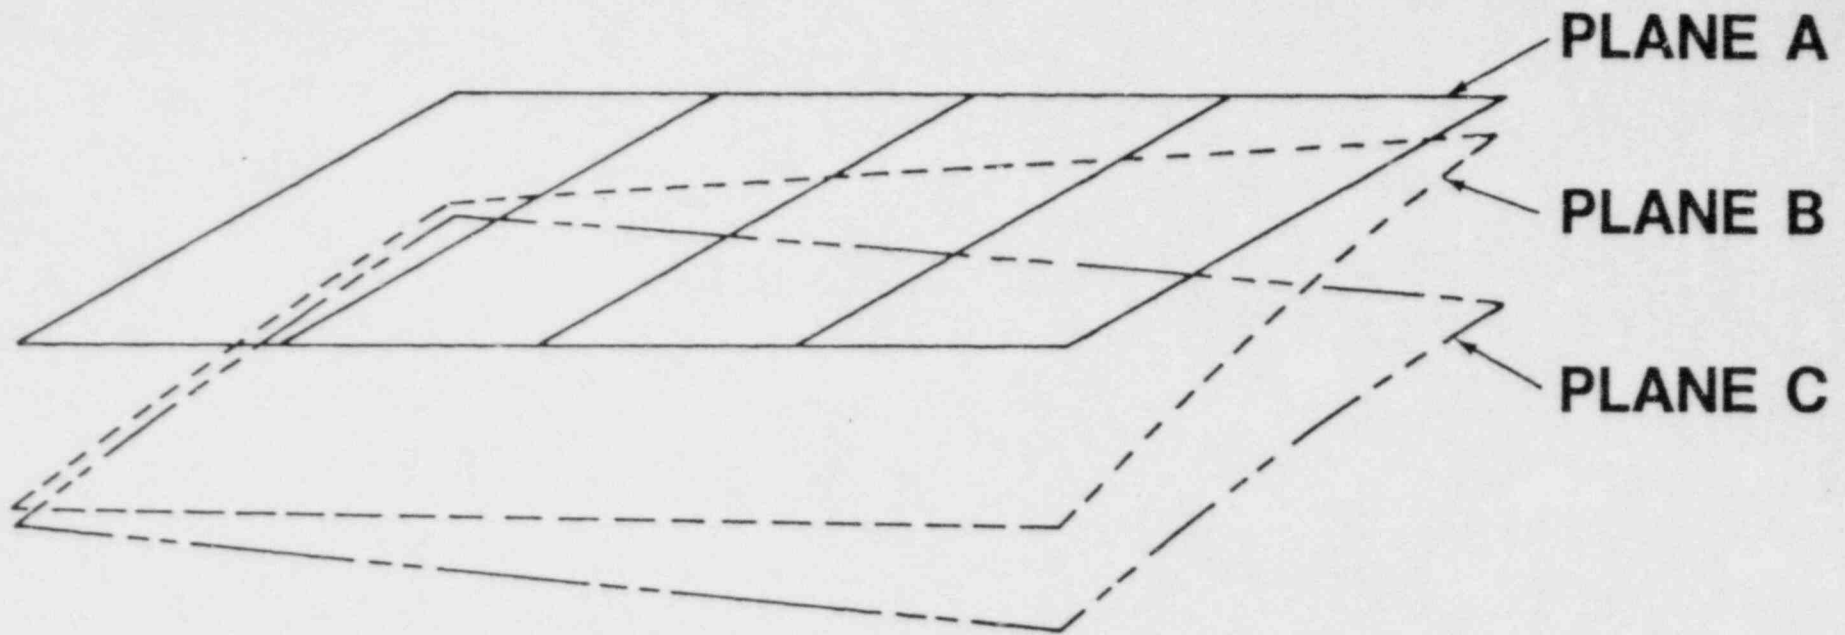
DIESEL GENERATOR BUILDING TREND OF MEASURED SETTLEMENT

- Plane A Nominal reference plane
- Plane B Settlement plot as of 11/16/78
before cutting duct banks loose
- Plane C Settlement plot as of 12/28/78
approximately a month after cutting duct banks

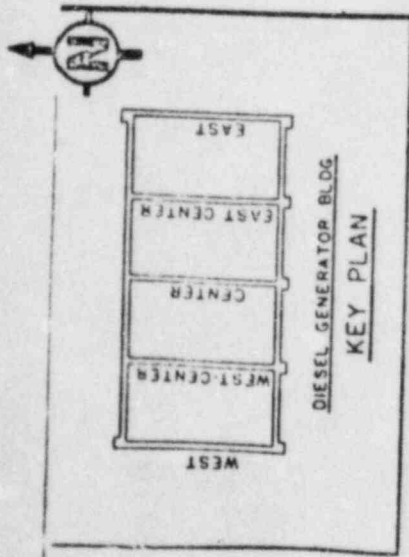
CENTER WALL - WEST SIDE
LOOKING WEST

1. CRACK SHOWN WERE MAPPED PRIOR TO PLACING THE PRELOAD. (12-15-78 TO 12-18-78).
2. NORTH & SOUTH WERE NOT MAPPED SINCE NO SIGNIFICANT CRACKS WERE OBSERVED.
3. IN GENERAL, ALL CRACKS WERE HAIRLINE WITH SOME CRACKS WITH A THICKNESS OF 28 MILS AS OF 2-2-79.

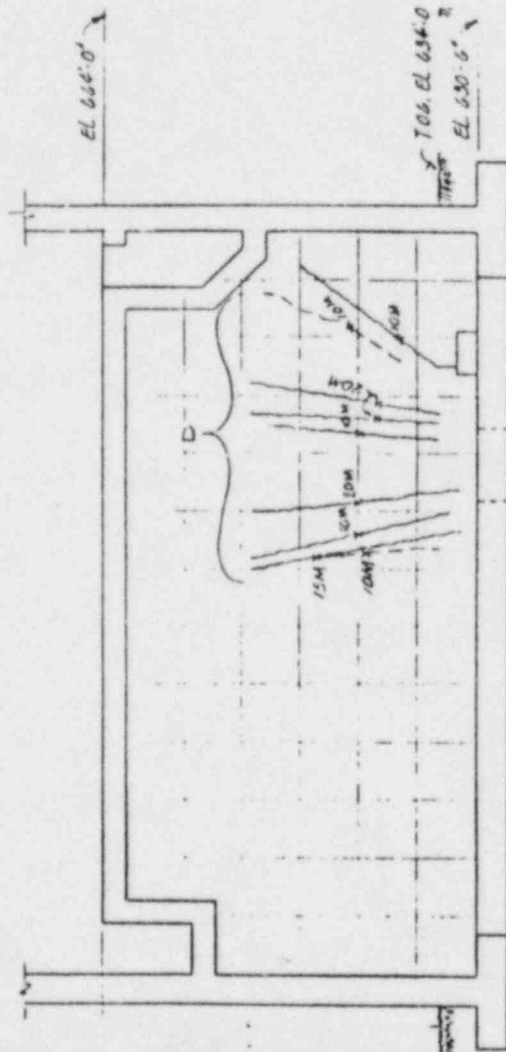
FIGURE 3 B - 2

1. IN GENERAL ALL CRACKS MAPPED IN DEC 1978 WERE HAIRLINE. SOME CRACKS HAD A THICKNESS OF 2.8 MILS AS OF 7-7-79.
2. FOR CRACK MAPPING OF WALLS FROM EL. 664'-0" TO EL. 681'-6" SEE FIS. 28-3
3. CRACKS LESS THAN 10 MILLS IN SIZE ARE NOT MAPPED.
