SUBJECT: NRR SALP III ASSESSMENT FOR MIDLAND PLANT, UNITS 1 & 2

FACILITY NAME: Midland Nuclear Plant, Units 1 and 2

LICENSEE: Consumers Power Company

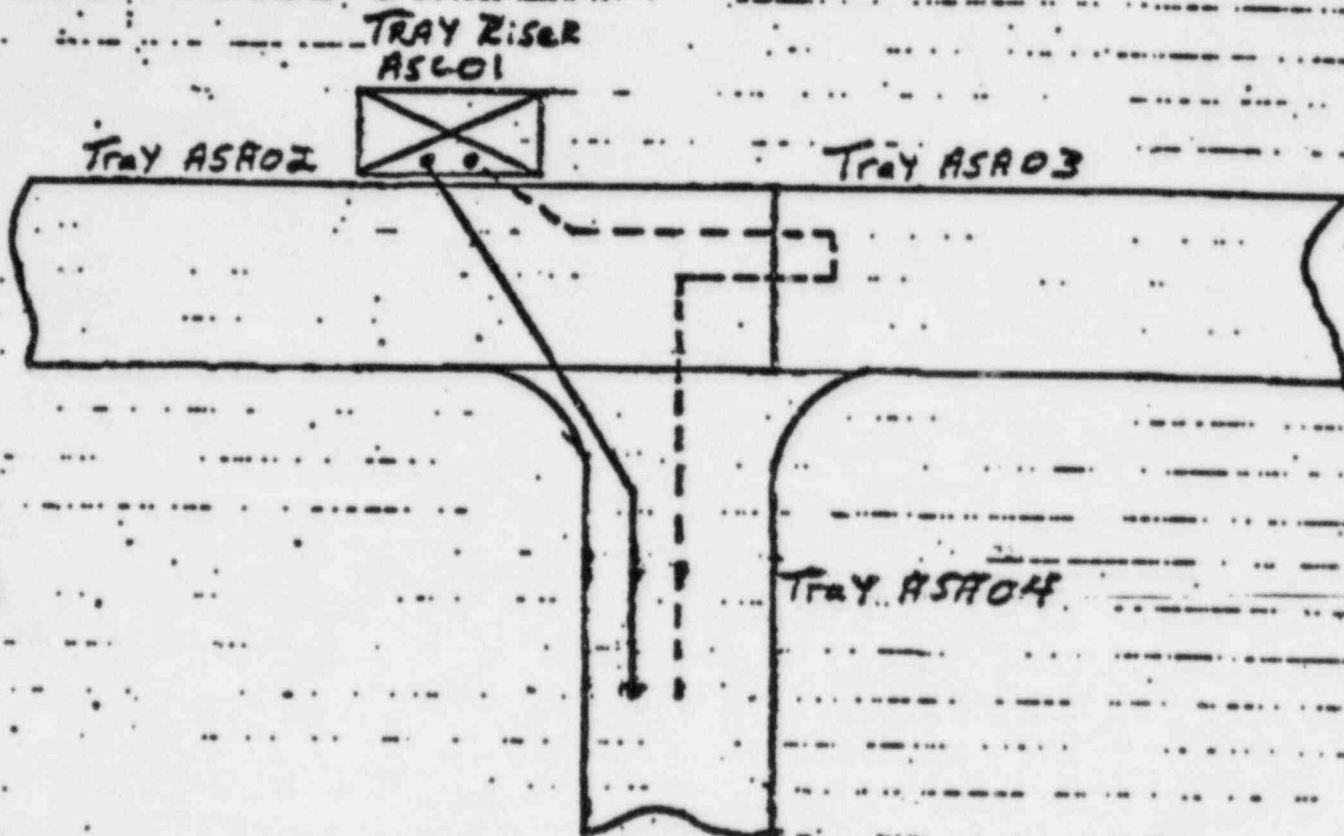
SK-2

— Cable <sup>is</sup> routed by field  
- - - cable should be - Per E-37

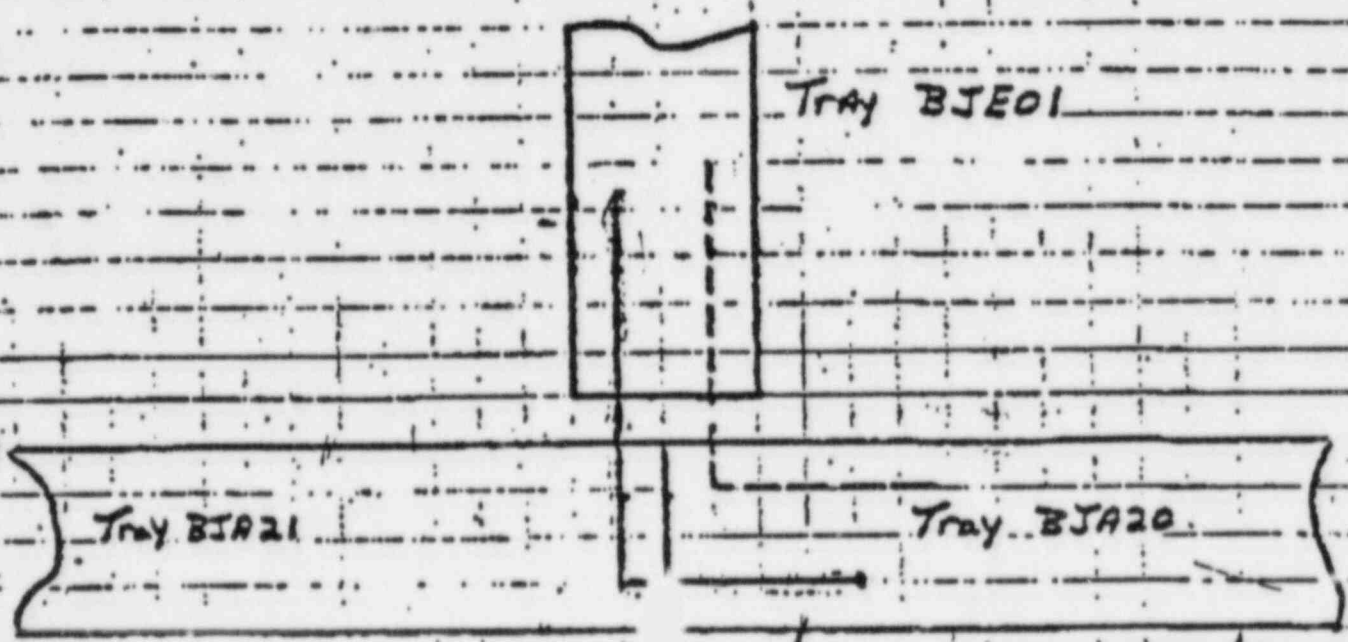
Trays are installed per E-36 and lay out dwgs.

————— Cable <sup>is</sup> routed - By field

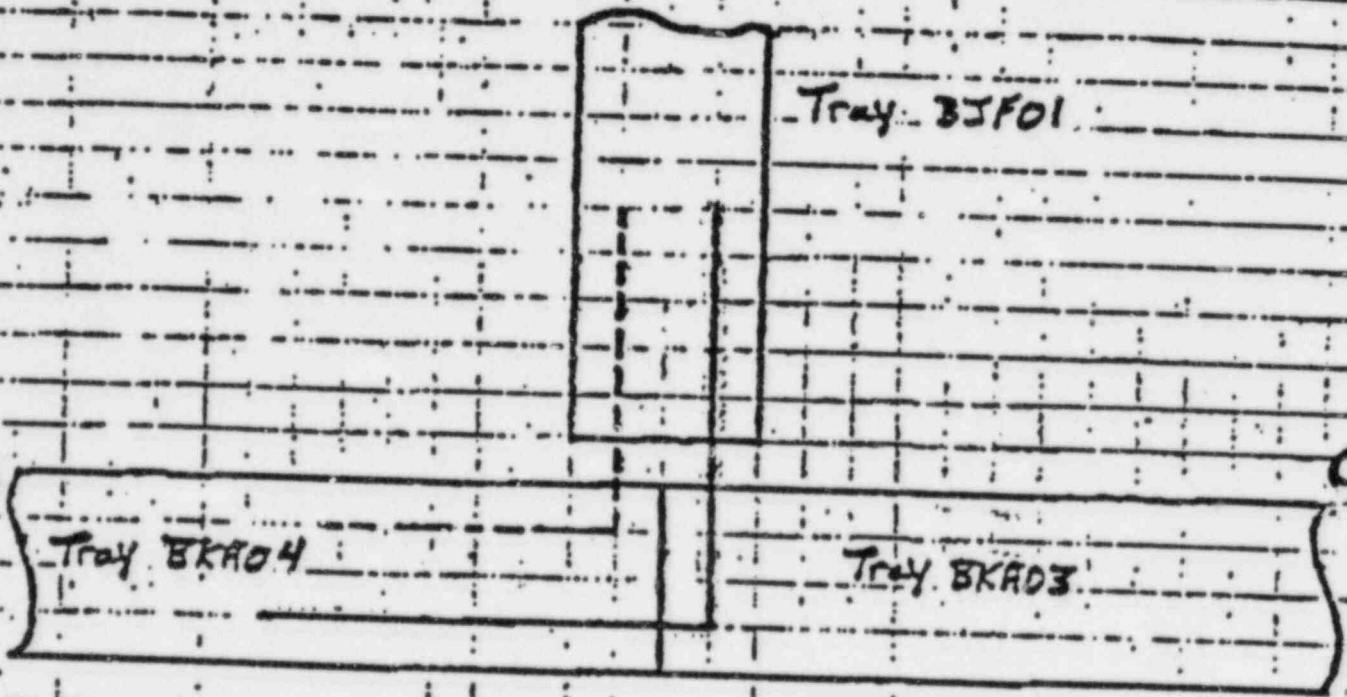
Trays are installed per E-36 and lay out drawings

Cable is routed by field

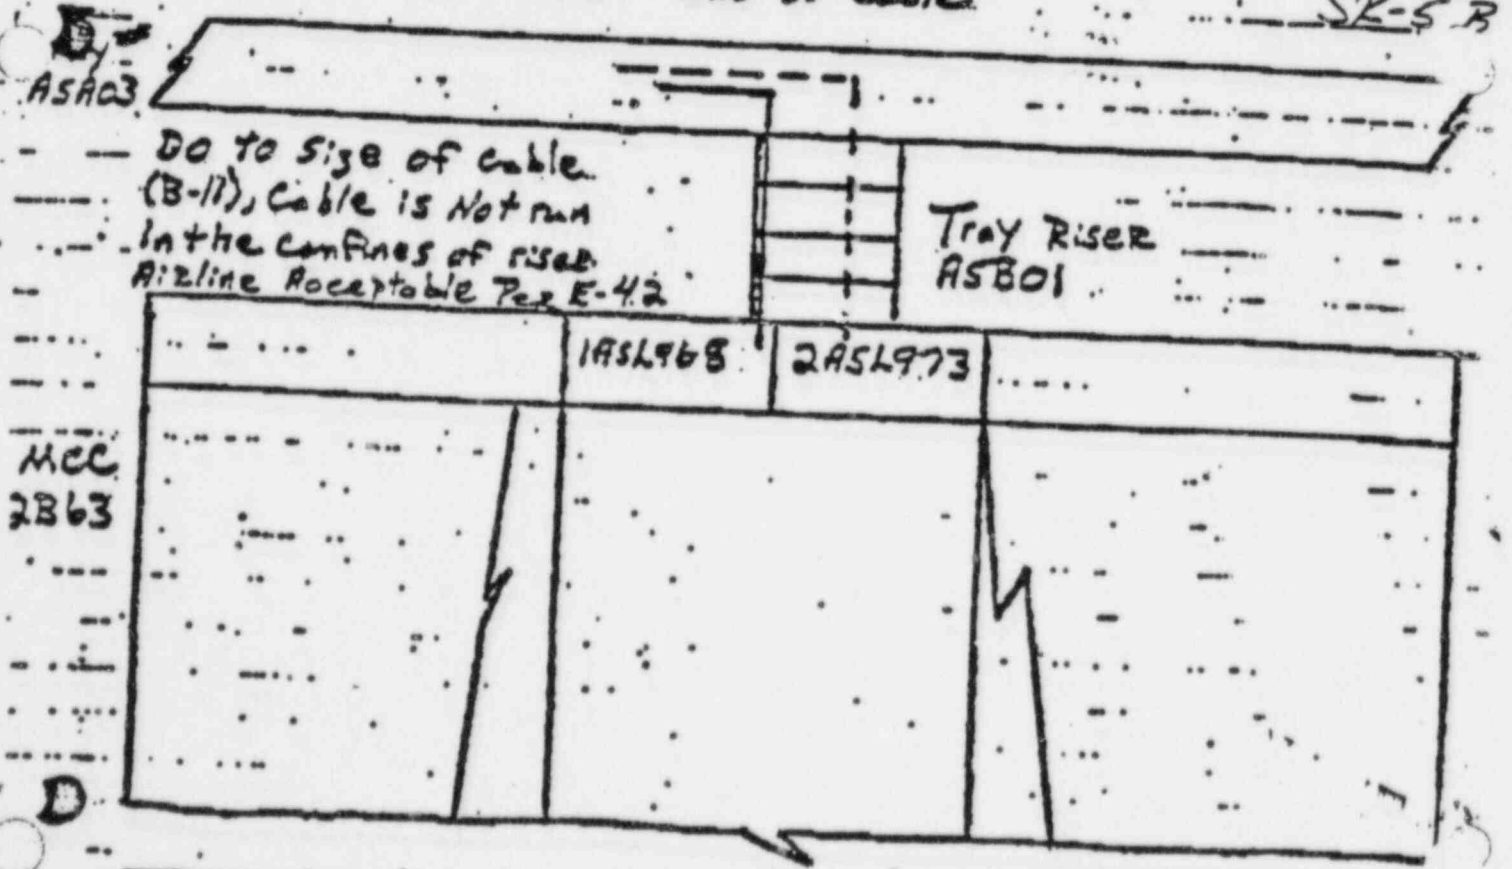
SK-5-B

DO TO SIZE OF cable  
(B-11), Cable is Not run  
in the confines of riser.  
Airline Acceptable Per E-4.2

Cable is routed by field  
Cable should be routed per E-37

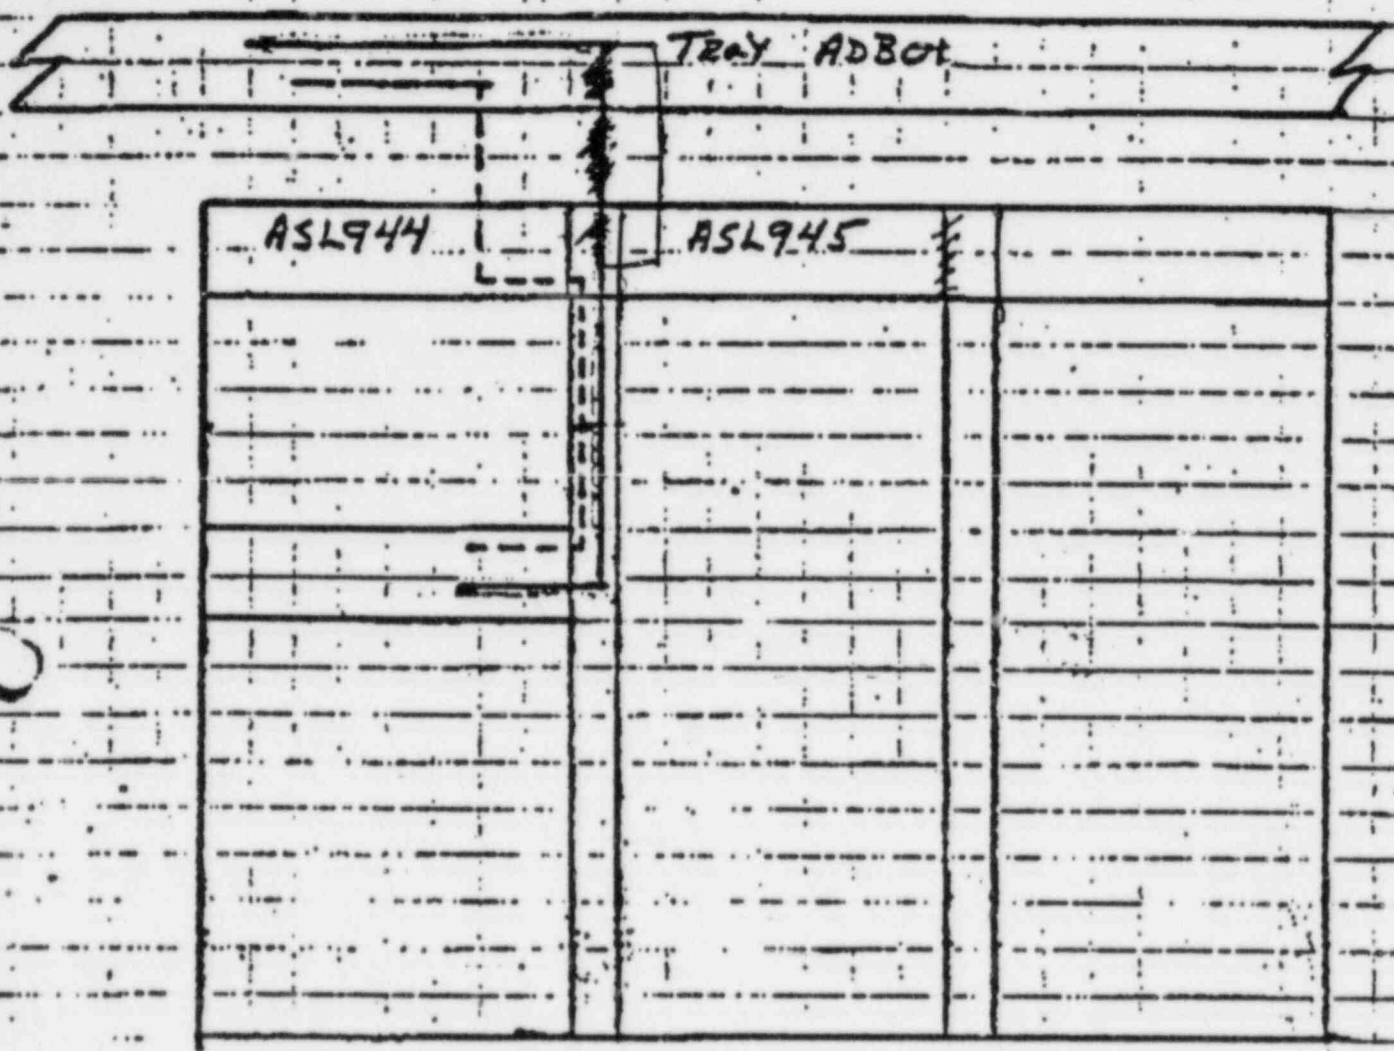
SK-6

Cable is routed by field.  
Cable should be routed per E-37

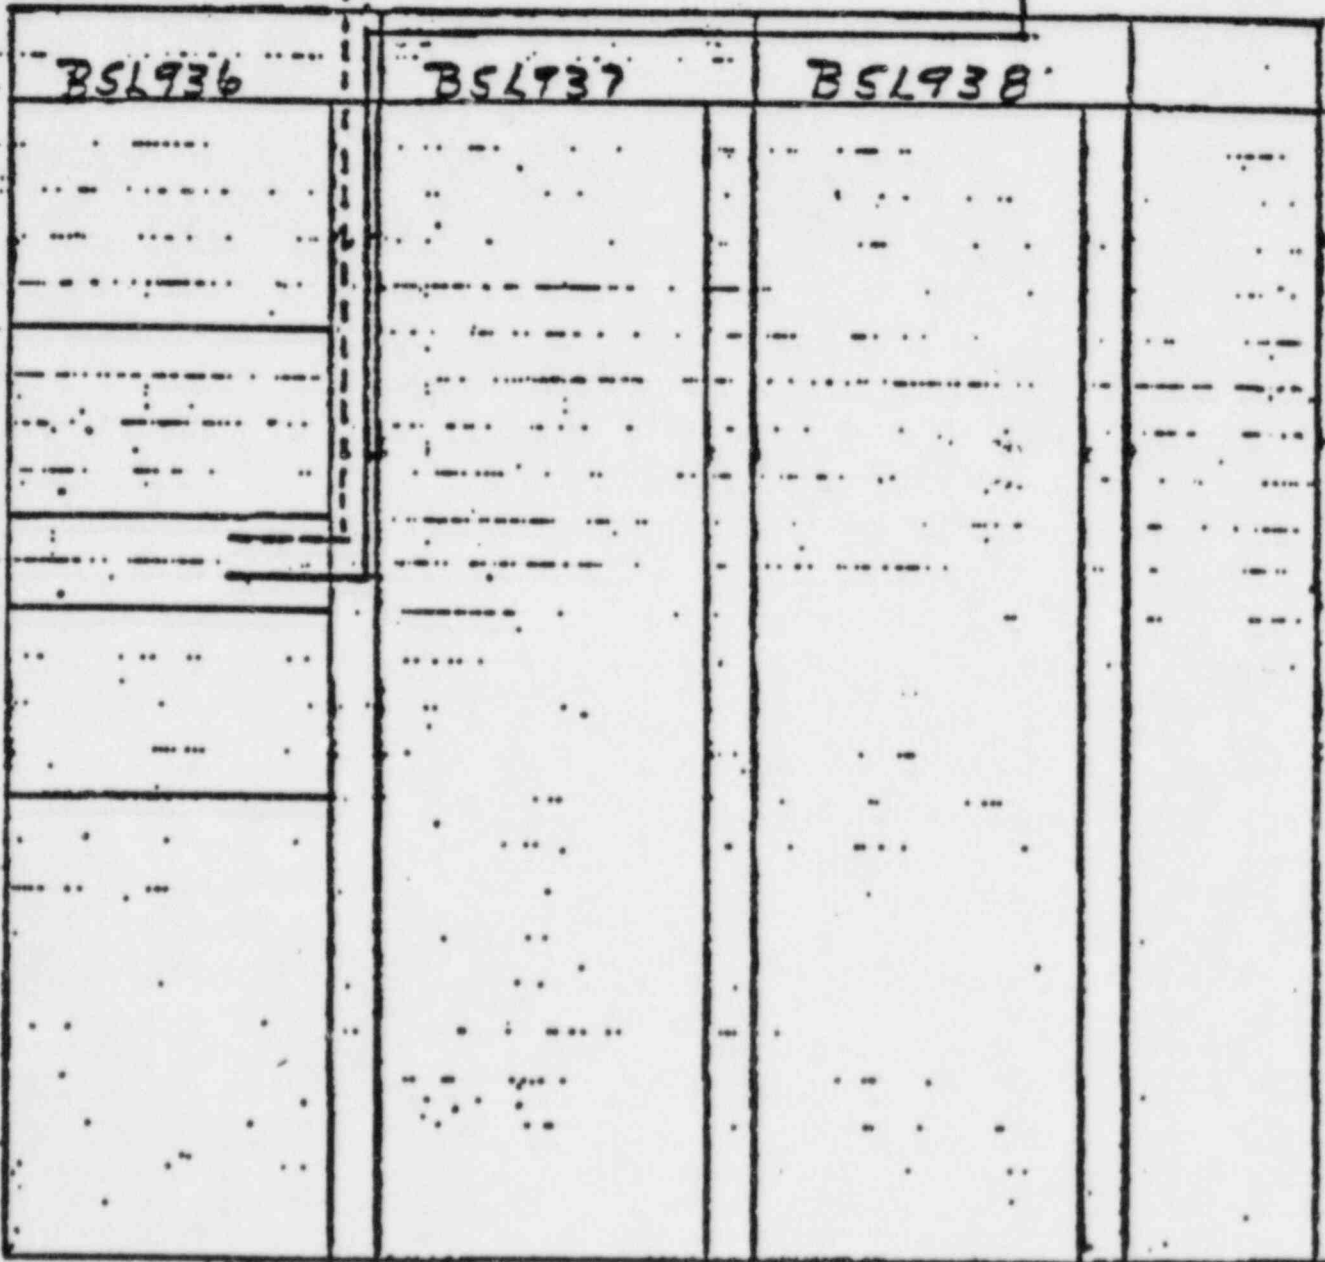
SK-7

Cable is routed by field  
Cable should be routed per E-37

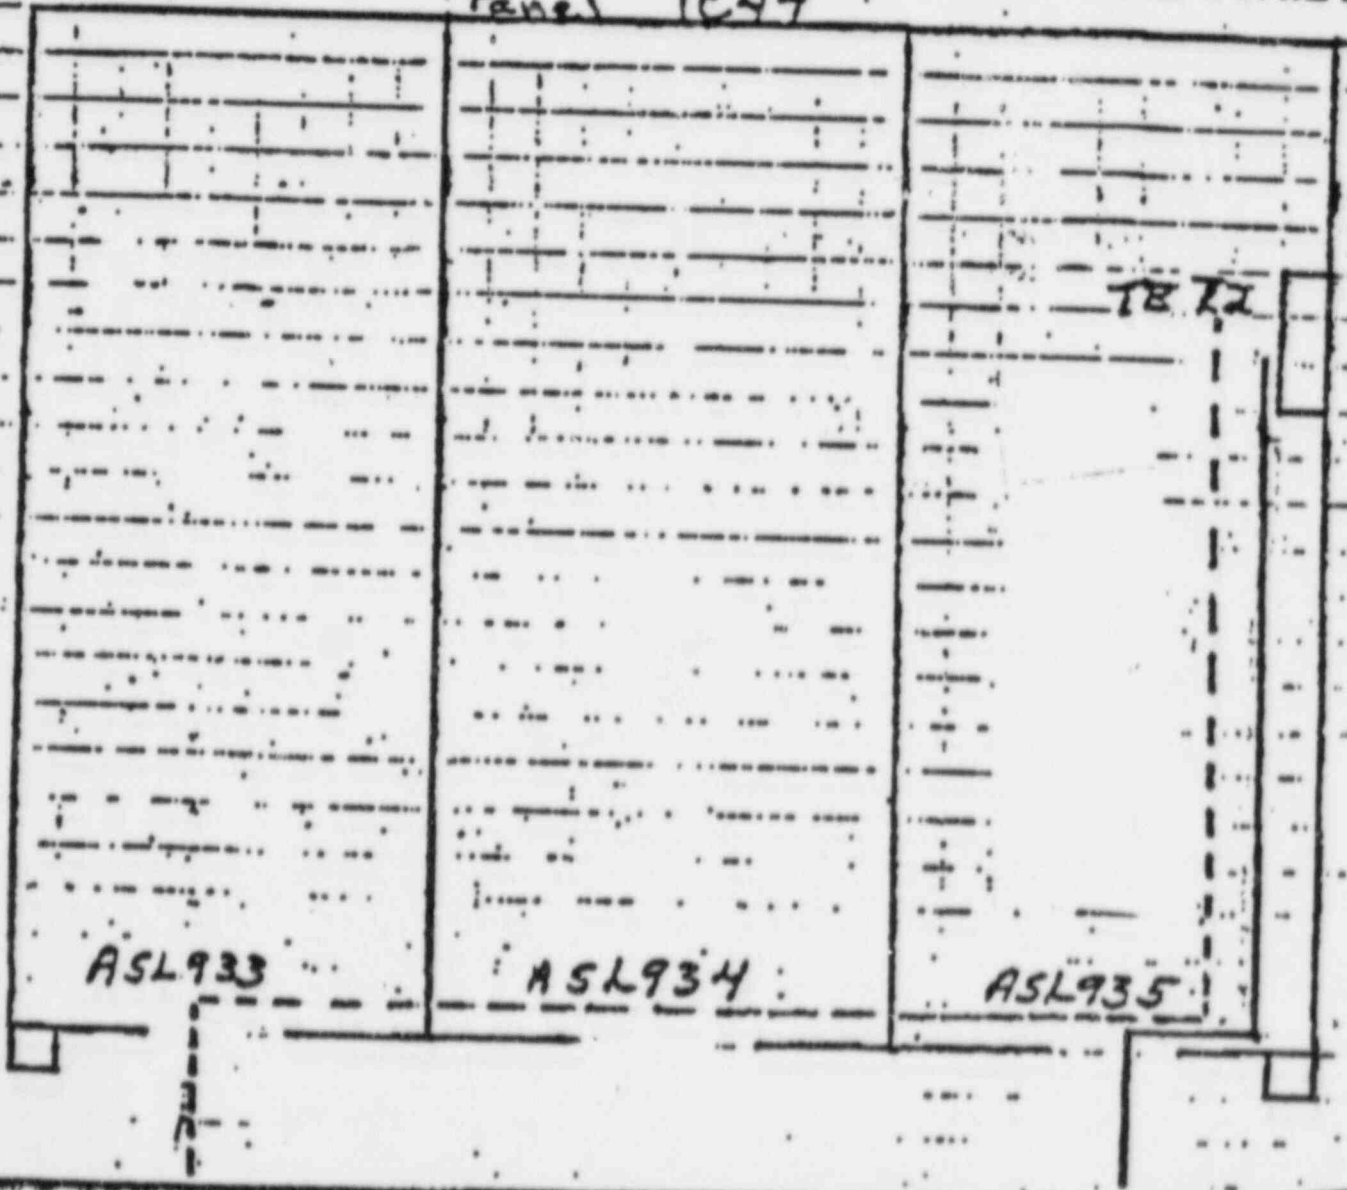
SK-8

IS Routed-by field  
Should be Routed-per E-37

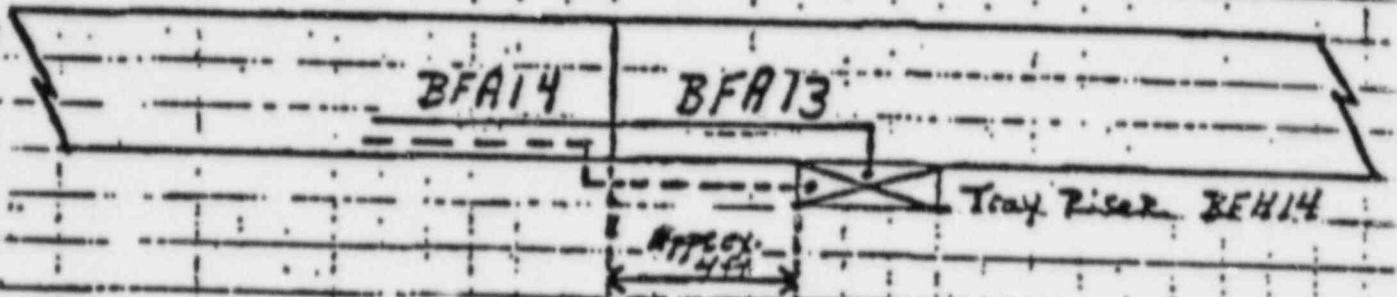
SK-9

Cable is Routed by Field  
Cable should be Routed per E-37

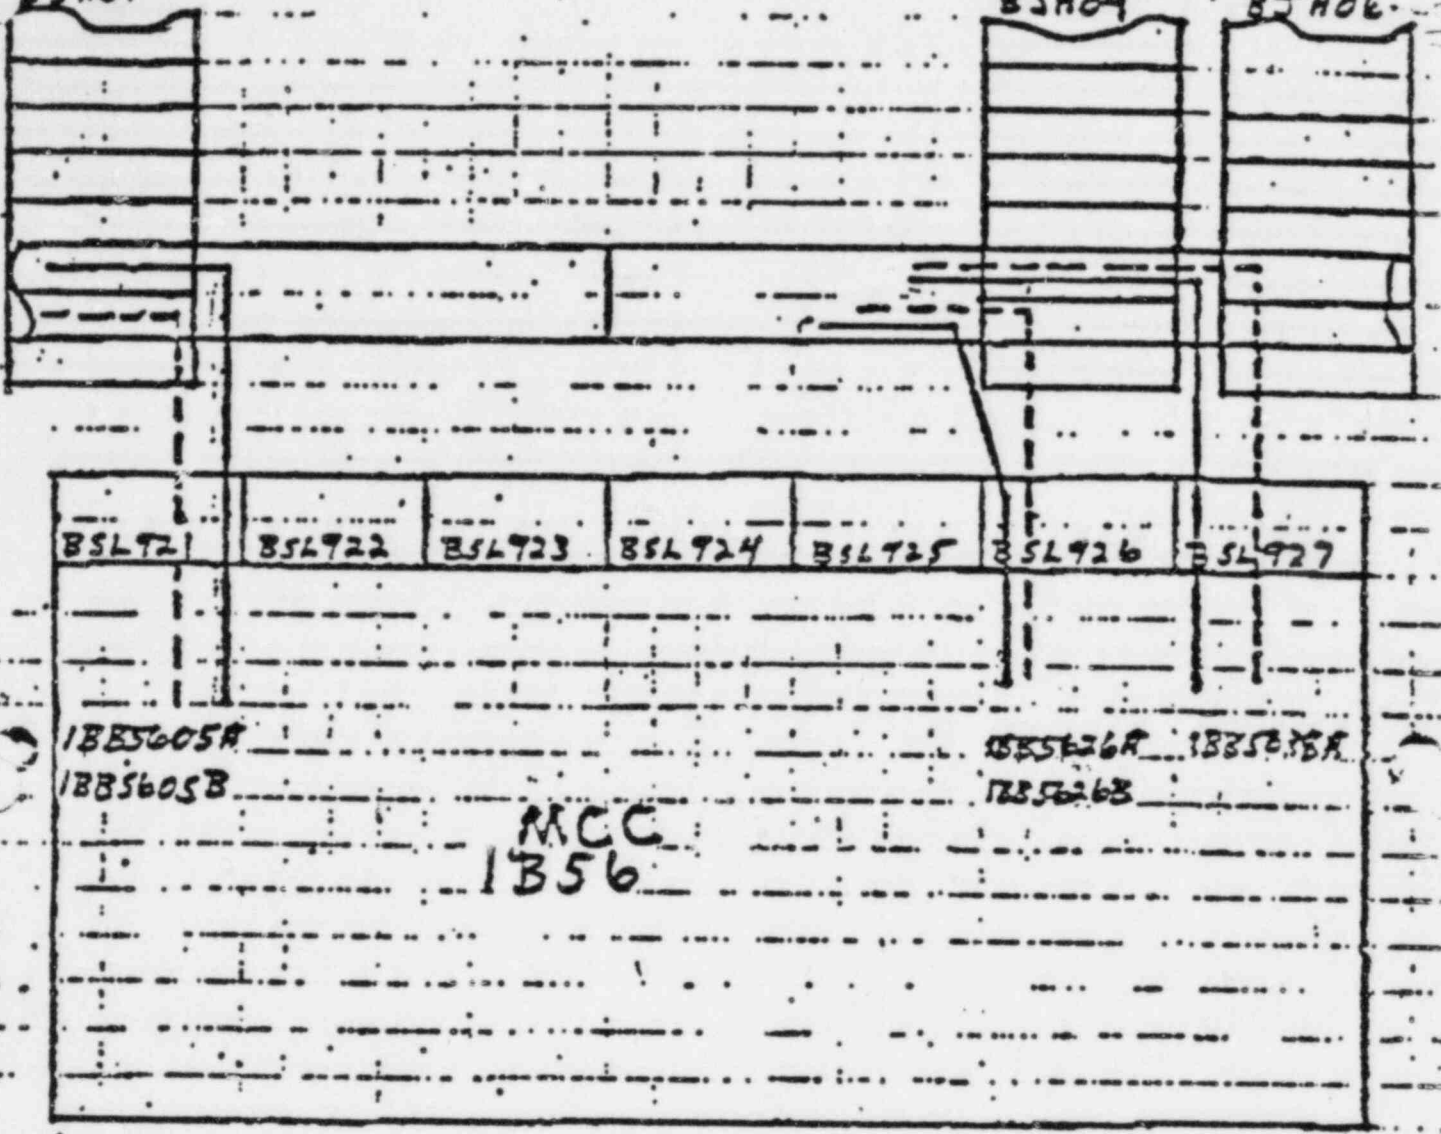
————— Cable is Routed - By field

- - - - - Cable should be - Per E-37

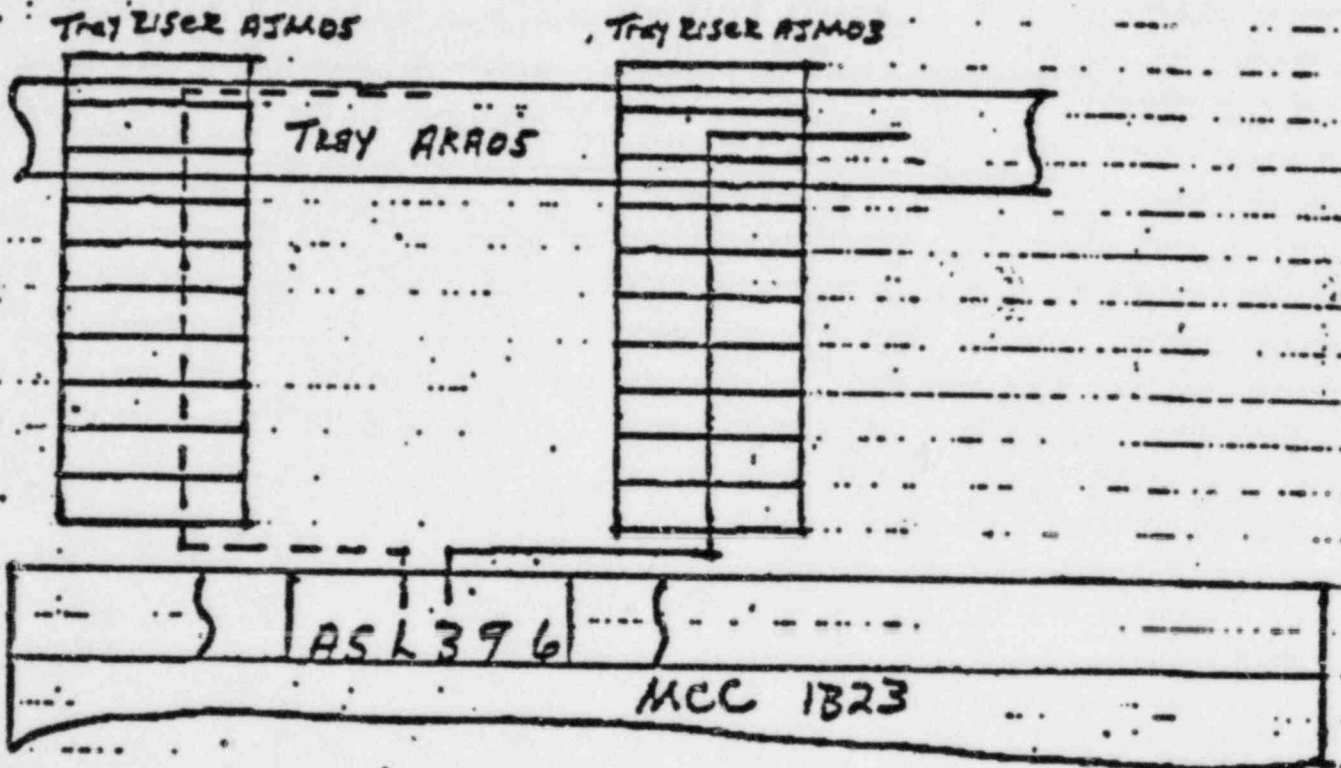
SK-11

Cable is Routed - by field

Cable should be - Per E-37

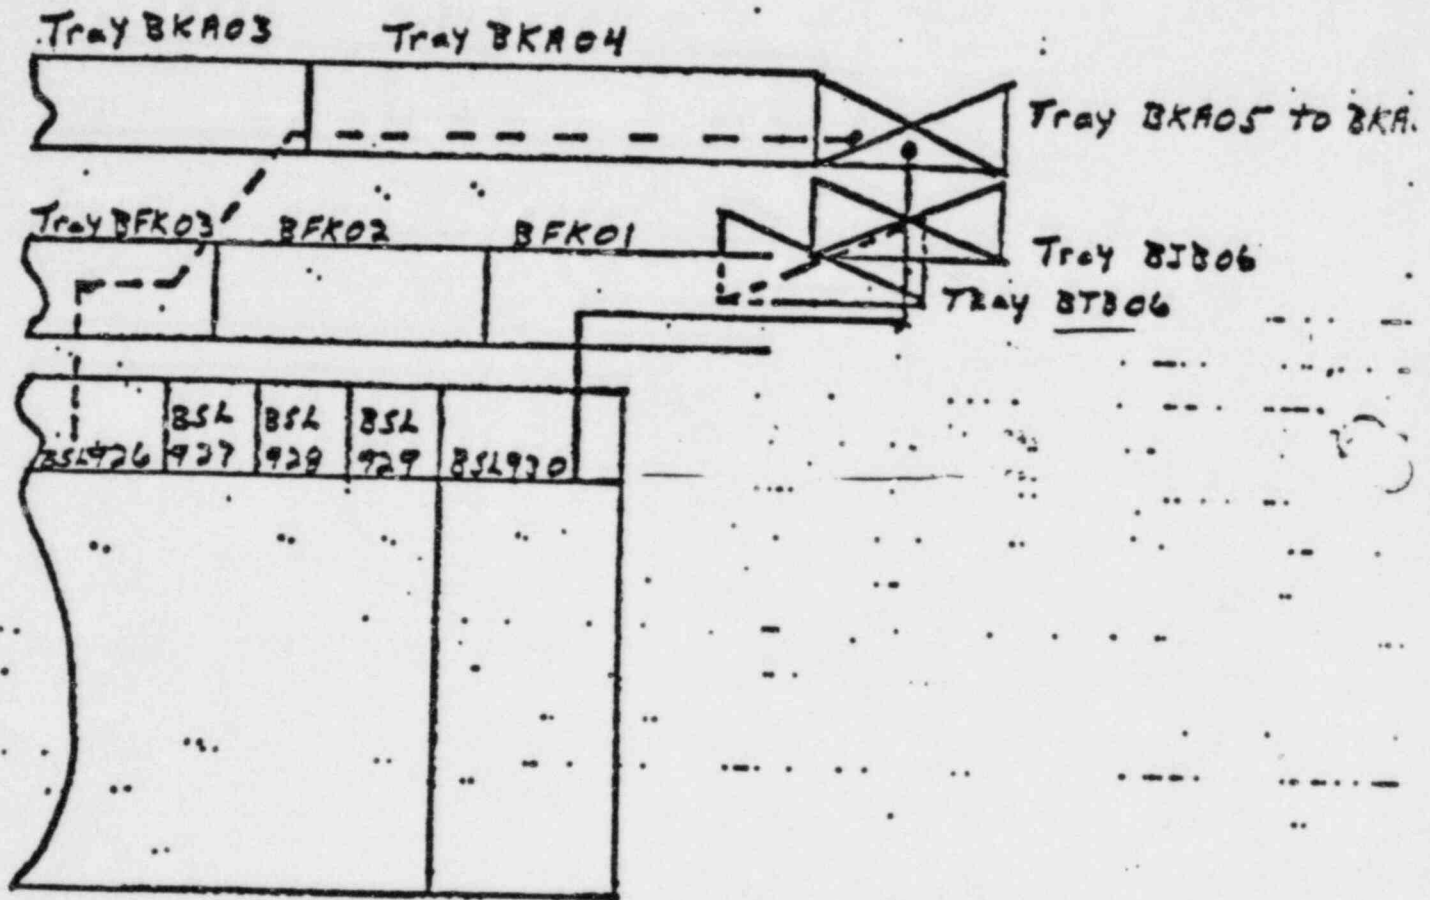
SK.12

Cable is Routed - by field

Cable should be - Per E37

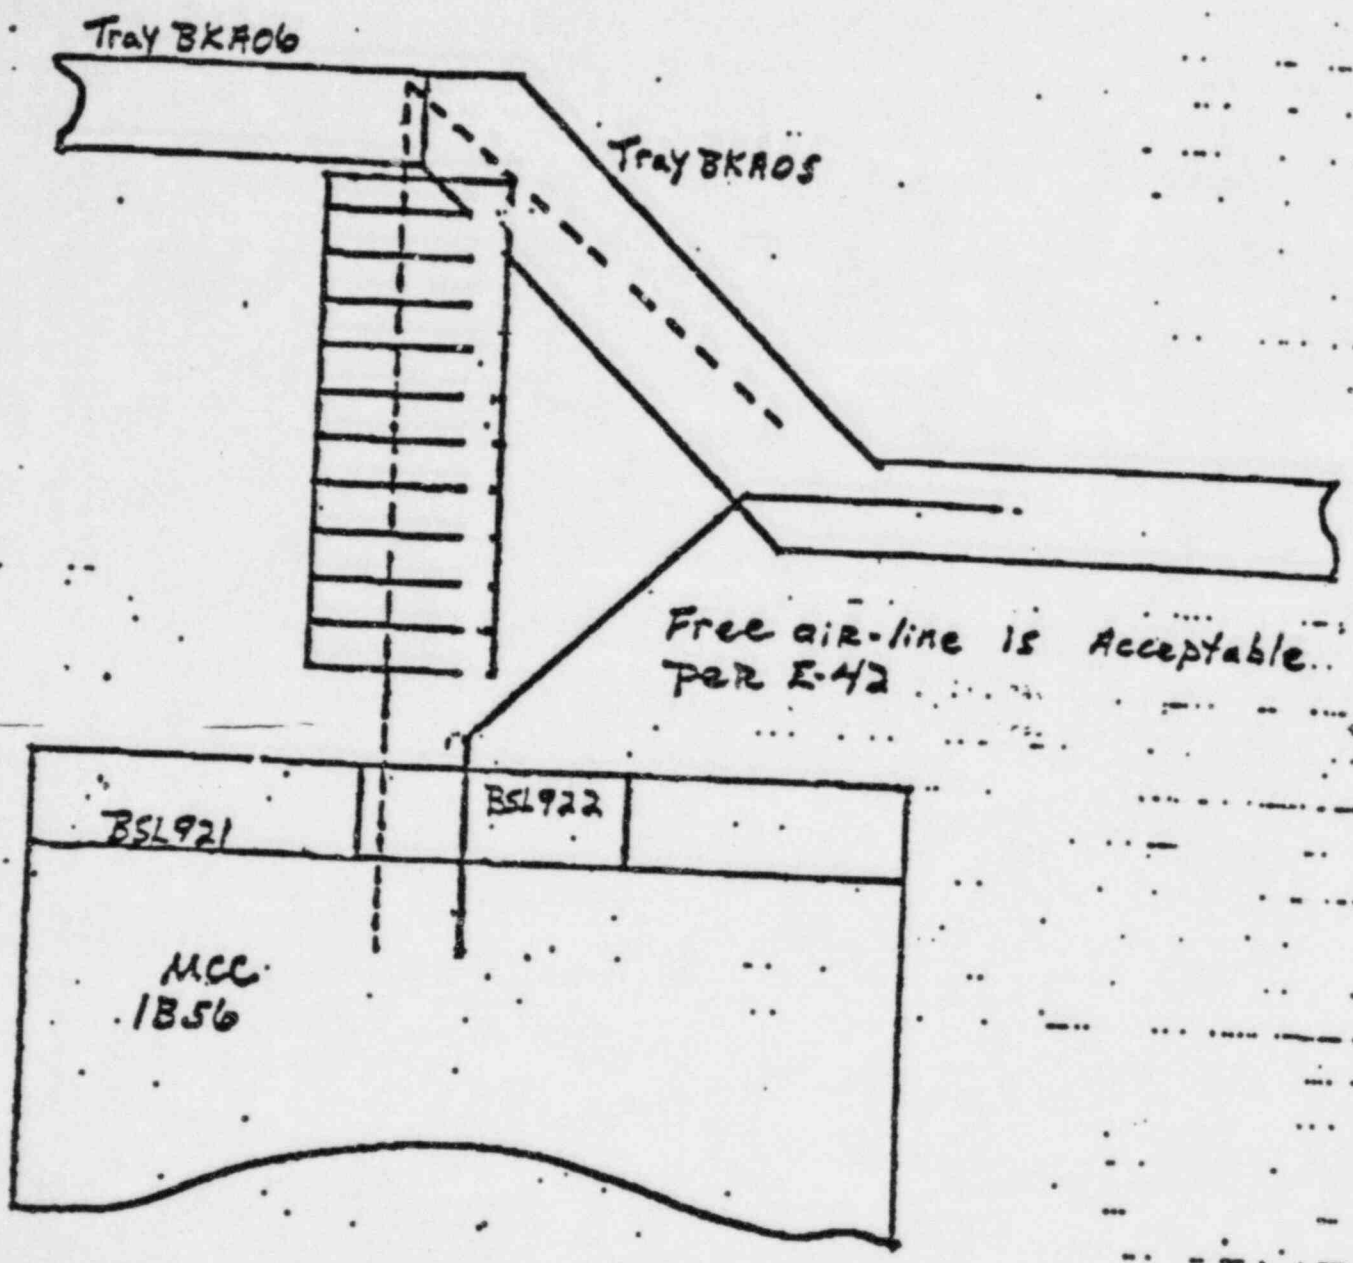
SK-13

————— cable is routed - by field  
----- cable should be - per E-37

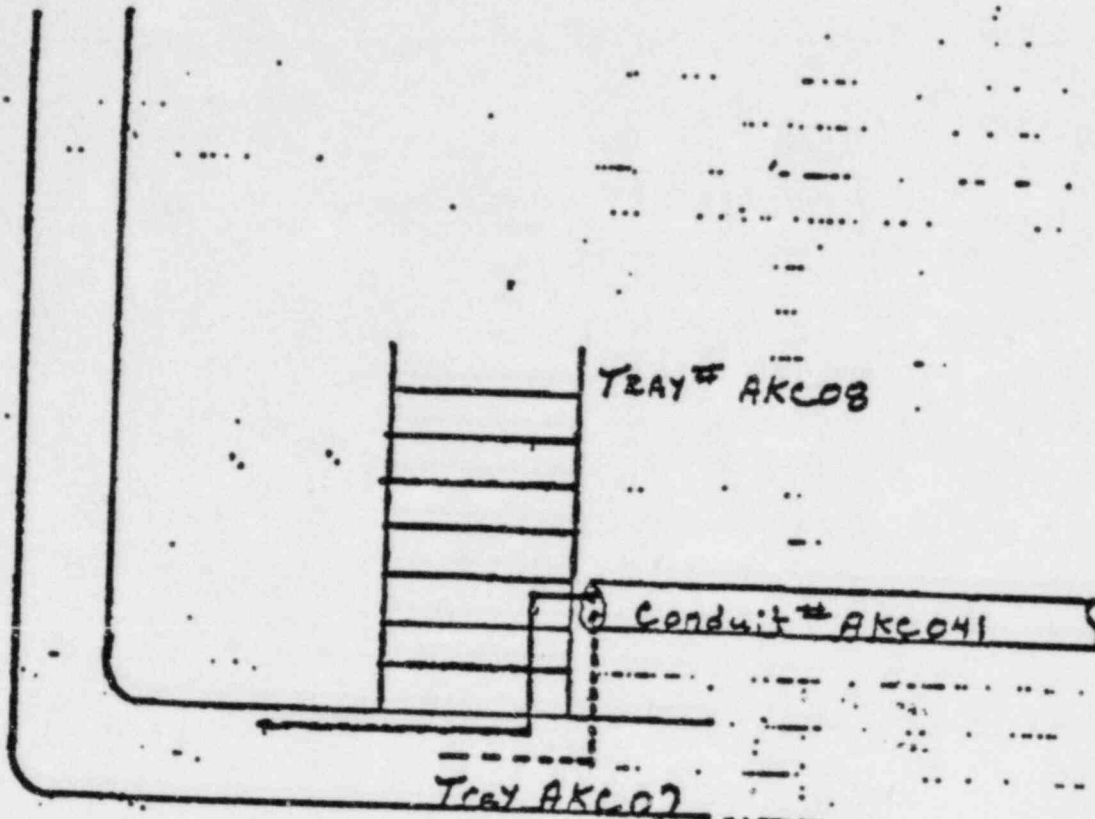
SK-14

———— Cable is routed - by field  
----- cable should be - PAR E-37

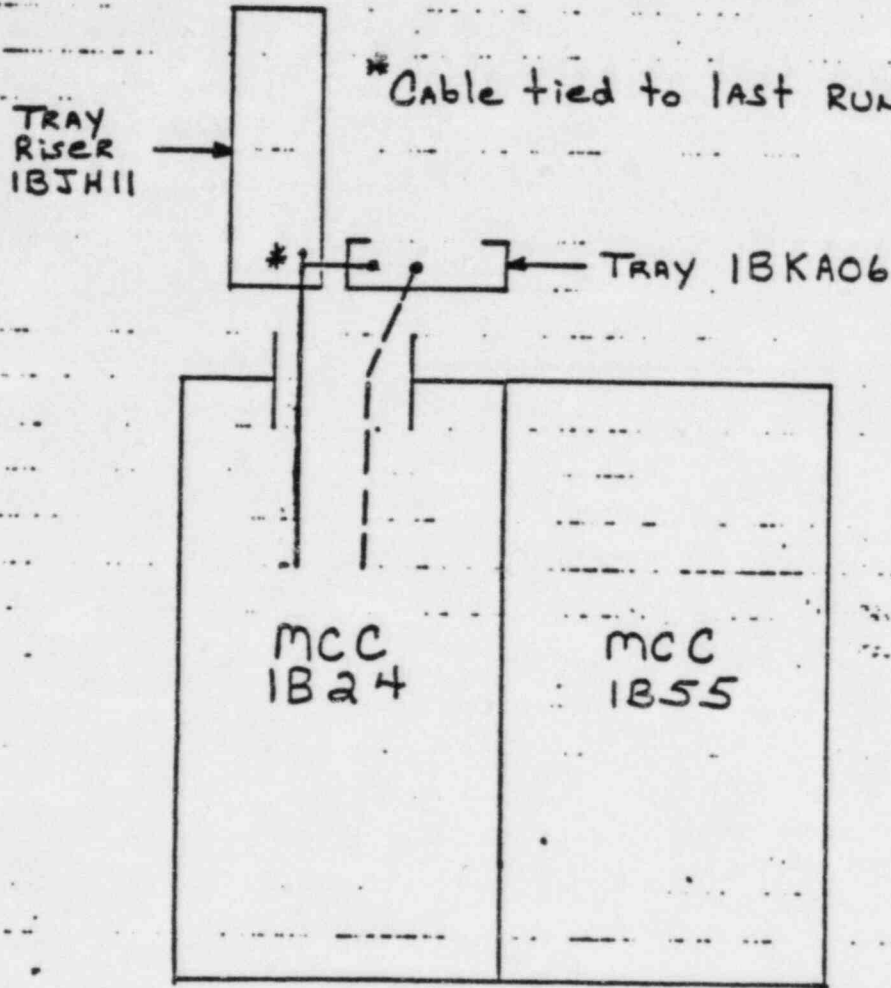
————— Actual cable route in field

----- Cable route per E-37

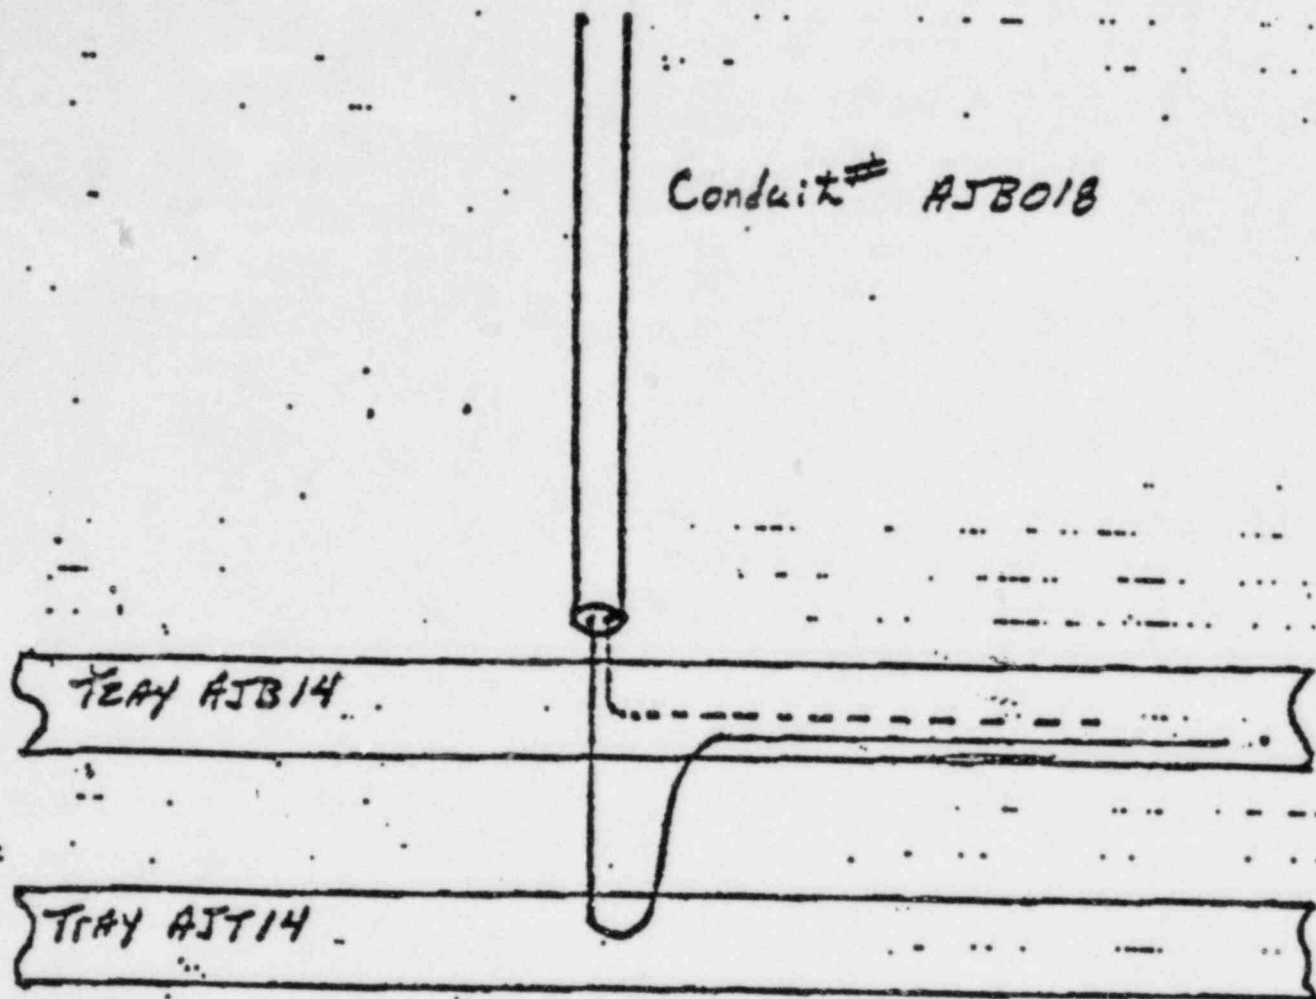
———— Cable is routed - by field.

----- Cable should be - Per E-37

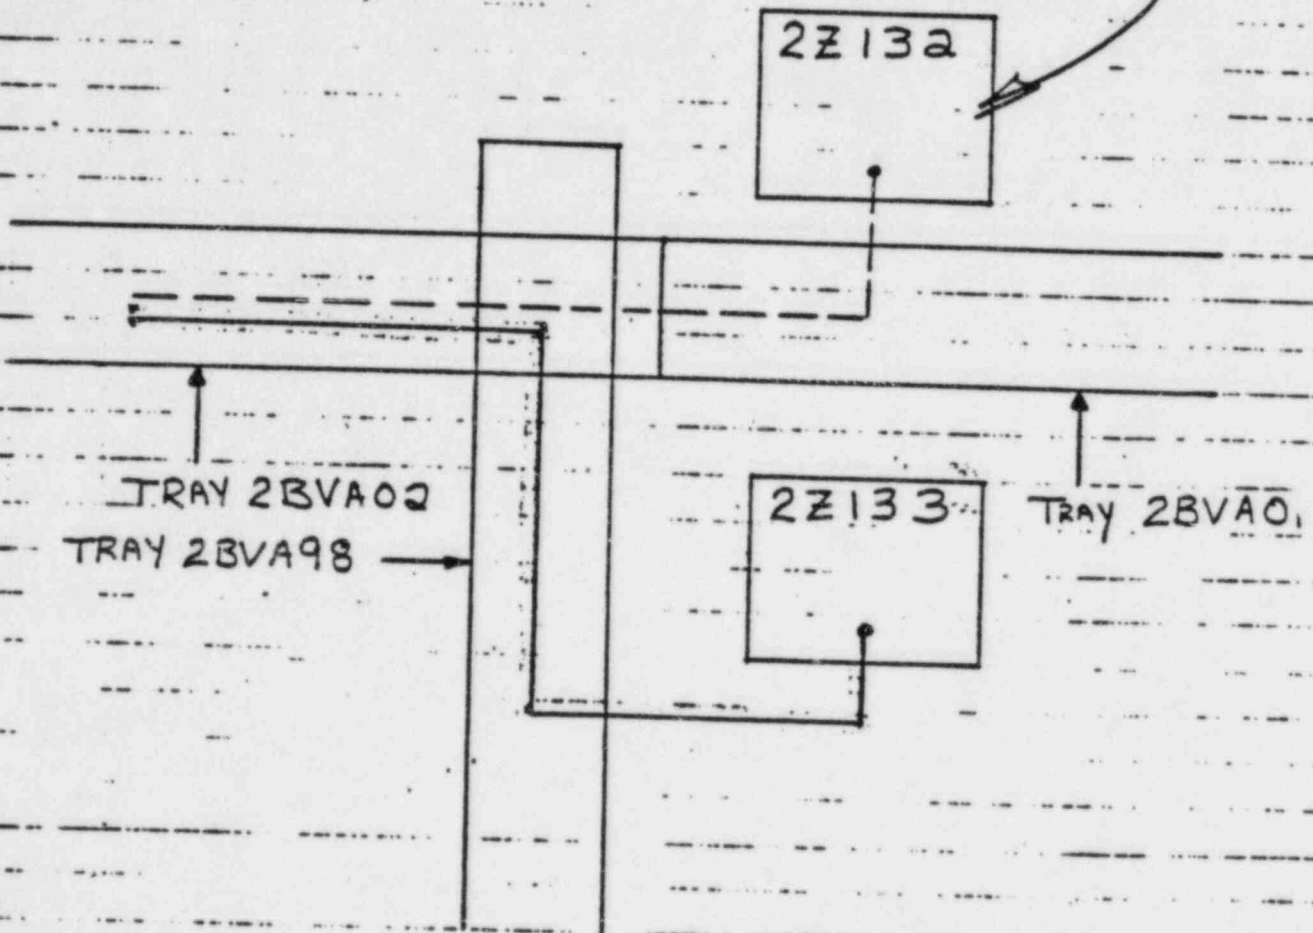
----- Cable route per E-37 -----

====> Actual Route of cable in field

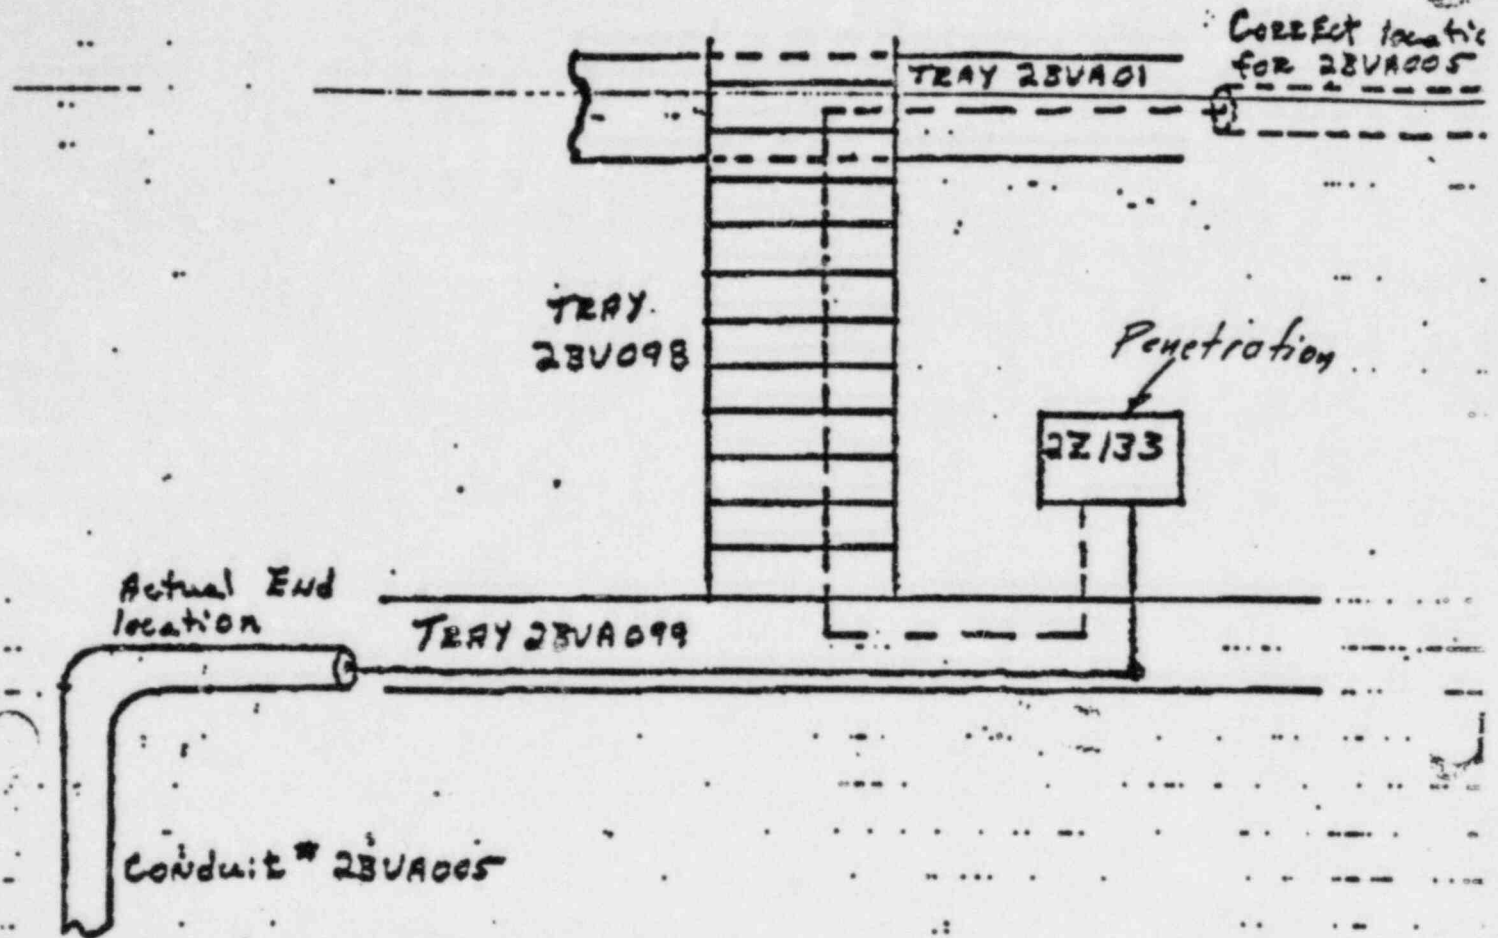
CONDUIT # 2BVA005 installed at incorrect. End. locat  
 should run to 2BVA01 ± 18" into adjoining tray section

Cables vias per E-37 ARE: BVA005 BVA01 BVA98 BVA99.

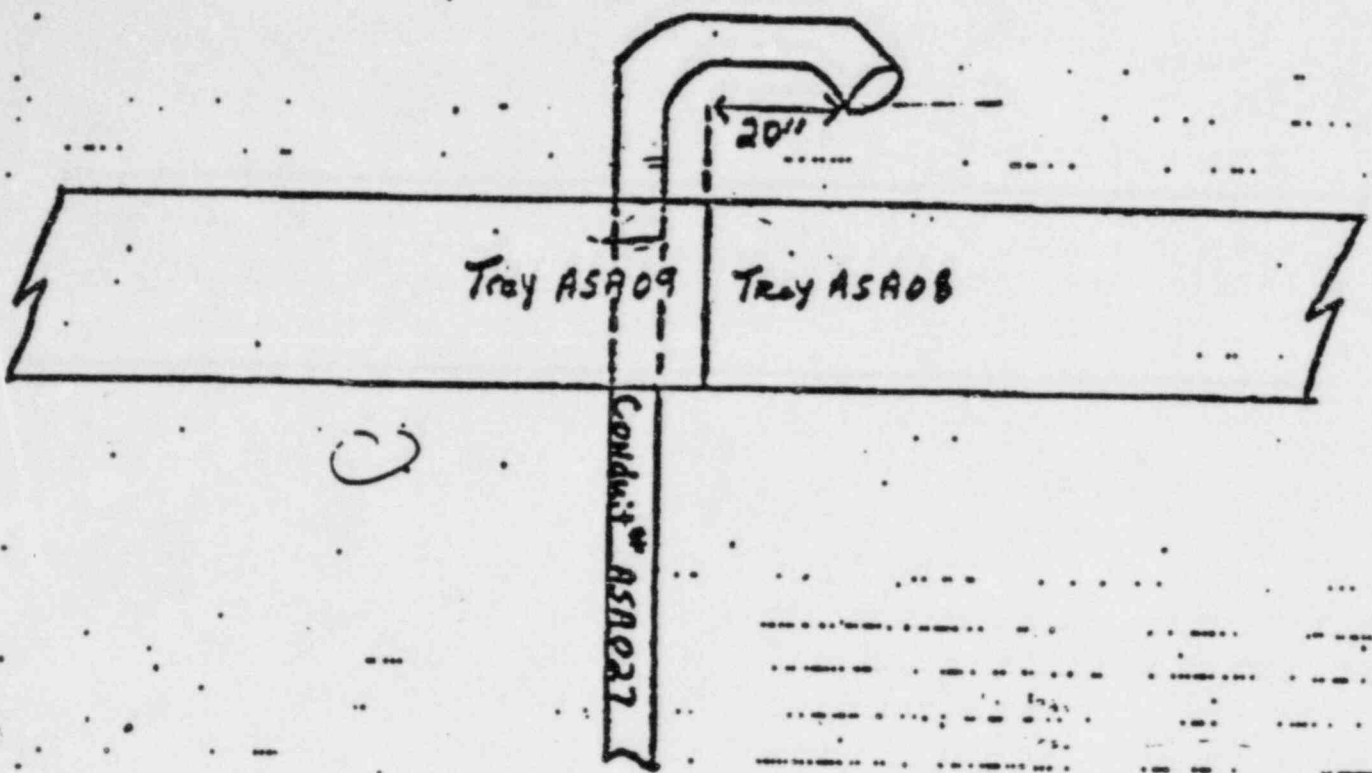
SK-19

CONDUIT # ASA027 installed at incorrect END location.  
Should run to ASA09 ± 18" into adjoining tray section.  
Cable vias per K-37 are: ASA027 ASA09 ASAOB  
Due to incorrect END location: ASA027 — ASAOB
