SUBJECT: NRR SALP III ASSESSMENT FOR MIDLAND PLANT, UNITS 1 & 2

FACILITY NAME: Midland Nuclear Plant, Units 1 and 2

LICENSEE: Consumers Power Company

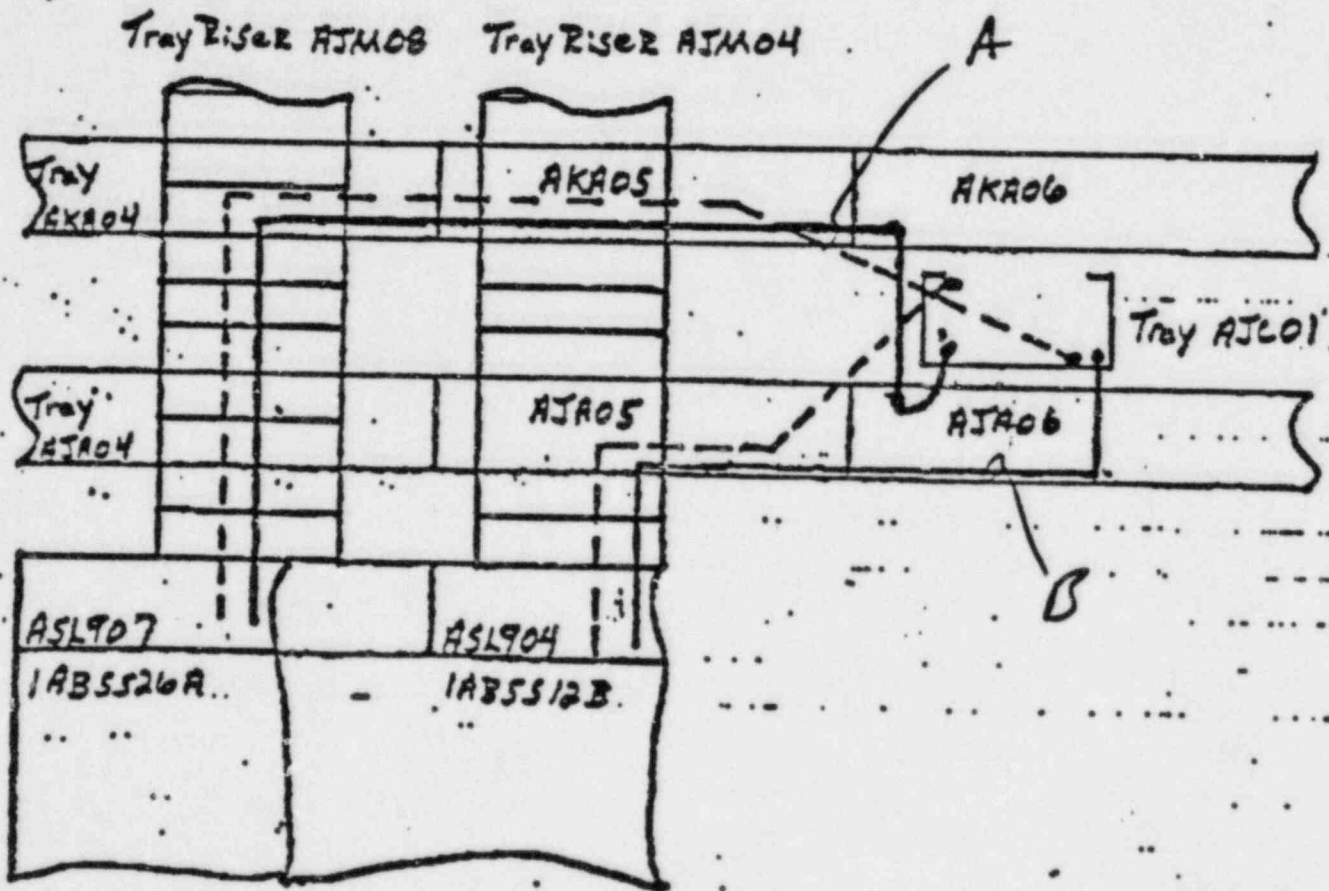
SK-20

———— Cable is routed - by field  
----- Cable should be - Per E-37

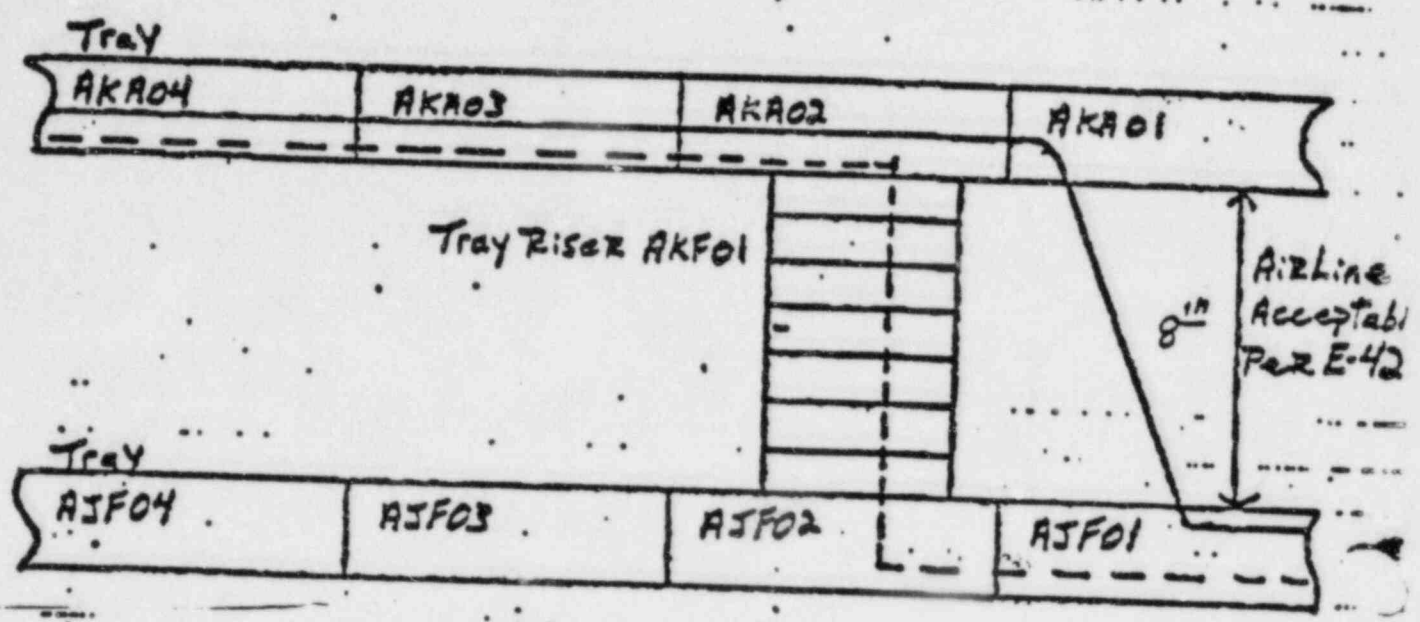
———— Cable is Routed - by field

- - - - - Cable should be - Per E-37

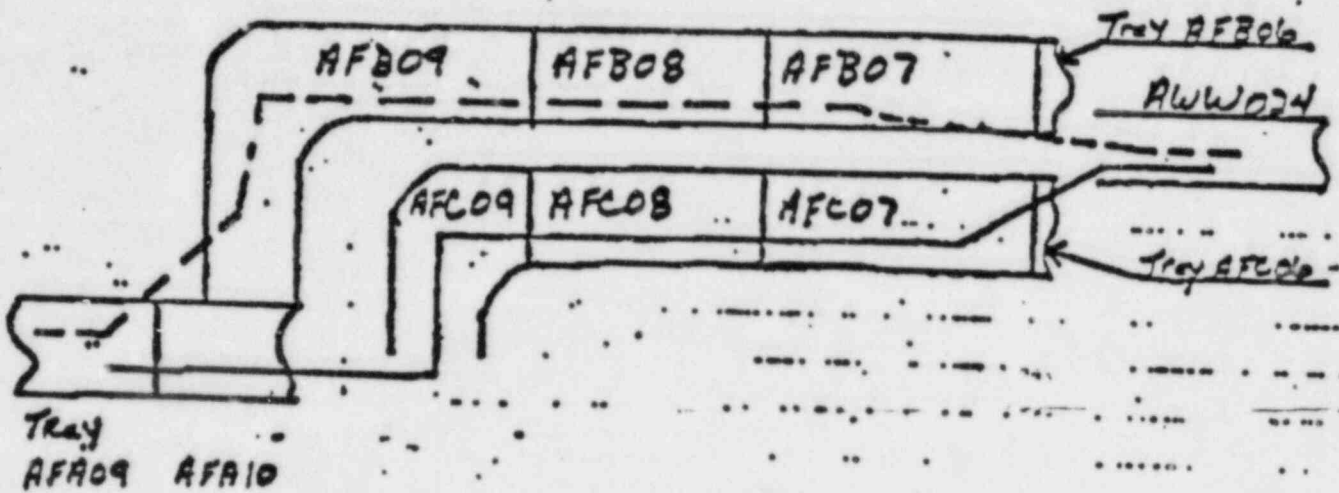
SK-23

Cable is routed - by field  
Cable should be - Per E-37

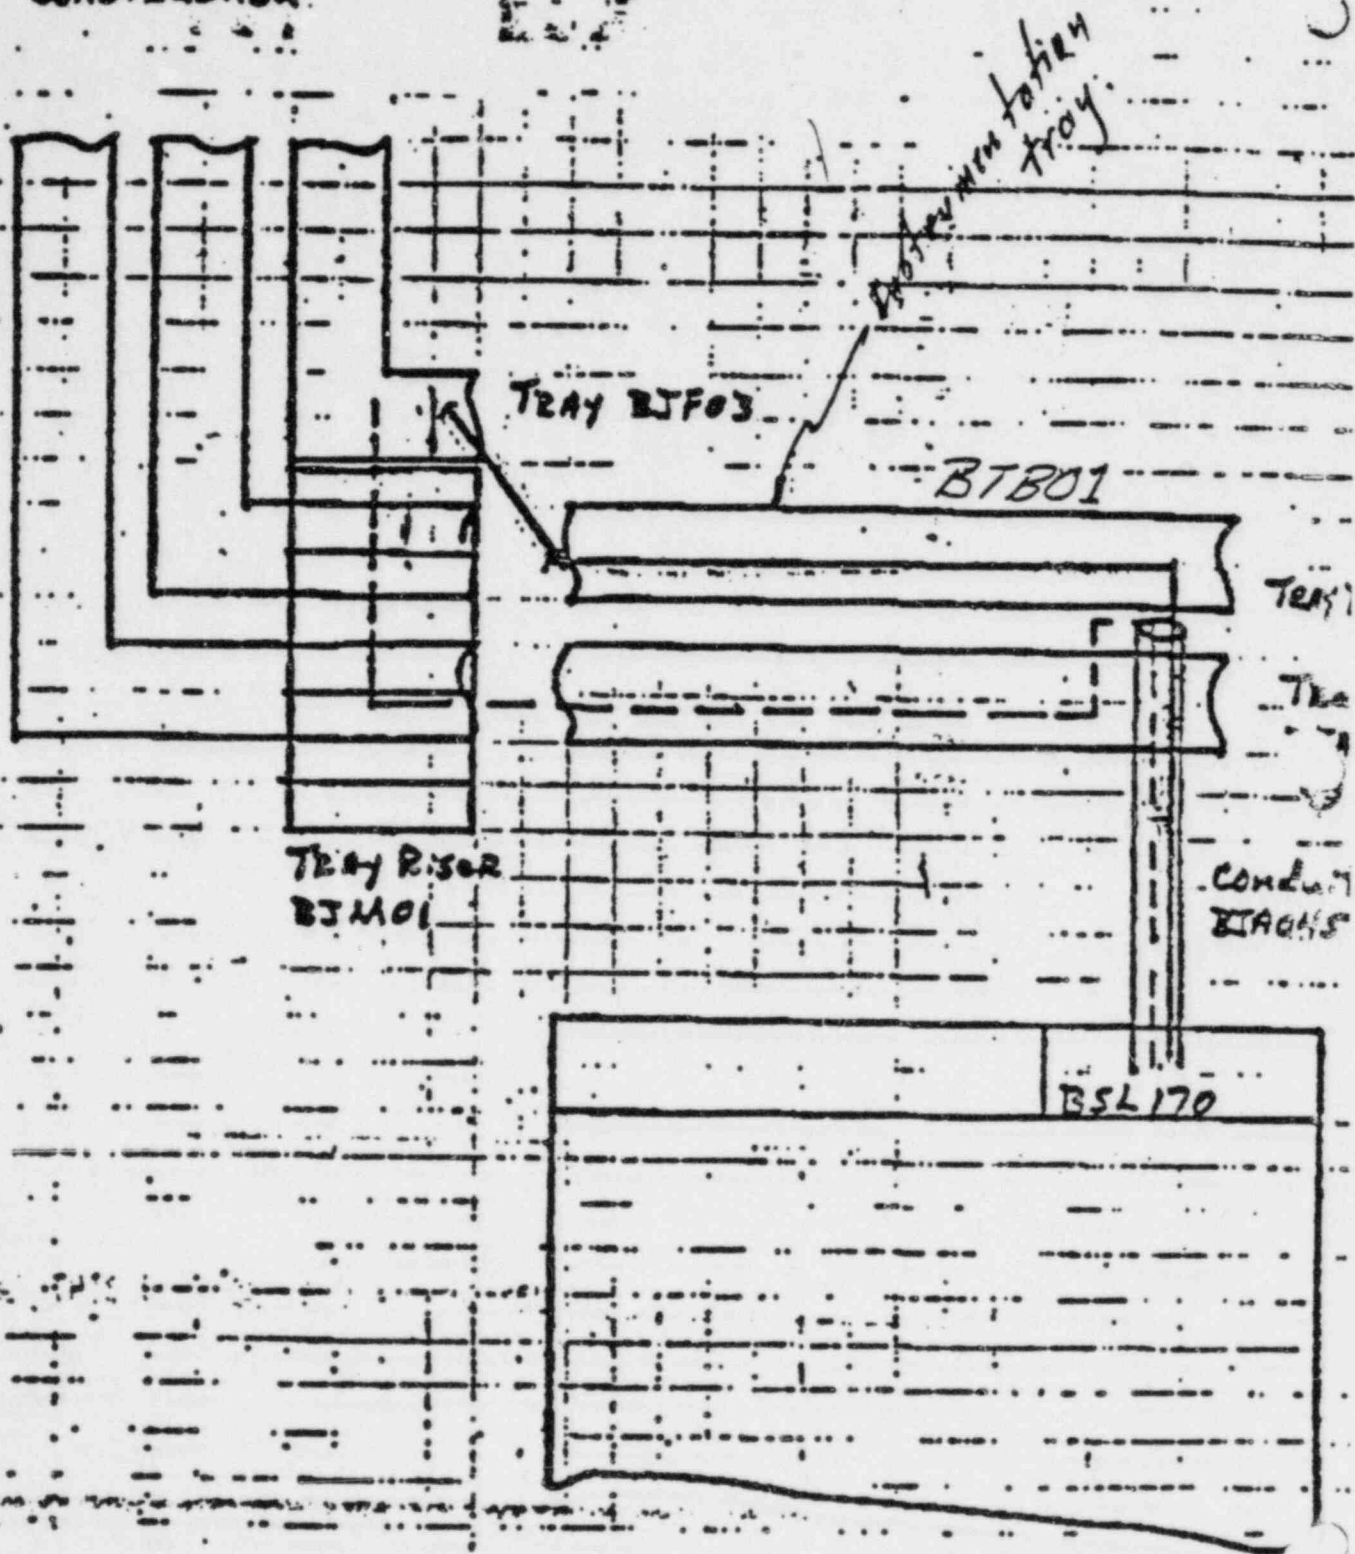
Cable is routed - by field

Cable should be - per E-37

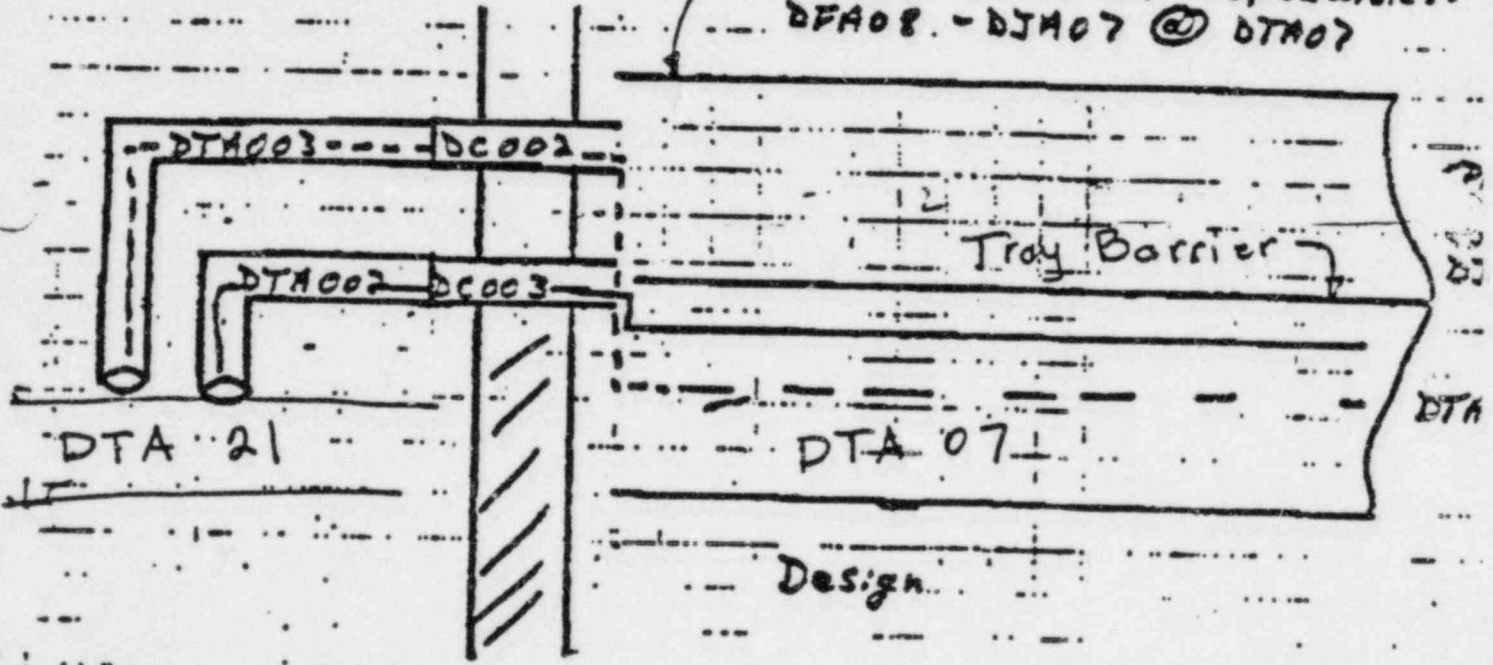
SK-25 Unique Case

Troy Construction  
CROSS OVER OF SEPARATORS.  
DFA08 - DJA07 @ DTA07

Cable routed by Field  
Cable should be per E-37

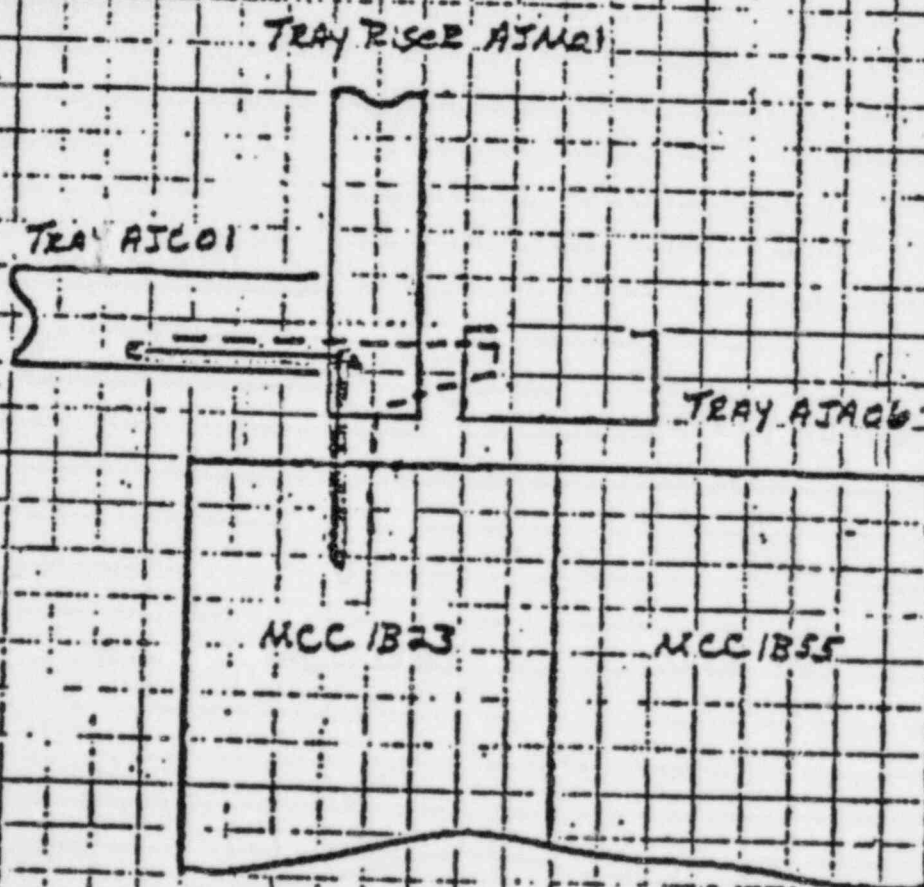
→ Cable is Routed - by field  
Cable should be - Per E-37
