SECY-92-131

For: The Commissioners  
From: James M. Taylor  
Exec 've Director for Operations  
Subject: REPLY TO COMMISSION'S QUESTIONS ON VOGTLE'S  
DIESEL GENERATORS AND ASSOCIATED INSTRUMENTATION

SUBJECT: POTENTIAL MALFUNCTIONS OF CALIFORNIA CONTROL COMPANY  
MODEL A3500 TEMPERATURE SENSORS

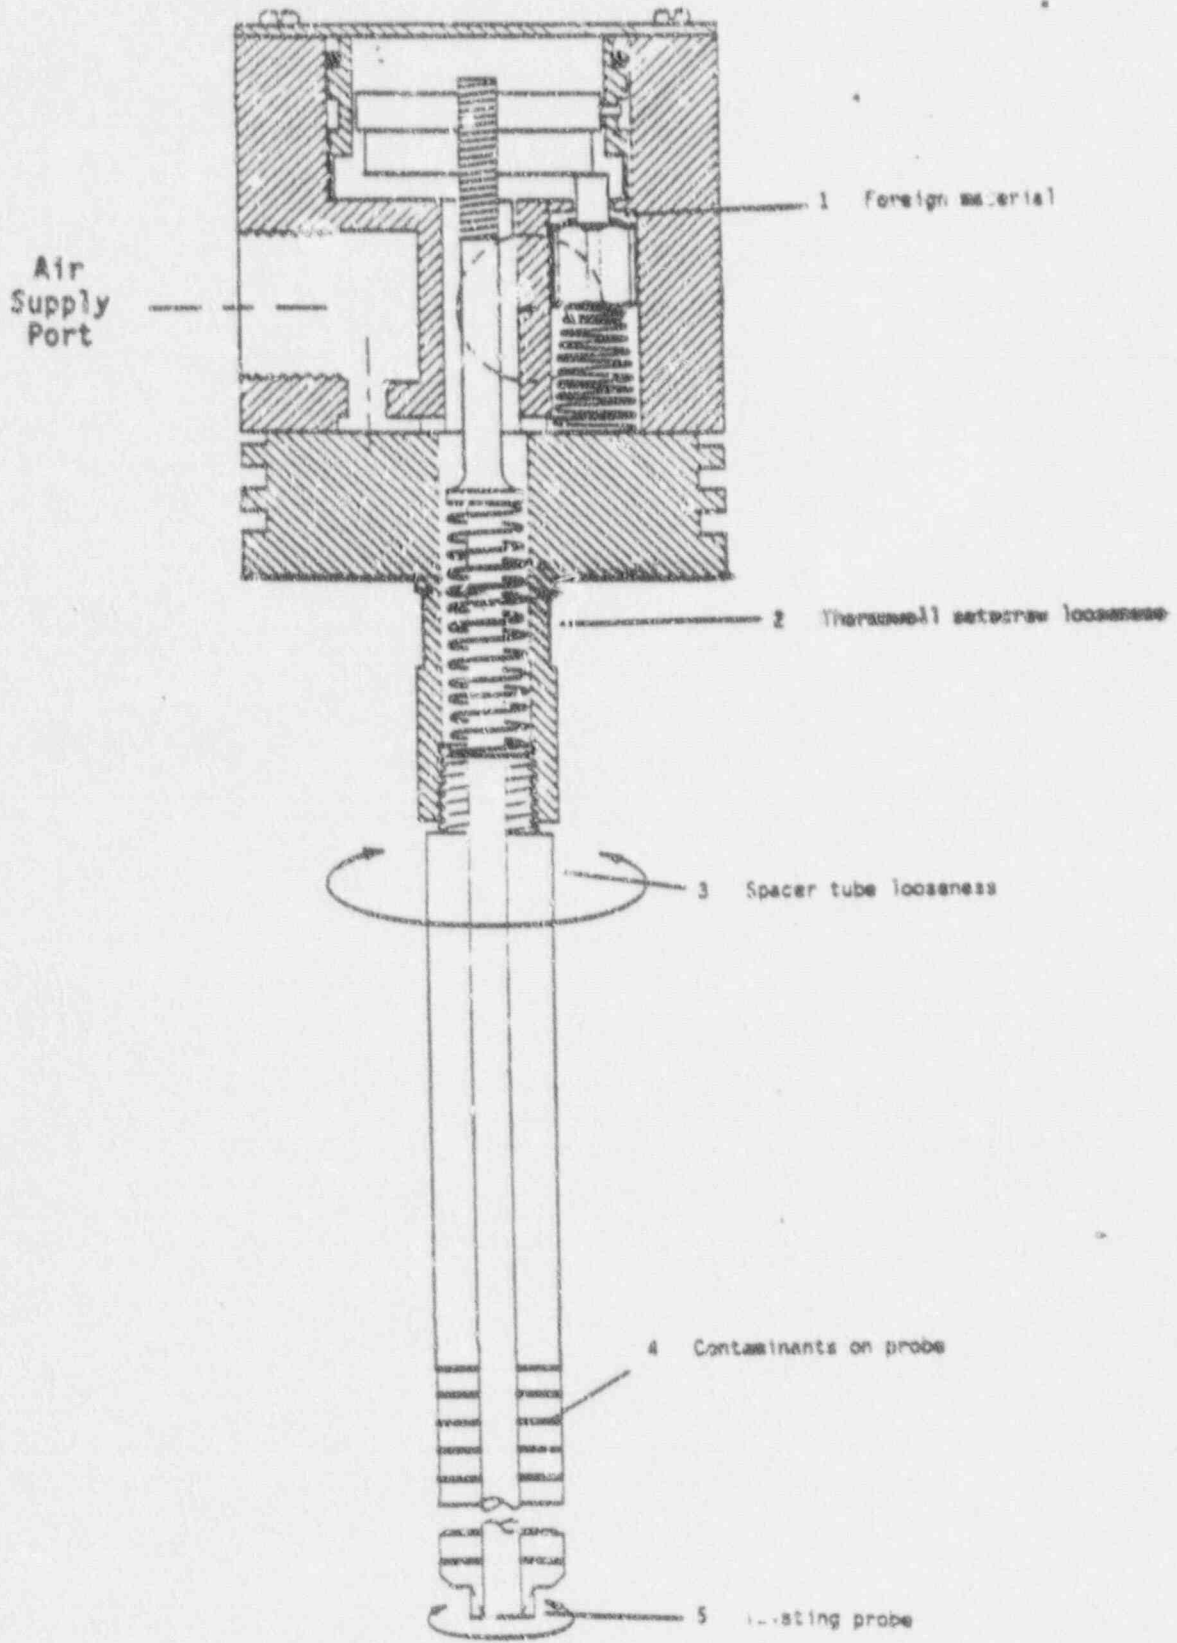
Figure 1. Schematic of a Calcon A3500 Temperature Sensor

A schematic showing the major components of a Calcon temperature sensor is shown in Figure 1. The temperature sensor is shown in the tripped state, without a thermowell and with a loose spacer tube.

1. Foreign material in the temperature sensor - During disassembly of leaking temperature sensors, Wyle discovered thread shavings (apparently from the air supply port threads) and excess thread sealant in the poppet seat region of the temperature sensor (Item 1 in Figure 1). The foreign material can prevent an air-tight seal between the poppet seat and the poppet head orifice, and thereby cause the temperature sensor to leak air and be placed in a tripped state. After Wyle cleaned the poppet seat and the air supply port they were able to properly calibrate the affected temperature sensors.

2. Thermowell setscrew tightness - The temperature sensor is secured in its thermowell with a setscrew (Item 2 in Figure 1). Wyle performed calibration checks with the setscrew loosened, and observed a 2°F increase in the trip temperature. This change is apparently caused by the resulting loss of hard contact between the temperature sensor and the thermowell, which decreases the heat transfer rate from the bath to the temperature sensor, and thereby delays the temperature sensor response to changing water temperatures.

3. Spacer tube position - The spacer tube is located between the probe and the body of the temperature sensor, and screws into the base of the temperature sensor body (Item 3 in Figure 1). Wyle tested the setpoint sensitivity to the looseness of the spacer tube and determined that the temperature sensor setpoint decreases approximately 80°F for each full turn that the spacer tube is loosened.

5. Handling of the temperature sensor probe - Twisting the temperature sensor probe (Item 5 in Figure 1) can affect the temperature sensor setpoint in much the same manner as turning the calibration disk the same number of turns in the opposite direction.

Wyle and Calcon recommend that licensees avoid the use of excessive thread sealant on the air supply swage-lock fitting, and that the temperature sensor threads in the air supply inlet be cleaned and deburred before installing the swage-lock fitting into the air supply port.

Wyle recommends performing calibrations with the thermowell setscrew tightened.

Wyle and Calcon recommend applying a thread-locking compound to the spacer tube threads to ensure that the spacer tube remains in its tightened position during for all calibrations, tests, and in-service use.

Calcon recommends that the temperature sensor be transported to and from the EDG in a thermowell, and not be removed from the thermowell except when necessary.
