VIRGINIA ELECTRIC AND POWER COMPANY
NORTH ANNA POWER STATION
P. O. BOX 402
MINERAL, VIRGINIA 23117

Report No. 50-338/92-008-00

LICENSEE EVENT REPORT (LER)

TITLE (4)
BOTH TRAINS OF "F" TRANSFER BUS UV INPUT TO AFW PUMP AUTO START LOGIC DEFEATED

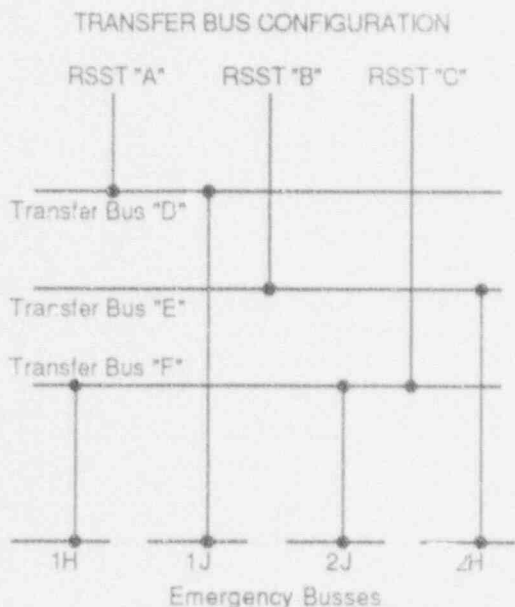
Figure 1

"F" Transfer Bus supplies Unit 1 H and Unit 2 J Emergency busses (Figure 1). Inputs from "F" Bus to the Station Blackout AFW pump auto start circuitry consist of four UV relays per unit. These inputs are divided into two trains of two relays each. For example: Unit 1 Train "A" AFW pump Station Blackout auto start circuit uses two series connected Train "A" relays on "F" Transfer Bus in series with two series connected Train "A" relays on "D" Transfer bus (Figure 2). Train "B" is similar with separate relays, as is Unit 2 which utilizes "E" and "F" Transfer Bus Relays. In all cases, Removal of one or more relays in a train will defeat that train of Station Blackout protection.

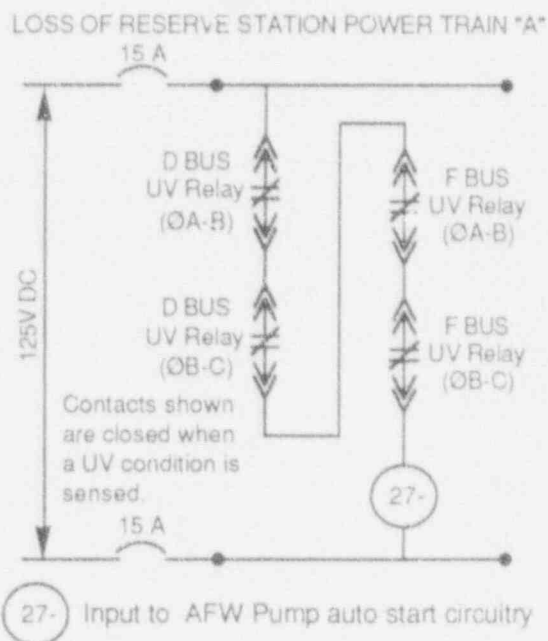
Figure 2

EMP-P-RT-85A directed that the four "F" Transfer Bus Station Blackout UV relays on the unit being tested be removed simultaneously. The procedure did not indicate that removal of the four F Transfer Bus relays on the operating unit (Unit 1) would defeat both trains of Station Blackout

protection circuitry and cause the AFW pump UV auto start feature to be inoperable. Therefore, during EMP-P-RT-85A testing on March 19, 1992, both trains of Unit 1 Station Blackout protection AFW pump Station Blackout auto start logic were inoperable which resulted in a violation of TS CO 3.3.2.1 Table 3.3-3 Item 6e.

A revision to EMP-P-RT-85A was submitted which adds detail to the Initial Conditions and Instructions sections. The revised procedure specifies that only one train of Transfer Bus "F" relays will be tested at a time, and it provides instructions to install jumpers which effectively place the applicable circuit in a trap condition while UV relays are removed from the circuit and tested.
