LIMERICK GENERATING STATION

SUBJECT: Licensee Event Report  
Limerick Generating Station - Unit 1

Reference:	Docket No. 50-352
Report Number:	1-92-004
Revision Number:	00
Event Date:	March 21, 1992
Report Date:	April 16, 1992
Facility:	Limerick Generating Station P.O. Box 2300, Sanatoga, PA 19464-2300

TITLE (4) Loss of Reactor Enclosure Secondary containment Integrity due to a Reactor Enclosure Overpressurization Transient causing a blowout panel to open.

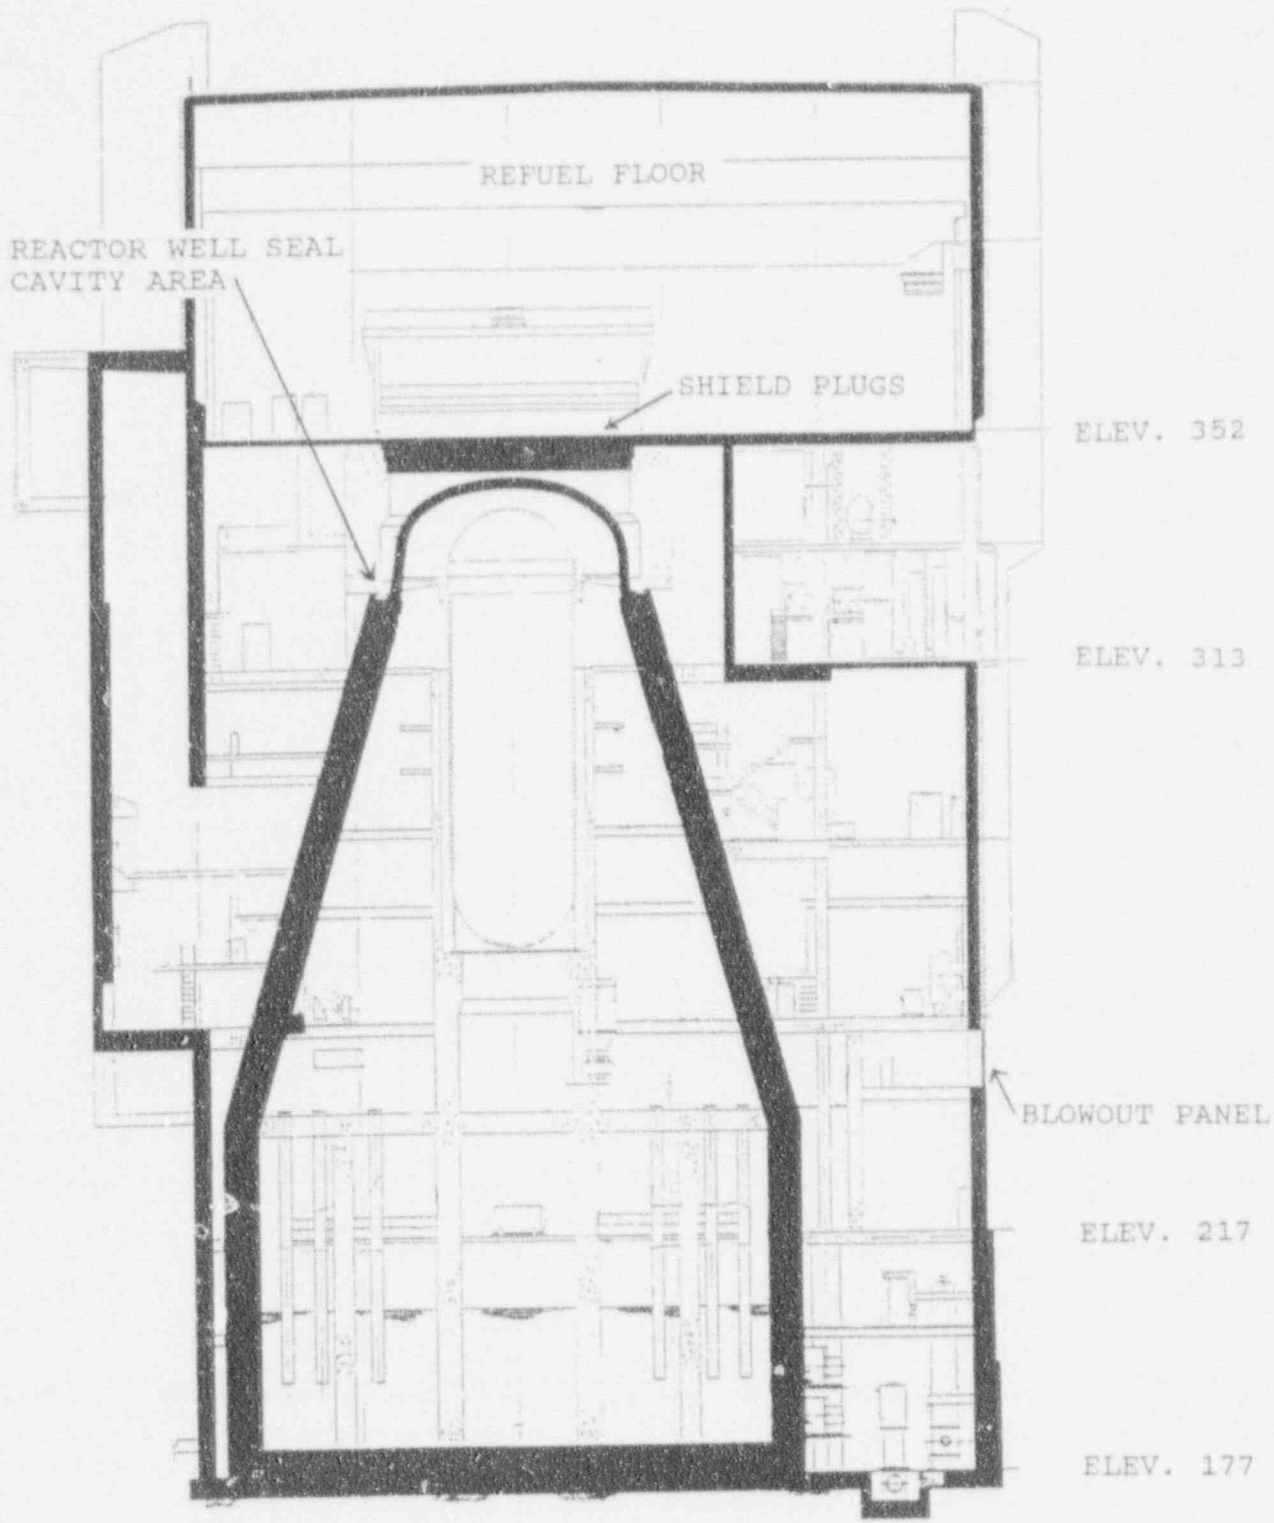
UNIT 1 REACTOR ENCLOSURE  
FIGURE 1

One event that occurred following the failure of the supply air fan to trip was the actuation of the blowout panel in the Unit 1 Safeguard System Access Area (see Figure 1). The blowout panel opened as designed, and therefore this was not an equipment malfunction. This was identified by operations personnel at 1945 hours. MCR Operations personnel notified Maintenance personnel to re-install the blowout panel. MCR personnel also notified Health Physics (HP) personnel to monitor the blowout panel penetration for contamination. Air sample and survey results taken from the blowout panel area indicated no detectable level of contamination.
