April 14, 1992

Subject: Arkansas Nuclear One - Unit 1
Docket No. 50-313
License No. DPR-5.
Special Report - Once Through Steam Generator
Tubing Surveillance - Category C-3 Results

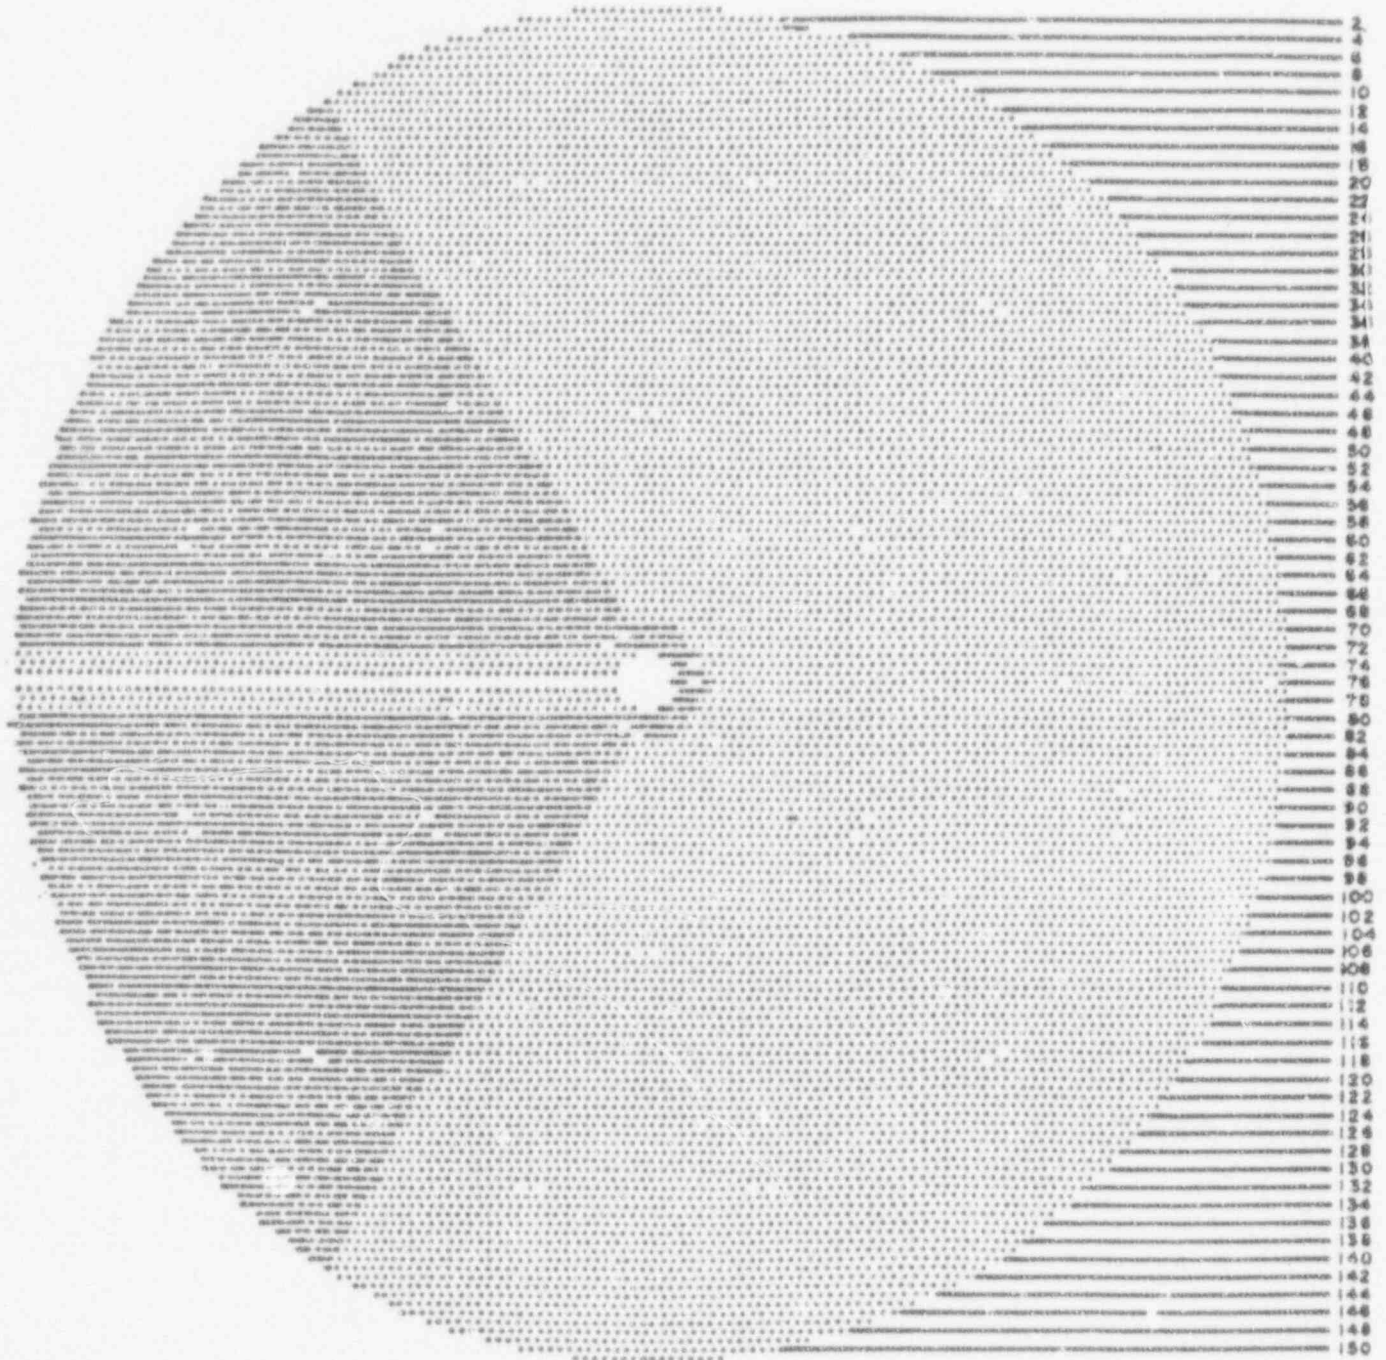
Upper Tube Sheet View of Wedge Shaped Group (Group A-3) per Specification 4.18.3.a.3

Figure 1 provides an upper tube sheet view which identifies the A-1 and A-3 groups. The A-1 group is the three rows on either side of the open inspection lane (row 76) from the periphery to the center of the OTSG. The A-2 group is defined by ANO-1 Technical Specifications as all unplugged tubes with sleeves installed. Group A-3, or the wedge group from the 15th tube support plate and up, is immediately adjacent to the A-1 group.

GROUP A - 1: Lane region
tubes as defined in
4.18.3.a.3(1)

GROUP A - 3: Wedge shaped
group depicted by darkened
region of figure

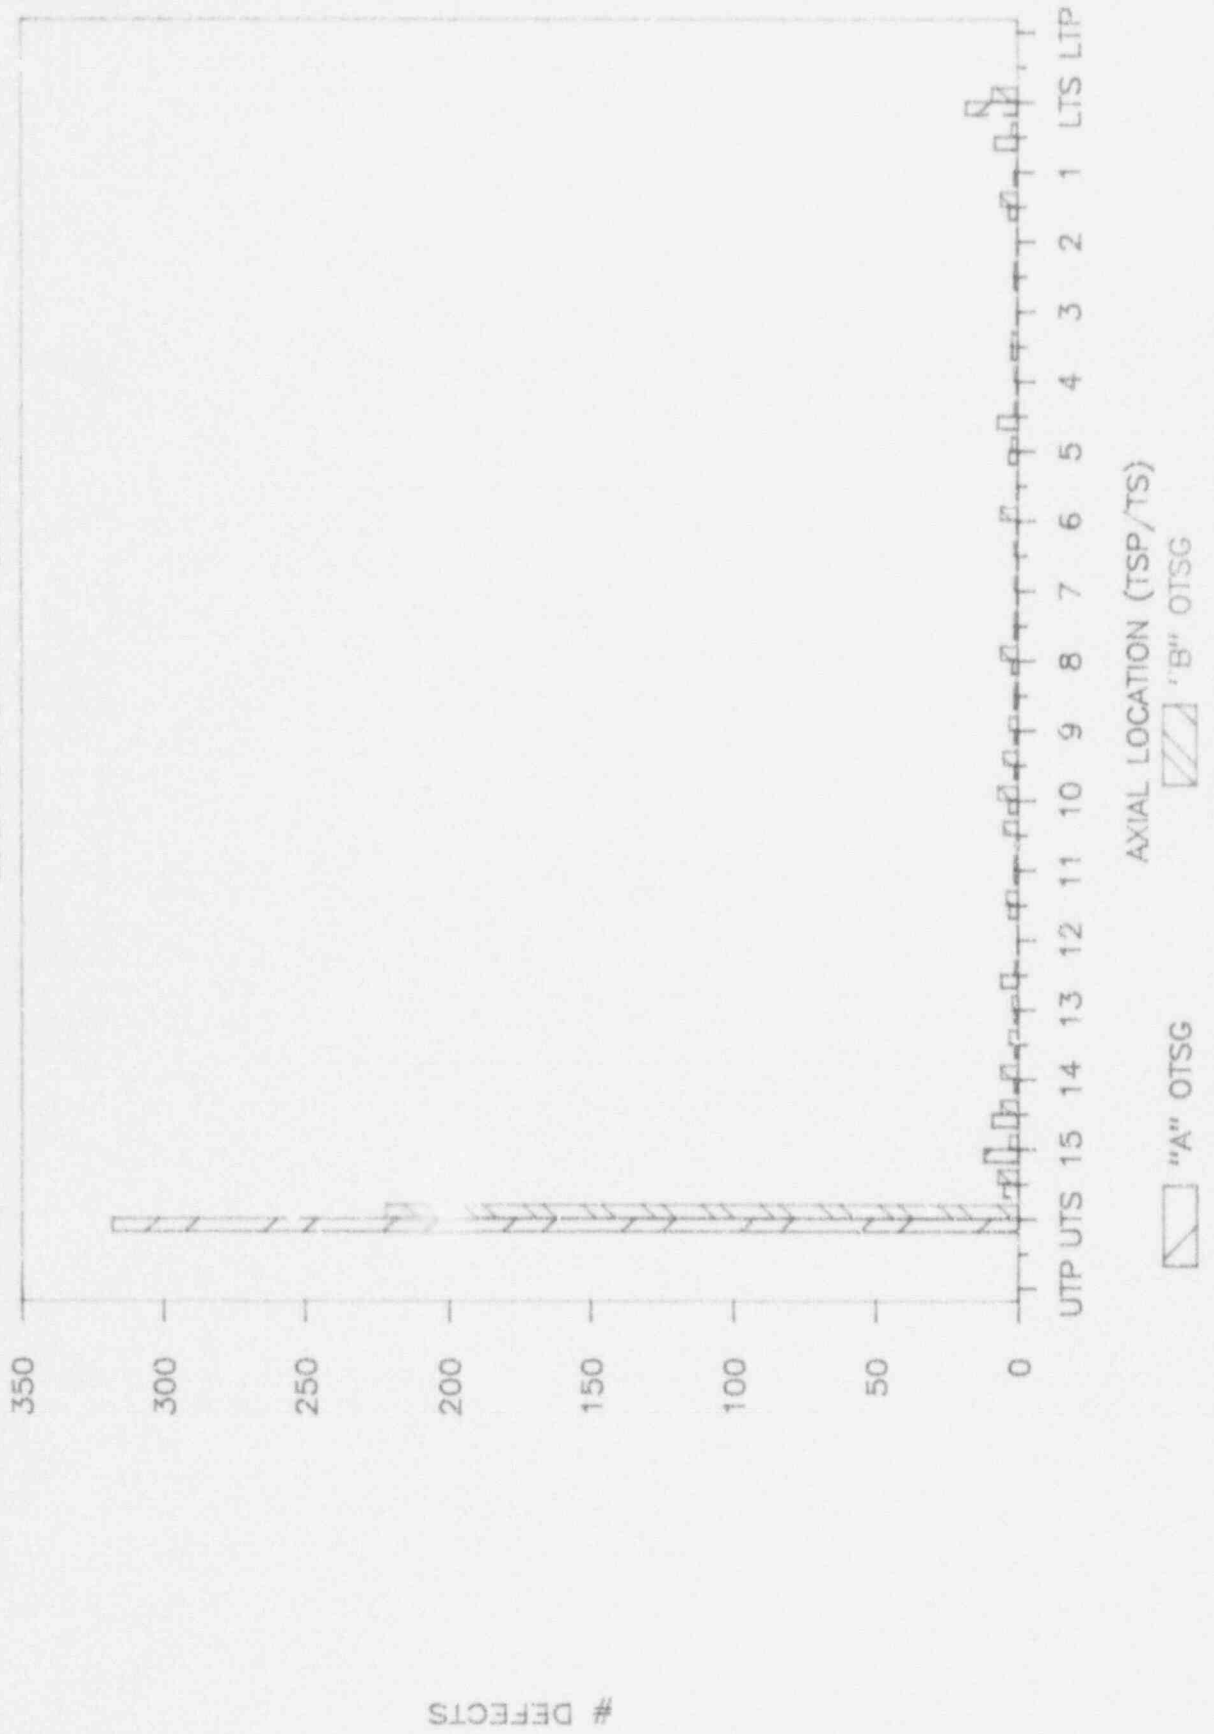
FIGURE 2

The defects in both OTSGs were primarily located above the 15th tube support plate with a significant fraction located within the upper tube sheet or at the face. Figure 2 depicts the axial locations of the defects identified during this inspection for the "A" and "B" OTSGs. Figure 3 depicts the axial location of reportable (>20% throughwall) indications identified during the 1R6 through 1R9 inspections for the "A" and "B" OTSGs. The distribution of the defects across the bundle identified during the current outage is shown in Figures 4, 5, 6, and 7 for the "A" and "B" OTSGs. The cumulative results for all previous indications are shown in Figures 8 and 9. Comparing the previous inspection results to those obtained during this outage shows similar distribution of defect locations both axially and across the bundle.

LOCATION OF 1R10 DEFECTS

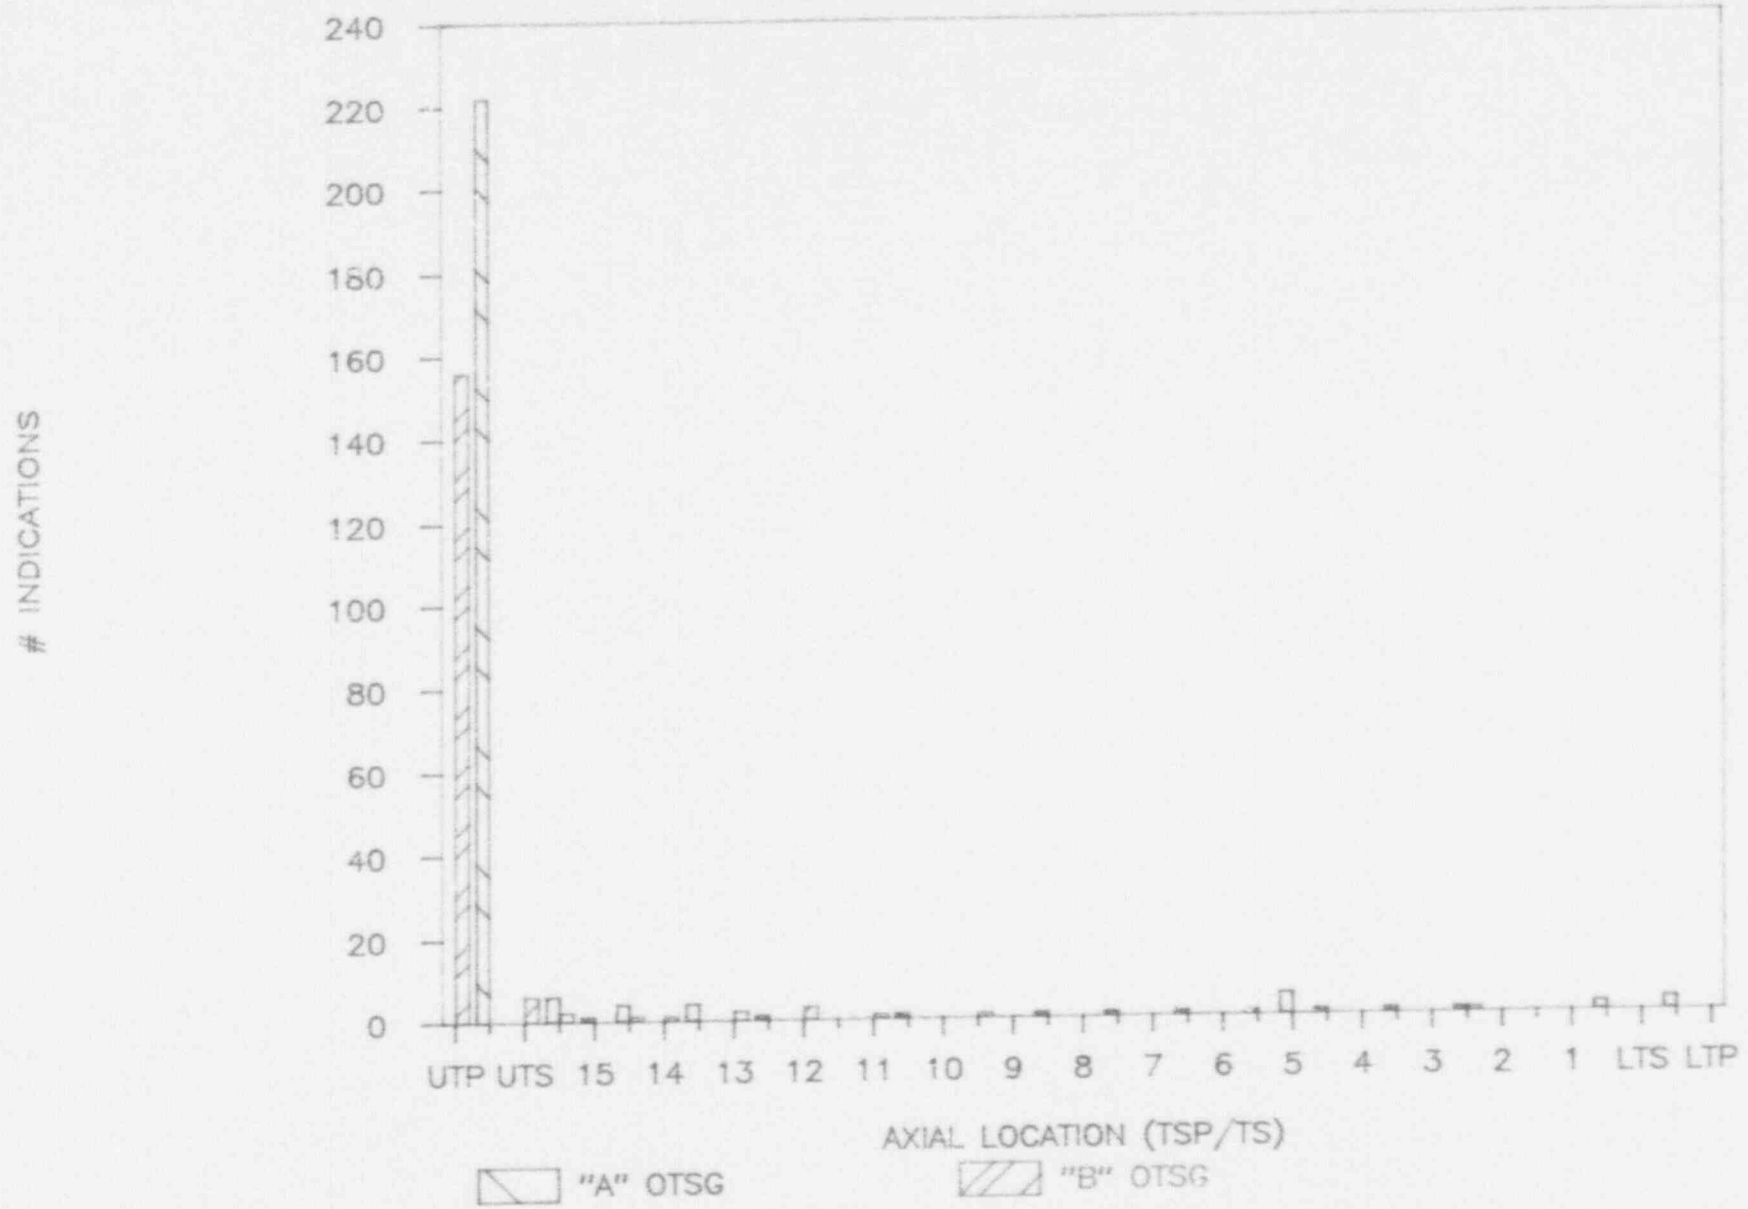
FIGURE 3

LOCATION OF 1R5-1R9 INDICATIONS

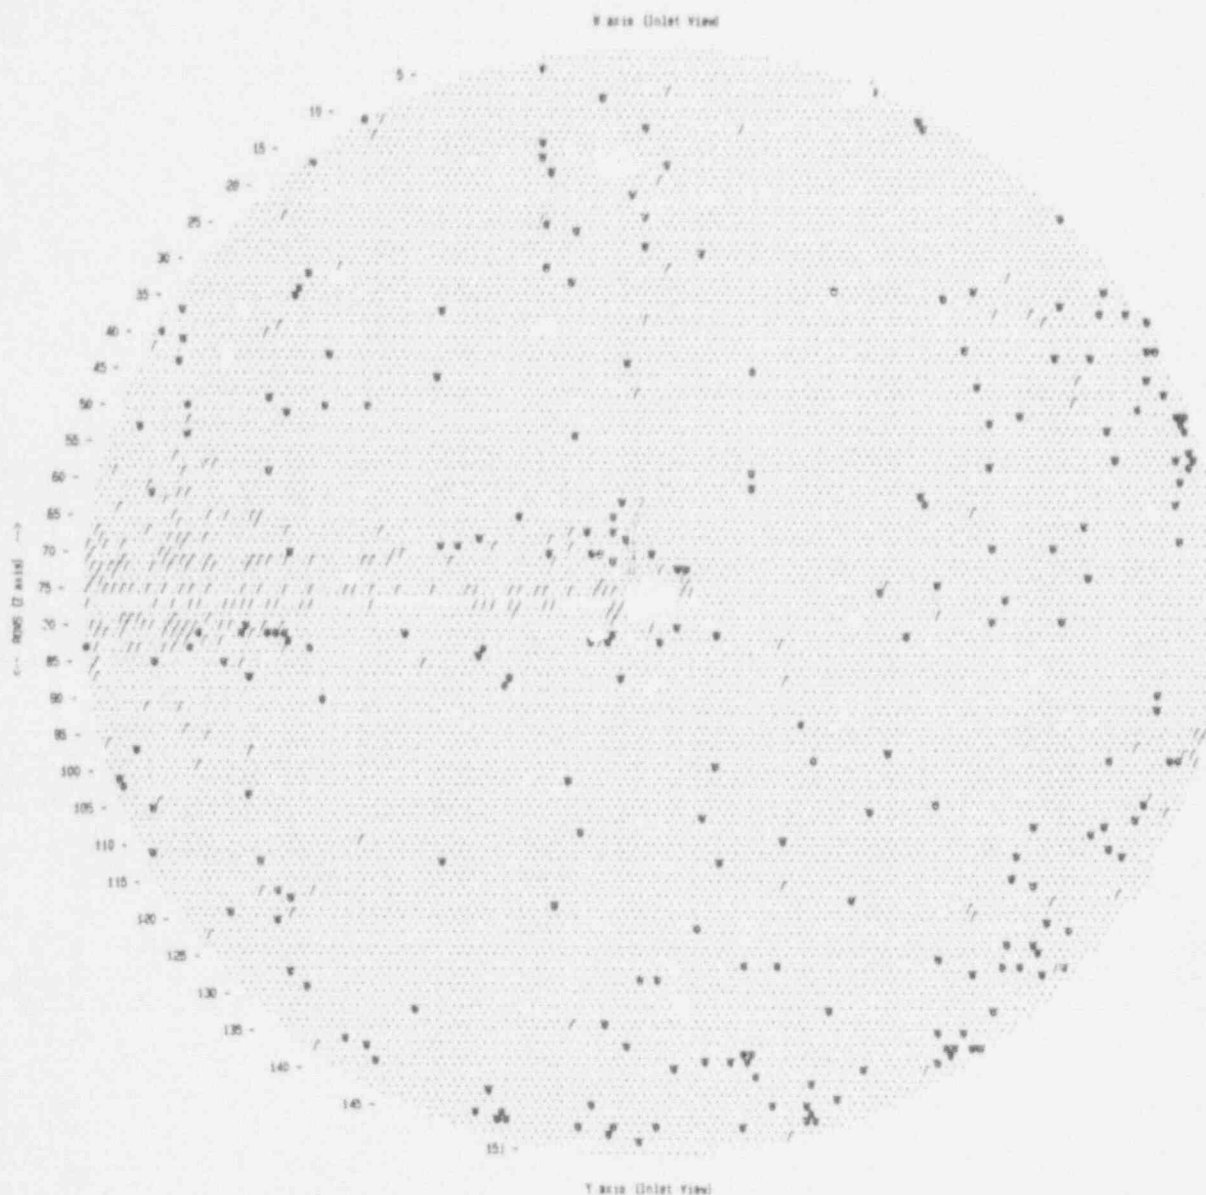
FIGURE 4

TUBES TO BE PLUGGED DURING 03/92 RFO

● = TUBES TO BE PLUGGED DURING 1910 (234)

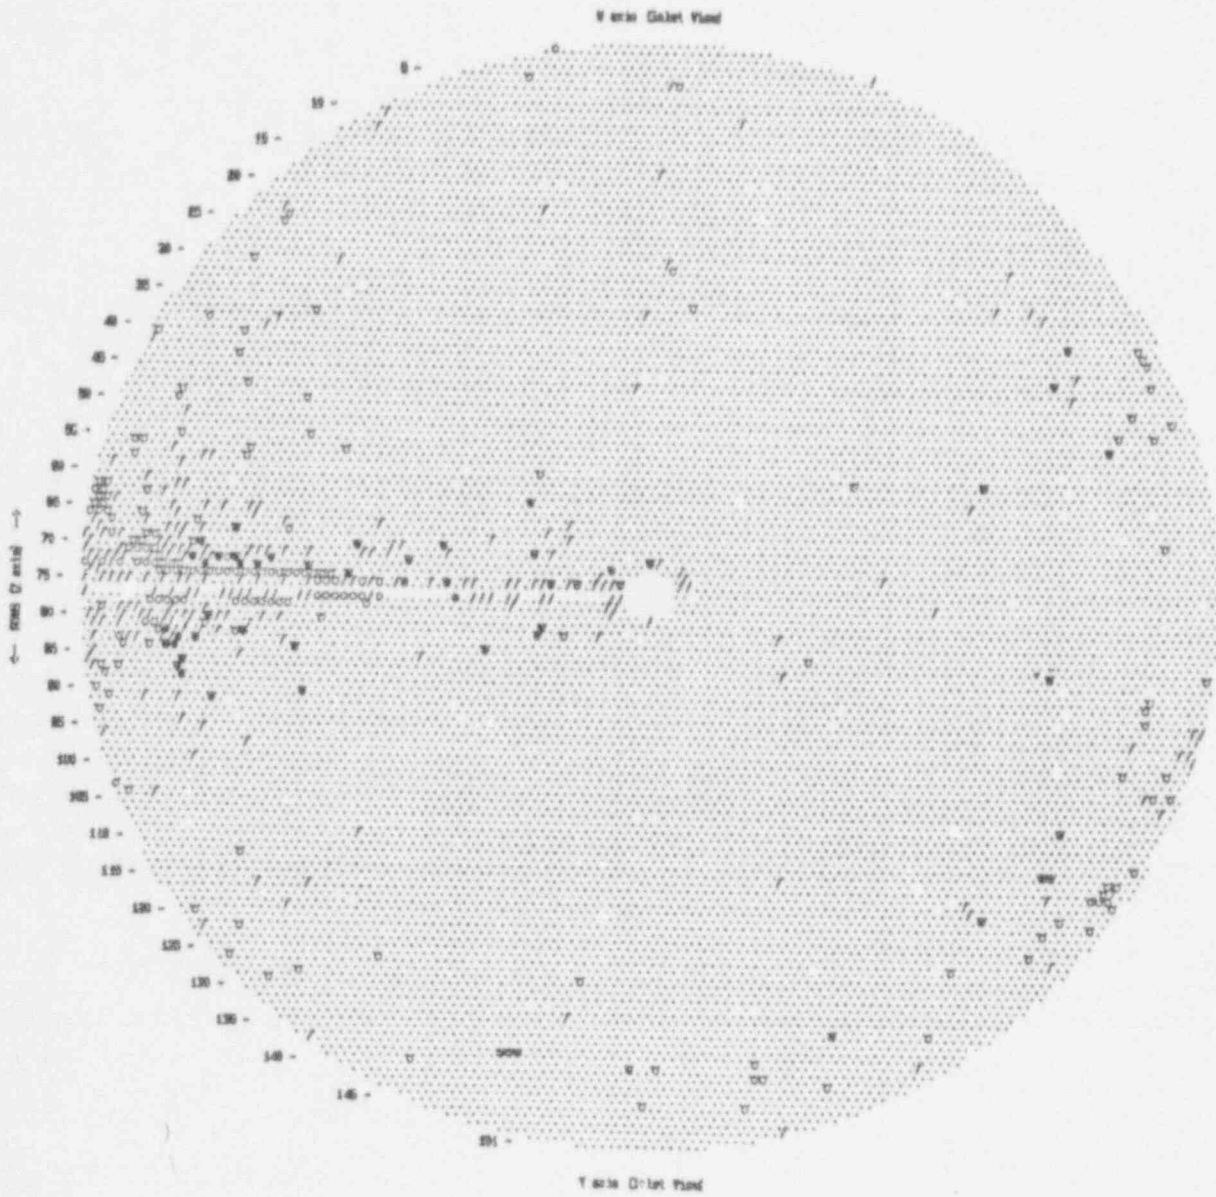
FIGURE 5

TUBES SLEEVED DURING 03/92 RFO - 31" AND 80" SLEEVES

● = TUBES WITH 31" SLEEVES (54)

○ = TUBES WITH 80" SLEEVES (177)

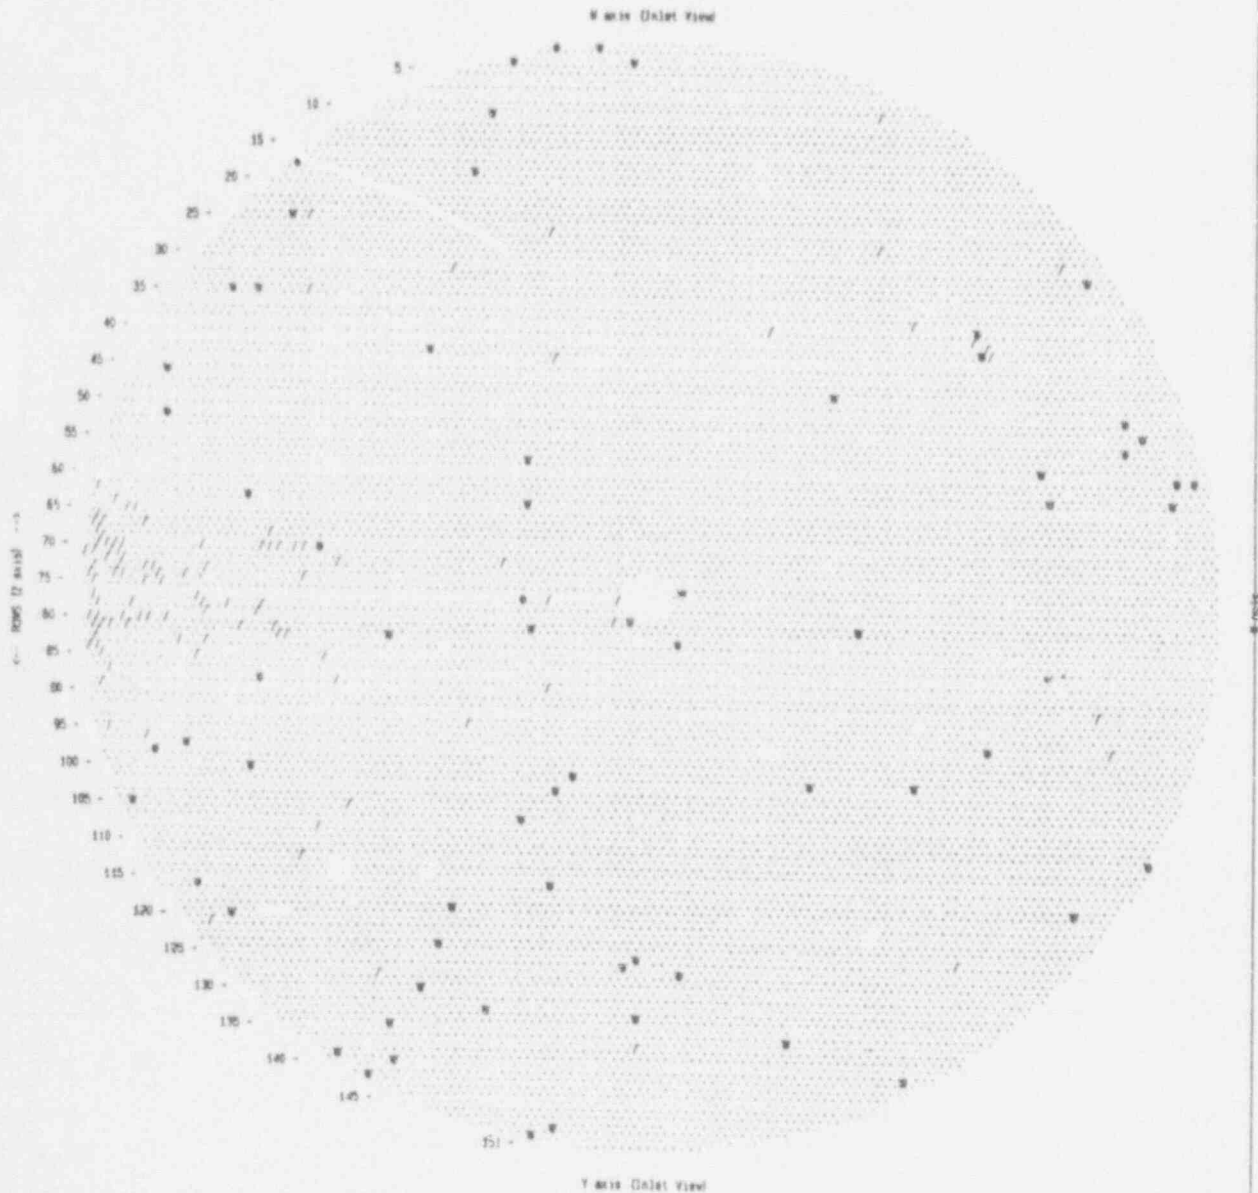
FIGURE 6

TUBES TO BE PLUGGED DURING THE 03/92 RFD

● = TUBES TO BE PLUGGED - 03/92 RFD (68)

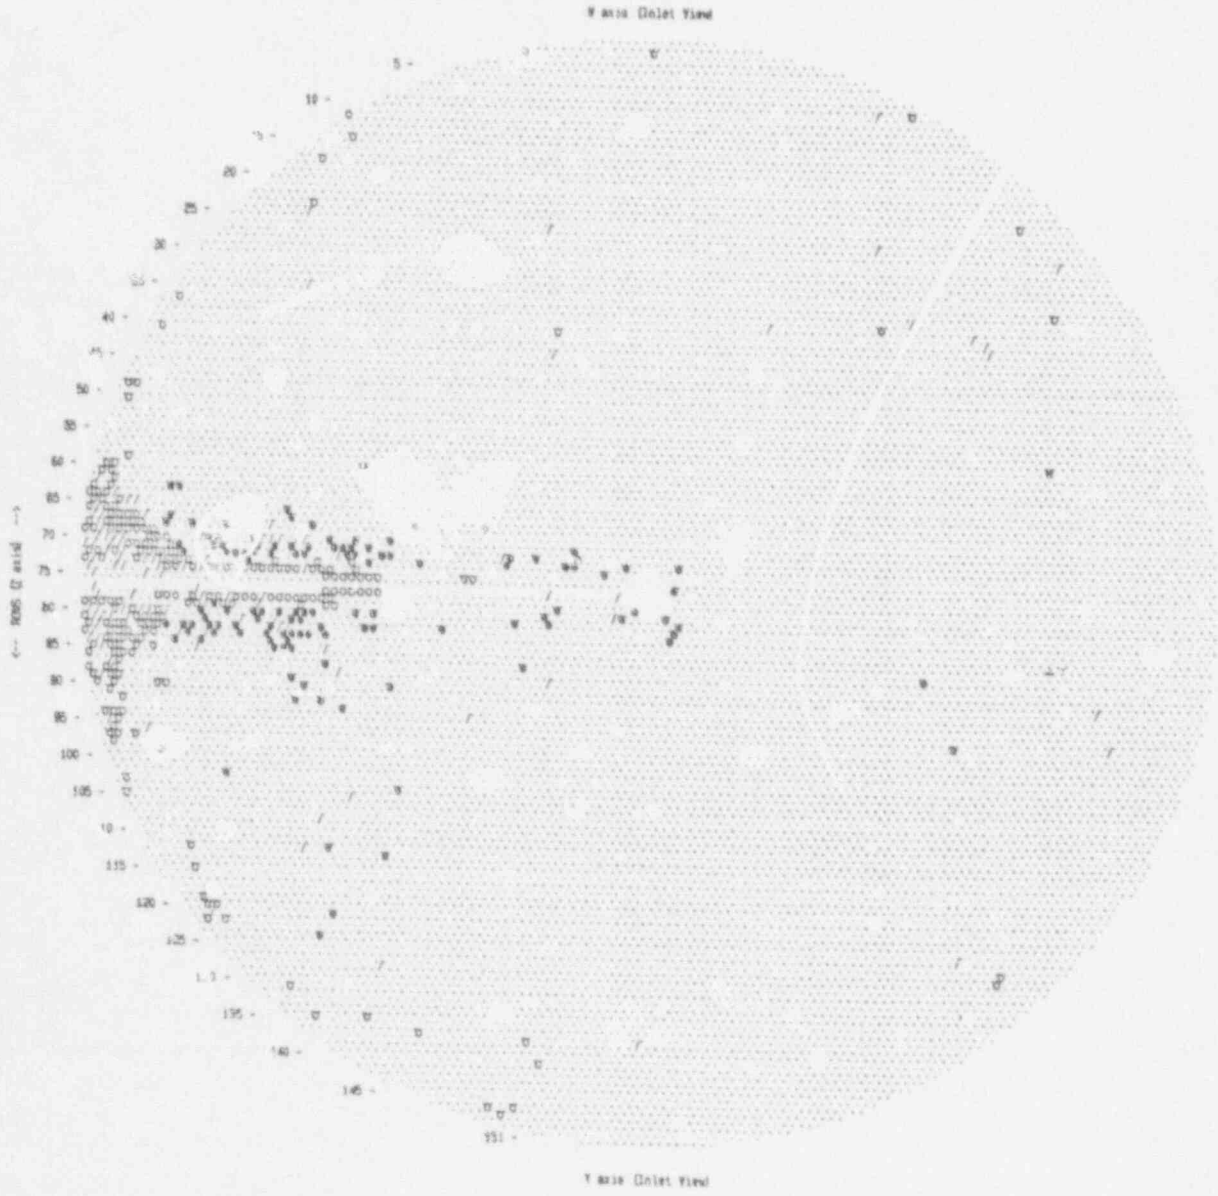
FIGURE 7

TUBES SLEEVED DURING 03/92 RFO - 31" AND 80" SLEEVES

● = TUBES WITH 31" SLEEVES (124)

○ = TUBES WITH 80" SLEEVES (220)

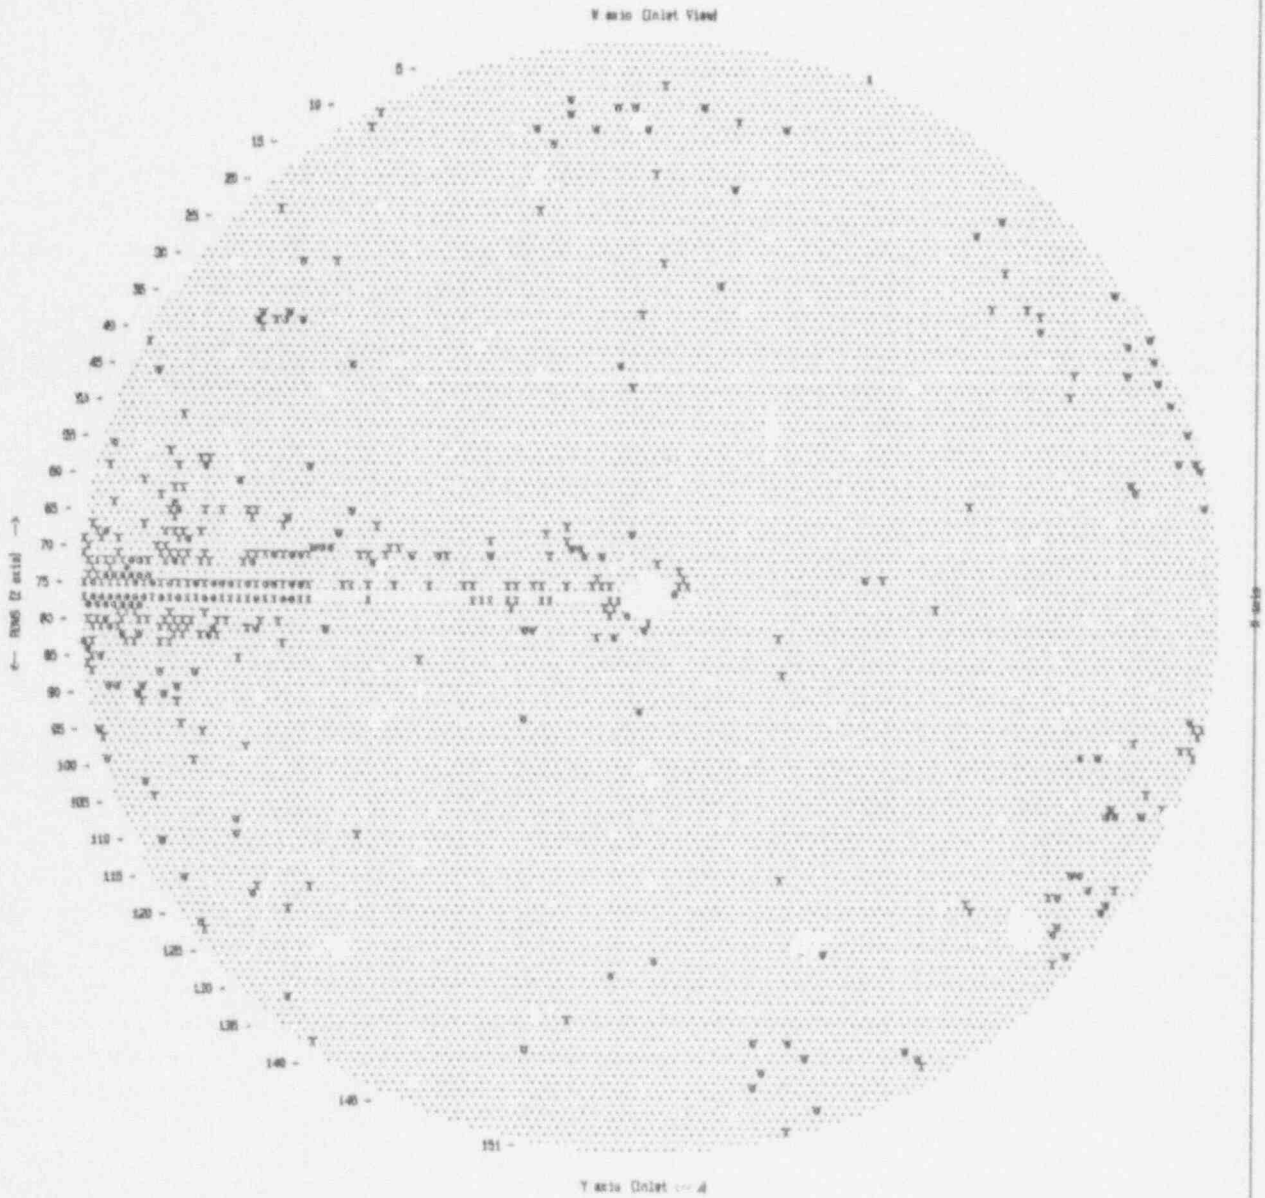
FIGURE 8

SLEEVES AND PLUGS EXISTING PRIOR TO THE 03/92 RFO

X = TUBES PLUGGED THROUGH 10/90 RFO (236)

◆ = TUBES SLEEVED THROUGH 10/90 RFO (176)

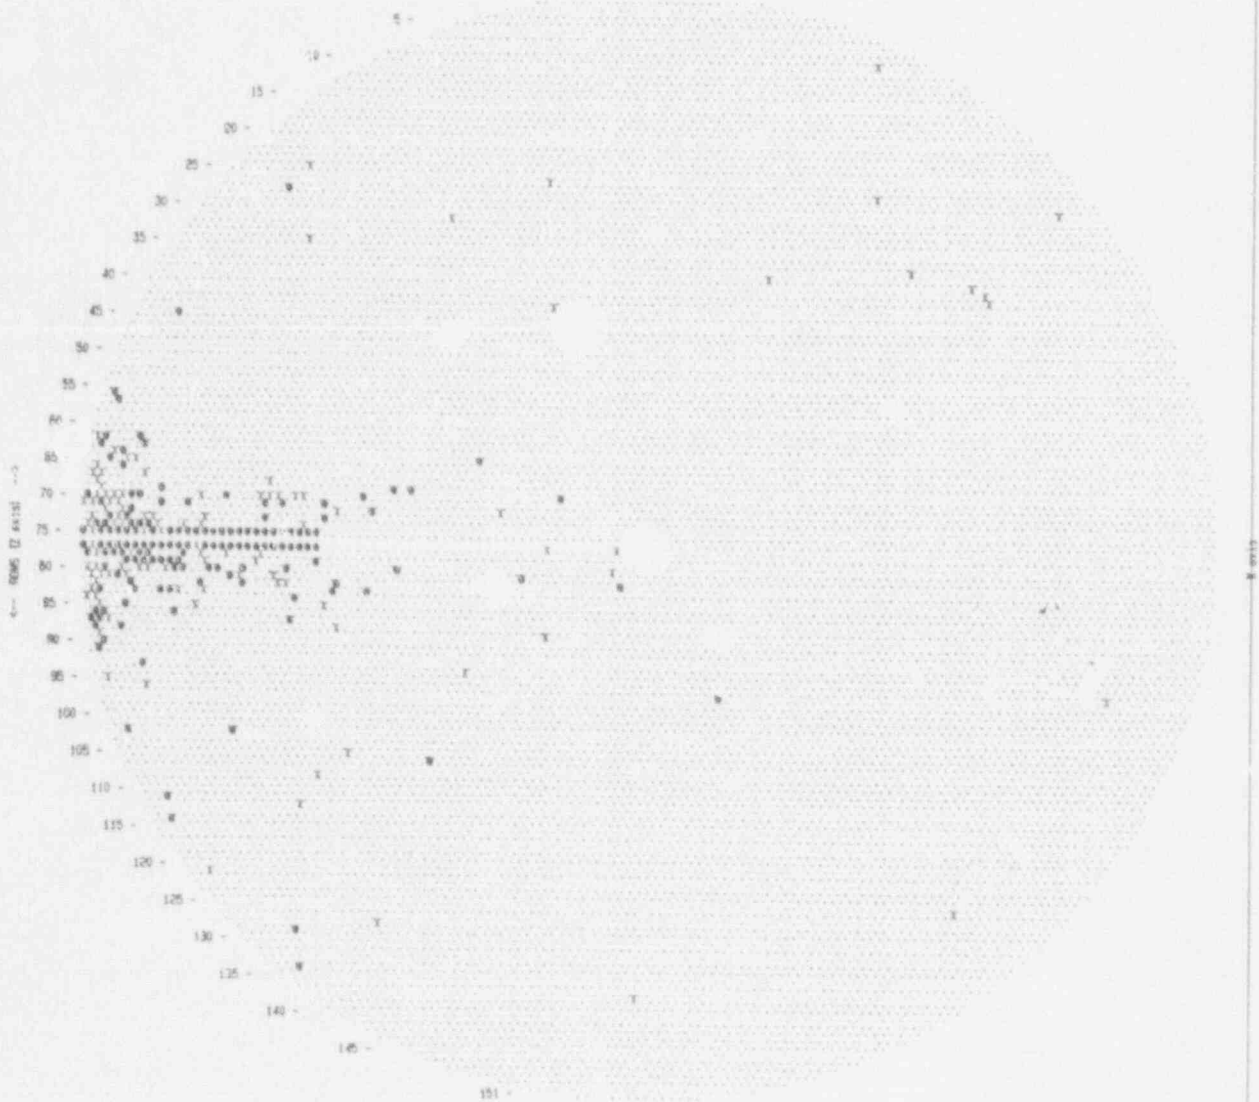
FIGURE 9

SLEEVES AND PLUGS EXISTING PRIOR TO THE 03/92 RFO

X = TUBES PLUGGED THROUGH 10/90 RFO (108)

● = TUBES SLEEVED THROUGH 10/90 RFO (147)
