TENNESSEE VALLEY AUTHORITY - SEQUOYAH NUCLEAR PLANT UNIT 1 AND UNIT 2 -  
DOCKET NOS. 50-327 AND 50-328 - FACILITY OPERATING LICENSES DPR-77 AND  
DPR-79 - LICENSEE EVENT REPORT (LER) 50-327/92007

LICENSEE EVENT REPORT (LER)

TITLE (4) Inoperable Ice Condenser Lower Inlet Doors Because of Upward Movement of the Floor.

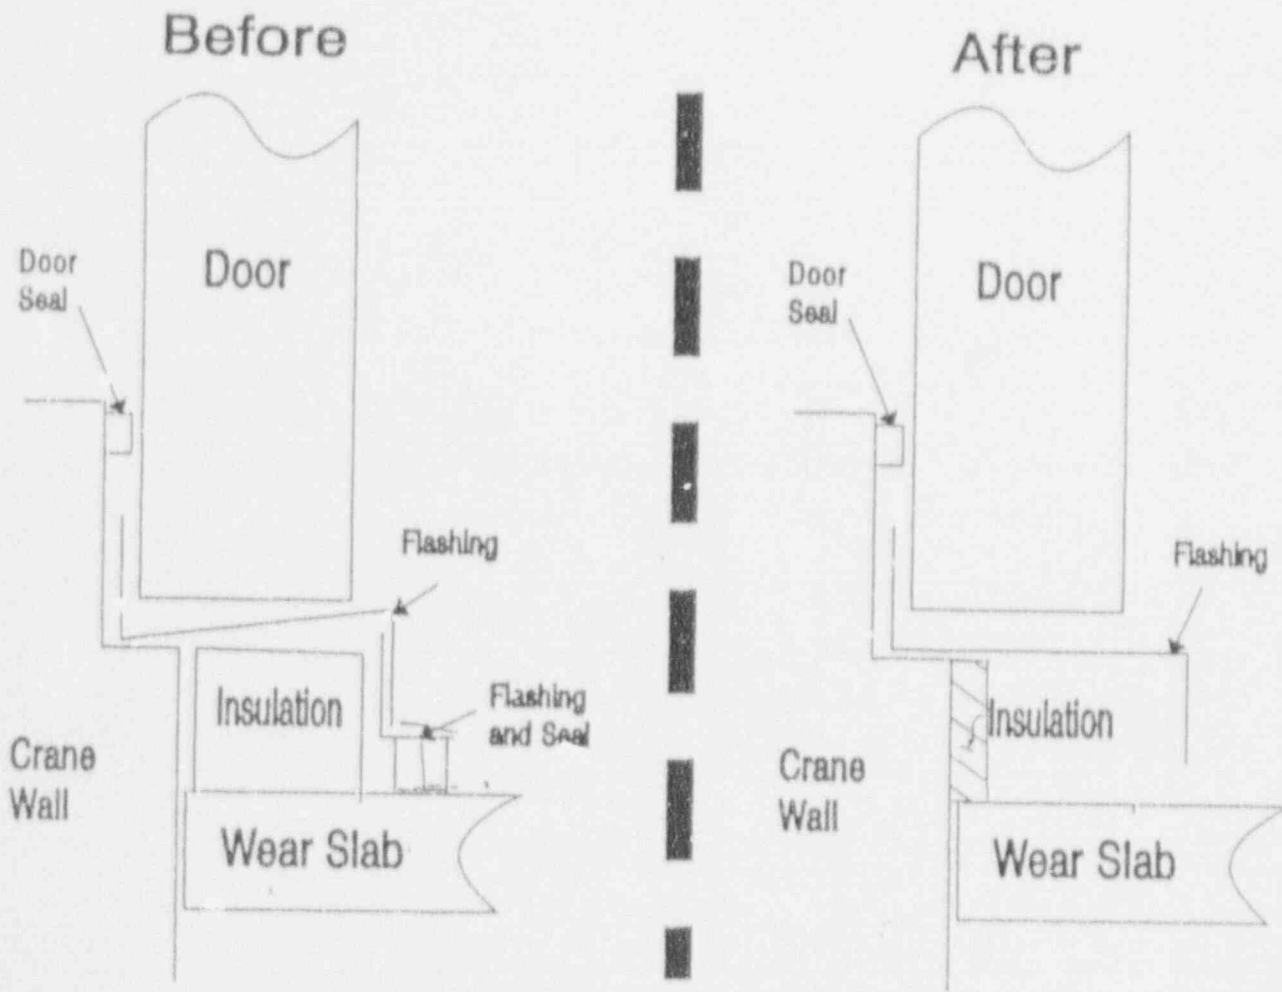
Figure 1

A. On March 16, 1992, Technical Support and Systems (TSS) personnel were informed by the ice condenser maintenance crews that several of the Unit 2 ice condenser (E11S Code BC) lower inlet doors were inhibited from opening. TSS personnel performed a walkdown of the ice condenser doors and confirmed that the doors would not move as freely as required. TSS then initiated a problem evaluation report. The TSS personnel initially believed that the insulation beneath the doors had absorbed water, frozen, and expanded up underneath the doors, thus "jamming" the doors. On March 17, 1992, a team of TSS and Nuclear Engineering (NE) personnel inspected the Unit 2 ice condenser doors. During the inspection, ice condenser maintenance personnel informed them that they had seen cracks in the floor slab. The team inspected the floor slab in detail and identified the cracks in the floor and concluded that the floor slab had moved upward in various locations resulting in interference between the sheetmetal flashing and the base of the doors (see attached Figure 1).

Ice Condenser Lower Inlet Door

3. A temporary modification was performed to remove the lower "L-shaped" sheetmetal flashing and gasket mounted on the wear slab and connected to the flashing piece that forms the jam for the lower inlet doors (see Figure 1). This removed the interference with the bottom of the doors and provided physical margin for wear slab growth without interference with the doors.

5. A second temporary modification was implemented to replace the insulation bags installed under the flashing with a double layer of Armaflex rubber insulation. This provided improved sealing of air-leakage paths and ensured retention under accident conditions (see Figure 1).

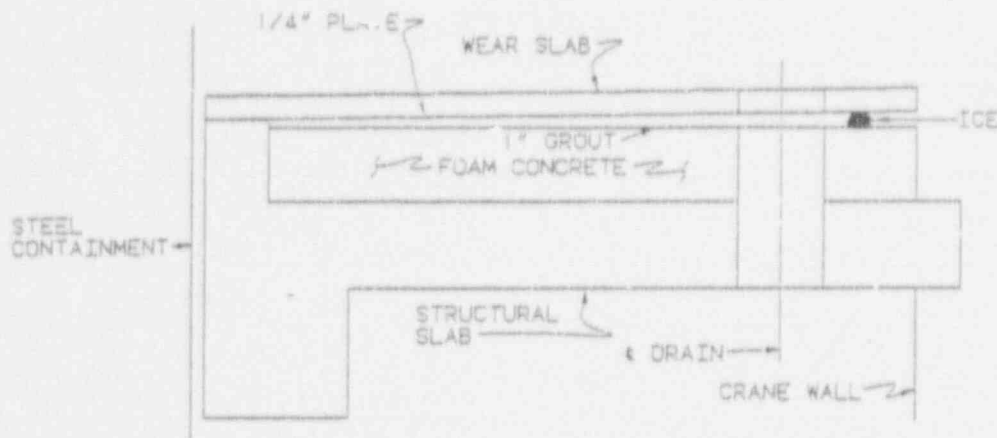
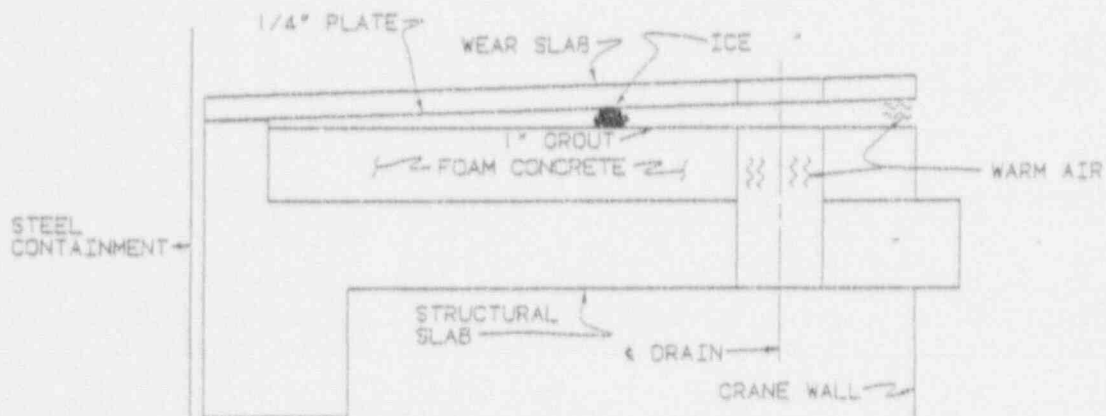
The immediate cause of the wear slab degradation was water intrusion, freezing, and expansion within the floor assembly. (See Figure 2 for depiction of floor assembly.)

The root cause of this condition was determined to be the failure to install sealant material in some of the wear slab joints during initial construction, thereby providing paths for water intrusion to the floor assembly.

Also, the design of the floor assembly allowed the 1/4-inch plate located beneath the wear slab to be installed on hardened grout, allowing voids to form beneath the plate.
