Subject: McGuire Nuclear Station Unit 2
Docket No. 50-370
Licensee Event Report 370/92-03

LICENSEE EVENT REPORT (LER)

TITLE(4) Train B Of The Unit 2 Residual Heat Removal System Was Inoperable Due To A Degraded Flow Path Caused By Equipment Failure

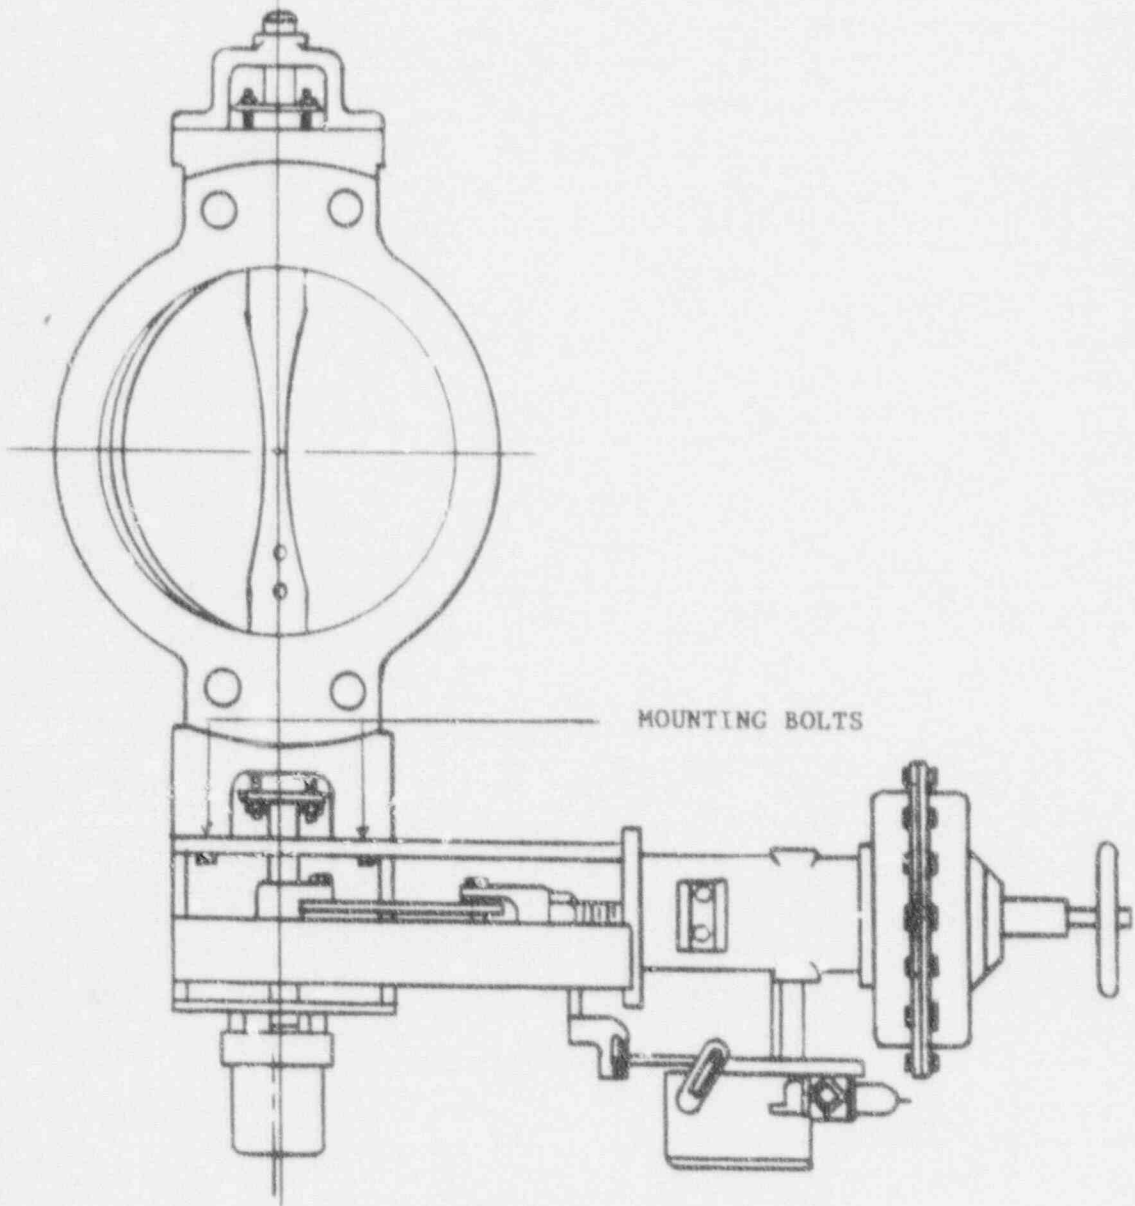
12" FISHER BUTTERFLY VALVE

This event is assigned a cause of Equipment Failure due to the failed bolts which secure the actuator to the valve body on valve 2KC-82B. Two of the four bolts had failed at an unknown time prior to discovery. One of the remaining bolts was determined to be approximately 95 percent corroded. Therefore, the valve actuator was held in place, at the time, by one intact bolt.

Two bolt heads were missing from the valve assembly at the time of discovery. MES Component Engineering personnel visually examined the remaining bolt parts during repair activities. They felt confident with the results of the visual inspection and subsequently determined that a full metallurgical analysis was not needed to determine the cause of failure. The cause of failure of the bolts was determined by MES personnel to be brittle failure due to reduced cross sectional area induced by general corrosion. Over a long period of time the cross sectional area of the mounting bolts was reduced due to corrosion from a packing leak on valve 2KC-82B. The bolts finally broke in brittle failure due to the tensile load applied by the weight of the valve actuator on the necked down bolts. A secondary possible contributing cause was system vibration and is currently being evaluated by Design Engineering personnel. MES personnel theorized the corrosion was caused by a packing leak on valve 2KC-82B, which had self-sealed at some previous unknown time. The actuator for valve 2KC-82B is oriented horizontally such that leakage from the valve stem will wet the valve operator mounting bolts. The identical valves on the redundant train (2KC-57A, ESF Residual Heat Removal Heat Exchanger 2A Outlet Flow Control) and Unit 1, (1KC-57A, ESF Residual Heat Removal Heat Exchanger 1A Outlet Flow Control, and 1KC-82B, ESF Residual Heat Removal Heat Exchanger 1B Outlet Flow Control) are not oriented in the same position and therefore are not susceptible to a similar failure.

- Planned:
- 1) The actuator mounting bolts on valves 2KC-57A, 1KC-57A, 1KC-82B will be replaced with grade B7 bolts.
 - 2) MES Component Engineering personnel will evaluate the bolts removed from valves 2KC-57A, 1KC-57A, 1KC-82B and take appropriate action based on the results of this analysis.
 - 3) MES Component Engineering personnel will work with Design Engineering personnel to evaluate the effects of flow induced vibration on valve 2KC-82B and determine if additional support is needed.
 - 4) MES Component Engineering personnel will implement a preventative maintenance activity to inspect the actuator mounting bolts on valve 2KC-82B.
 - 5) The valve stem packing will be replaced on valve 2KC-82B.
