SCOPING EVALUATION
FOR ARKANSAS NUCLEAR ONE, UNIT 1
REACTOR COOLANT PUMPS
PER THE REQUIREMENTS OF
ASME CODE CASE N-481

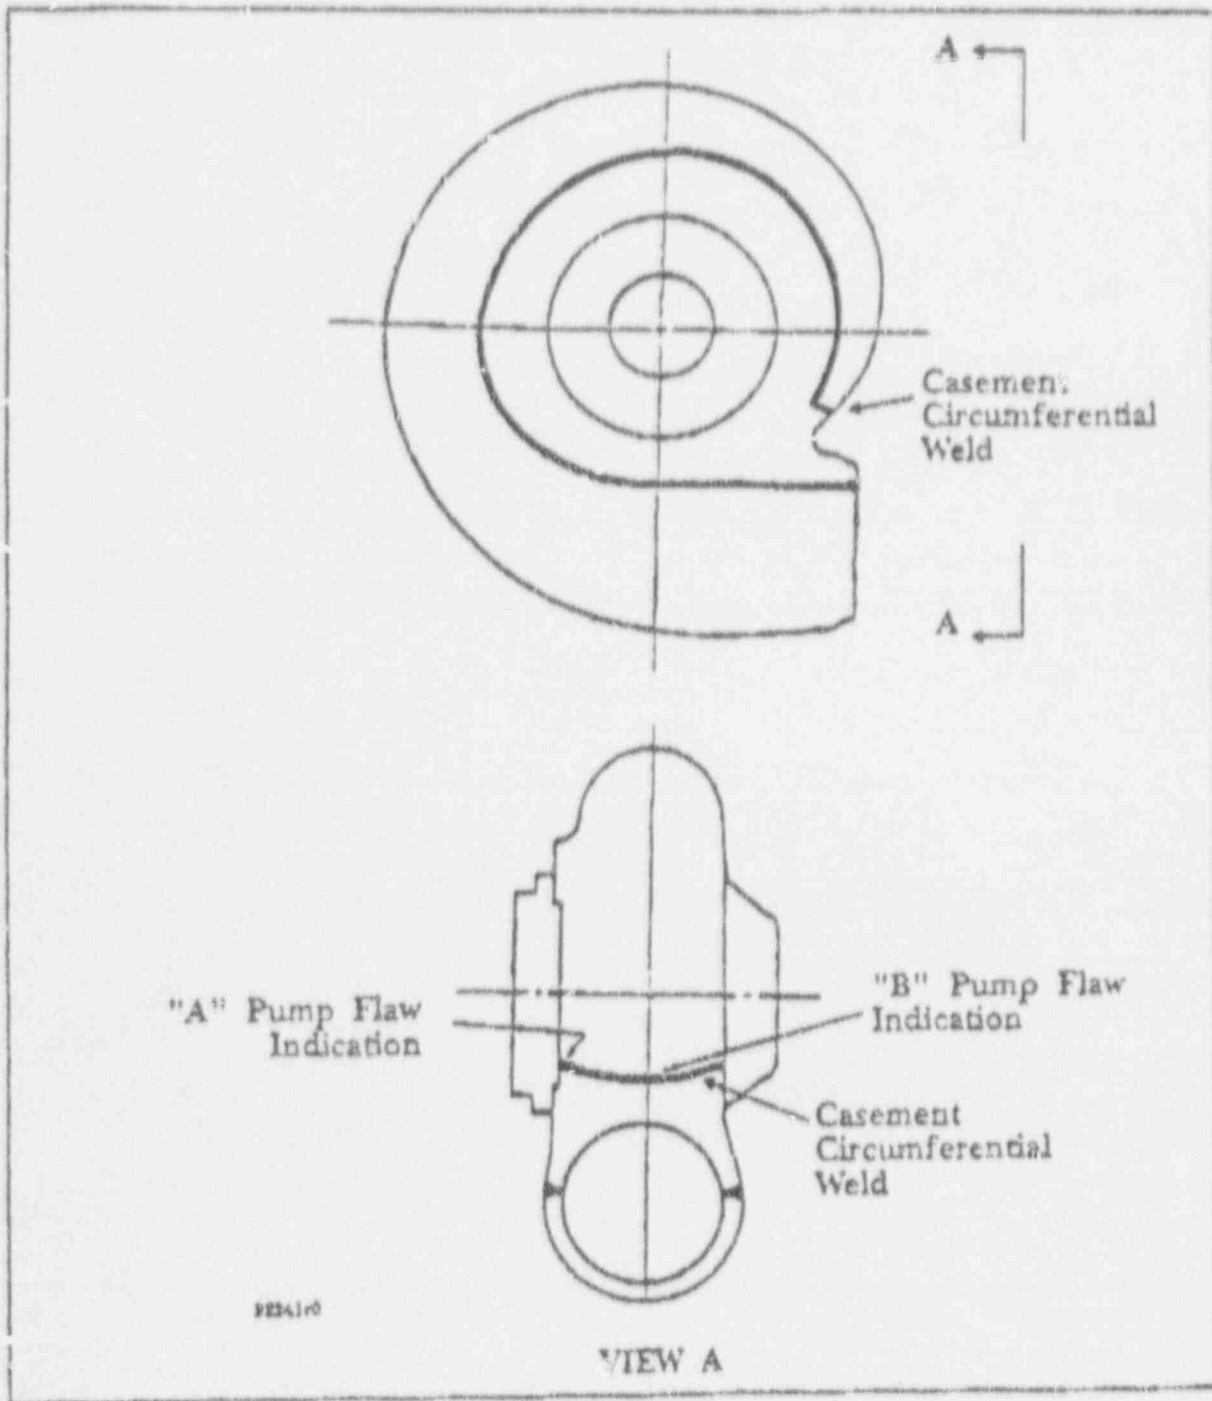
Figure 1-1. Schematic Drawing of Weld Flaw in Arkansas Nuclear One Reactor Coolant Pump, Unit 1

During the 1986 refueling outage, a volumetric RT examination was performed on the "A" RCP welds as required by the first 10 year ISI program. This program was based on the requirements of the 1974 Edition through Summer 1975 Addenda of Section XI of the ASME Code. The RT examination indicated the presence of a flaw which exceeded that allowable indication standards of IWB-3500. Since the acceptance criteria (IWB-3518) did not exist in the 1974 Edition of Section XI, the 1980 Edition was utilized. The indication is best described as a series of slag inclusions having an effective length (per ASME Section XI criteria) of 5.66 inches. The indication is located in the vertical weld which ties together the upper and lower welds of the pump casing (Figure 1-1). Radiographic parallax techniques indicate that the top of the flaw is 1.5 inches below the outside surface of the weld. The weld is approximately 2.6 inches thick in this area. Application of special UT techniques indicated that the flaw indication does not extend to the internal diameter of the pump casing. Thus, the maximum through-wall dimension of the flaw indication is less than 1.1 inches.

The flaw indication on the "B" pump, through the computer enhancement process, was shown as 1.5 inches in length. The original construction radiograph of this area shows a flaw of 0.625 inches in length which was acceptable per Code requirements at that time. The wall thickness in the area of the flaw indication is 3.1 inches. UT was performed in an attempt to better characterize the flaw indication. Due to the material of the pump casing (coarse-grained, statically-cast stainless) and the small size of the indication, UT was not able to specifically characterize the flaw. However, from these examinations, it was determined that the flaw size was no larger than 1.5 inches long by 1.5 inches deep.

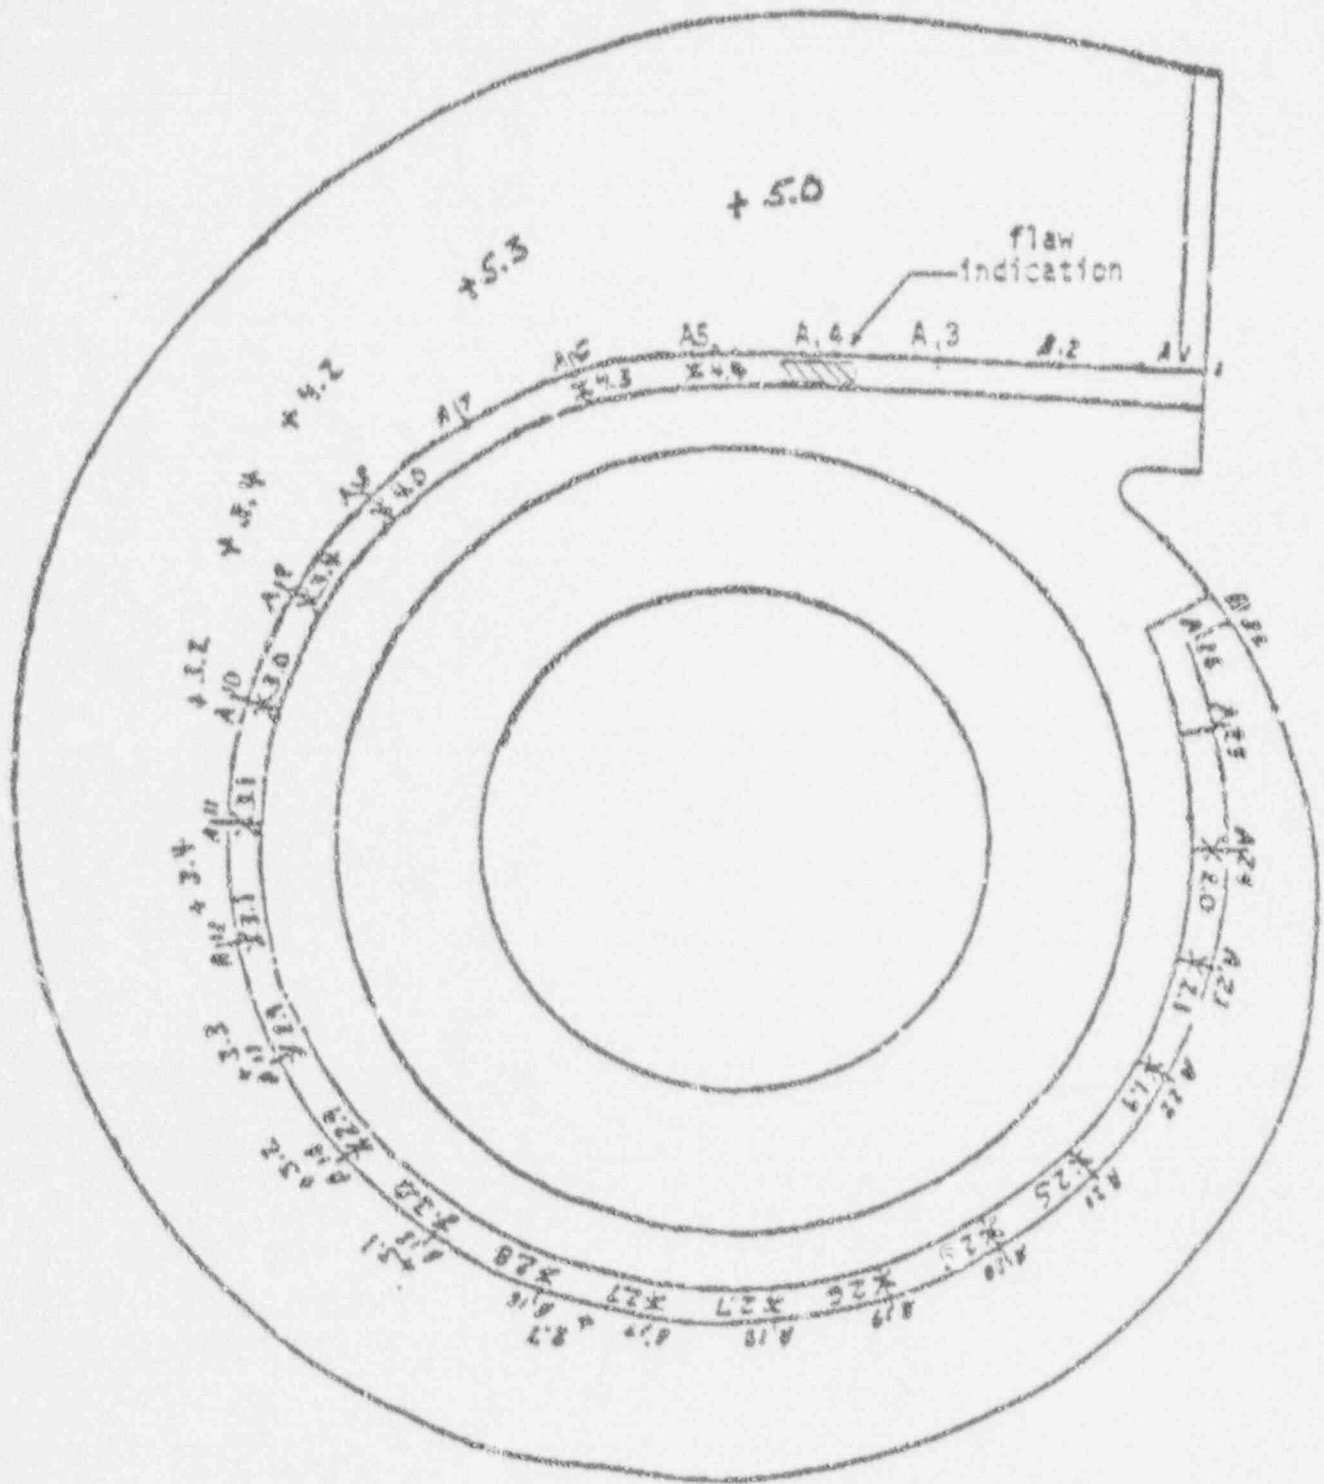
Figure 4-1. Byron-Jackson Reactor Coolant Pump Weld and Base Material Thickness Lower Scroll Weld Flaw Indications ANO-1 "B" RCP 1988 UT Exam

In the lower scroll weld, several indications were detected (using ACCUSONEX) in an area bounded by a rectangle with a length of 4.1 inches and a through-wall dimension of 1.8 inches at a depth of 0.9 inches below the outer weld surface in a region where the weld is 4.75 inches thick. These indications were considered to be slag inclusions located approximately 0.5 inches to 0.75 inches from the weld centerline. The upper

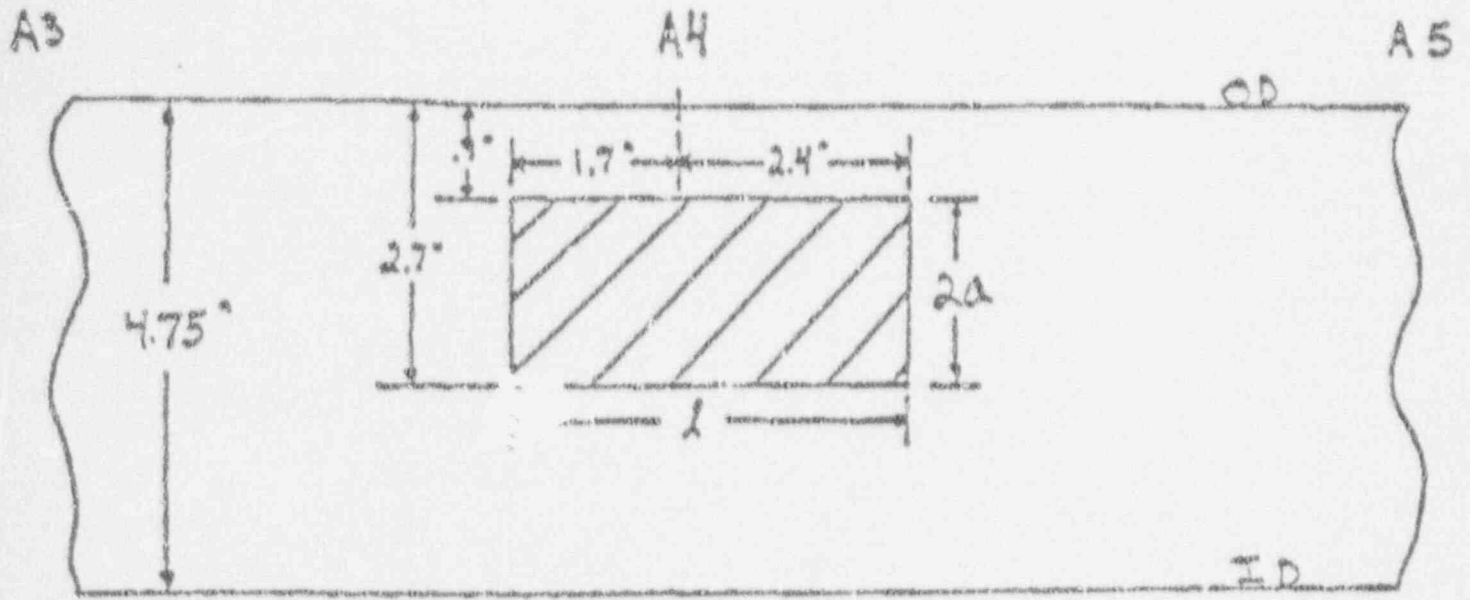
Figure 4-2. ANO-1 1988 UT Exam of "B" RCP Lower Scroll Weld Indication Section View

$l = 4.1''$
 $2a = 1.8''$ ($a = 0.90''$)
 $s = 0.90''$

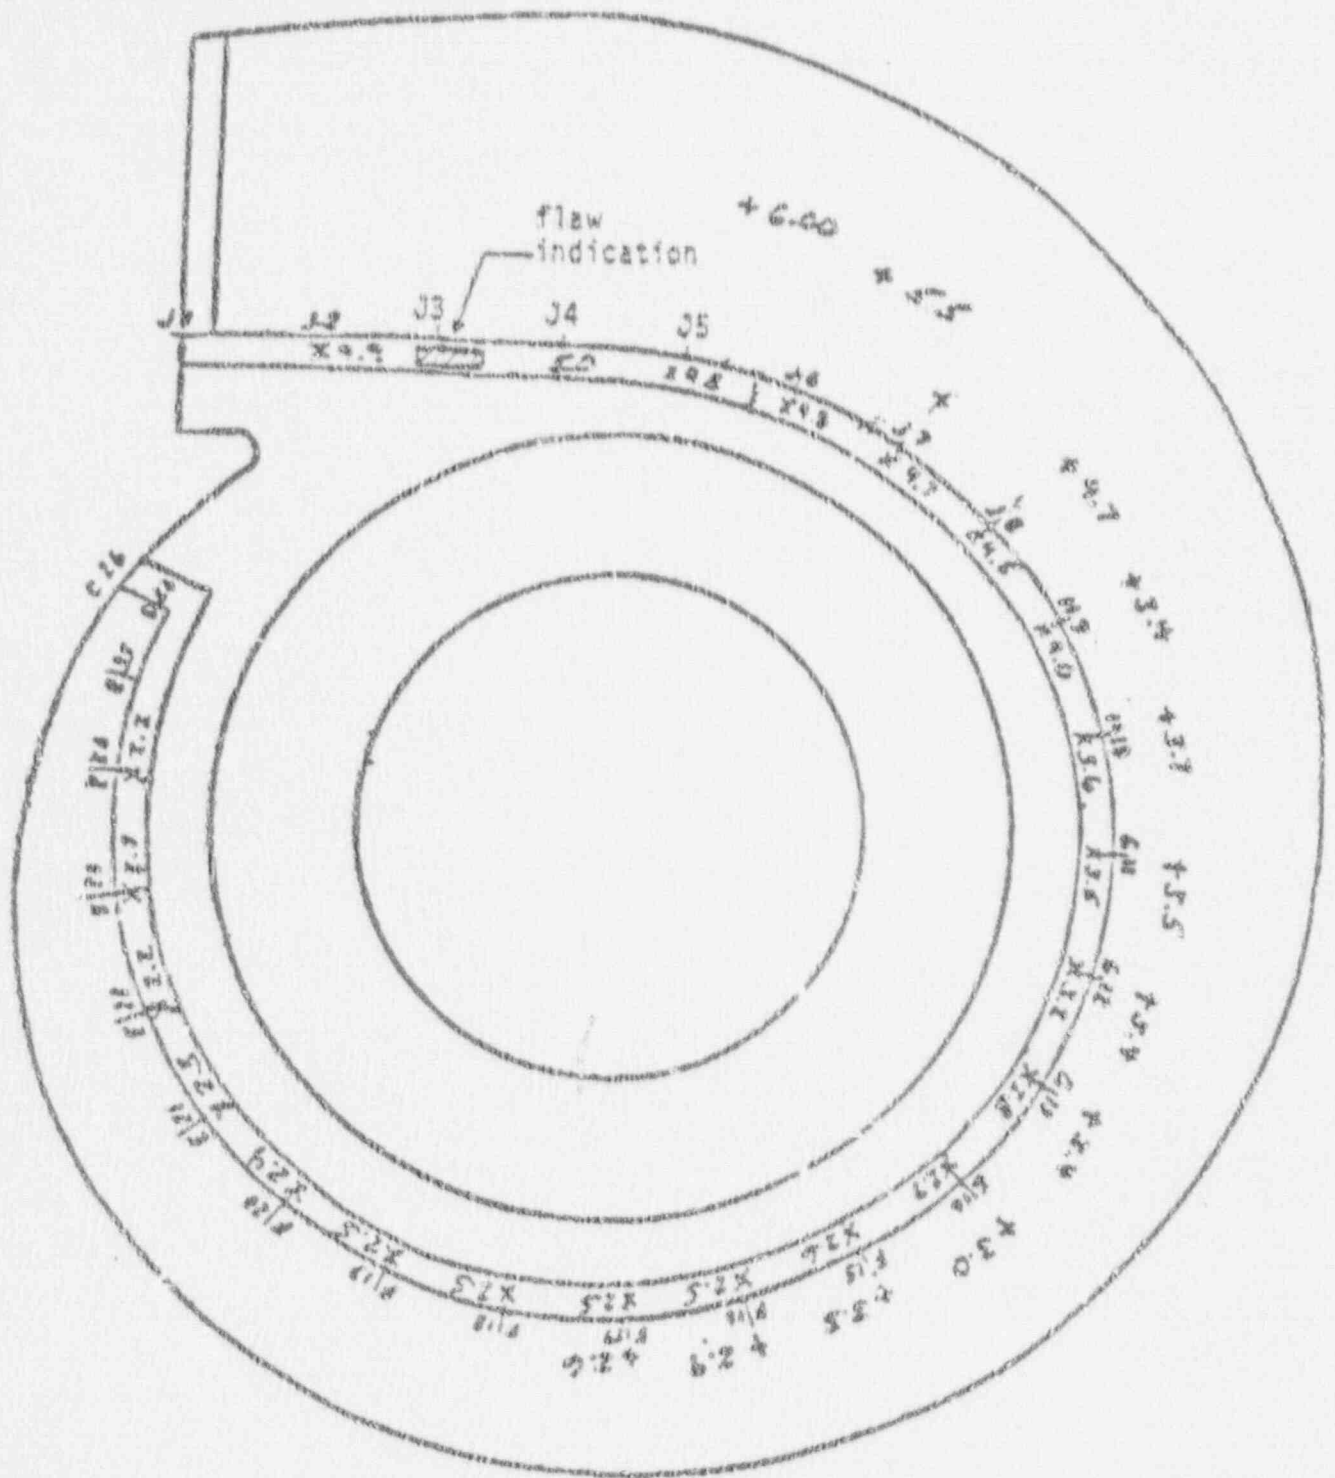
Figure 4-4. Byron-Jackson Reactor Coolant Pump Weld and Base Material Thickness Upper Scroll Weld Flaw Indication ANO-1 "B" RCP 1988 UT Exam

scroll weld could not be examined with ACCUSONEX due to insufficient access for the robot; however, a manual scan was performed which identified three indications. The composite size was conservatively determined to be no larger than a 4.5 inch long by 1.25 inch through-wall dimension rectangle at a depth of 1.35 inches from the outside surface. The weld is also 4.75 inches thick in this region. This indication is located approximately on the weld centerline to 0.6 inches from the centerline. It is also considered to consist of slag inclusions resulting from the original construction welding process and not a service induced condition.

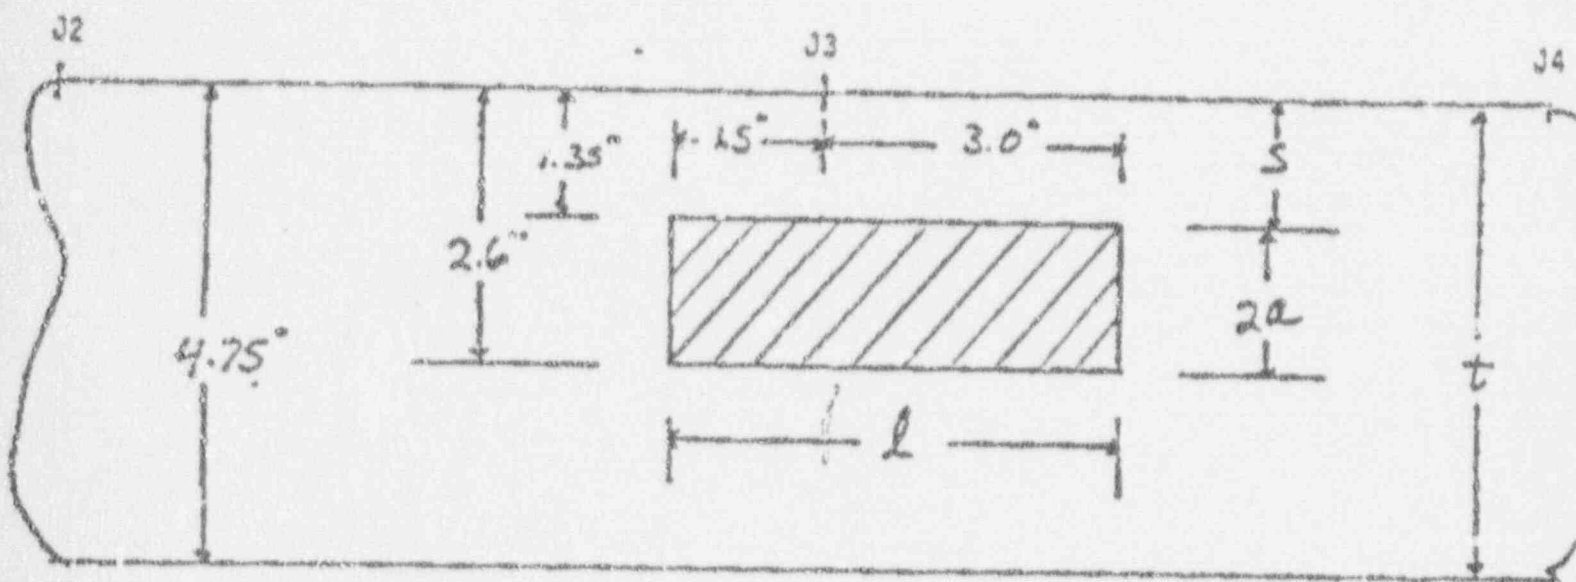
Figure 4-5. ANO-1 1988 UT Exam of "B" RCP Upper Scroll Weld Indication Section View

$l = 4.5"$
 $2a = 1.25"$ ($a = 0.62"$)
 $s = 1.35"$
