WOLF CREEK
NUCLEAR OPERATING CORPORATION

Subject: Docket No. 50-482: Licensee Event Report 95-006-00

FACILITY NAME (1)
WOLF CREEK GENERATING STATION

TITLE (4)
Loss of Emergency Bus NB02 Due to Degraded Gasket on Motor Operator Cabinet

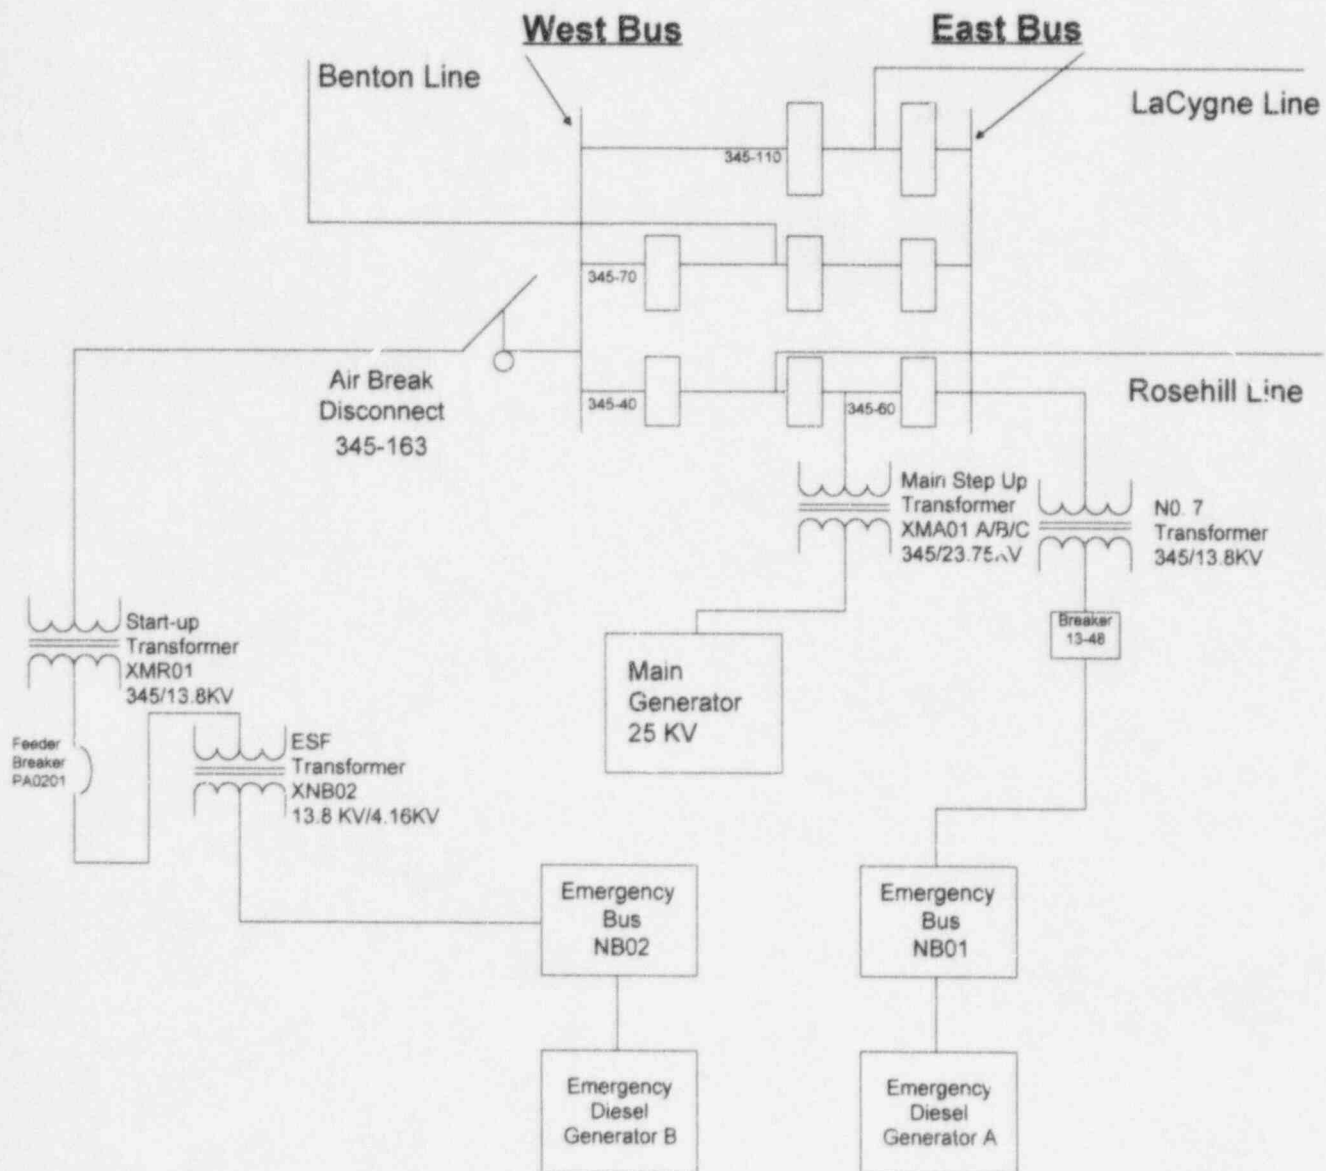
Figure 1

At 1942 CST, on November, 10, 1995, a degraded gasket allowed moisture (snow, ice, sleet) to intrude into the motor operator cabinet [CAB] for air break disconnect [DISC] 345-163. The cabinet is located in the WCGS switchyard. The moisture caused open contacts to short which energized the motor and opened air break disconnect 345-163. The disconnect opened with the line energized. Air break disconnect 345-163 is an electrically operated switch designed to be operated, either locally or remotely, under no load conditions. When air break disconnect 345-163 opened, power from the switchyard was lost to the Start-up Transformer and ESF Transformer (XNB02), which supplies the Emergency Bus (NB02). Three breakers (345-70, 345-40, and 345-110) [BKR] opened in the switchyard on the differential relay trip completely de-energizing the West Bus (Reference Figure 1).

The root cause of this event was equipment failure. A degraded door gasket allowed moisture (snow, ice, sleet) to intrude into the motor operator cabinet for air break disconnect 345-163. The moisture caused open contacts to short in the motor operator circuitry which subsequently led to a loss of power to the West Bus.

As an immediate corrective action, the motor operator cabinet door gasket was repaired. To prevent a similar occurrence, power was removed from all air break disconnect motor operators. This additional corrective action was initiated on November 11, and completed by November 13, 1995. This action remained in place until inspections on the cabinets could be completed.
