June 22, 1984

TXX-4201

COMANCHE PEAK STEAM ELECTRIC STATION
UNITS 1 and 2
PROTECTIVE COATING ALLEGATIONS TRANSMITTED
BY LETTER OF MAY 18, 1984
FILE NO. 906.1

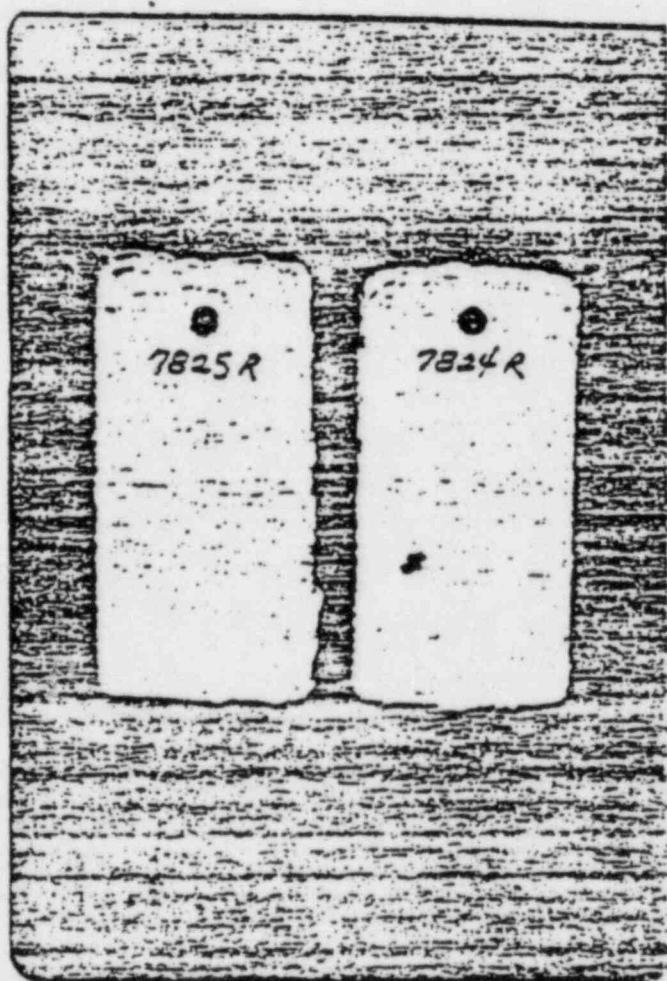
7824-7825 R

Of the eight abrasive blasted faces coated with Nutec 11S, five exhibited no defects and one contained only very few #6 size blisters. Oak Ridge also reported one face of panel 7829 (rear) as having #2 medium blisters. Imperial evaluated the panels thoroughly and believes that ORNL mistakenly evaluated the same face (front side) twice. Imperial has reevaluated the rear of panel 7829 to only few #4 blisters. The front side of panel 7829 was borderline.
