SUBJECT: MEETING SUMMARY - SEQUOYAH ICE CONDENSER AND FEEDWATER  
PIPE CRACKING

**TVA/NRC MANAGEMENT MEETING**

**ICE CONDENSER FLOOR ISSUE**

**CRACKING OF FEEDWATER PIPING**

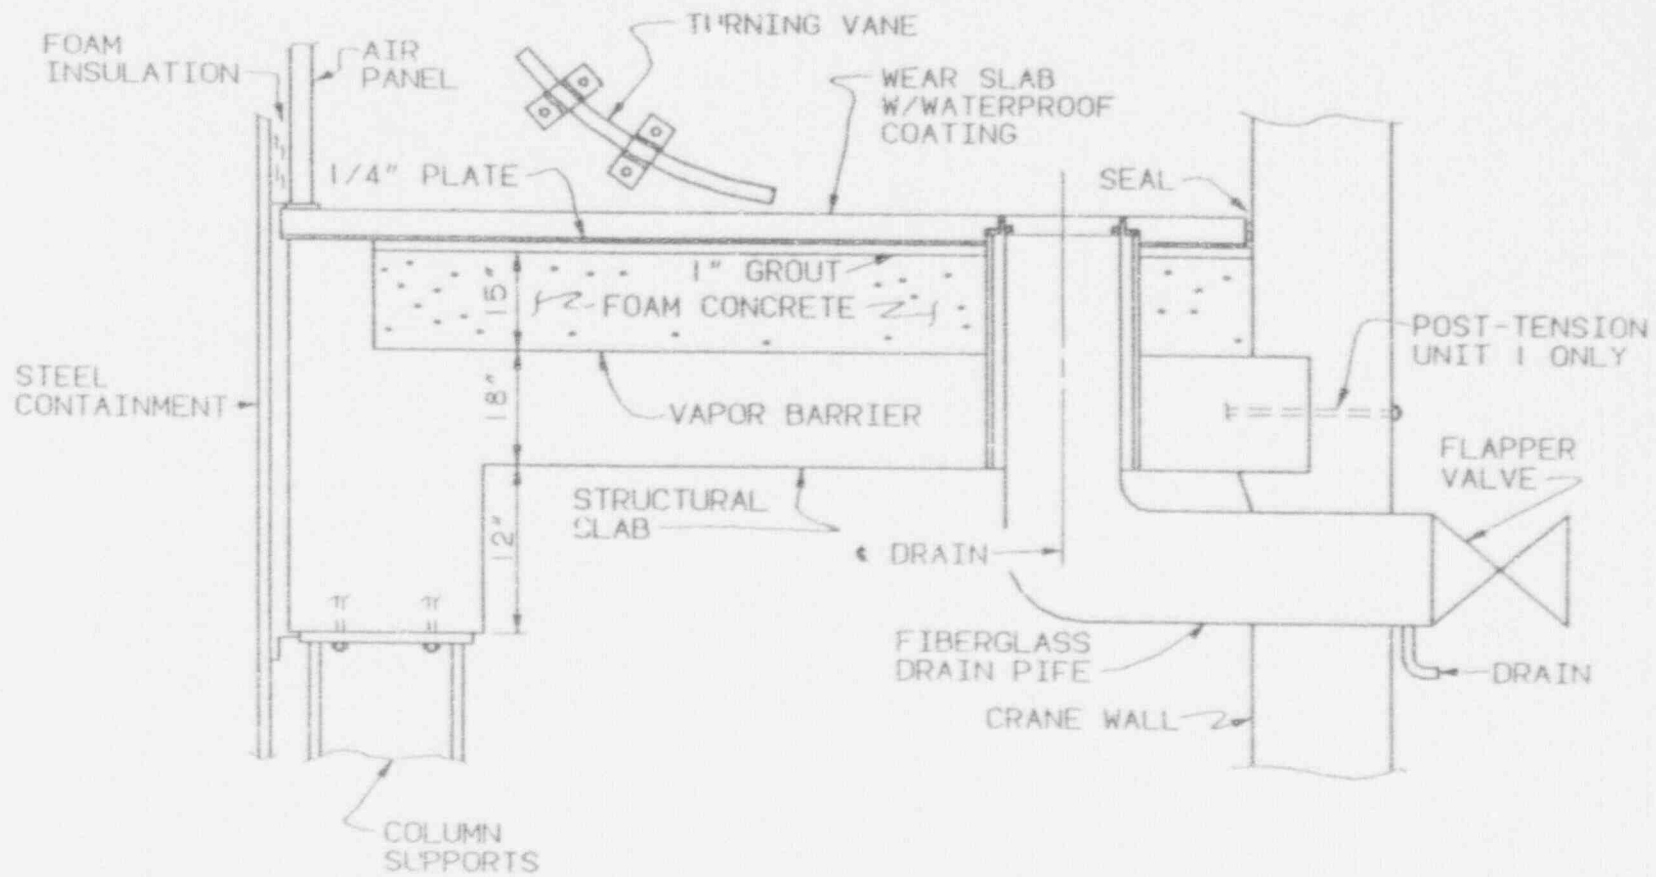
Figure 4

ICE CONDENSER  
FLOOR SLAB

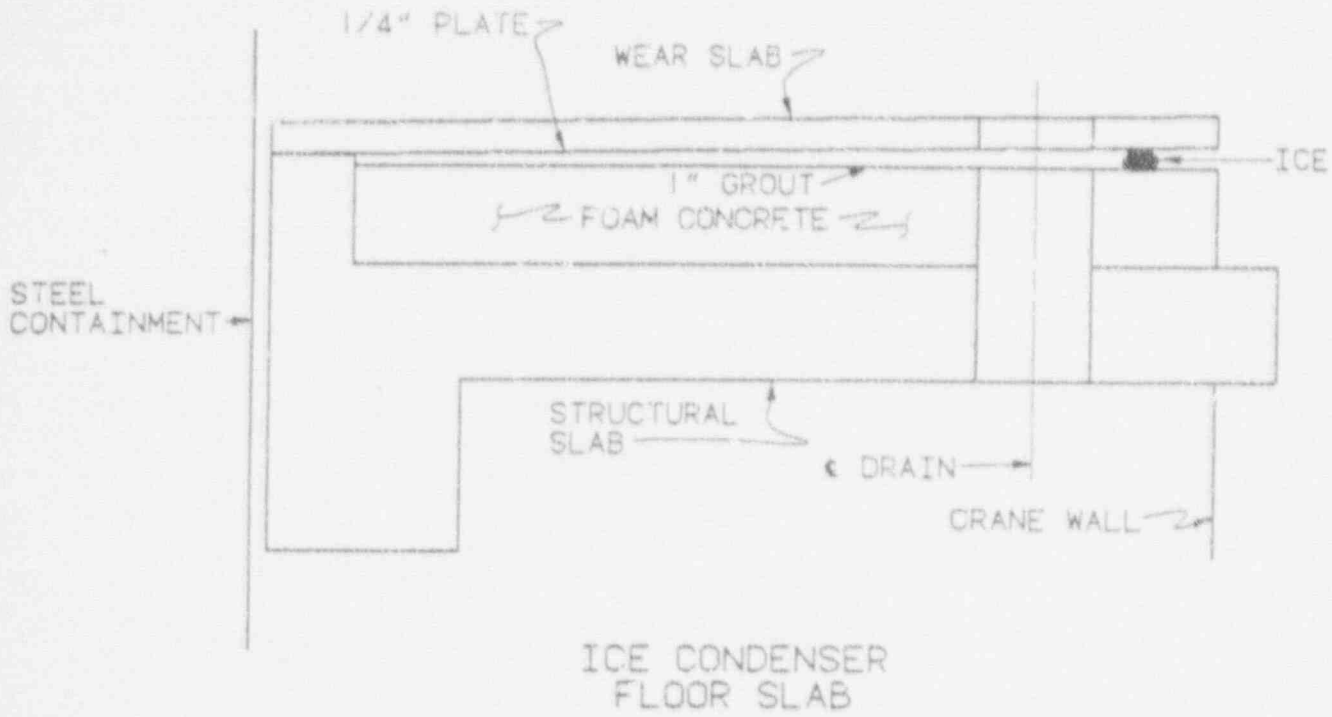
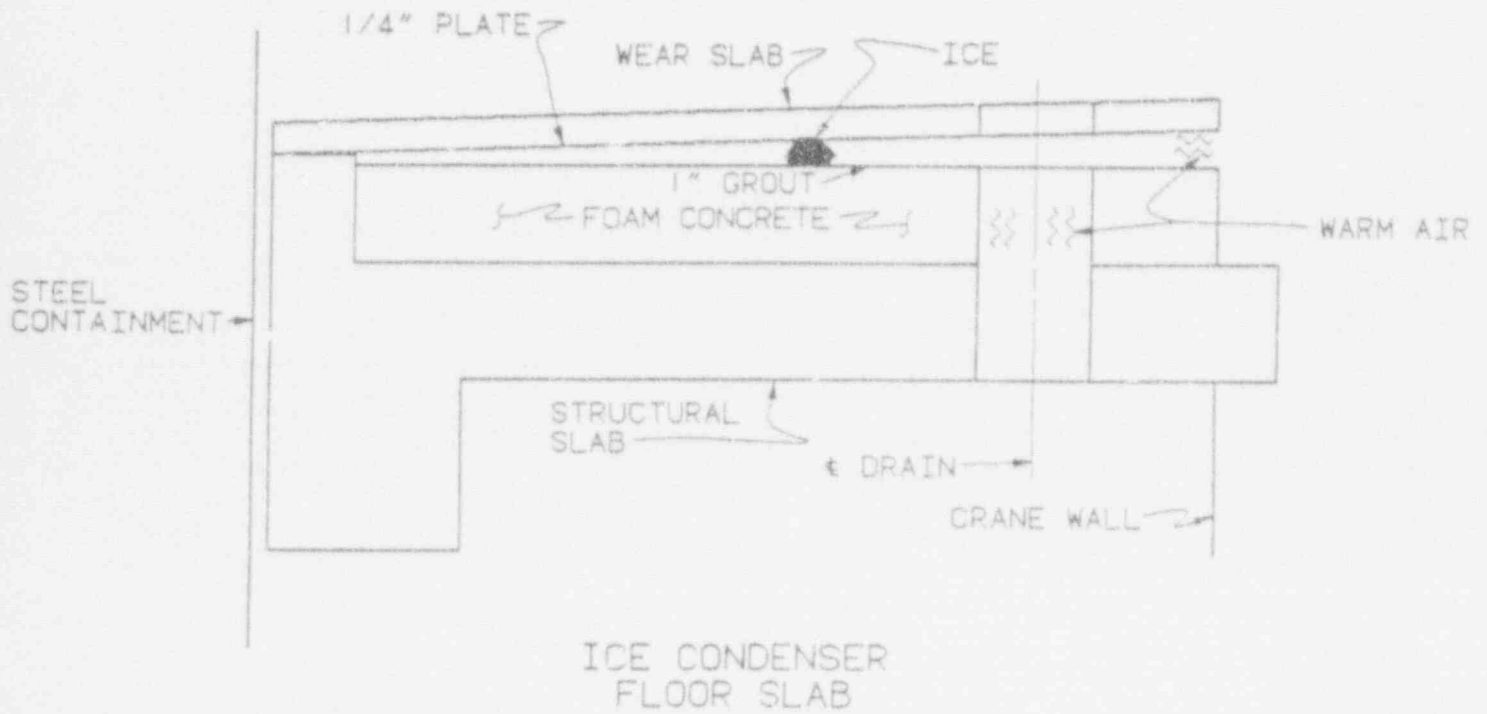
Figure 6

# STAGE 1 INITIAL

# STAGE 2 CURRENT

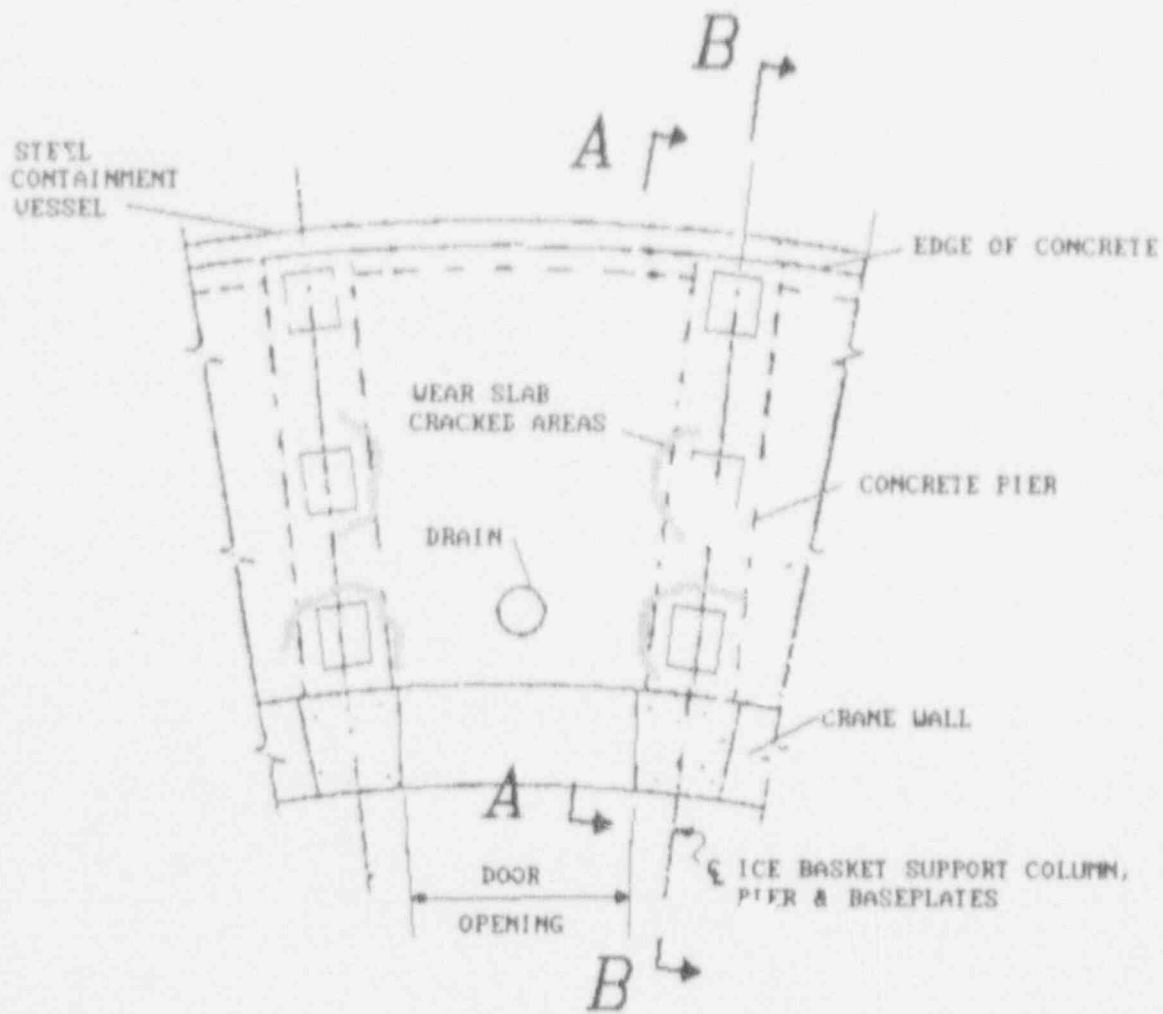
Figure 8

ICE BAY  
 FLOOR SEGMENT

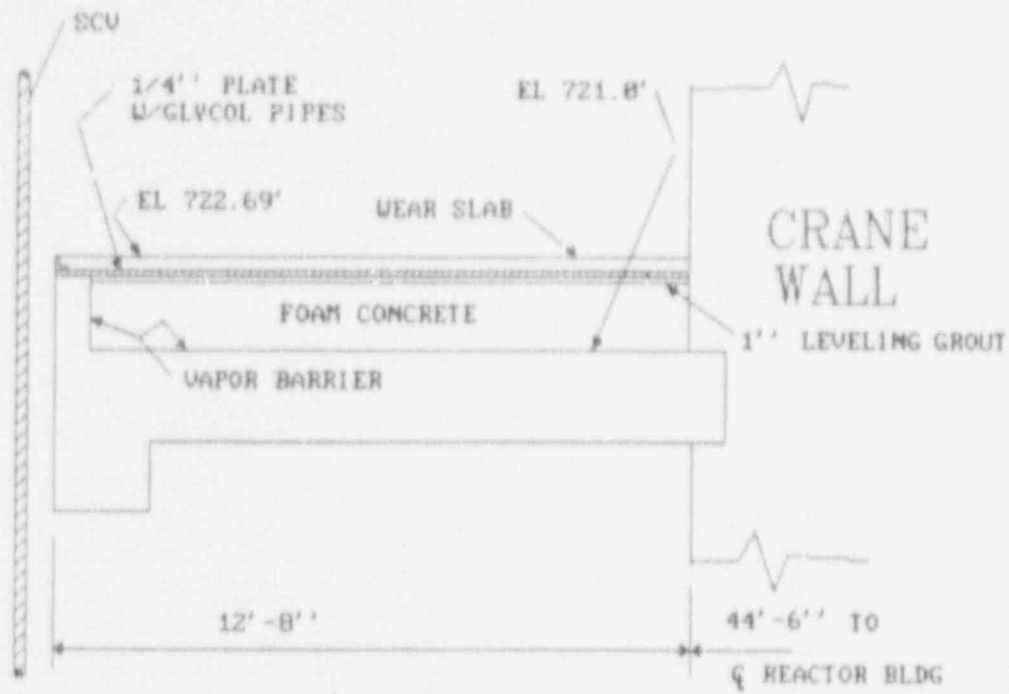
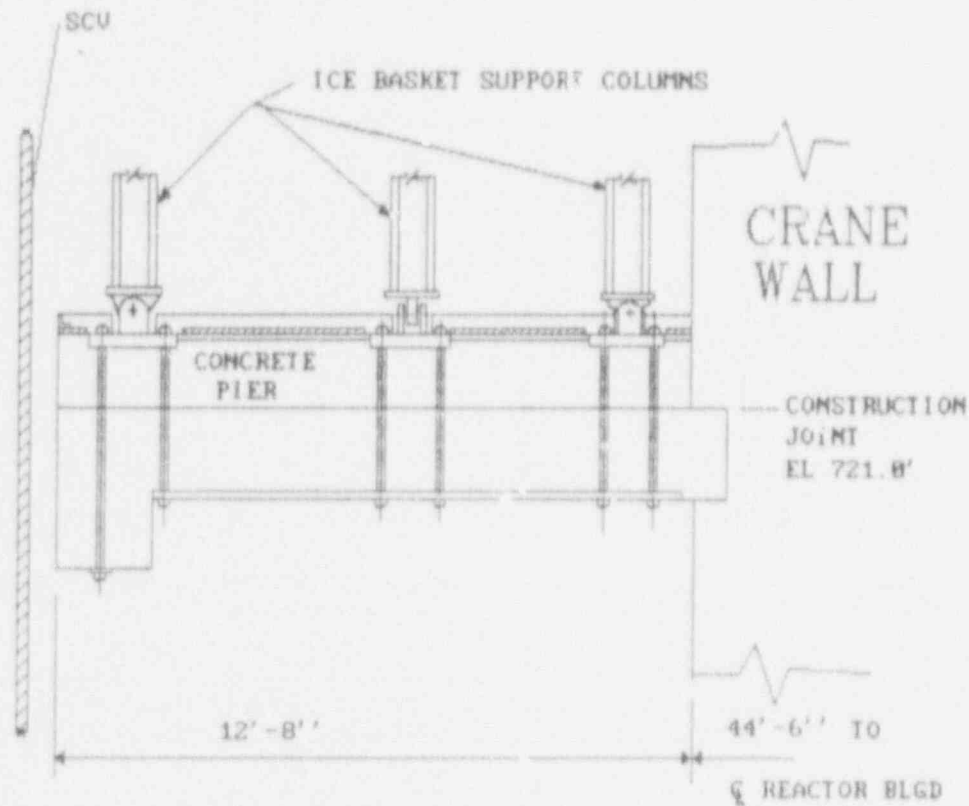
Figure 9

FOAM CONCRETE FILL SECTION

CONCRETE PIER/BASEPLATE SECTION

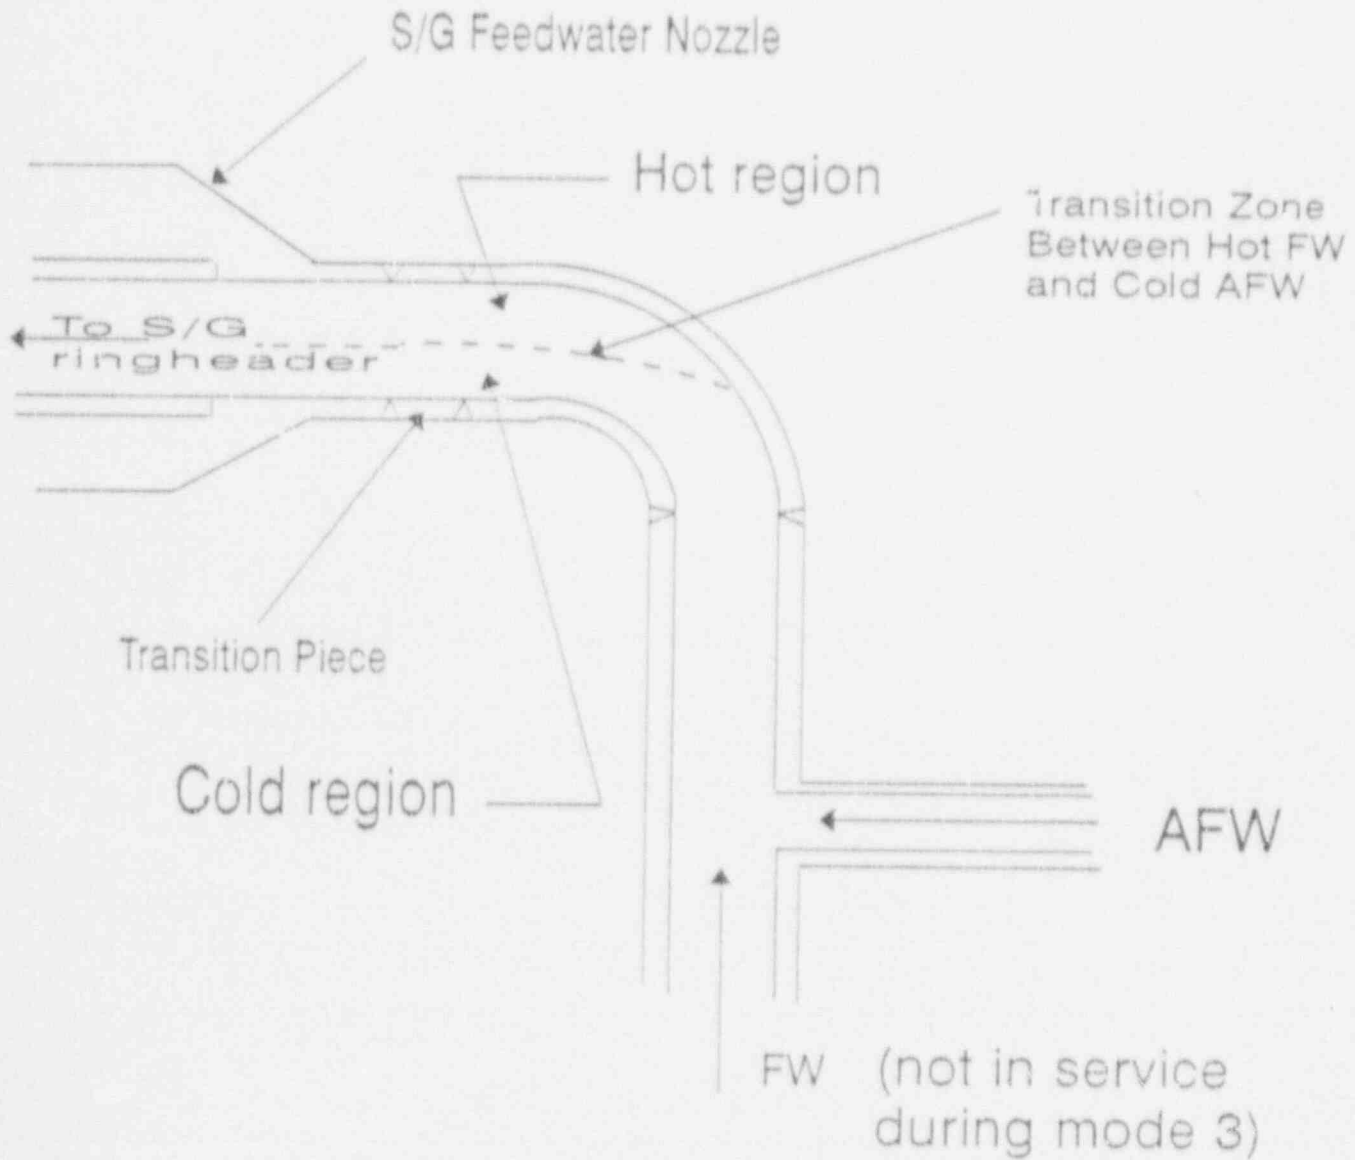
FIGURE 1

# HALF-PIPE FLOW

RADIOGRAPH INSPECTION RESULTS OF STEAM GENERATOR FEEDWATER NOZZLE

UNIT	CRACKING IN TRANSITION TO ELBOW WELD		CRACKING IN TRANSITION TO NOZZLE TO APPROX.	LOCATION	LENGTH	COMMENTS
	SG	WELD				
1	N	N	-	-	N/A	Intermittent machine marks confirmed on Construction Radiographs
2	N	N	N/A	N/A	N/A	
3	N	Y	270°		6.7"	Nozzle weld FDF-131, transition side of root.
4	N	Y	90° & 270°		1. 90° 5.3" 2. 270° 4.9" 3. 270° 5.5"	1. Noz. Weld FDF-022 transition side of root 2. Noz. Weld FDF-022, multiple circumferential cracks Transition side of root 3. Noz. Weld FDF-022 nozzle side of root
2	N	Y	Essent. Top Dead Center (0°)		5.1"	Noz. Weld FDF-011 Transition side of root
2	N	N	N/A		N/A	N/A
3	N	Y	90° & 270°		1. 90° 0.4" 1. 90° 2.4" 2. 270° 6.7"	1. Noz. Weld FDF-131 Transition side of root 2. Noz. Weld FDF-131 Transition side of root
4	N	Y	90°		1.6"	Noz. Weld FDF-022 Transition side of root

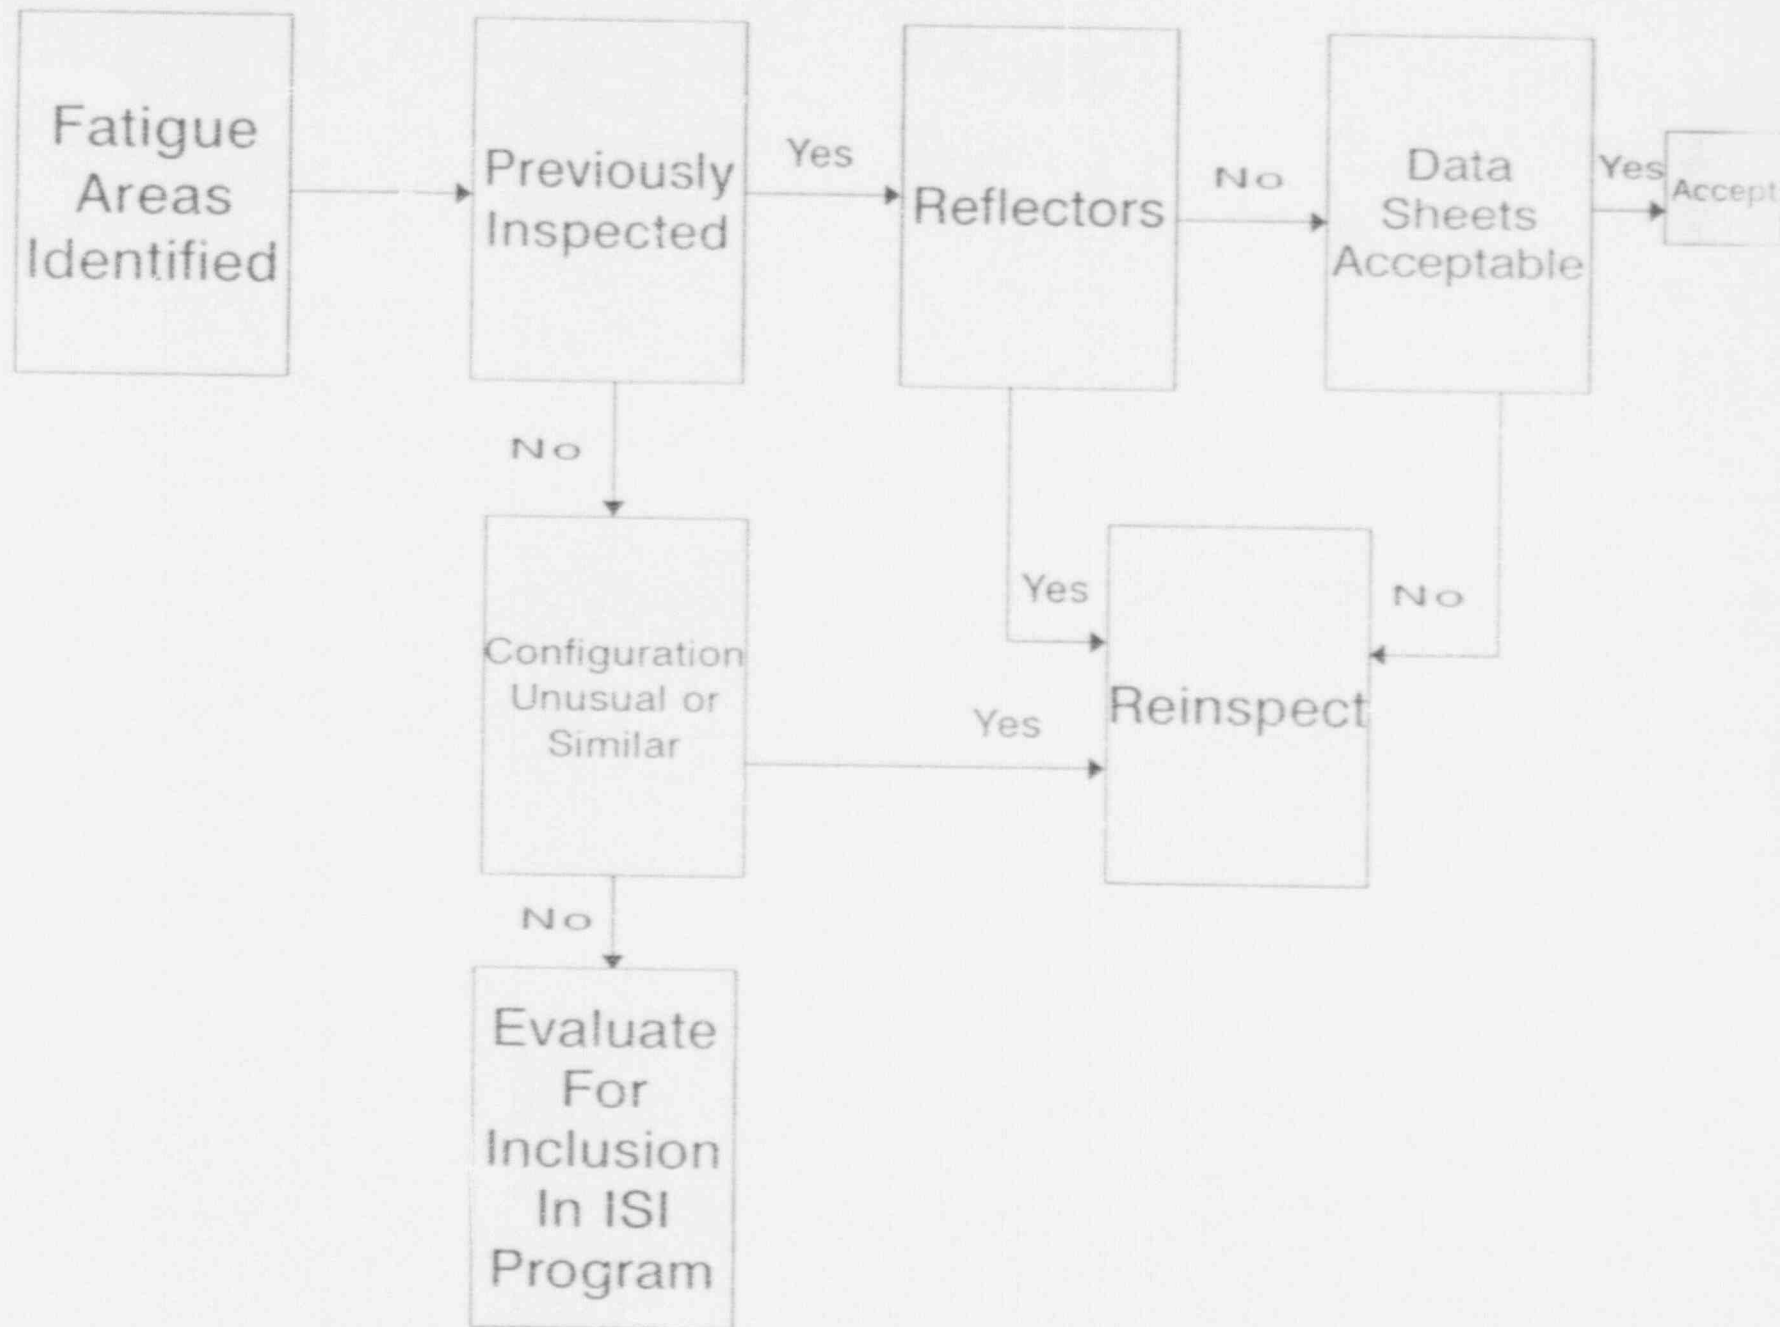
## VII. EVALUATION OF EXTENT OF CONDITION FAILURE MECHANISM

- **Failure Mechanism - Thermal Stratification**
- **Inspection Process/ Technique - Geometry**
- **Disposition of Indications - Reflectors**
