U.S. NUCLEAR REGULATORY COMMISSION  
REGION I

Report No. 50-293/84-14

Facility Name: Pilgrim Nuclear Power Station

Inspection on May 9-11, 1984 (Report No. 50-293/84-14)

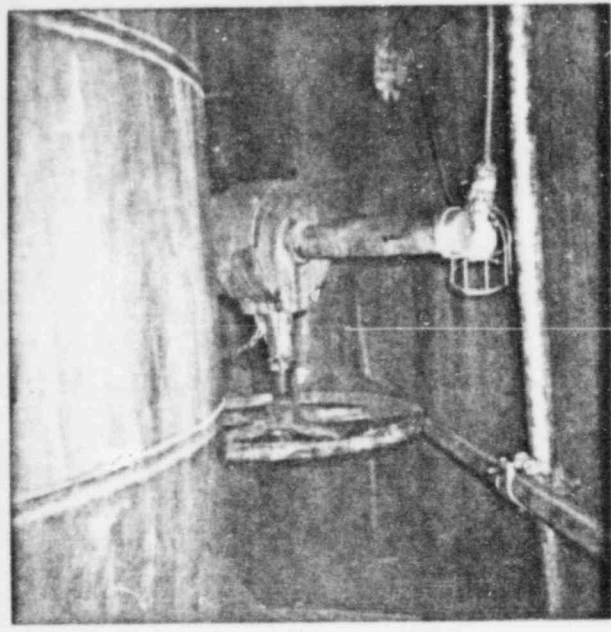
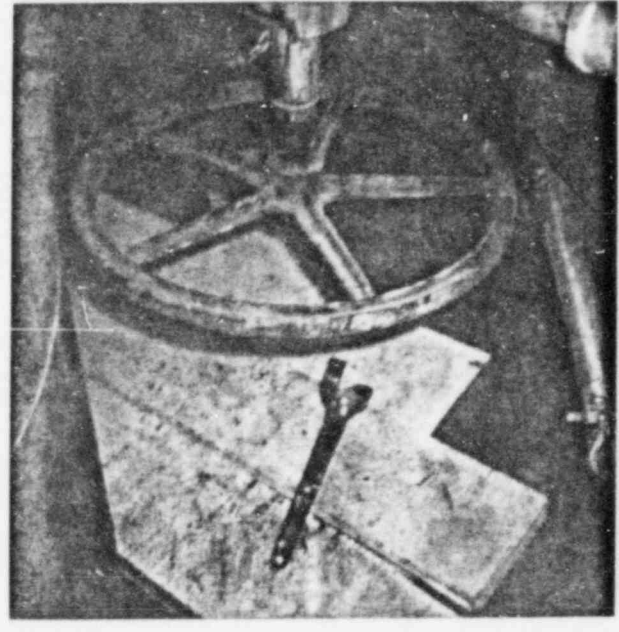
"A" RHR Heat Exchanger Outlet Valve, 1001-17A

<u>Parameter</u>	<u>May 4 Survey</u>	<u>May 7 Survey</u>
Airborne Activity	1.7% MPC (1.49 E-10 uCi/ml)	30% MPC (3.22 E-9 uCi/ml)
Airborne Posting	No	Yes
Surface Contamination	150,000 dpm/100 cm <sup>2</sup> (in vicinity of valve 1001-17A)	180 mrad/hr/100 cm <sup>2</sup> , <sup>B</sup> 8 mr/hr/100 cm <sup>2</sup> , <sup>X</sup> (on valve 1001-17A)

While performing the surveillance tour of the A-RHR quad, the operator manipulated the RHR heat exchanger outlet valve (No. 1001-17A).
