LICENSEE EVENT REPORT (LER)

FACILITY NAME (1) Callaway Plant Unit 1	DOCKET NUMBER (2) 0 5 0 0 0 0 4 8 3 1	PAGE (3) 1 OF 0 4
--	--	----------------------

TITLE (4)
RCS Depressurization Event

DOCKET NUMBER 50-483
CALLAWAY PLANT UNIT 1
FACILITY OPERATING LICENSE NPF-25
LICENSEE EVENT REPORT 84-016-00
DEPRESSURIZATION OF THE REACTOR COOLANT SYSTEM

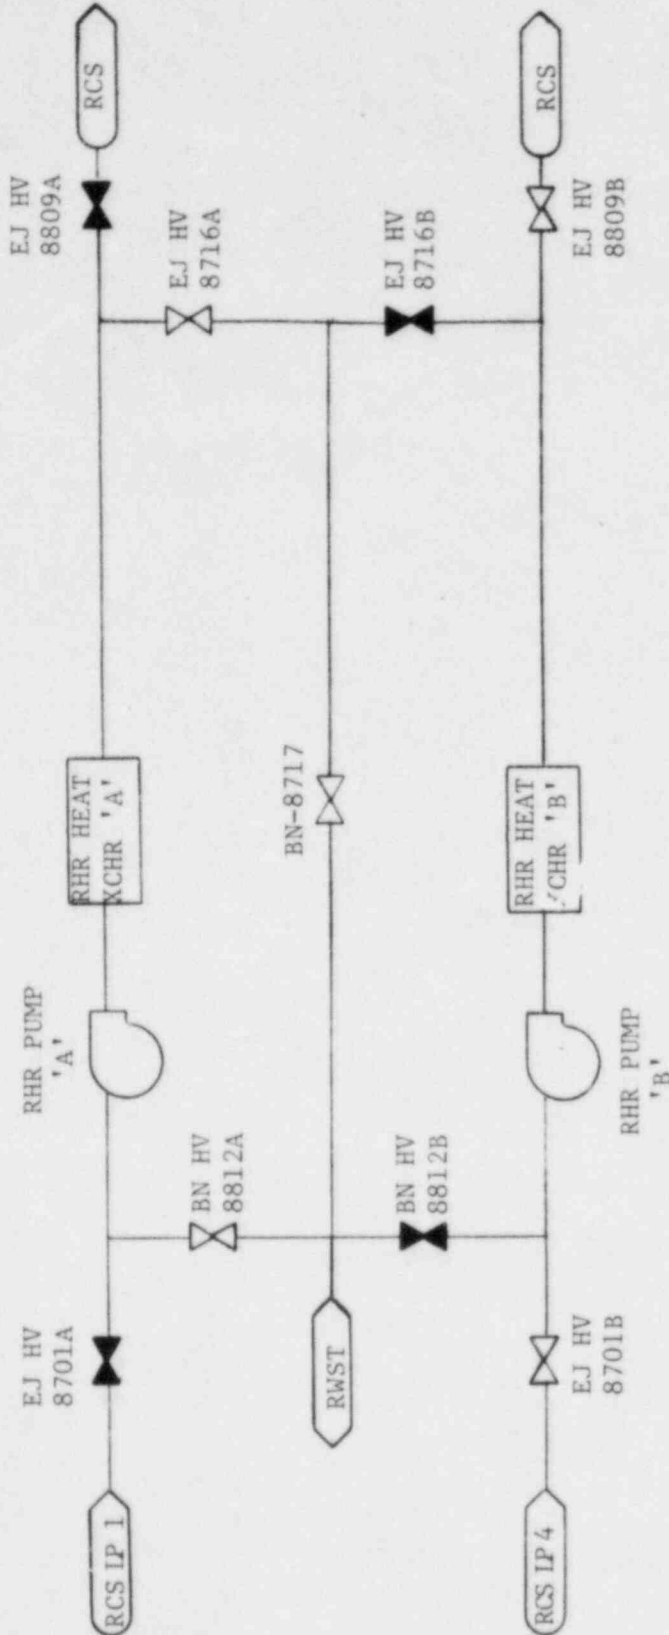
Figure 1: Simplified piping diagram
Residual Heat Removal System

The valve lineup just prior to this event is shown in Figure 1. The RHR Pump 'A' surveillance procedure was being completed and the restoration in progress. RHR Pump 'A' was secured and at 1309 CDT valve EJ-HV-8716B was opened per the surveillance procedure restoration. Coincident with opening this valve, there was suddenly a loss of RHR 'B' flow to the RCS, a drop of RCS pressure to approximately 0 psig and a 1% increase in RWST level. Also coincident with this event was a sharp drop in seal return flow from the RCP's.

Analysis of this incident revealed the root cause to be improper sequence of valve operation in RHR Train 'A' surveillance procedure OSP-EJ-P001A, "Section XI RHR Train 'A' Operability." The restoration checklist in the procedure specifies to open valve EJ-HV-8716B, "RHR Injection Balance Line Isolation Valve," prior to closing valve BN-8717, "RWST Return Line Manual Isolation Valve." Thus, when valve EJ-HV-8716B was opened, the RCS immediately depressurized through RHR 'B' discharge, valve EJ-HV-8716B and valve BN-8717 to the RWST, which is at atmospheric pressure. This accounts for the 1% increase of RWST level at the time of the incident. This procedure had been utilized on at least two previous occasions under different plant configurations without incident. However, the procedure was in error for this particular configuration with RHR Train 'B' aligned to the RCS.

Temporary Change Notice 84-788 was issued 7/17/84 to correct the procedure restoration checklist valve lineup. Similar procedures were also reviewed for system impact when performed in various plant operating conditions.
