NUREG/CR-3894

**ULTRASONIC AND METALLURGICAL EXAMINATION
OF A CRACKED TYPE 304
STAINLESS STEEL BWR PIPE WELDMENT**

J. Y. Park and D. Kupperman

January 1984

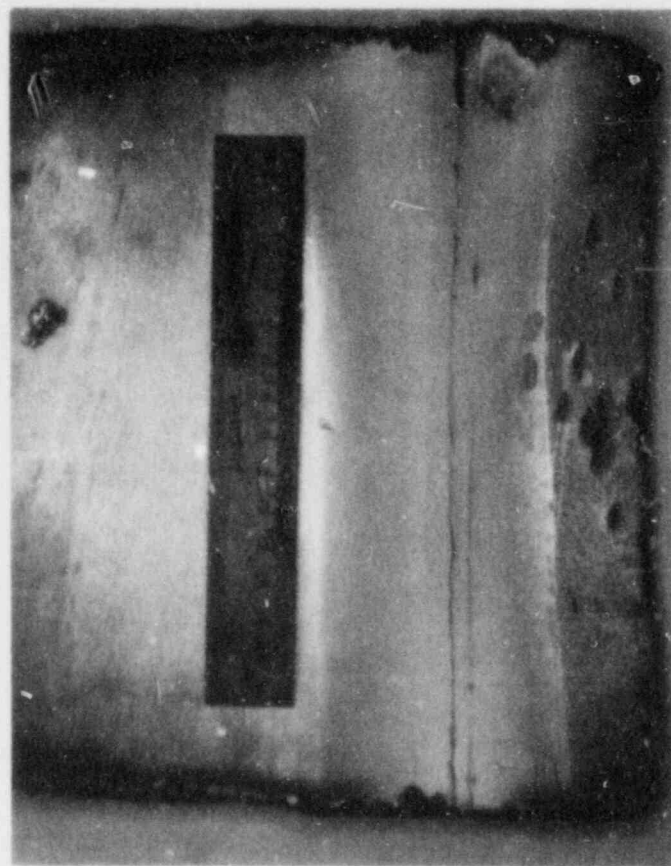
The pipe manifold end-cap weldment was decontaminated with inhibited solutions of potassium permanganate/potassium hydroxide and phosphoric acid (Turco Decon 4502 and Turco WO No. 2) in order to remove corrosion film and reduce radioactivity. Magnaflux dye penetrant was then applied to the inner surface of the weldment. Extensive penetration of the dye was observed at the weld fusion line (WFL) on both sides of the weldment (dark lines in Fig. 2). However, destructive examination of the weldment section (discussed below) showed that the dye penetrated mostly through geometric discontinuities and undercuts at the WFL.

Fig. 2. Manifold End Cap of Hatch-2 after Dye Penetration
Check of Inner Surface.

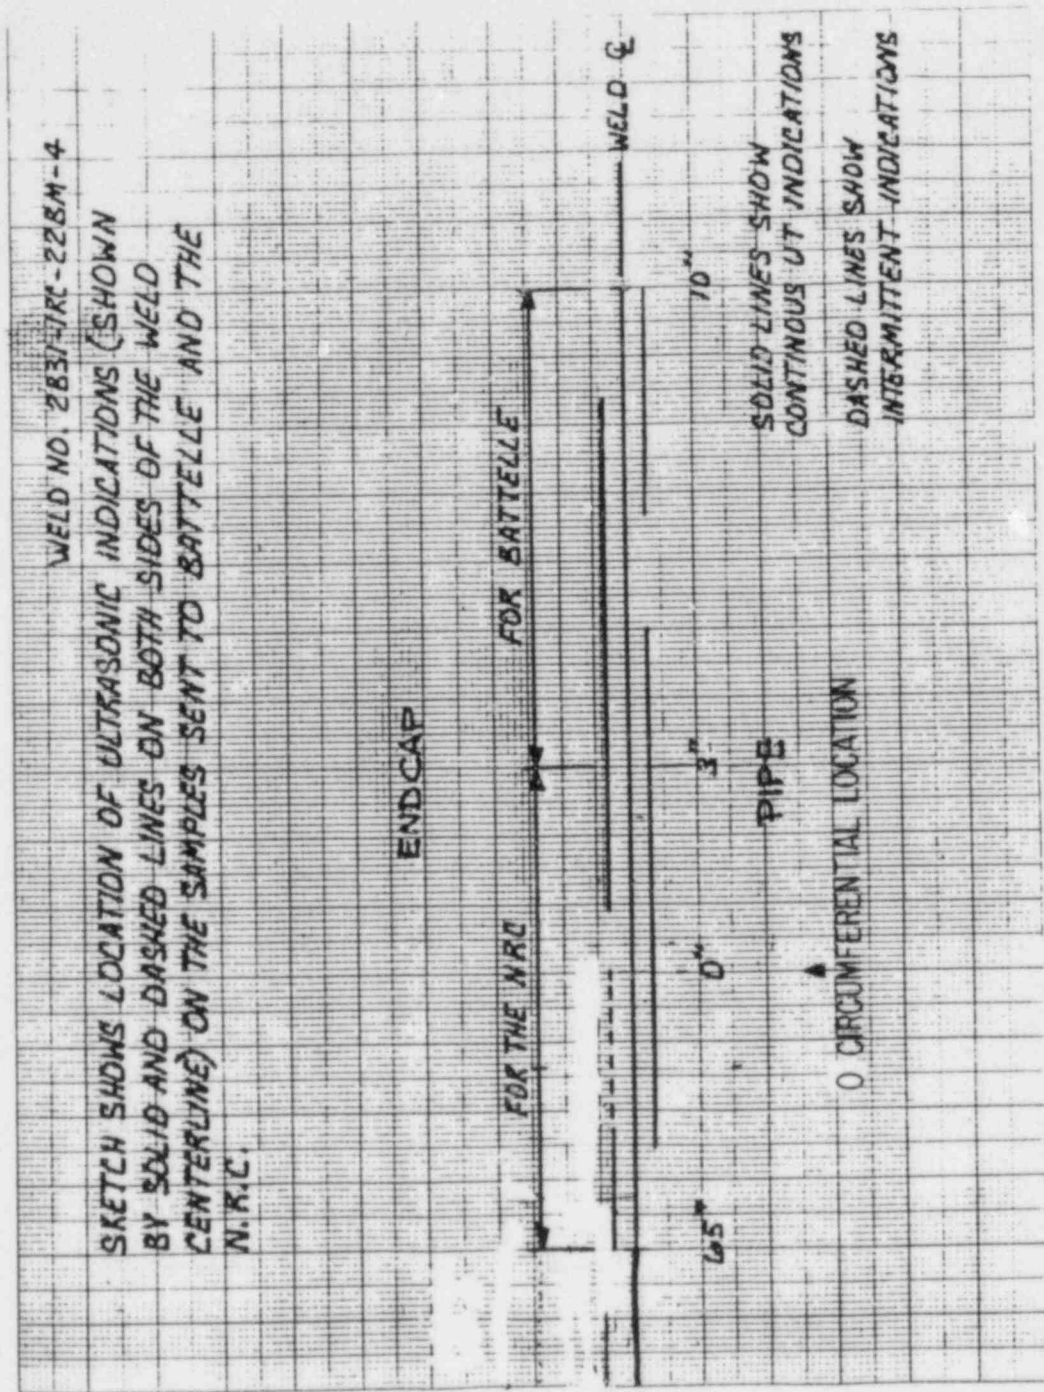
The results of the ultrasonic ISI, which was performed according to NRC I&E Bulletin 83-02, were provided to ANL by the Georgia Power Company and are reproduced in Fig. 3. The results of the ISI indicated that circumferential cracks had developed on both sides of the weldment to a depth of 30% of the pipe wall thickness. The location of the ultrasonic test (UT) indications, however, does not agree with the location of the actual crack, as discussed in the next section. The crack depth estimated from the UT indications is in general agreement with the actual value. However, data will be presented in the following sections to show that this agreement is probably a coincidence.

Fig. 3. Results of Ultrasonic In-Service Inspection of Hatch-2 End Cap.

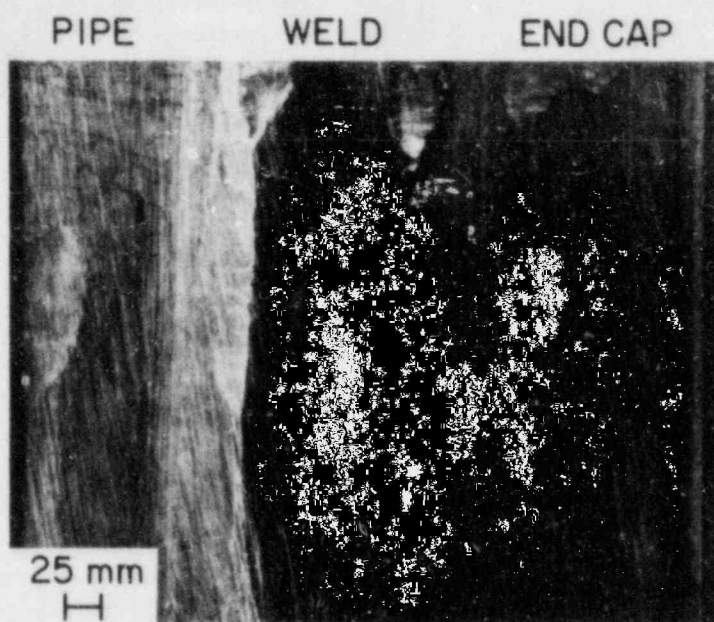
Postweld grinding marks were visible on the inner surface of the weld crown and at the heat-affected zone (HAZ), as shown in Fig. 4. Postweld grinding of the HAZ is known to increase susceptibility to cracking, since it introduces heavy cold work and unfavorable residual stresses.¹

Fig. 4. Inner Surface of End Cap Weld Crown and HAZ. Showing Postweld Grinding Marks.

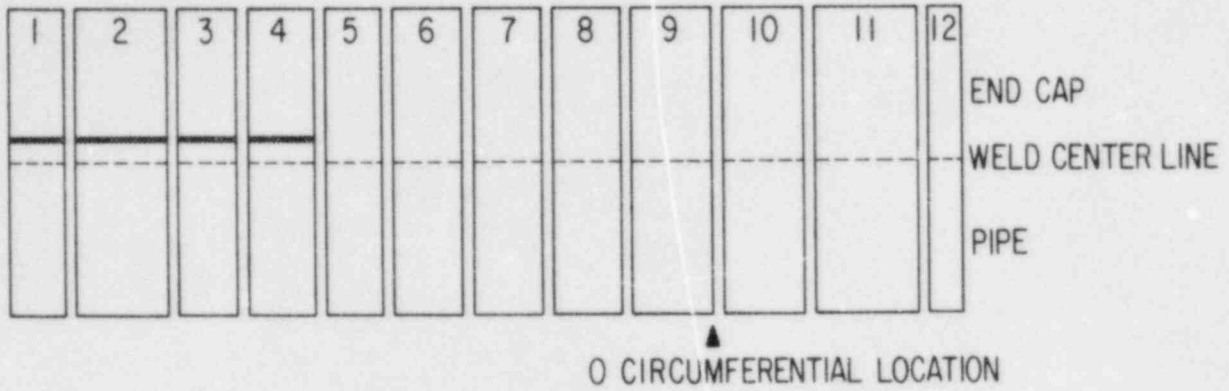
The weldment was sliced into 12 pieces (0.25 to 1 in. in width) by sawcutting in the axial direction (Fig. 5). Cross sections of the weldment were examined for cracking at metallographically polished faces of the slices. Cracks were observed in the end-cap side of the weldment sections between circumferential locations 4 to 7 inches from the reference mark 0* (Sections 1 through 4 in Fig. 5). There was no cracking on the pipe side of the weldment. The cracks initiated at the inner surface close to the WFL in the HAZ. The cracks are intergranular but they have not propagated into the weld metal more than a quarter of a grain diameter. They appear to be typical of intergranular stress corrosion cracks (IGSCCs) which have been observed frequently in sensitized Type 304 SS under stress in BWR or oxygenated-water environments (see Fig. 6). The depth of the crack in each slice of the weldment was optically measured at 50X magnification and plotted in Fig. 7. The maximum depth was 0.265 in. (23% of the nominal pipe wall thickness of 1.125 in.) at the circumferential location -4.7 in. (Fig. 7). This value is consistent with the ISI estimate that the maximum crack depth was 30% of the wall thickness, but the results discussed in the next section of this report suggest that the agreement is fortuitous. Undercuts at the WFL of the weld on the end cap side were observed at the inner surface, as shown in Fig. 8.

Fig. 5. Hatch-2 End Cap Weldment (No. 2B31-1RC-22BM-4) Sectioned to Examine Cracking (Viewed from the OD). The sections containing cracks (sections 1 to 4) are marked with xxxx.

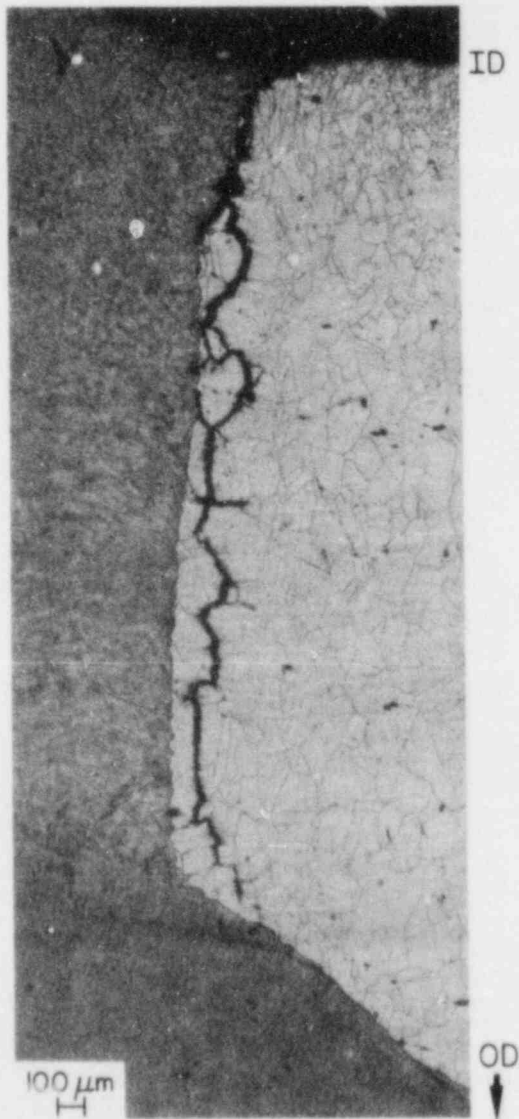
Fig. 6

1. Intergranular cracks with a maximum depth of 0.265 in. were observed in the HAZ of the end cap side of the weldment. The cracks are similar to the IGSCCs observed in the sensitized Type 304 SS components of other BWRs. The cracks were located close to the WFL, but did not propagate more than a half-grain diameter through the weld metal.

Intergranular Crack in HAZ
of End Cap at -6.25 in.
from the Reference 0.

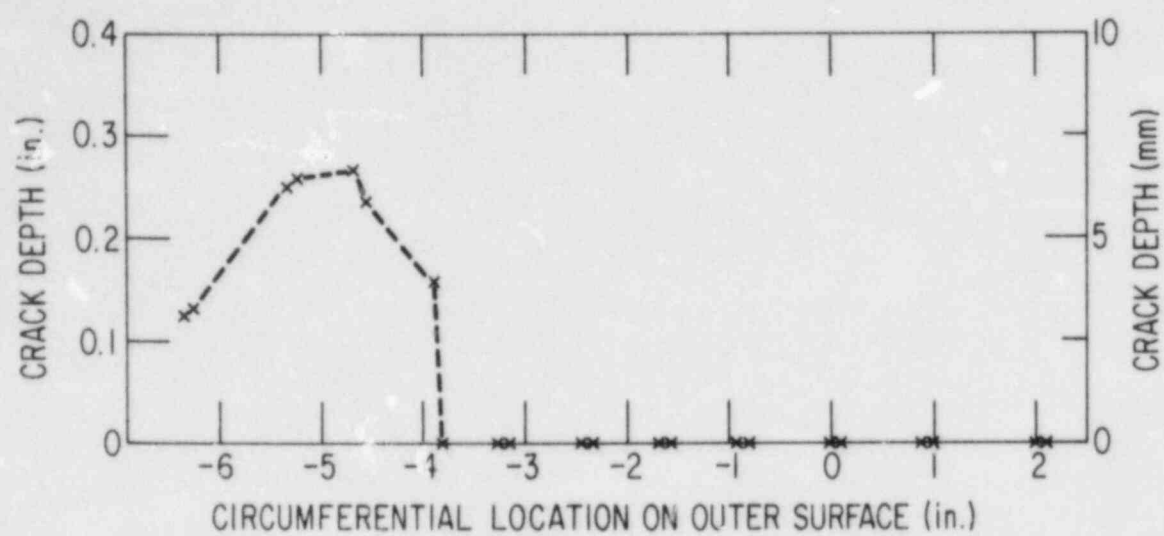
Fig. 7. Crack Depth vs Circumferential Location.

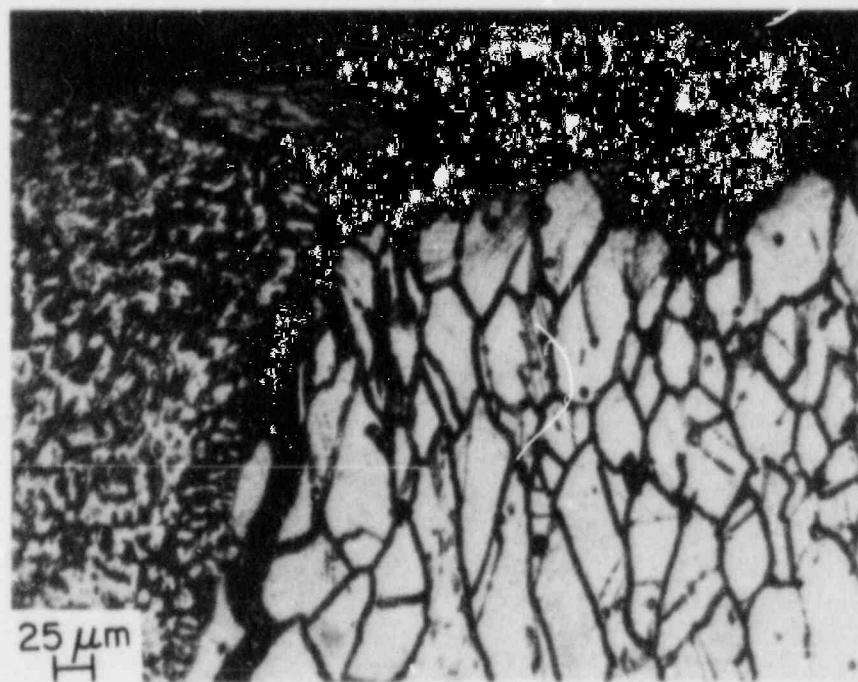
Fig. 8. Undercut at Weld Fusion Line of the End Cap.

Crevice conditions may have occurred in the undercuts; however, it was not possible to determine accurately from metallographic examination whether the crevice formation would have been severe enough to initiate cracking.

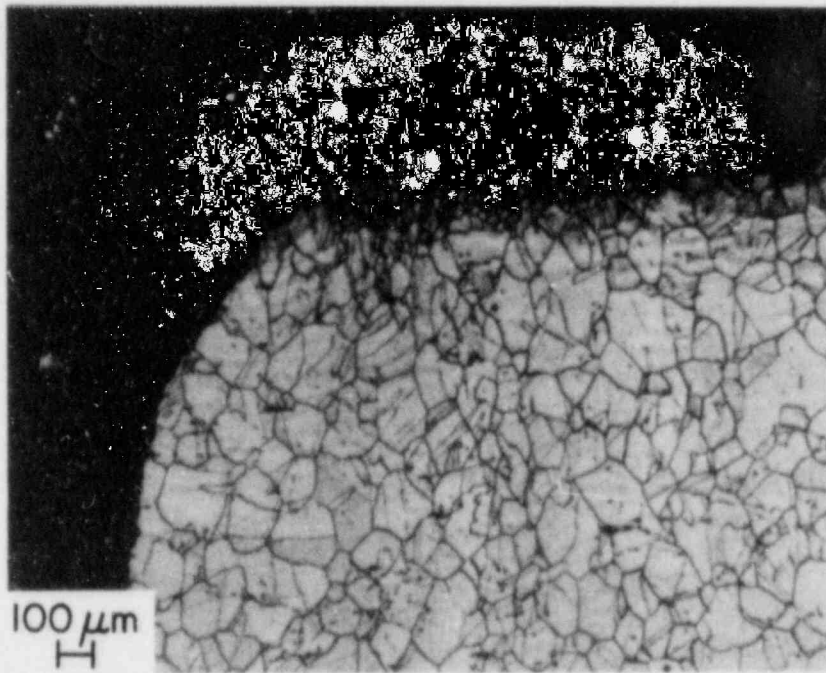
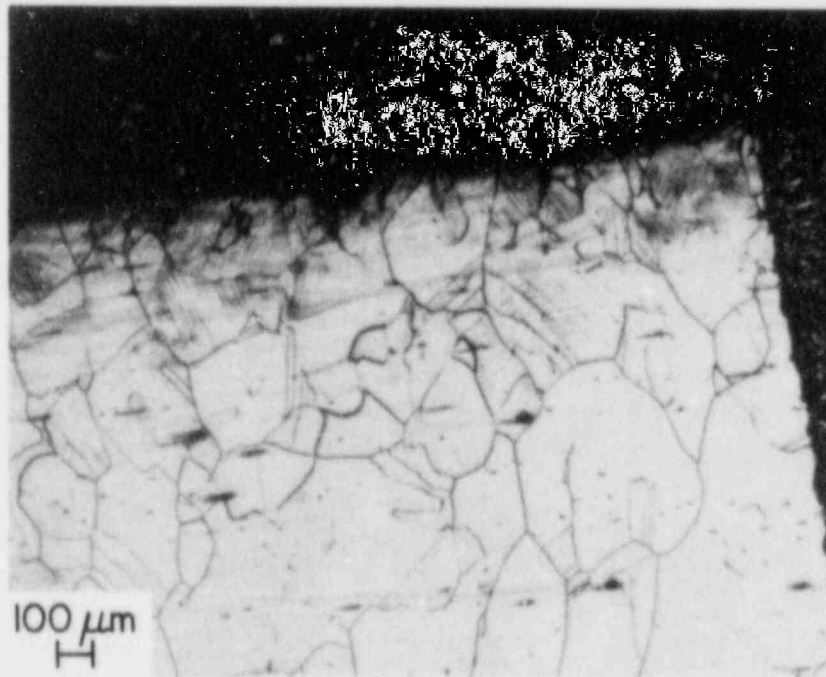
The degree of sensitization (DOS) in the HAZ of the weldment was measured by the ASTM A262-A and -E and the electrochemical potentiokinetic reactivation (EPR) methods.² The ASTM A262-A test showed that the DOS is higher on the end cap side of the weldment (ditch structure) than on the pipe side (dual structure), as shown in Figs. 9a and 9b. The ASTM A262-E test also showed that the end cap side is significantly sensitized: intergranular attack was observed at the end cap side about 2.5 mm from WFL to a maximum depth of 0.5 mm (Fig. 10), while no intergranular attack was visible at the pipe side. The EPR measurements were performed at different locations (0.3-2 mm from the WFL) in the HAZ, and the EPR values ranged from 22 to 29 C/cm² for the end-cap side and from 37 to 50 C/cm² for the pipe side. However, the correlation of the measured EPR values with grain boundary sensitization or intergranular corrosion susceptibility is less satisfactory for this weldment than in many other cases because of the presence of many intragranular precipitates in the base material and the large grain size of the pipe material (ASTM No. 0.3). The electrochemical potentiokinetic activation ratio (EPAR) was also measured.³ The EPAR value was 5% for the end cap and 1.5% for the pipe. It has been reported that materials with EPAR values of less than 1% possess excellent resistance to intergranular stress corrosion cracking.³

Fig. 9. Results of ASTM A262-A Etch Test. (a) End cap side; (b) pipe side.

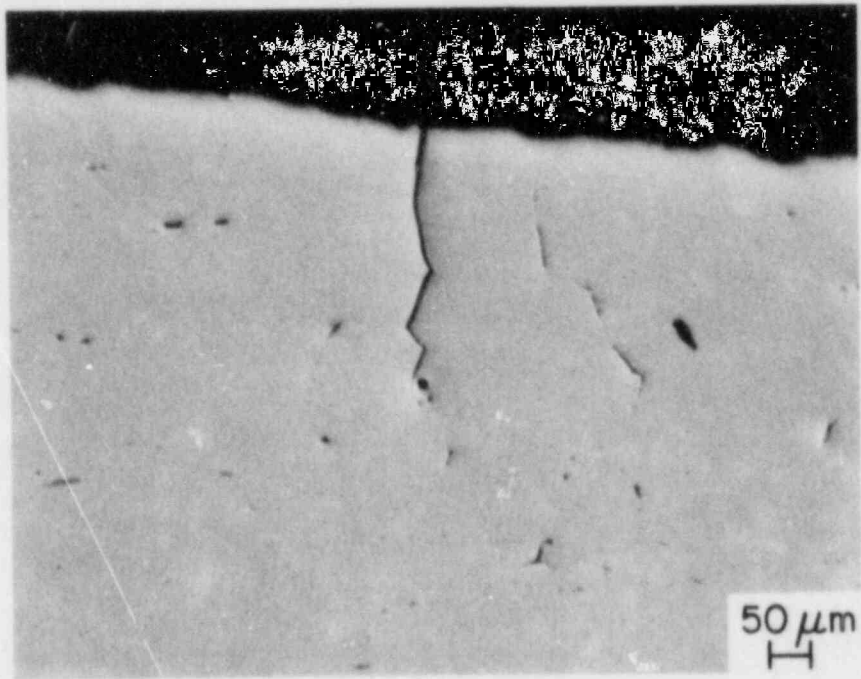
Fig. 10. Intergranular Fissure in HAZ of End Cap Weldment after ASTM A262-E Test.

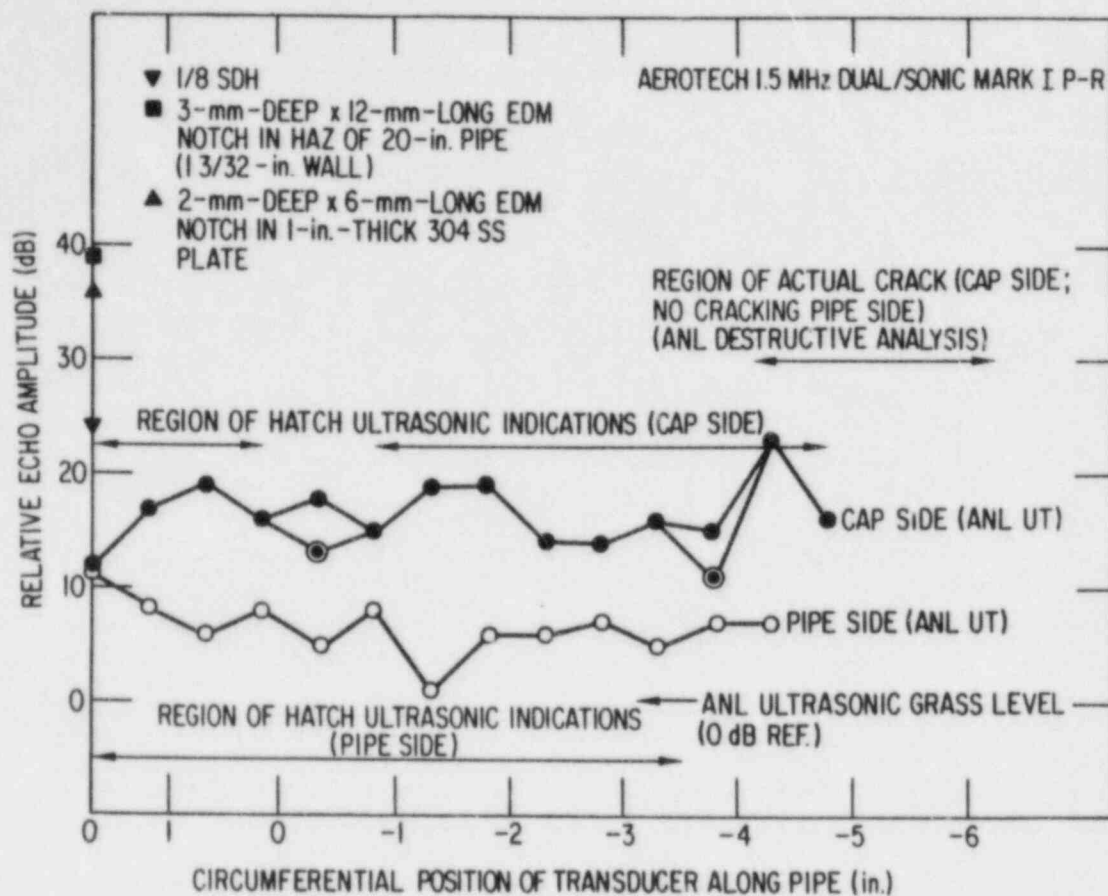
A laboratory ultrasonic examination was performed before the destructive examination described in the previous section. ANL personnel examined the specimen with a Sonic Mark I pulser-receiver, a KB-Aerotech dual 1.5-MHz, 45° shear-wave probe, and Ultragel couplant. A 32-mm-diam side-drilled hole was used as a reference reflector. Figure 11 shows the ultrasonic echo amplitude data as a function of the circumferential position of the transducer; the indications reported by Hatch are also shown in this figure. The amplitudes of echo signals obtained from both sides of the weld were generally greater than 10% of DAC values, and showed a variation of 10 dB. The echoes from the cap side had greater amplitudes than those from the pipe side. The ISI suggested that cracks were present on both sides of the weld, but subsequent destructive analysis revealed a crack on the cap side only. The largest echo signal observed at ANL was from this region but it was only a few dB larger than the cap-side signals that were produced by geometrical reflectors. At each of two cap-side probe positions, two separate signals with different transit times were detected. In such a case, the two signals could be interpreted as arising from a crack and from the weld root, respectively. However, destructive analysis revealed that no cracks were present at one of those positions. Both signals at that position were attributable to geometrical reflectors.

Considerable overcalling of cracks is evident in this example. The overcalling appears to be due to the presence of the undercuts on the cap side of the weld and a weld root oriented in such a way that relatively strong signals reflected from the root were detected with the transducer on the pipe side.

Fig. 11. Ultrasonic Echo Amplitude Data as a Function of Circumferential Position of Transducer. In the two locations indicated by dotted circles, two distinct but very closely spaced echoes were observed simultaneously from the cap side.

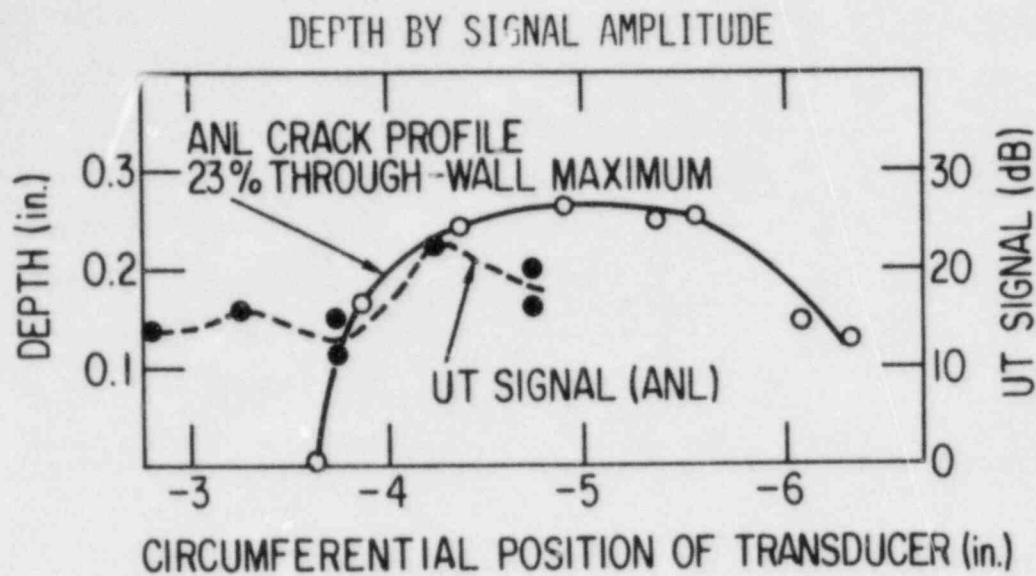
It is generally believed that IGSCC depths cannot be accurately estimated from the amplitude of the ultrasonic echo signal. This is because the amplitude is affected by the extreme tightness of the crack, the presence of corrosion products between crack surfaces, branching of the crack, and the irregular crack faces. Figure 12 shows the echo signal amplitude as a function of circumferential position and the crack depths obtained from destructive examination. As expected, there is no correlation between crack depth and echo amplitude. (The irregular cutting of the as-received specimen prevented ultrasonic data from being acquired near the end of the crack.)

Fig. 12. Comparison of Actual Crack Profile with Echo Signal Amplitude as a Function of Circumferential Position of Transducer.

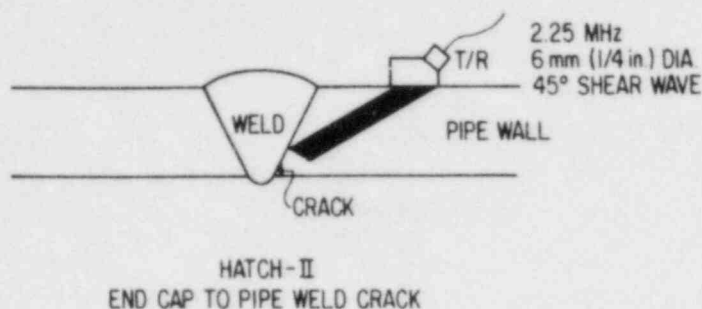
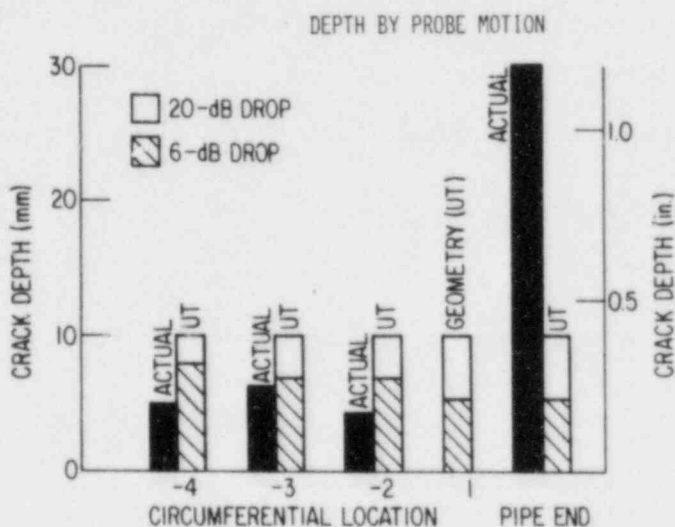
This technique can provide useful data for reflectors with surfaces normal to the ultrasonic beam, with very rough surfaces, or with irregular geometry. However, in situations where the pipe inner surface was inaccessible or where angle beam waves were used, attempts to measure IGSCC depths have been unsuccessful; shallow crack depths were overestimated and deep ones were underestimated.⁴ The ANL data presented in Fig. 13 are consistent with previous experience. Flaw sizes estimated from the 20-dB drop points, obtained with a 0.25-in., 2.25-MHz, 45° shear-wave probe, were independent of actual depth. Furthermore, the same level of response was obtained when a geometrical reflector or the end of the pipe was examined. Similar results were obtained with 6-dB drop points; that is, no correlation was found between the results of the probe motion technique and the actual crack depth in the IGSCC specimen. From the 6-dB drop ultrasonic measurement, the crack depth was estimated to be 28% throughwall. This is close to the Hatch result (30% throughwall), which suggests that they used the 6-dB drop method.

Fig. 13. Application of Probe Motion Method to Sizing of Cracks in Hatch-2 End Cap Specimen. (Top) Schematic showing relative positions of transducer and crack; (bottom) results obtained with 20- and 6-dB drop points, compared with actual crack depth determined by destructive examination.
