MEETING SUMMARY OF APRIL 8, 1992 MEETING TO SUBJECT:

DISCUSS VERMONT YANKEE REACTOR VESSEL

FLAWS (TAC NO. M83100)

Vermont Yankee

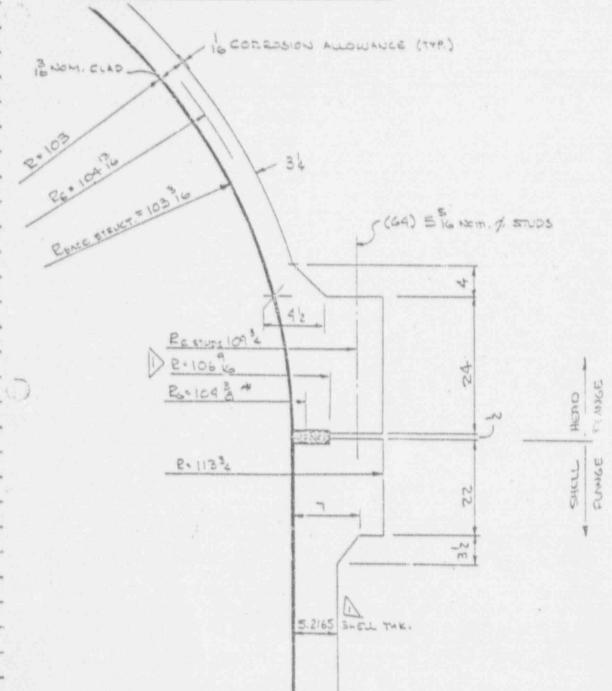
## B.Z FLANGE CONFIGURATION

- · STRESSES
  - Pressure/Bolt-up from Original Stress Report
  - Clad Stress
  - Weld Residual Stress
- FRACTURE MECHANICS MODEL
  - 360° Circumferential Crack in Cylinder
- CRACK GROWTH LAWS
  - SCC: Ford & Andresen Low Sulfur Law
  - Fatigue: ASME Section XI, Appendix A (Negligible)
- ALLOWABLE FLAW SIZE DETERMINED PER ASME SECTION XI, IWB-3600

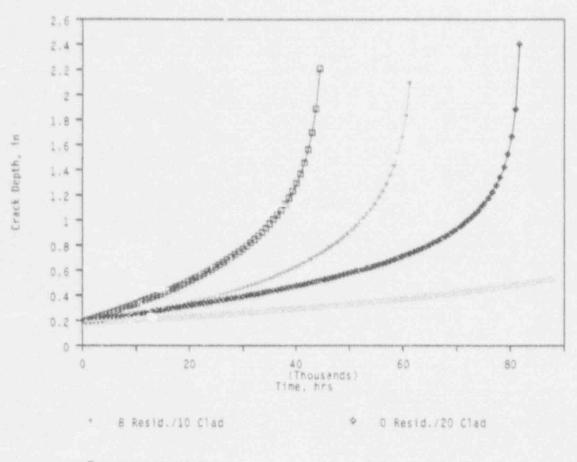
# Vermont Yankee Vessel Head

The licensee presented the results of its Fracture Mechanics Analysis. The licensee's fracture mechanics analysis indicated that cracks would not grow to an unacceptable size for at least 39,000 hours (4.5 years) of operation. Some further fracture mechanics information was requested by the staff which the licensee agreed to provide by April 10, 1992.

8 Resid./20 Clad

0 Resid./10 Clad

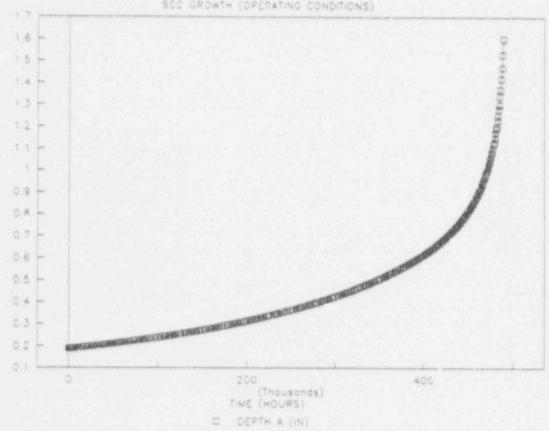
## VERMONT YANKEE STEAM DRYER BRACKET

- -More probable in manual clad regions due to low carbon content of machine welded clad (greater tolerance for carbon pickup)
- -Very low likelihood of propagation into low alloy steel basemetal
- -Detailed UT investigation of dryer support bracket indication, which is now known to be at least nine years old, demonstrates no propagation beyond the clad

- STRESSES
  - Pressure
  - Thermal
  - Clad
  - Bracket Loads
- · FRACTURE MECHANICS MODEL
  - 360° Circumferential Crack in Cylinder
- · CRACK GROWTH LAWS
  - SCC: Ford & Andresen Low Sulfur Law
  - Fatigue: ASME Section XI, Appendix A (Negligible)
- ALLOWABLE FLAW SIZE DETERMINED PER ASME SECTION XI, IWB-3600

SCC GROWTH (OPERATING CONDITIONS)
