UNITED STATES
NUCLEAR REGULATORY COMMISSION
WASHINGTON, D. C. 20555

In the Matter of
Texas Utilities Electric Company, et al.
(Comanche Peak Steam Electric Station, Units 1 and 2)
Docket Nos. 50-446 and 50-446

In Reply Refer To:
Docket: 50-445/84-17

Areas examined during the inspection included the teardown, inspection and reassembly of Unit 1 Train A Emergency Diesel Generator in accordance with the Transamerica Delaval recertification program.

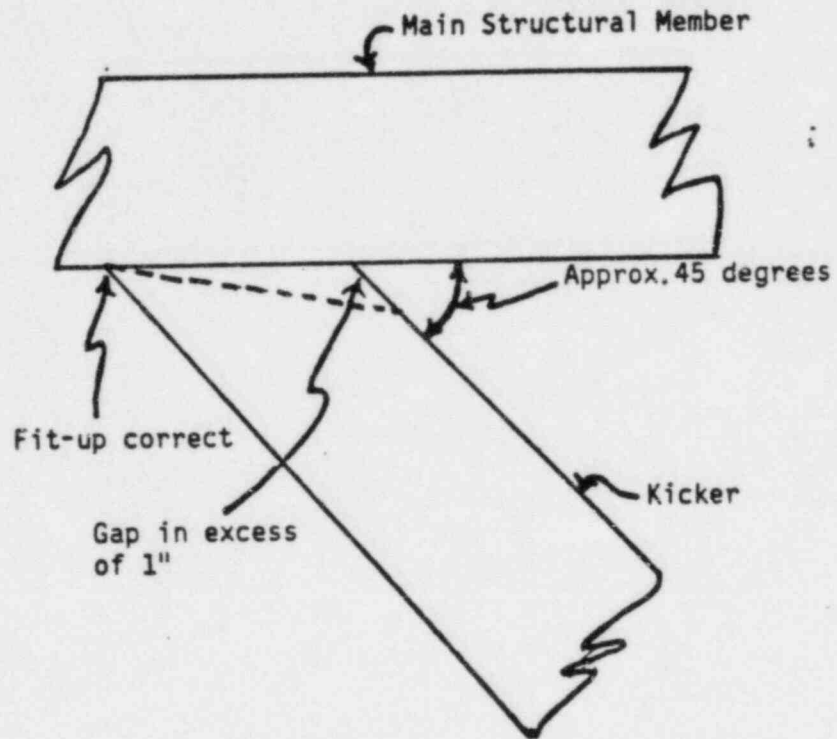
Figure 1

At the request of the NRC inspectors, the licensee had B&R grind and etch two areas on the support. Figure 2 shows the areas examined and the observation noted. In addition to the two etched areas examined, the NRC inspectors found that the weld joining the lower kicker to the main support member was consistent in appearance (approximately 1" wide) for the full length of both the upper and lower welds. On the inside angle of the kicker (45 degrees), a small edge of the weld prep (See Figure 3) was noted approximately 1-1/8" from the edge of

PLAN VIEW OF LOWER KICKER
JOINING MAIN STRUCTURAL MEMBER

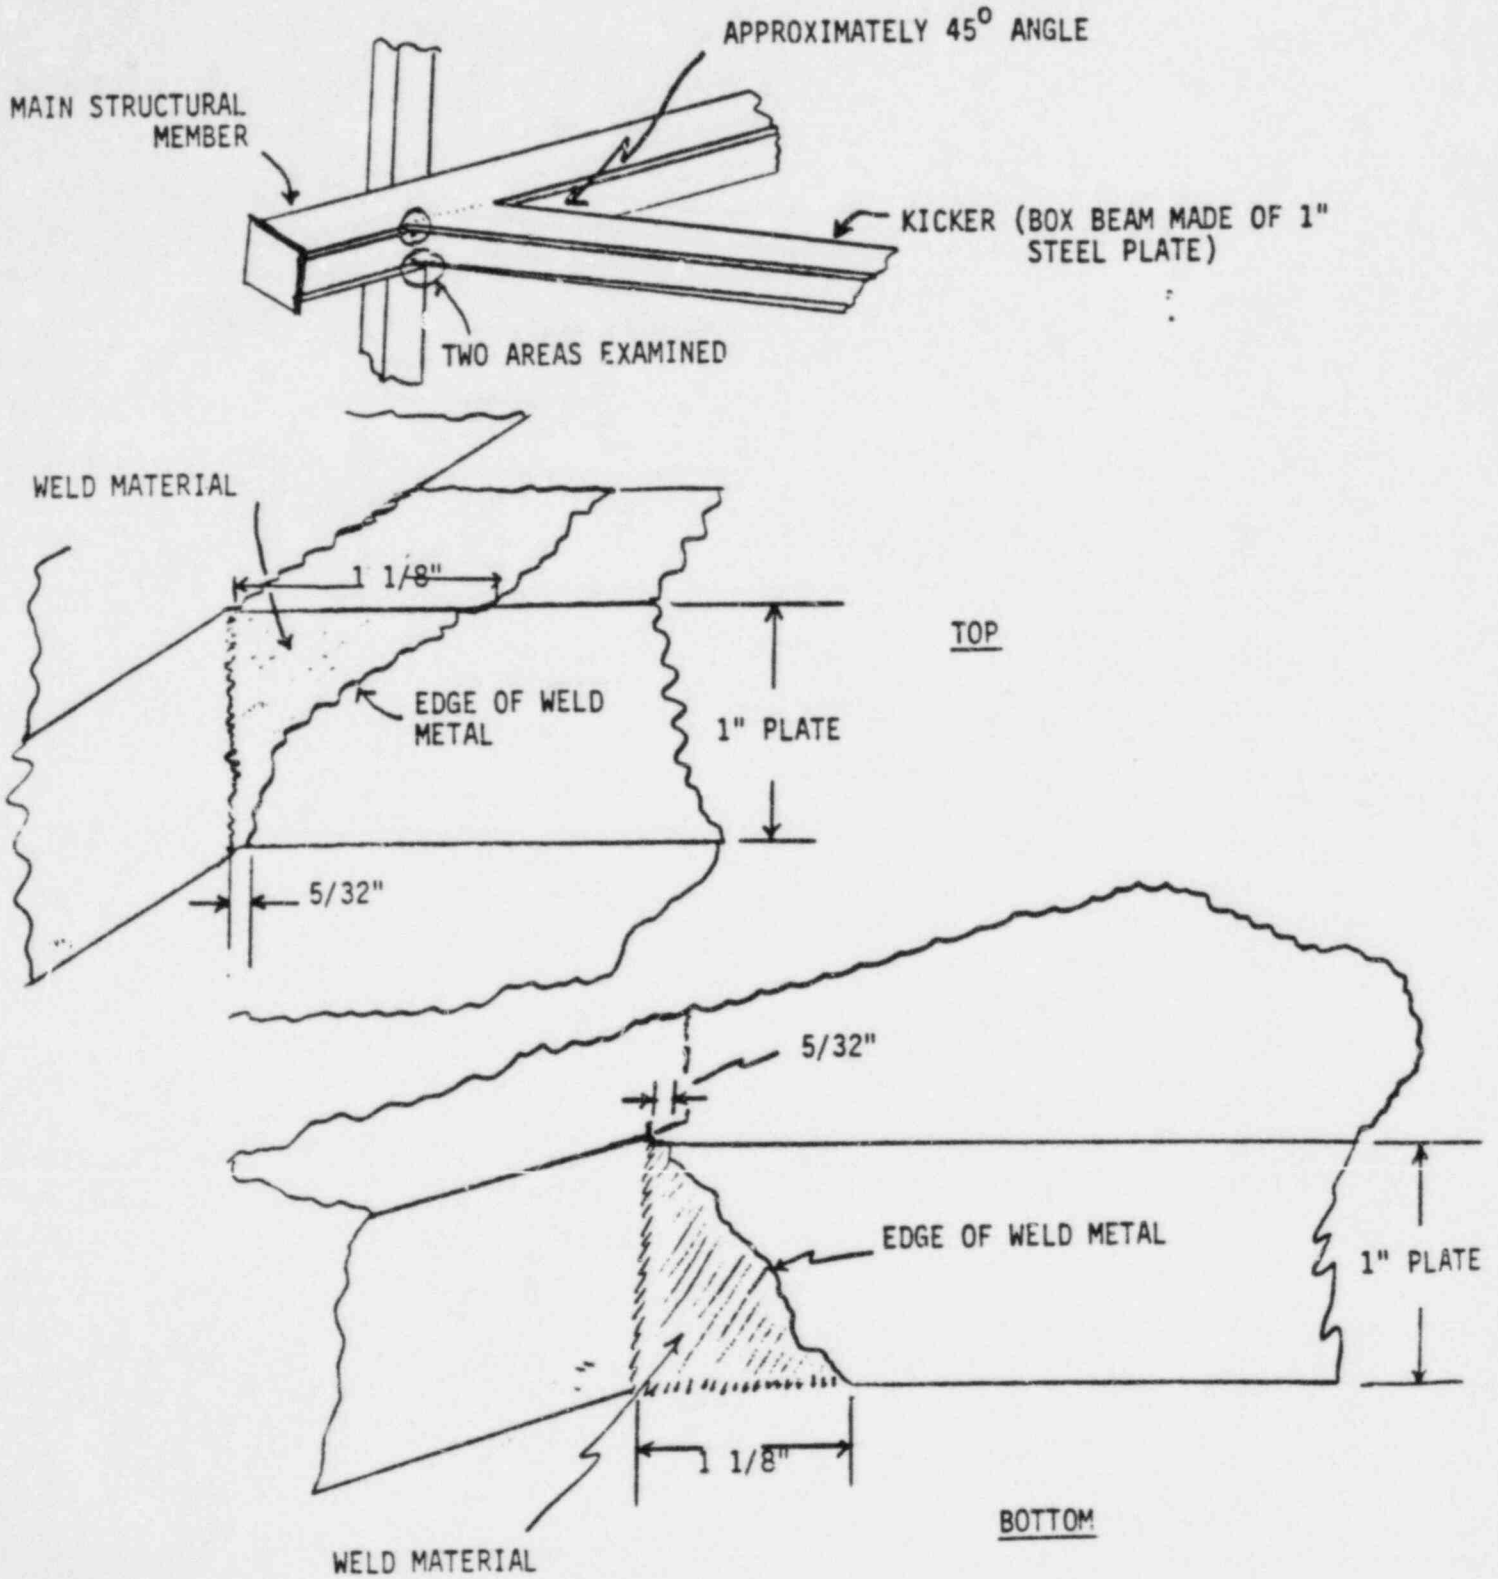
Figure (2)

plate A. The bottom weld was similar in appearance. The support had been painted; however, the size of the weld was noted to be consistent with the requirements of the B&R drawings and consistent with the experience of the NRC inspectors for similar type welds. Additional destructive testing was not done based on the evidence noted.

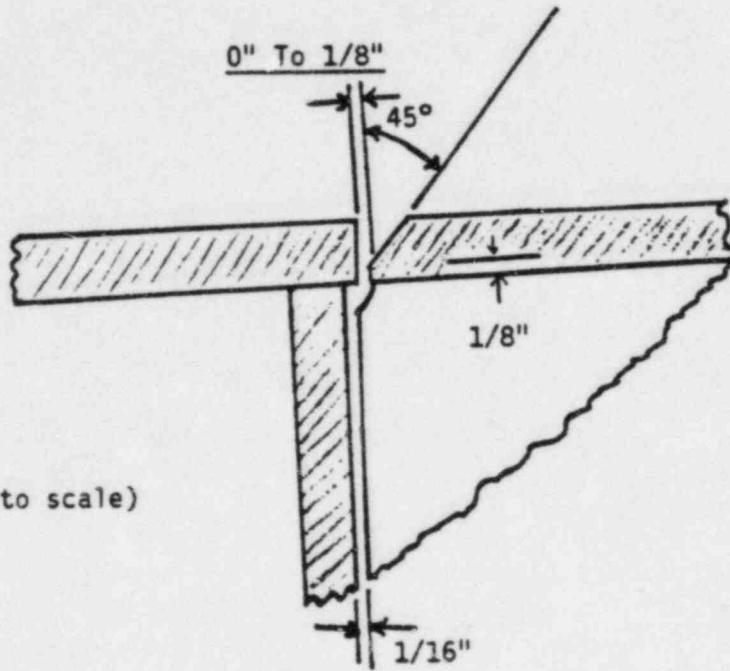
Figure 3

The NRC inspectors could not identify any evidence that would support the allegation regarding an excessive gap and unauthorized welding. There is evidence to support that the weld fit-up was done correctly. Observation of the etched areas and inspection of the remainder of the suspect weld confirmed that the requirements of the drawings were met. The requirement for weld preparation for the plates in question show that a 45 degree prep on a 1" plate for the full penetration weld with 1/8" clearance will give a 1" gap at the top of the area to be welded. See Figure 3. This is normal and according to procedures.

Lower plate has similar weld prep for full penetration weld

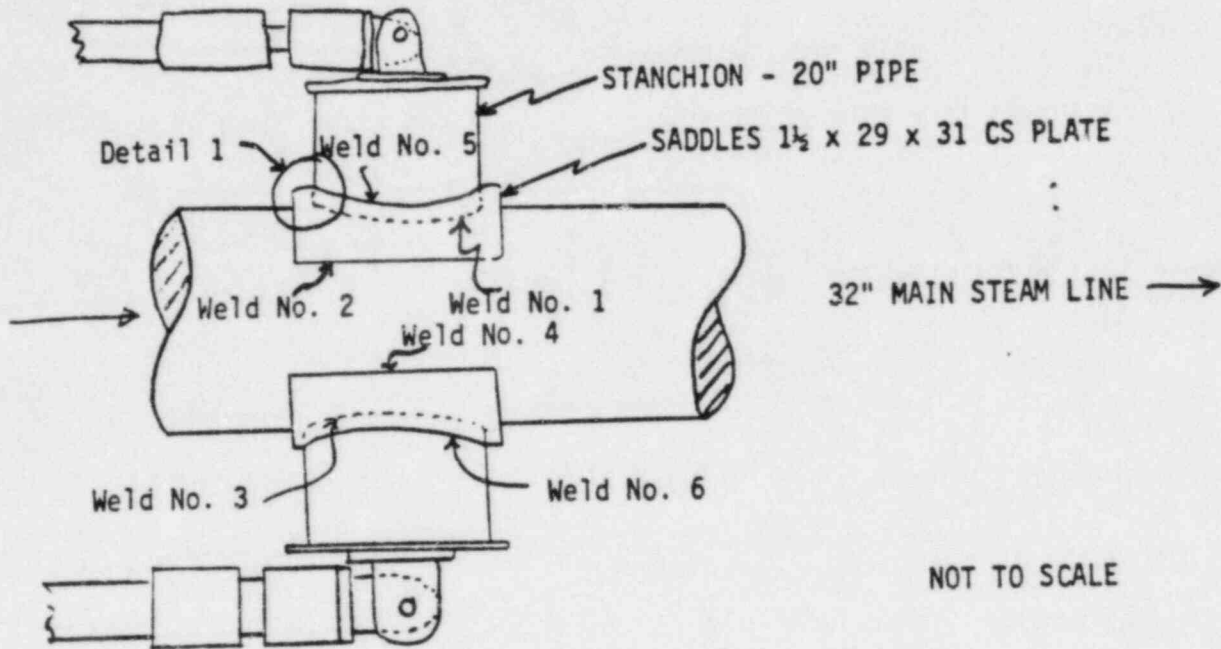
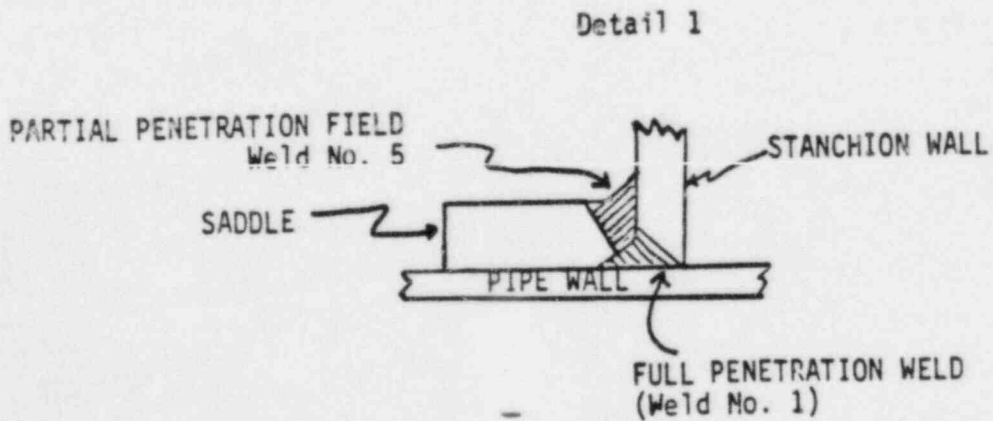
Figure 4
DETAILS OF MS-1-003-010-C72K

The allegor identified MS-1-003-010-C72K during the January 6, 1984, site tour. The specific problem identified was that the lower saddle had been heated to a "cherry red" condition and bent into shape around the main steam line using a come-a-long and a porta-power hydraulic jack.

During the January 26, 1984, discussion, the allegor stated that the lower saddle (on MS-1-003-010-C72K) had been cut into four pieces, and that the left hand, back quadrant piece had been heated and bent into position with a porta-power unit, a 1 ton chain "come-a-long," and hammering. The heating and bending operation was not an approved method or procedure. In addition, the allegor stated that he, in company with a welder, went to B&R management with this allegation. To the best of the allegor's knowledge, nothing was done by B&R to resolve the problem.

- MS-1-003-010-C72K stanchions were welded in place from July 13, 1981, to July 23, 1981 (WDC 45201)
- The upper saddle was cut in two pieces and repaired in accordance with CMC 53580. The item was cut incorrectly in fab shop.
- The lower saddle is one piece, with no visual indications that the saddle was split. It is smooth, without marks indicating that a chain or hydraulic jack was used to bend the saddle.
- The saddles were welded in place between August 11, 1981, to August 19, 1981 (WDC 45197).
- QC inspections of fit-up and welding indicate welds are "satisfactory."

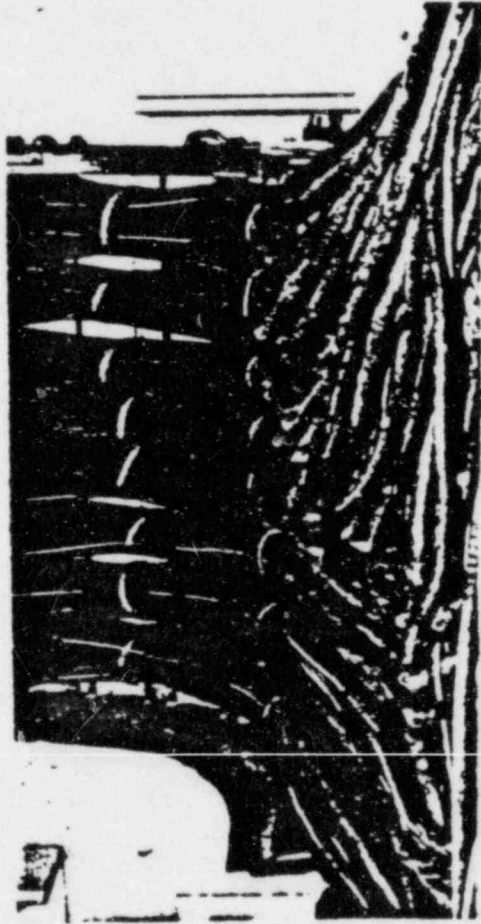
2
Node Point T13GCCM17
Actual Tee Intersection.
