PROJECT: Oyster Creek
Nuclear Generating Station

DOCUMENT TITLE: Isolation Condenser System Piping Cracked Welds - Repair and Failure Analysis

FAILURE ANALYSIS OF OYSTER CREEK ISOLATION CONDENSER PIPING

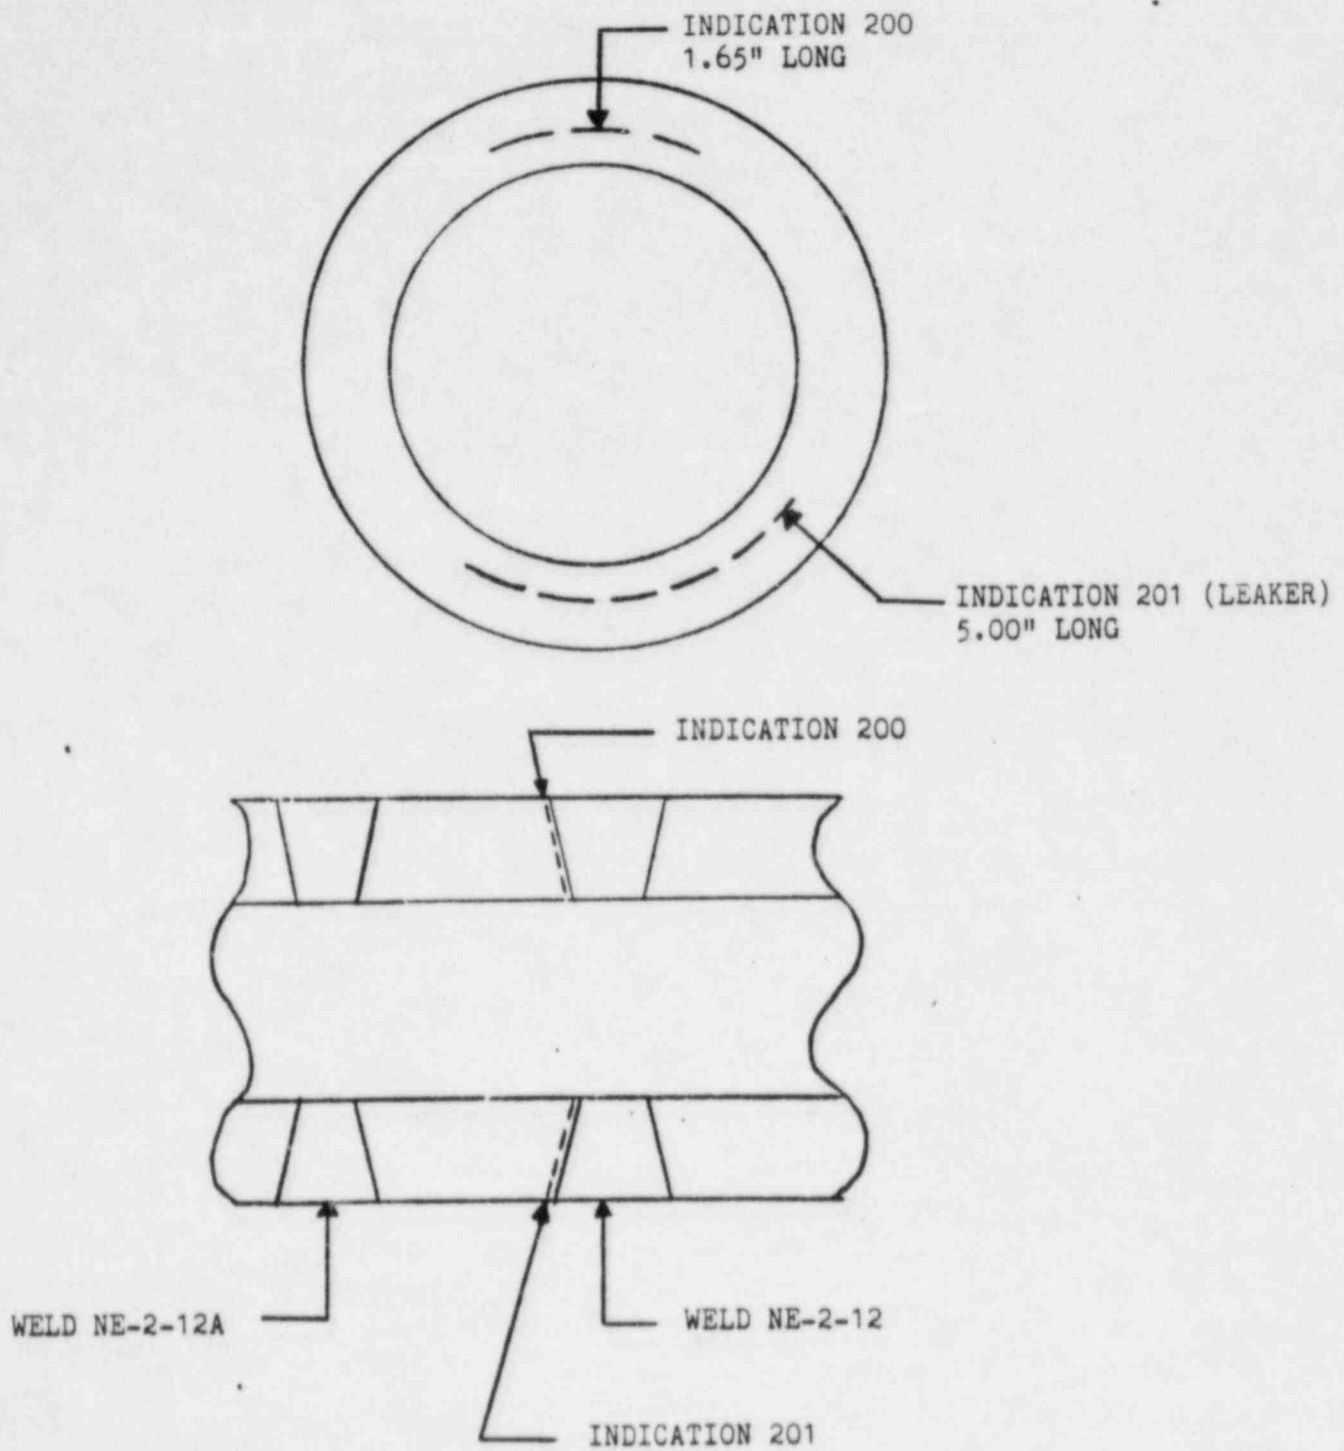
FIGURE 1- Defects in Weld NE-2-12

Weld NE-2-12 (the leaker) contained one through-wall crack and one crack-like indication (Figure 1).

Metallography of NE-2-12 and NE-1-15 revealed that both had cracks that were intergranular and adjacent to the weld bead. And, in NE-2-12, metallography revealed a second crack in the base material between the weld bead and the leaking crack. All the cracks were located within the heat-affected zone of the weld.

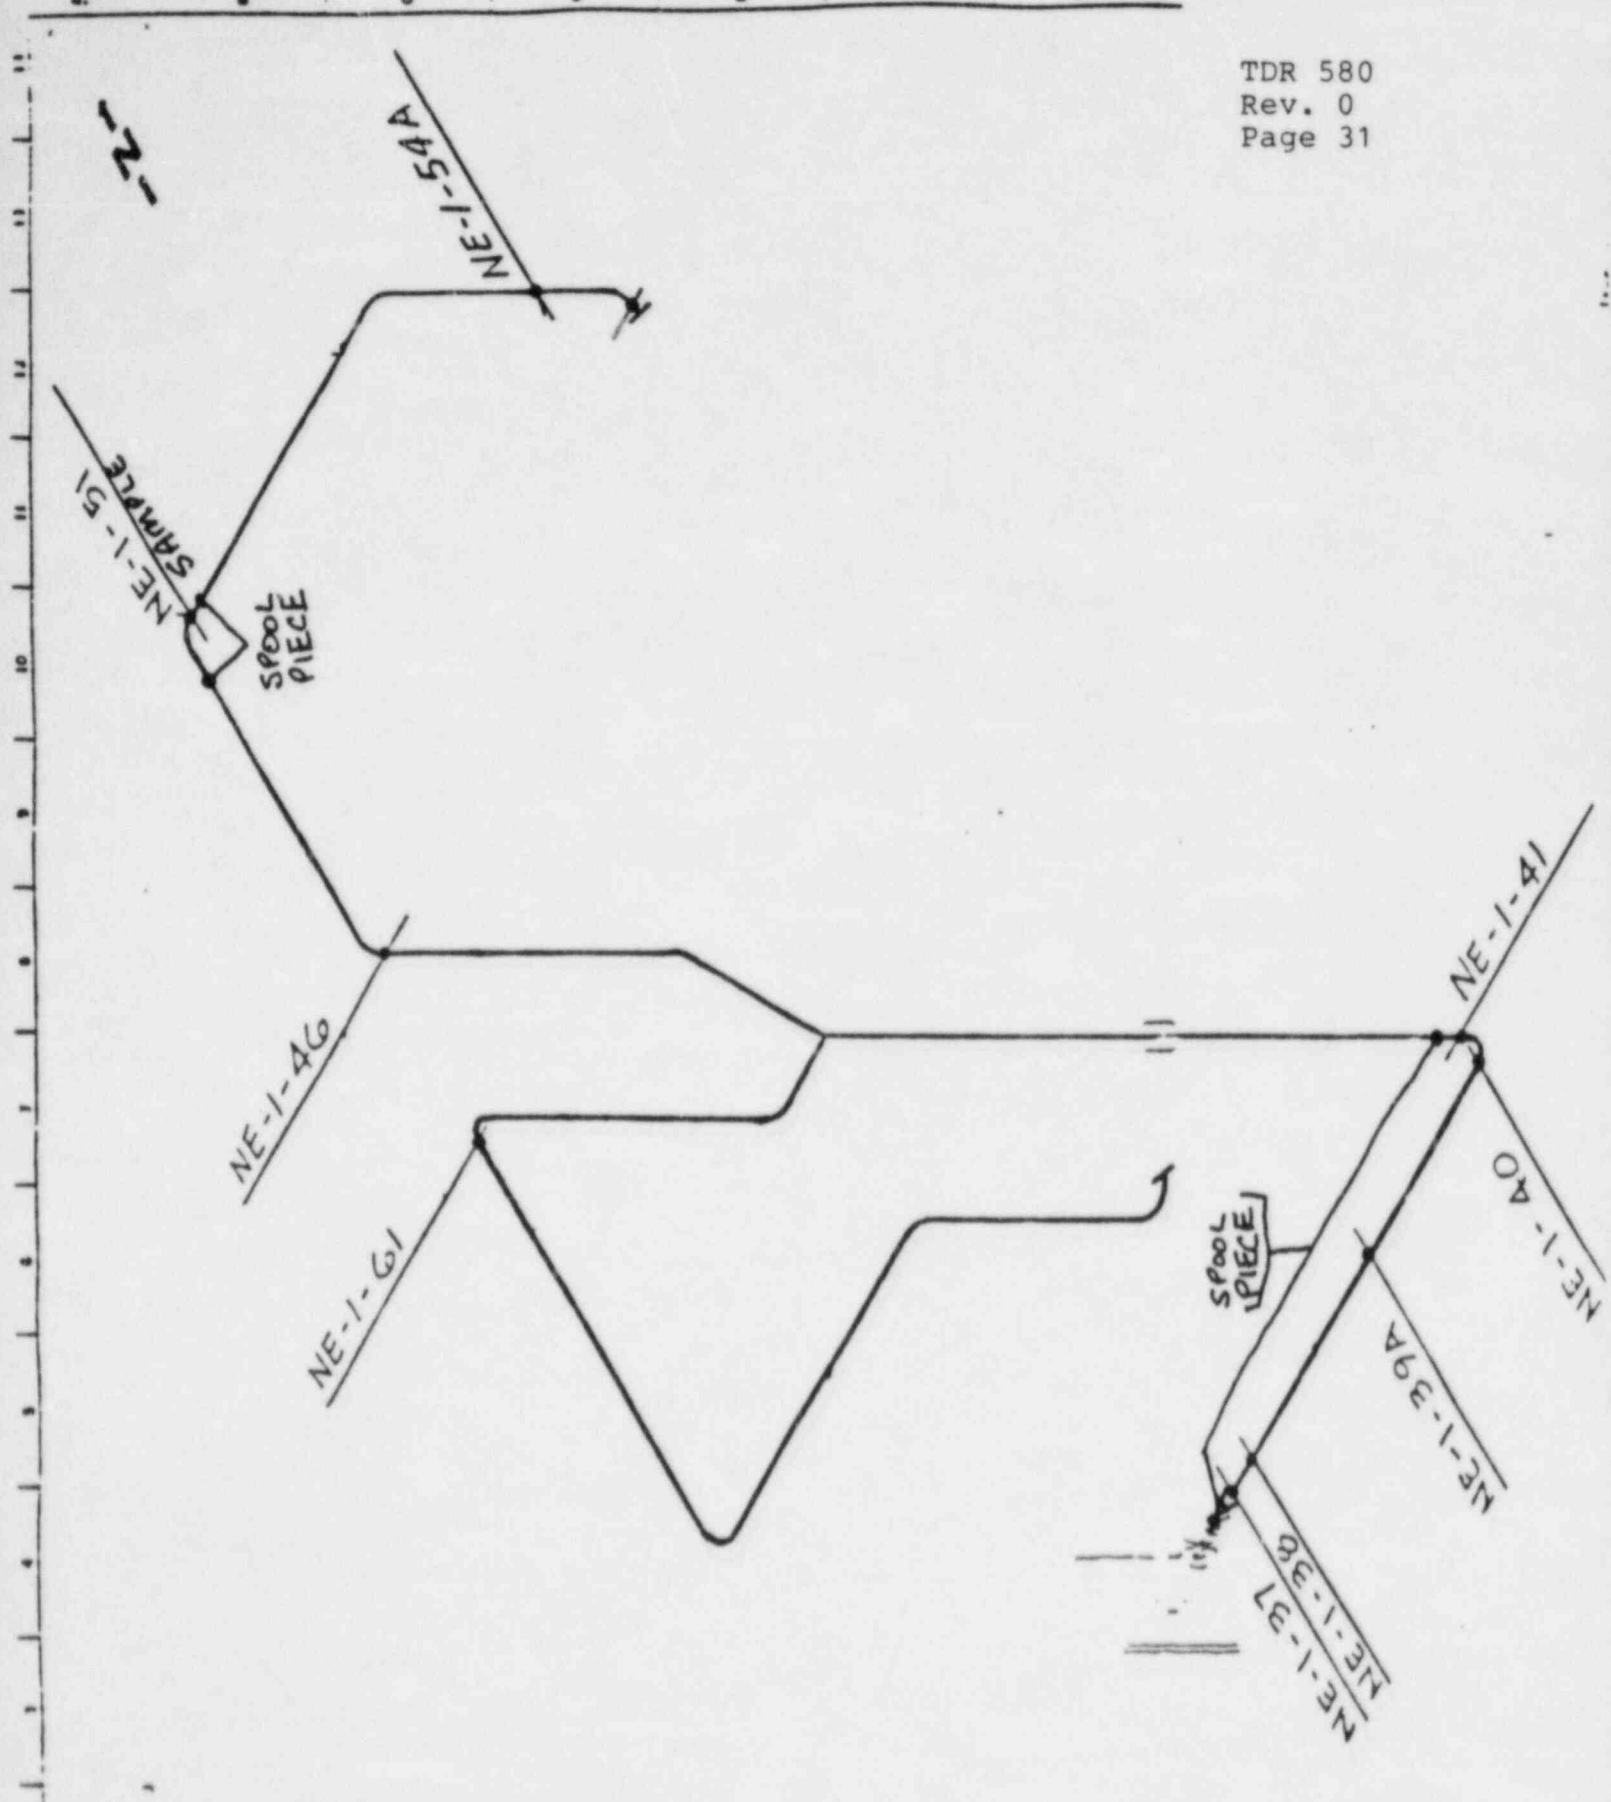
FIGURE 2- 'A' Supply Line, Defective Welds

Figures 2, 3, 4, and 5 show the locations of the defective welds.

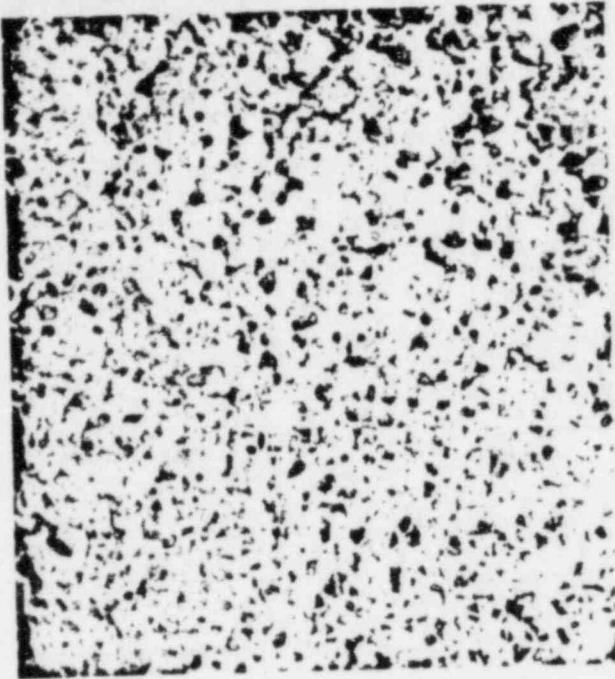
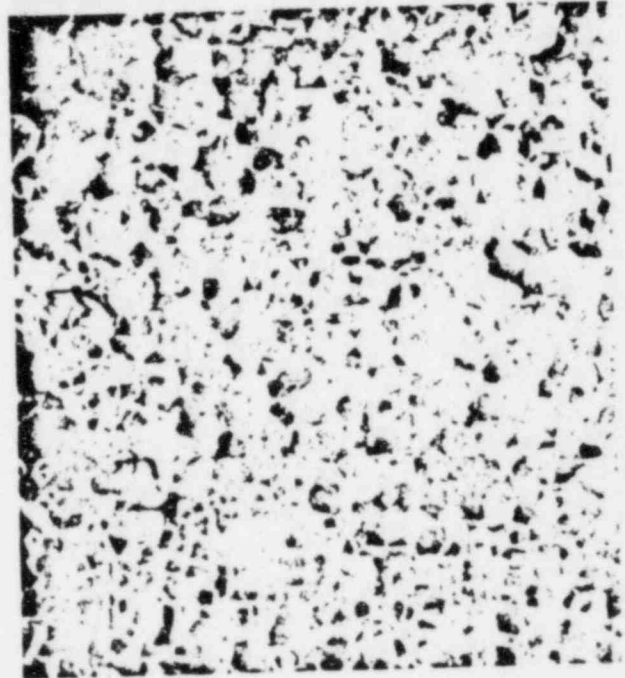
Figure 6- Scanning electron microscope fractographs of the leaking indication (?01) on 8 inch pipe

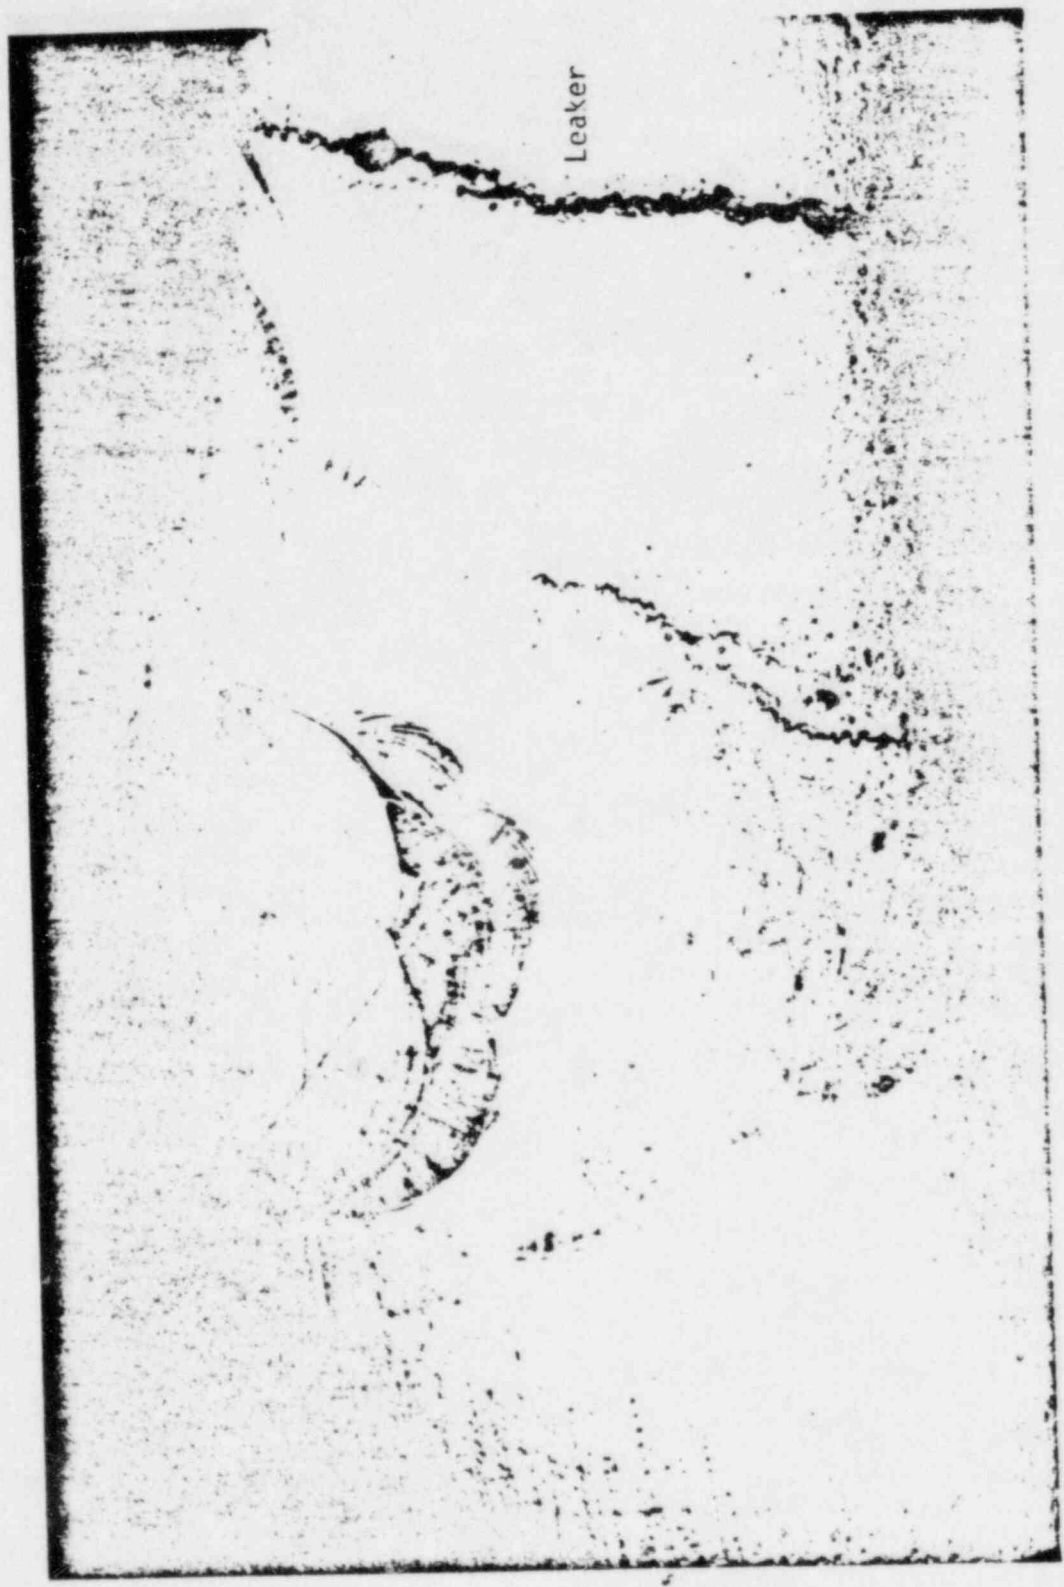
Figure 7 - Weld bead and two cracks found in NE-2-12 8 inch - Oyster Creek
8X
Kallings

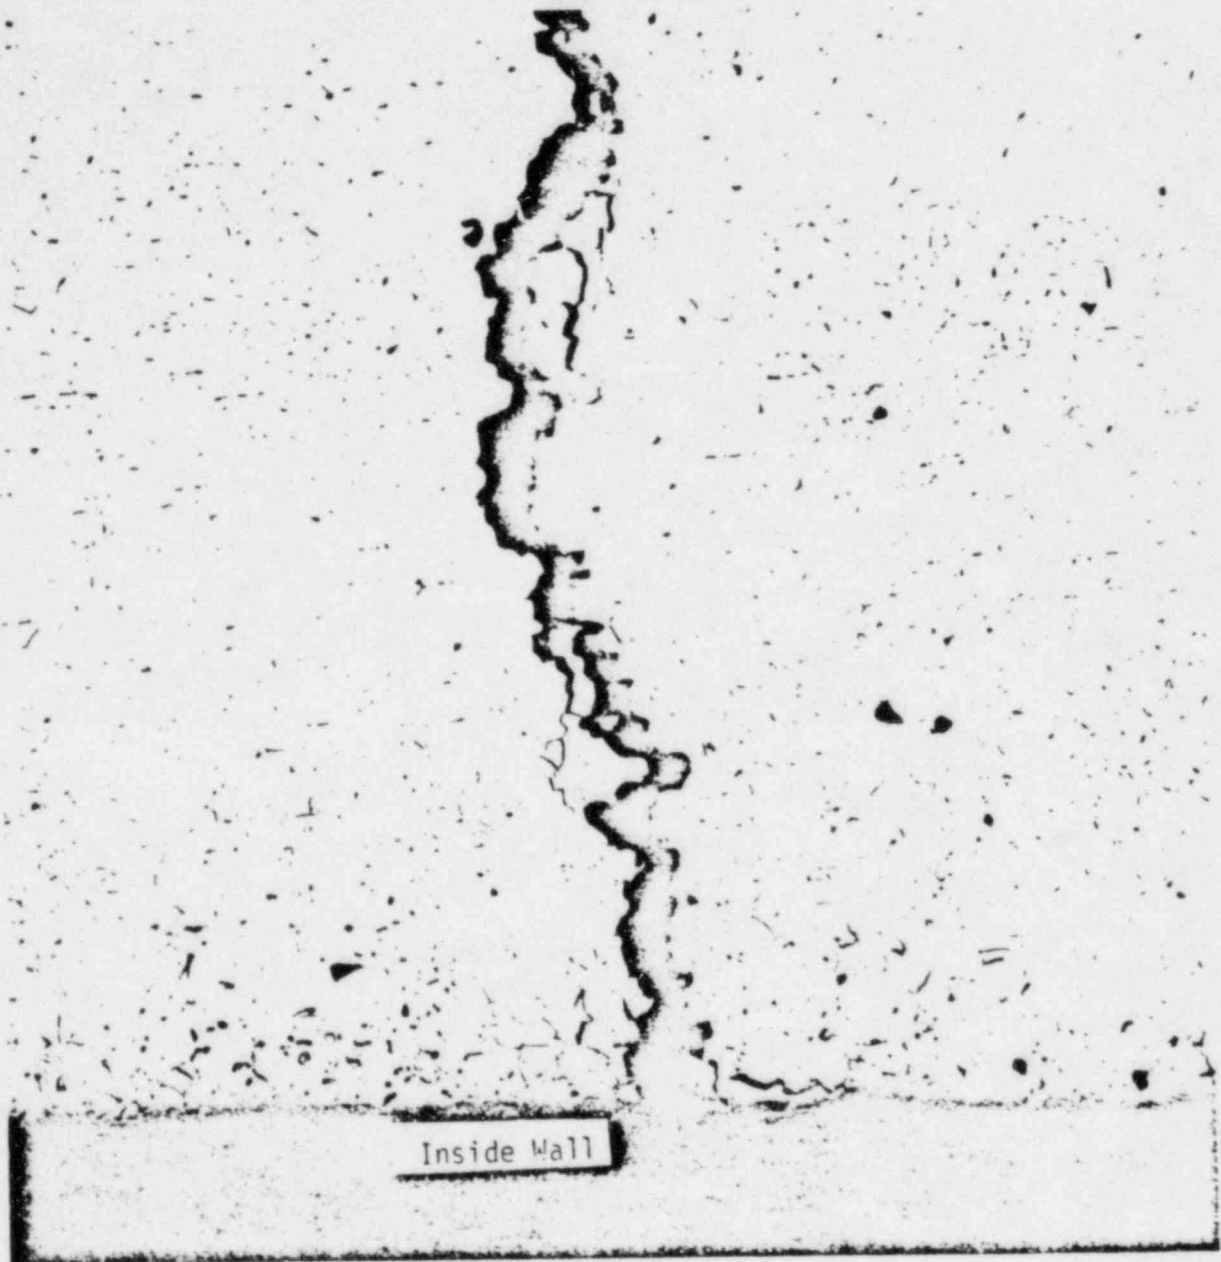
Figure 8 - Leaking crack in weld NE-2-12 8 inch diameter pipe.
Crack origin inside wall. 50X
Neg. No. 4-1481F-1 Kallings

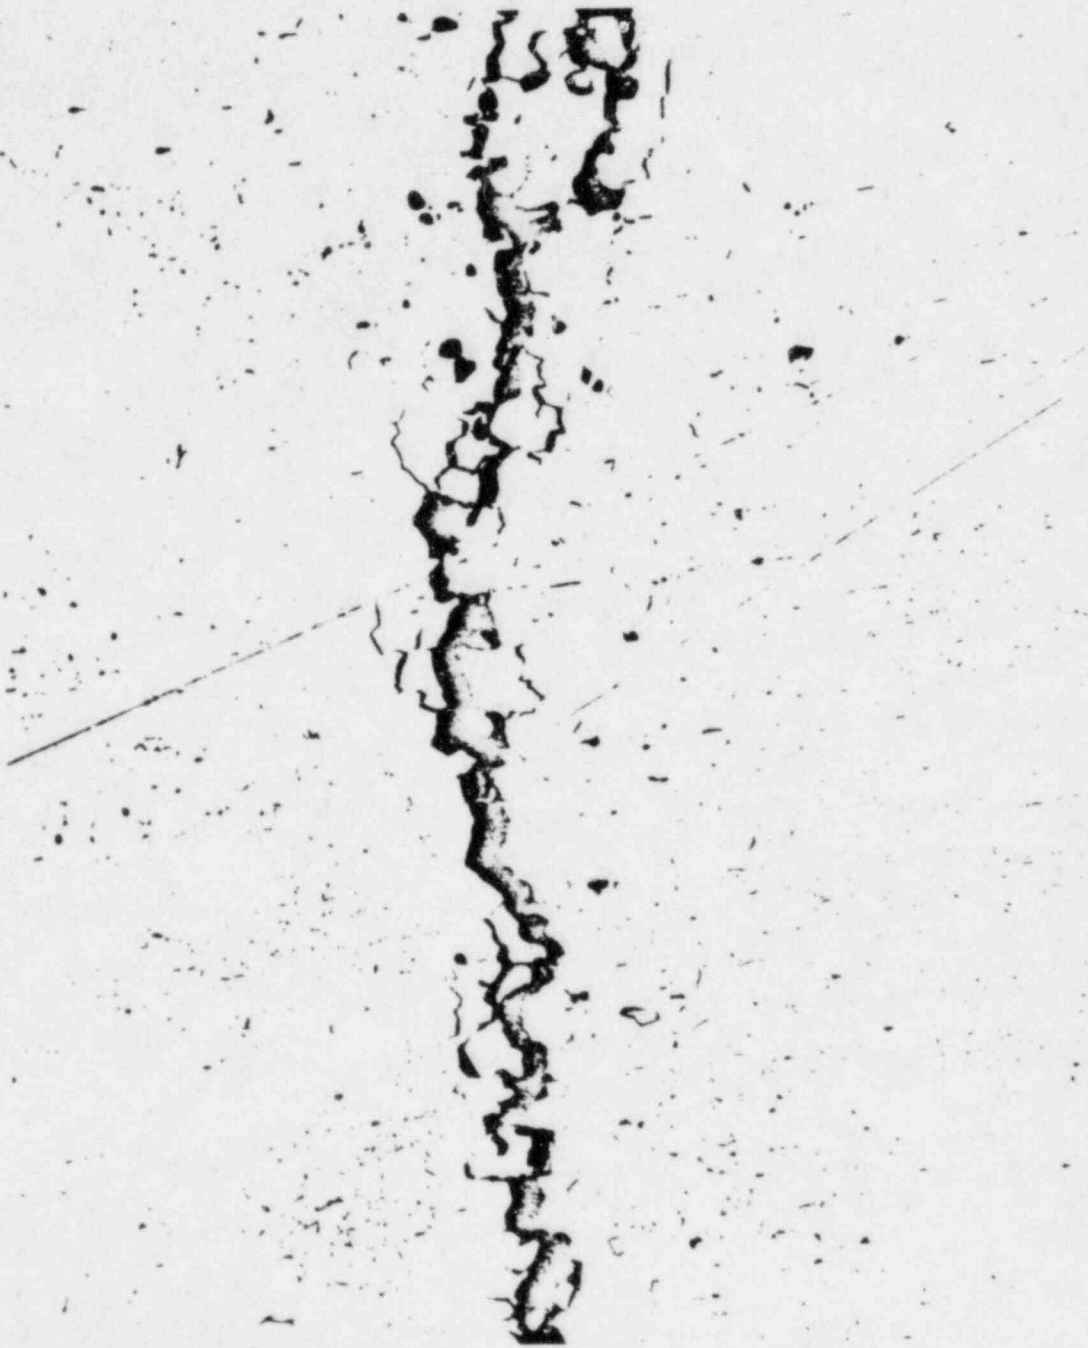
Figure 9 - Leaking crack in weld NE-2-12 8 inch diameter pipe.
Midwall location. 50X
Neg. No. 4-1481F-2 Kallings

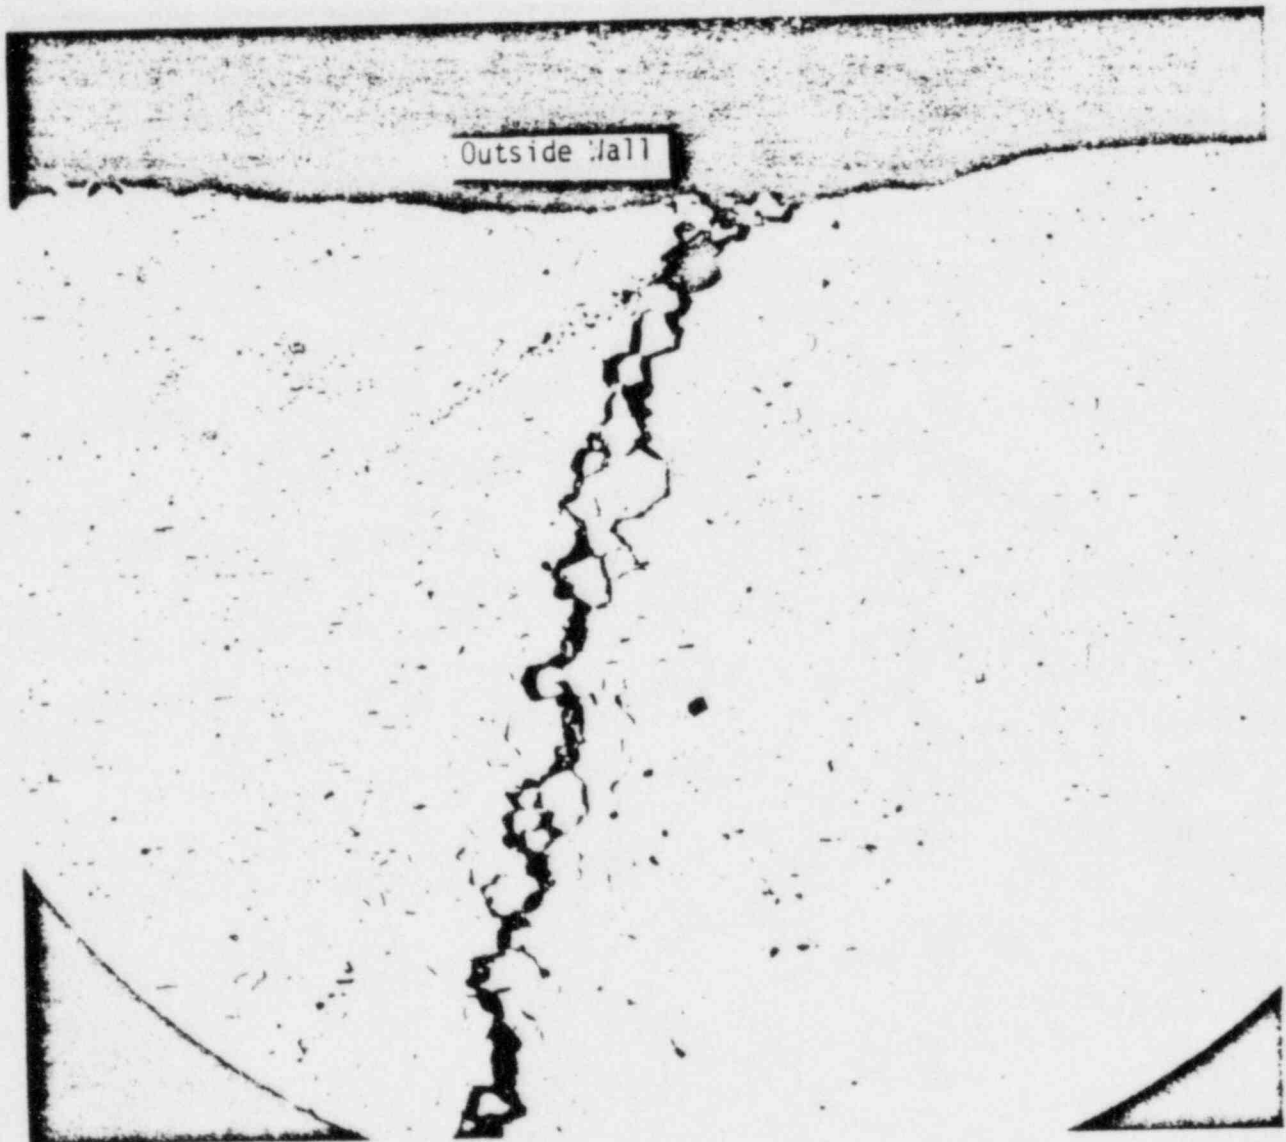
Figure 10 - Leaking crack in weld NE-2-12 8 inch diameter pipe.
Outside wall.
50X
Beg. No. 4-1481F-3
Kallings

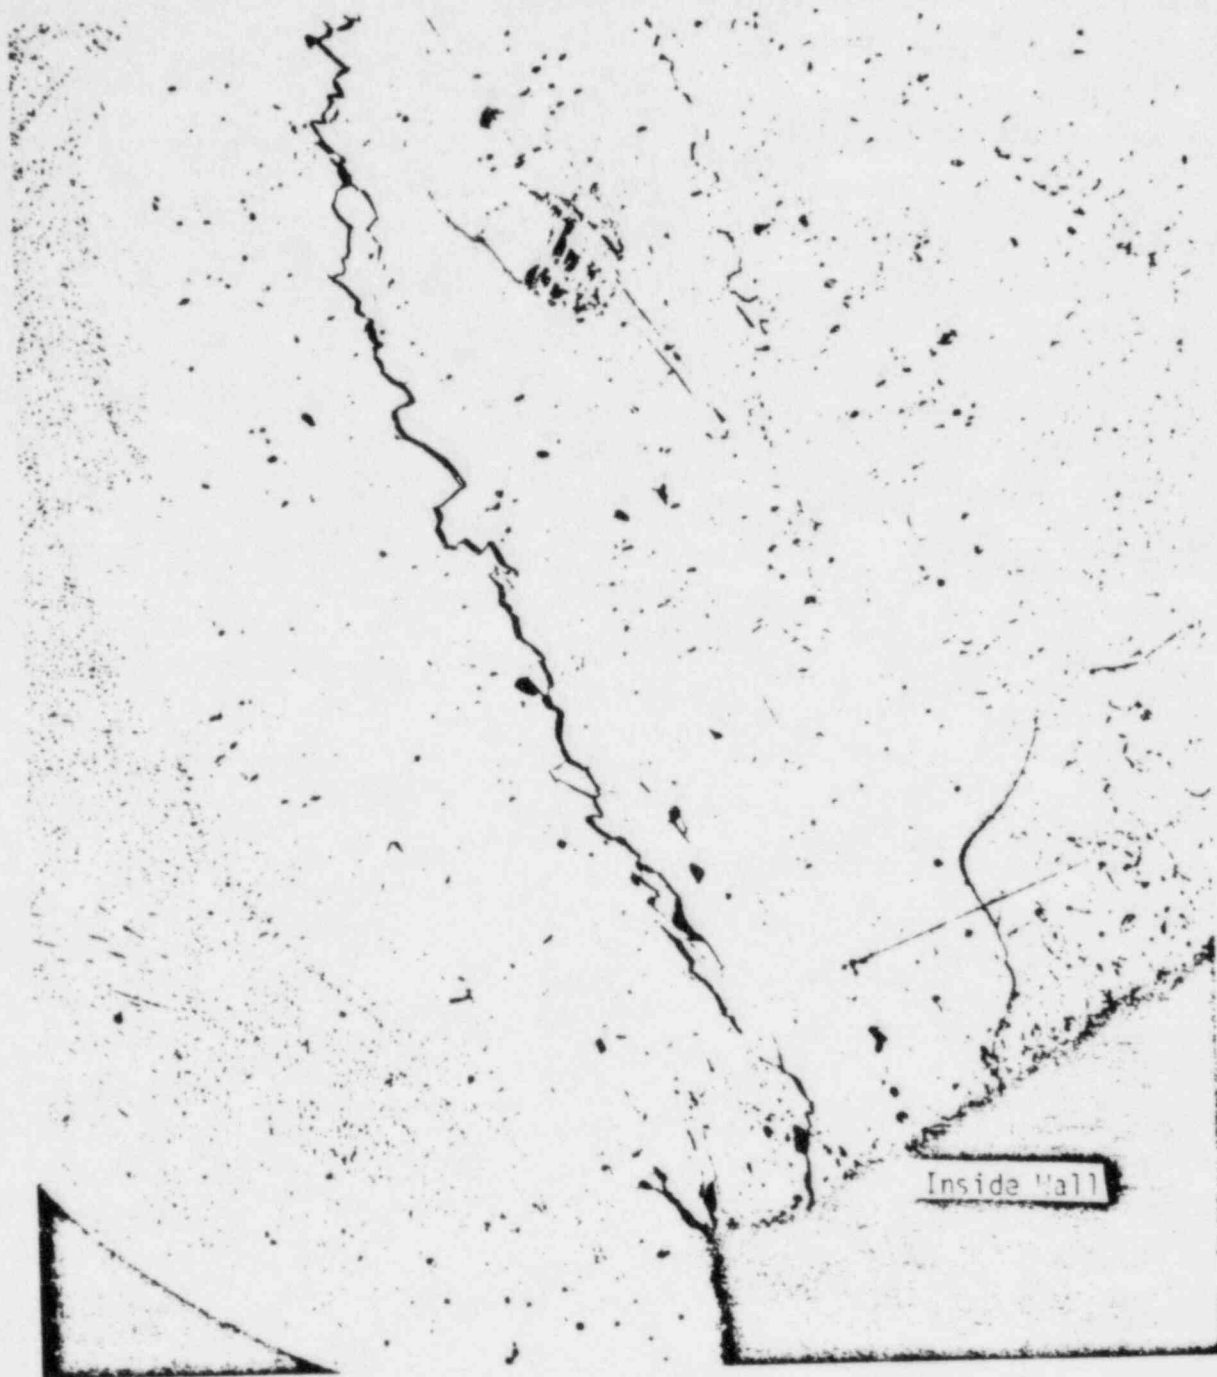
Figure 11 - Second crack found in NE-2-12 8 inch diameter pipe.
Crack origin inside pipe diameter close to notch.
Neg. No. 4-1481F-6
50X
Kallings

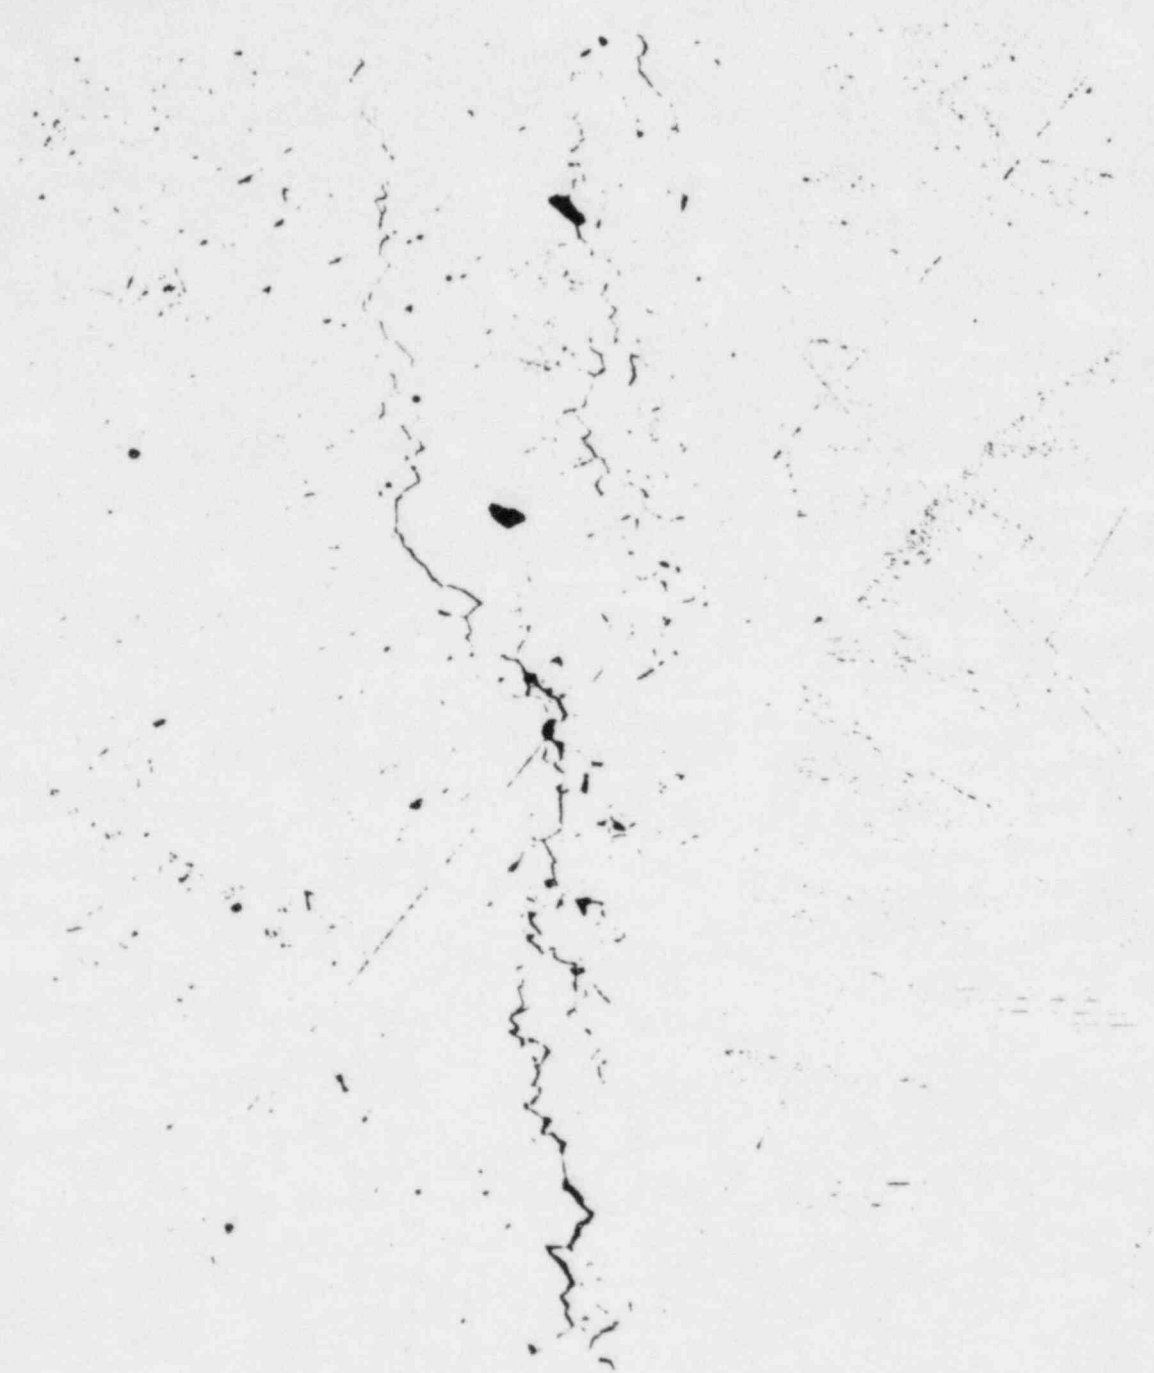
Figure 12 - Second crack found in NE-2-12 8 inch diameter pipe.
Midwall location "Growing End".
Neg. No. 4-1481F-5

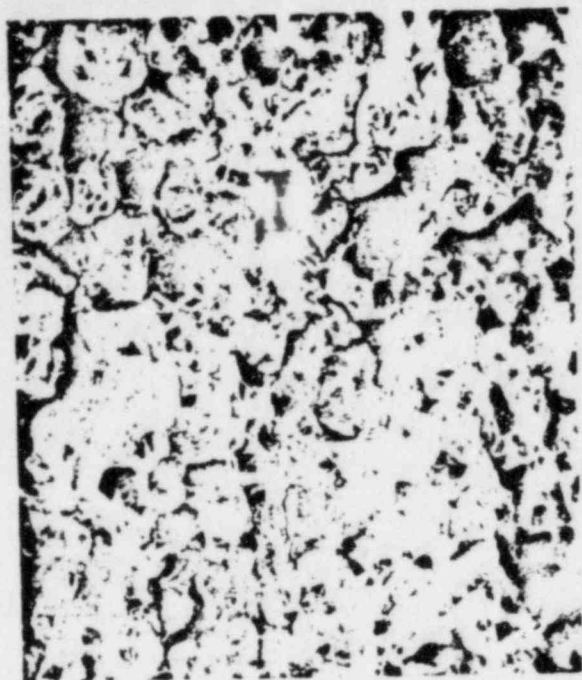
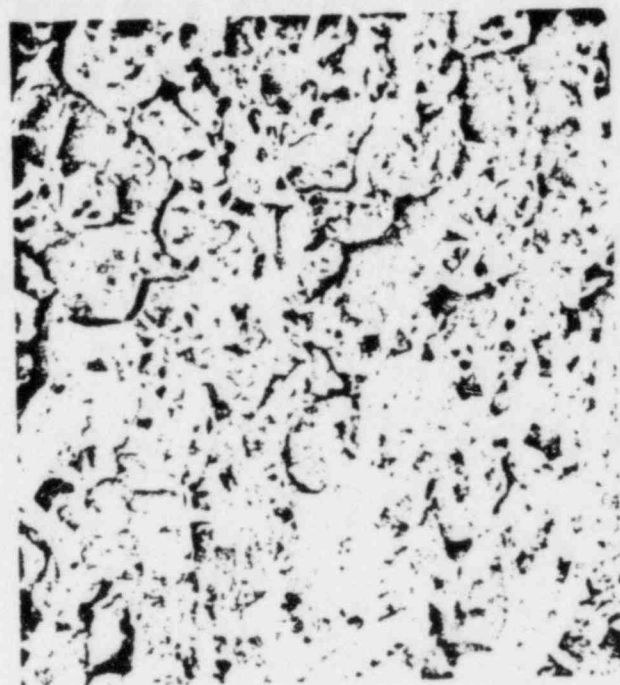
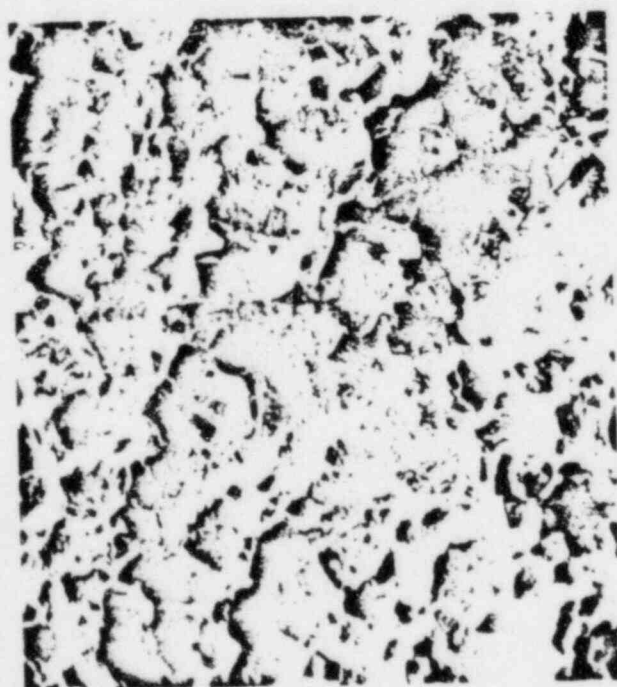
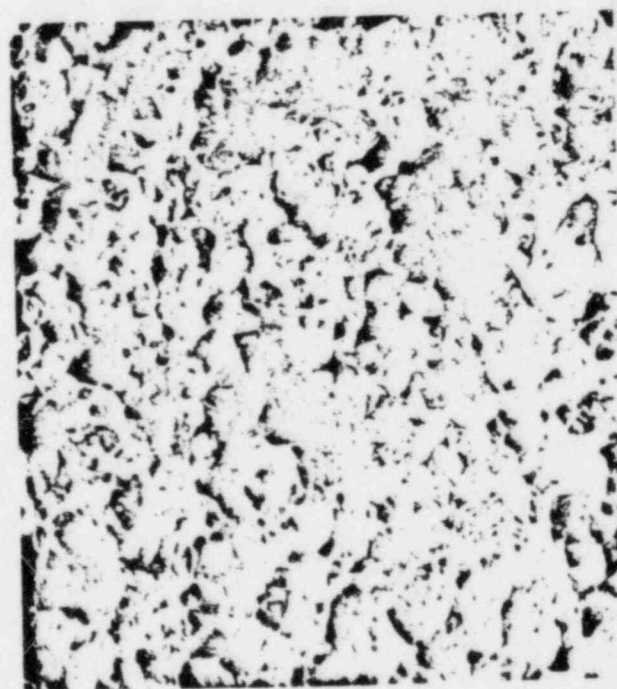
Figure 19 - Scanning electron microscope fractographs at the mid wall location - near the crack end 12 inch pipe

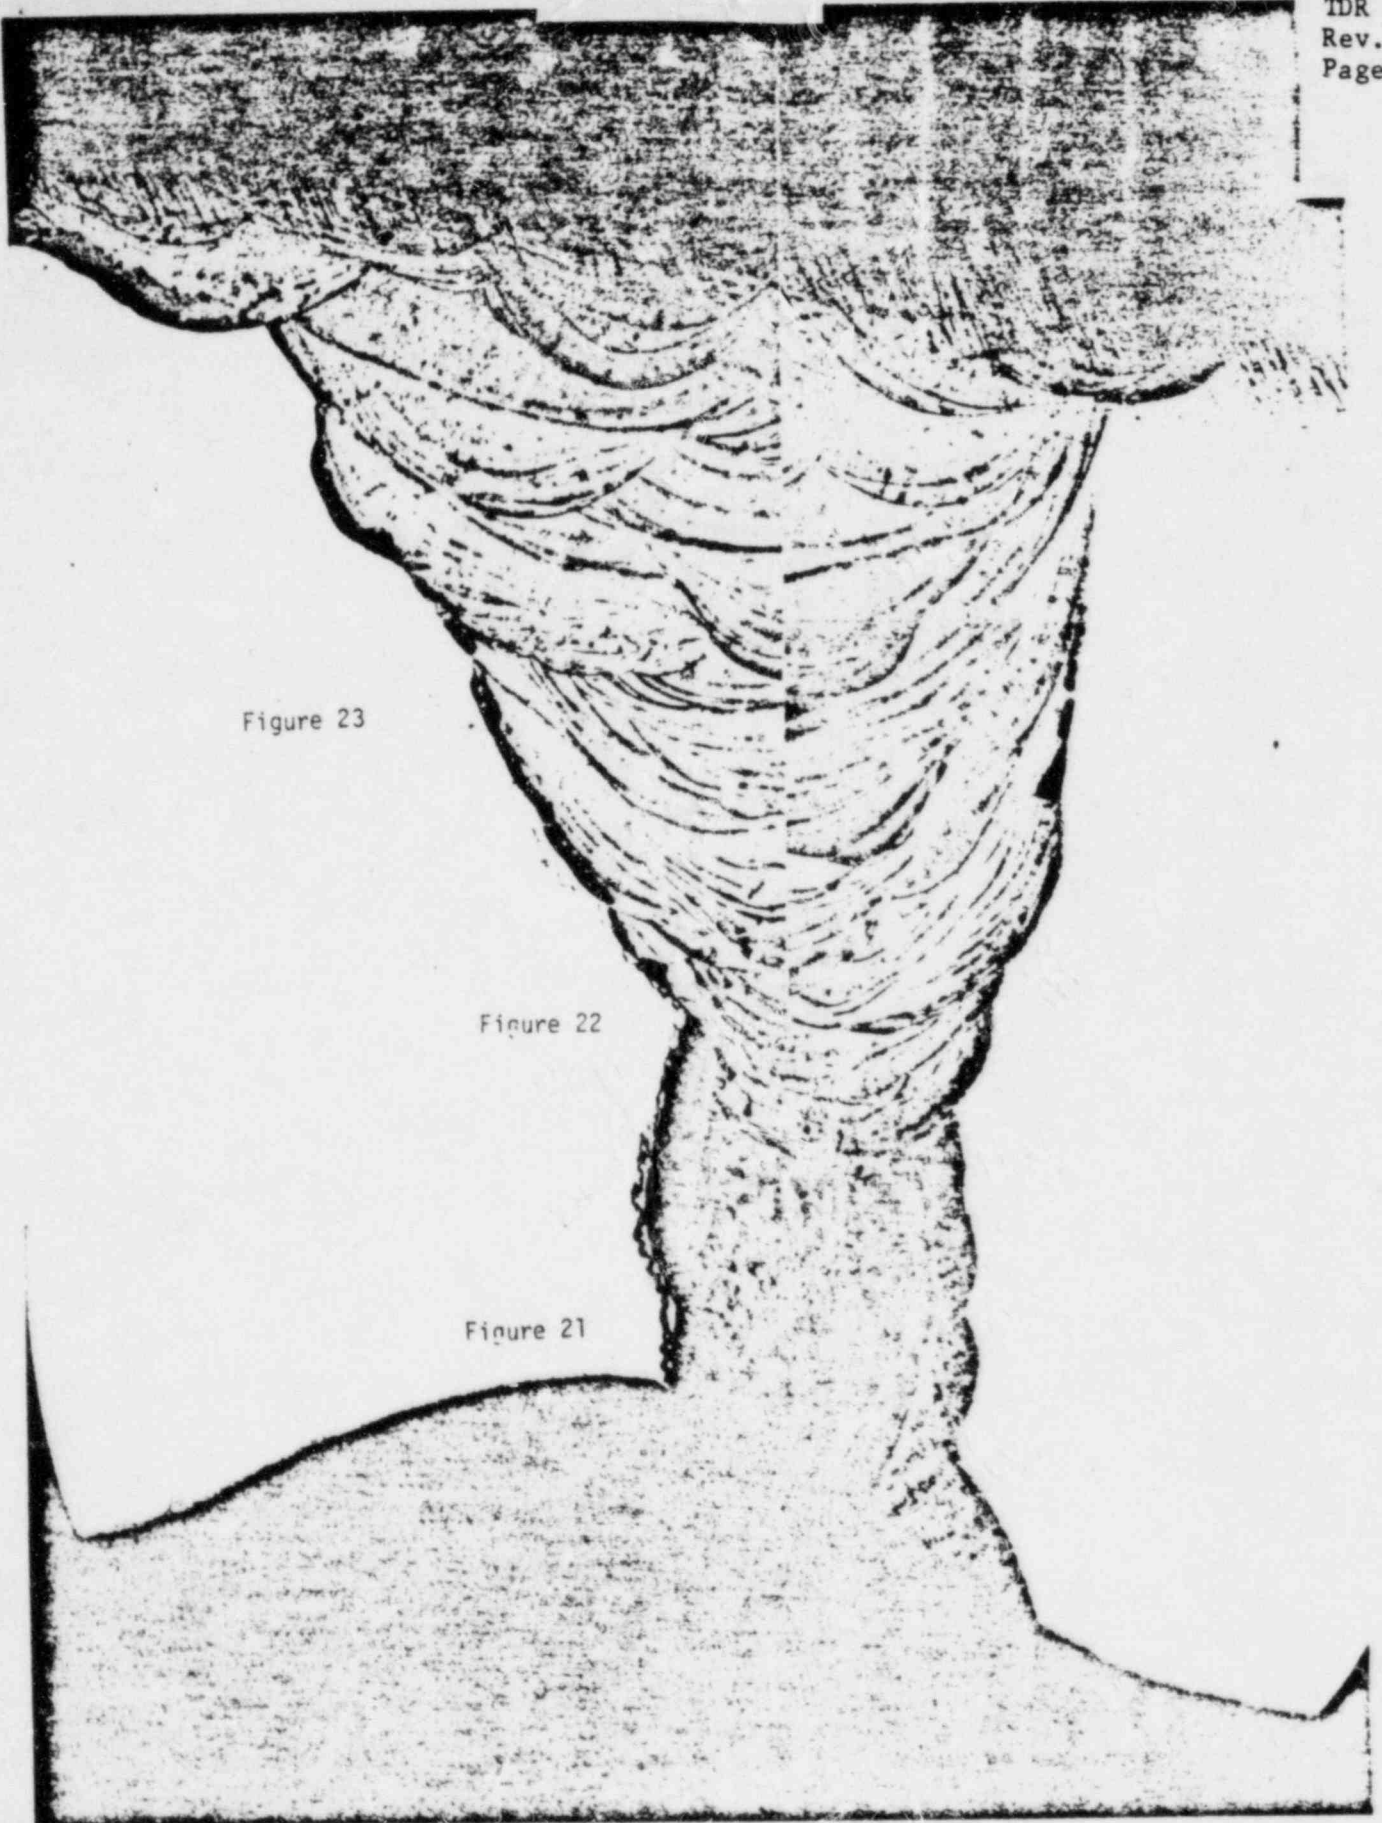
Figure 20 Twelve Inch Diameter Pipe Weld Bead and Associated Crack
Neg. No. 4-1480F1-3

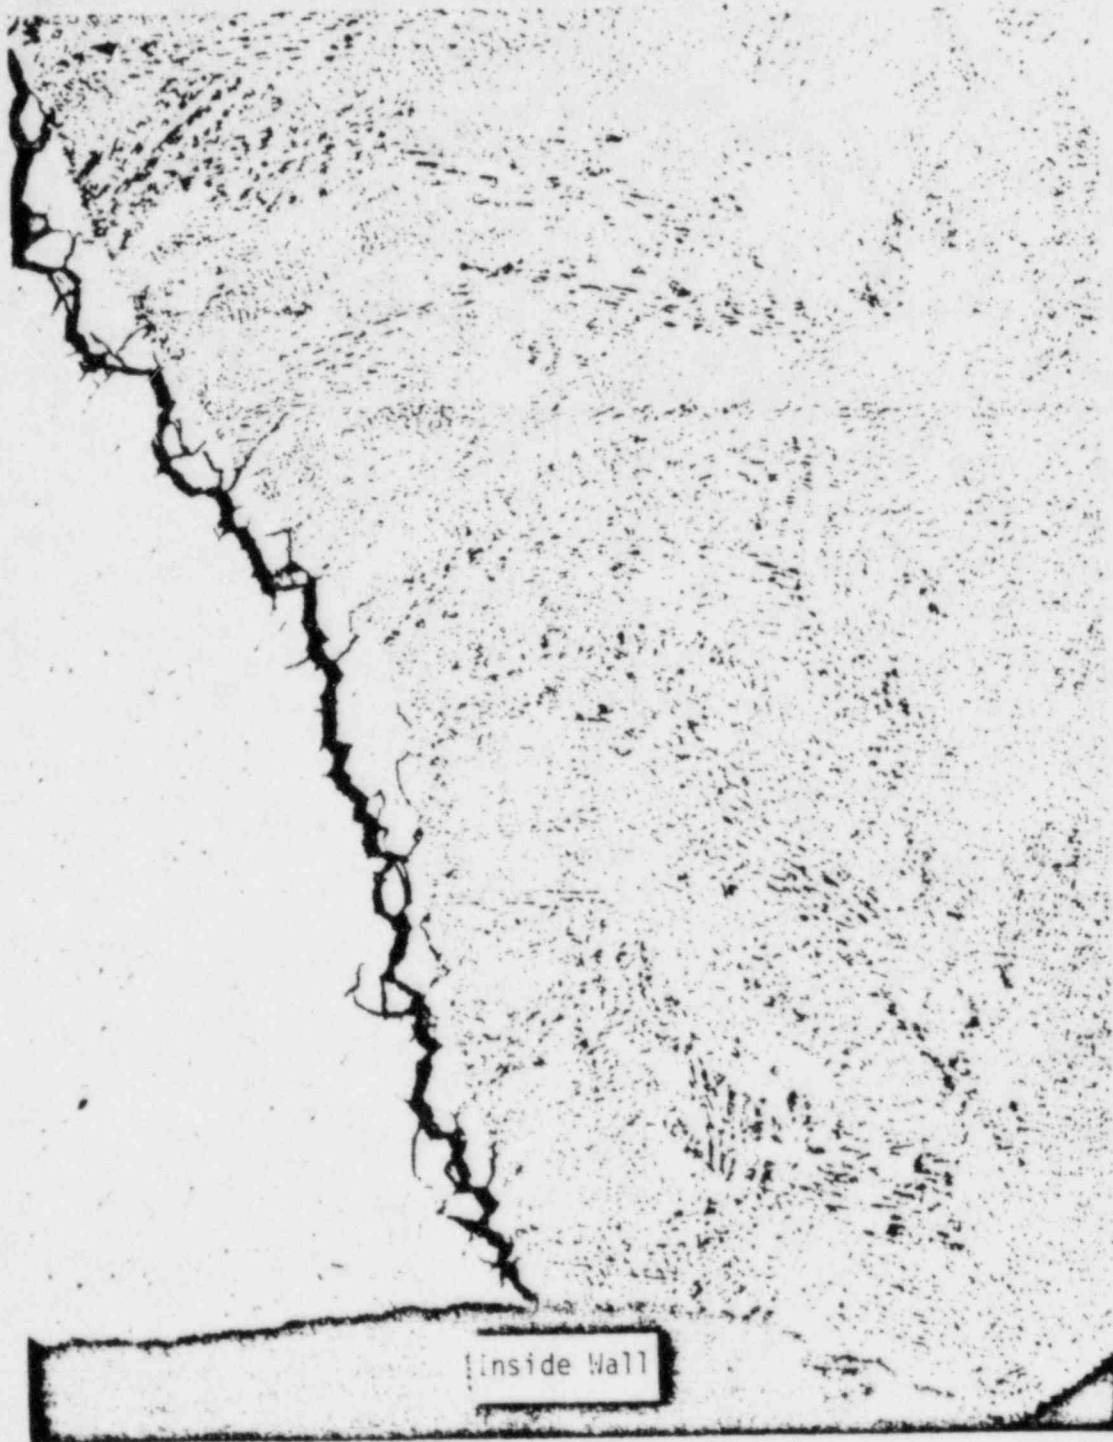
Figure 21 - Twelve inch diameter pipe crack at the inside surface; origin.
Neg. No. 4-1480F-4
50X
Kallings

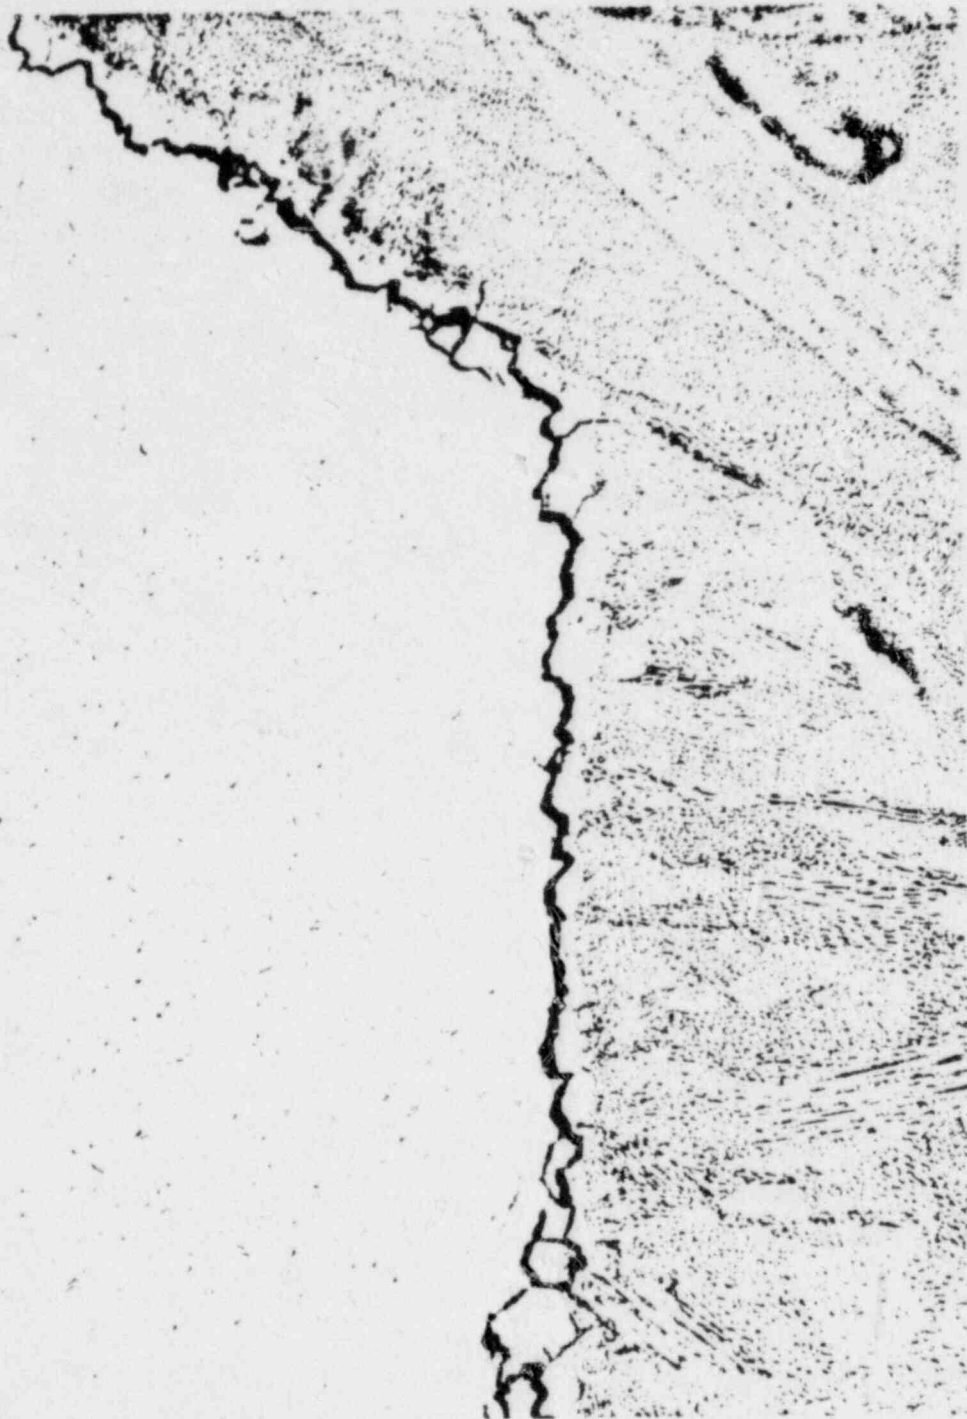
Figure 22 - Twelve inch diameter pipe crack at mid wall. Note the change in direction.
Neg. No. 4-1480-5
