PROJECT: Oyster Creek
Nuclear Generating Station

DOCUMENT TITLE: Isolation Condenser System Piping Cracked Welds - Repair and Failure Analysis

FAILURE ANALYSIS OF OYSTER CREEK ISOLATION CONDENSER PIPING

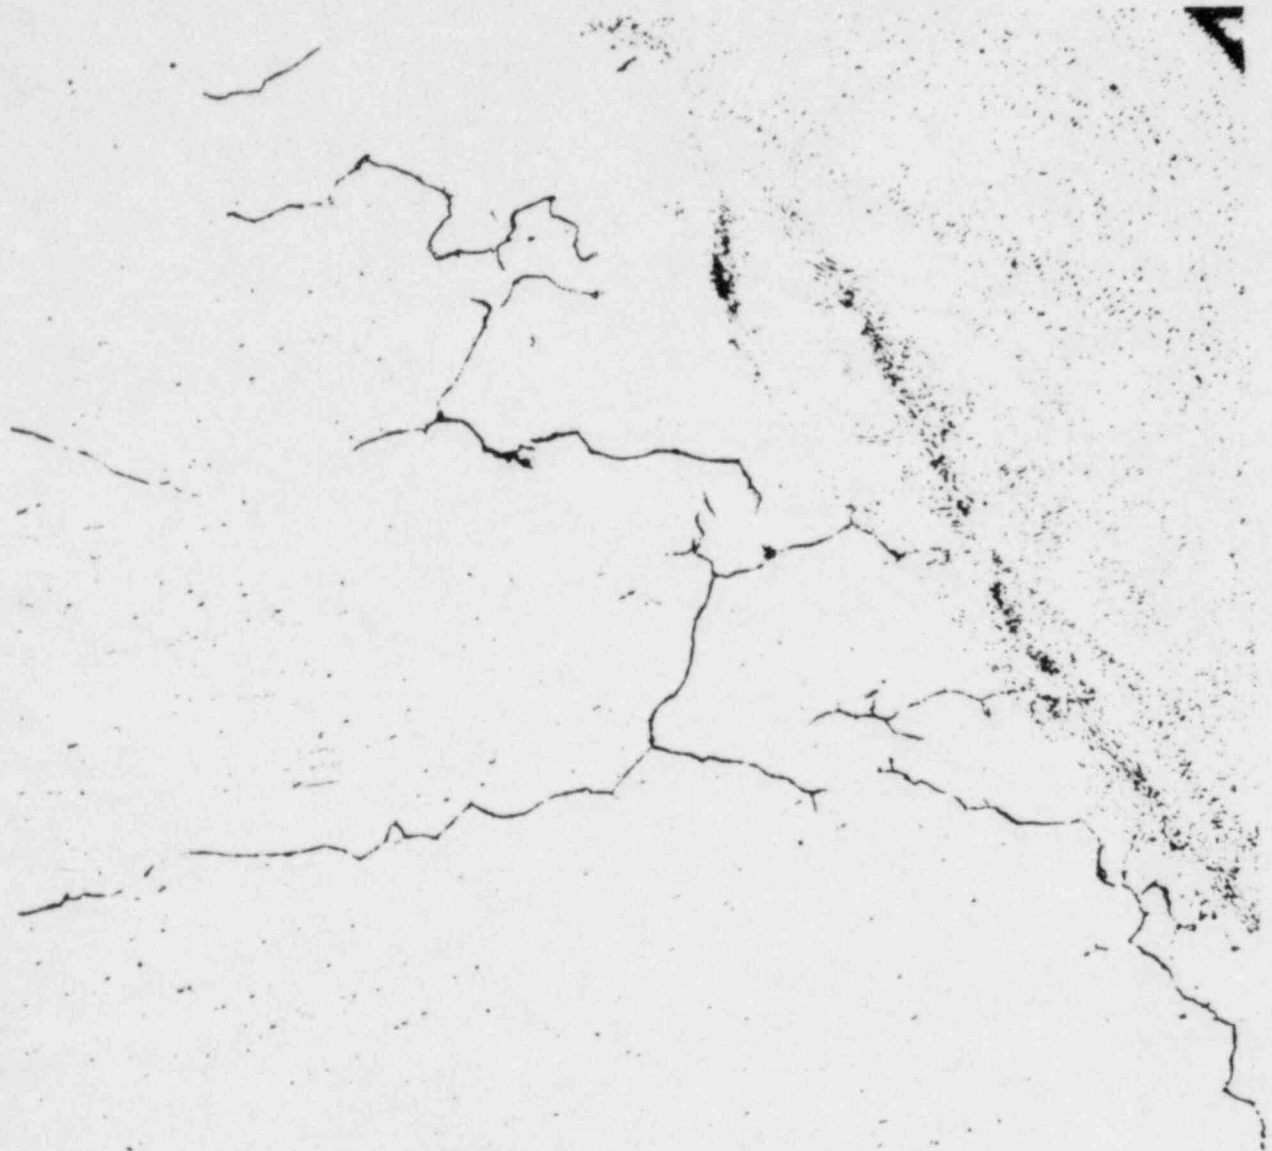
Figure 23 - Twelve inch diameter pipe crack at the "growing" end.
Neg. No. 4-1480F-6
50X
Kallings
