Subject: McGuire Nuclear Station Unit 2
Docket No. 50-370
Licensee Event Report 370/92-04

TITLE(4) A Unit 2 Reactor Trip Occurred From An Equipment Failure And Possible Installation Deficiency

Metallurgical Analysis Report

Linkage from Valve Positioner on 2CF20

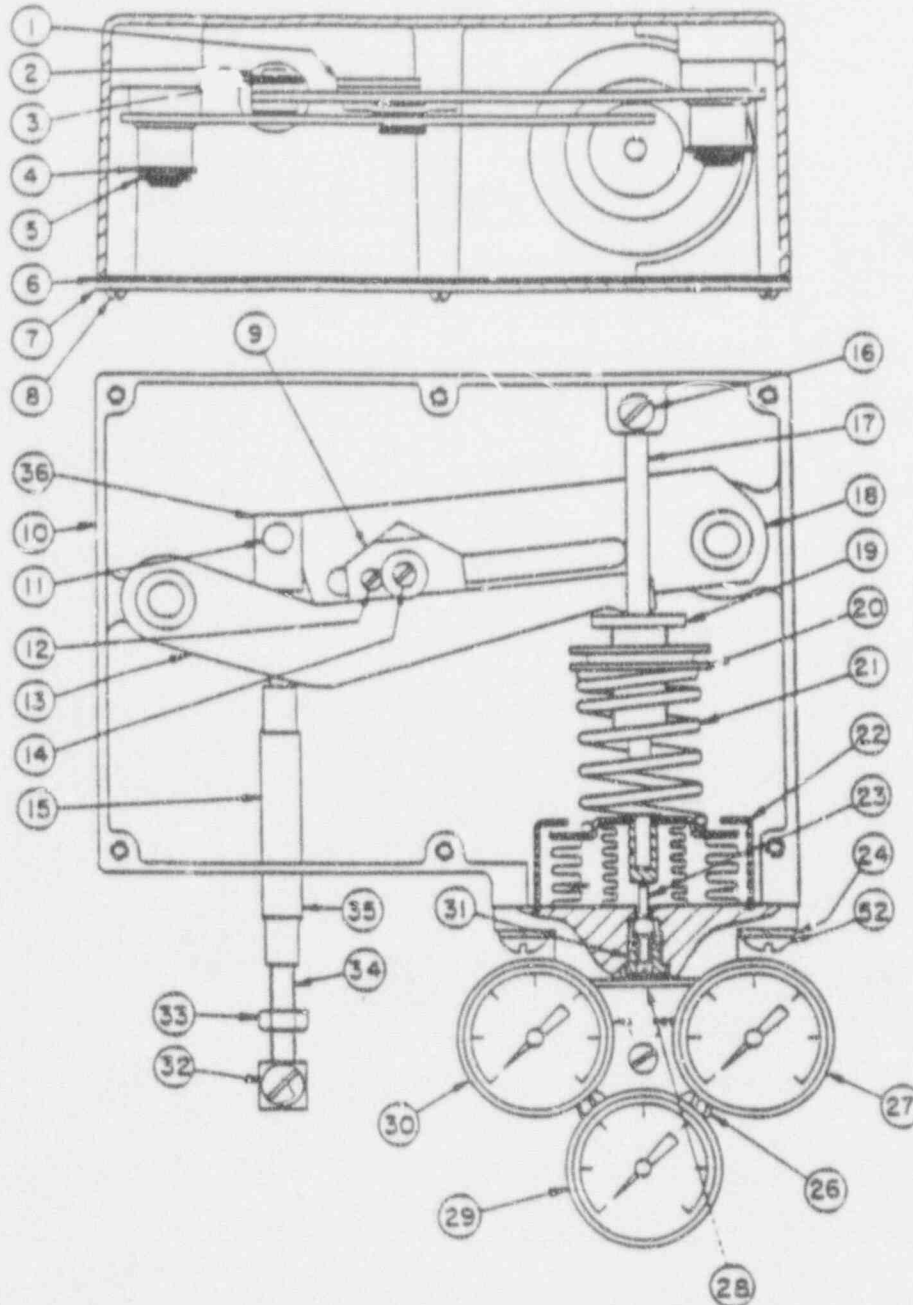
Figure 1 is a diagram of the positioner mechanism with the linkage location shown. The portion of the linkage supplied for analysis is shown in Figure 2, with the nickel-plated brass clevis threaded into the shaft. The shaft operated with a second clevis threaded into the other end, also pinned. A nut allowed for adjustment to get both clevis pieces in the same plane. A steel arm fit into the clevis gap and a steel pin passed through the hole, held in place by a steel cotter pin. A nickel-plated brass washer was located on the cotter pin side.

Figure 1 Diagram of linkage location in positioner box. Part #36 is the failed clevis, #11 the pin, #15 the shaft. (From Moore Products Co. Dwg. No. 118-222.)

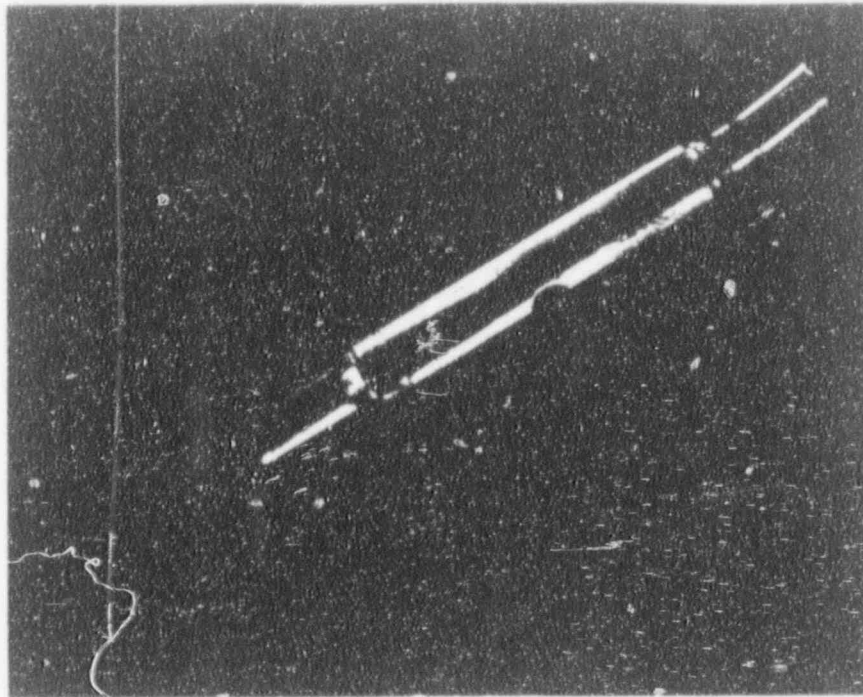
In Figure 2, a band of wear is visible along the shaft. This wear coincides with the location of another arm in the positioner box over the shaft. Nearer the damaged clevis, the wear was darker and not especially fresh; farther away, the damage was fresher and could have occurred on removal. The bend at the shaft end was reportedly created on removal. The damaged clevis was screwed very tightly into the shaft.

Figure 2 Overall view of linkage section, lit so as to highlight band of wear along shaft (arrows). Bend in end at right was created during removal. Ma-2208.

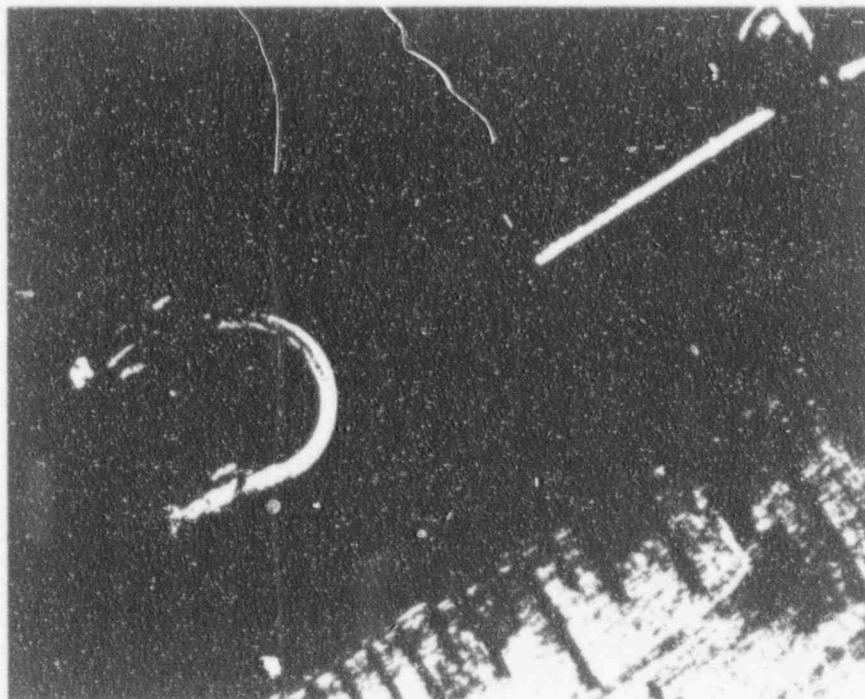
A great deal of material was missing from the failed clevis (Figure 3). Much of this material was recovered from the positioner box, mostly in the form of flat brass flakes with smeared surfaces. On the "top" side of the clevis (the visible side as installed), a groove was worn by the head of the pin. The portion around the pin opening which remained was circular. The path through the clevis was generally the width of the pin.

Figure 3 Detail of damage to clevis, "top" side as shown above. Circular groove left by head of pin before pin moved outward through clevis. Gauge = 1/16". Ma-2209.

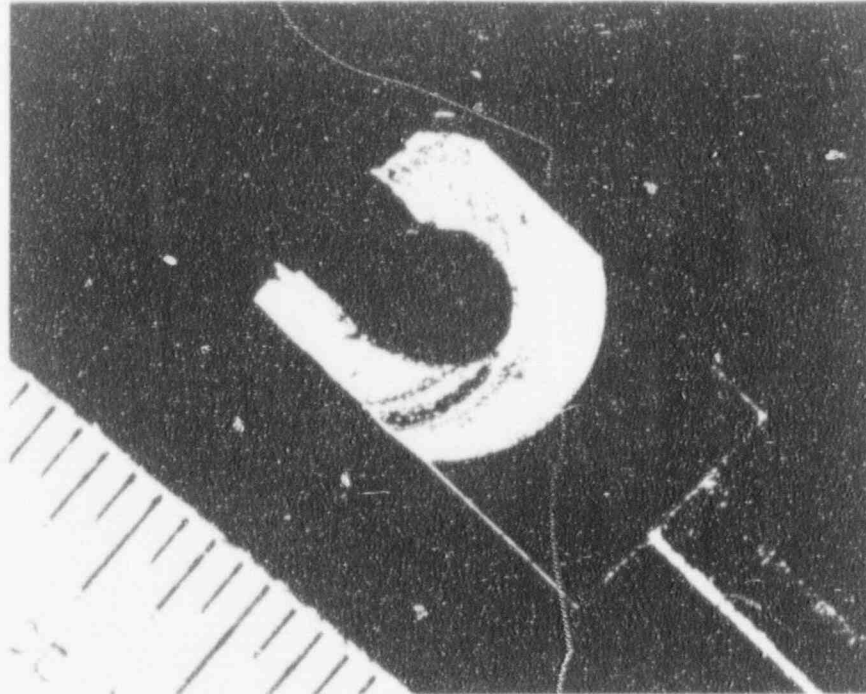
On the back side of the clevis, wear from the washer was evident (Figure 4). Wear at original washer location was uniform and not

particularly deep. A series of steps of progressively deeper wear from the washer occurred as the pin moved outward through the clevis.

Figure 4 Detail of clevis, "bottom" side where washer rode. Wear became progressively deeper as outward displacement of pin increased. Gauge = 1/16". Ma-2207.

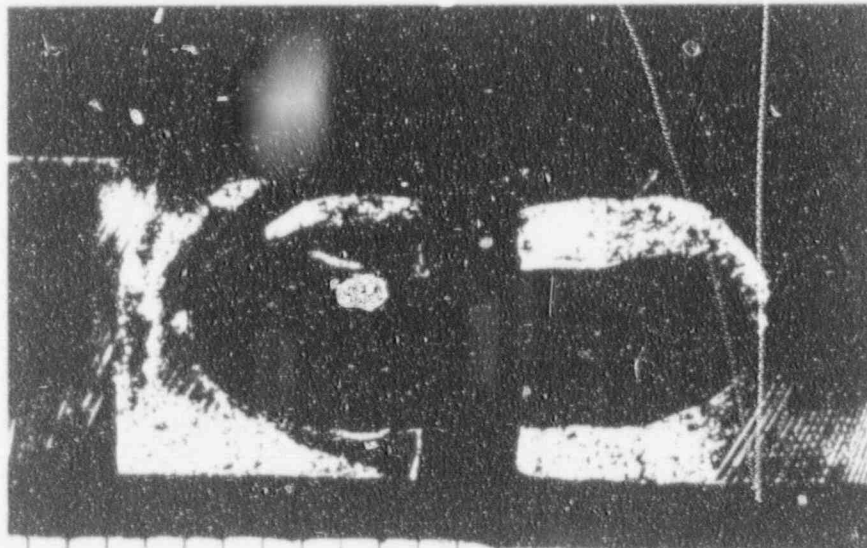
One tier of the clevis was cut off to reveal the wear pattern on the interior, where the clevis contacted the arm to which it was pinned. Wear to one side of the hole was heavier than to the other side (Figure 5). Wear on the interior of the top half (right in Figure 5) was heavier than wear on the bottom half.

The wear in the interior of the clevis was not uniform from side to side. This observation implies that the plane of the clevis was not parallel to the plane of the positioner arm to which it was pinned.

Figure 5 Wear on interior surfaces of clevis (cut open) from contact with arm in positioner box. Heaviest at lower right, lightest at upper left. G = 1/16". Ma-2213.
