Iowa Electric Light and Power Company

## April 21, 1992 NG-92-2091

Subject: Duane Arnold Energy Center Docket No: 50-331 Op. License DPR-49 Licensee Event Report #92-004

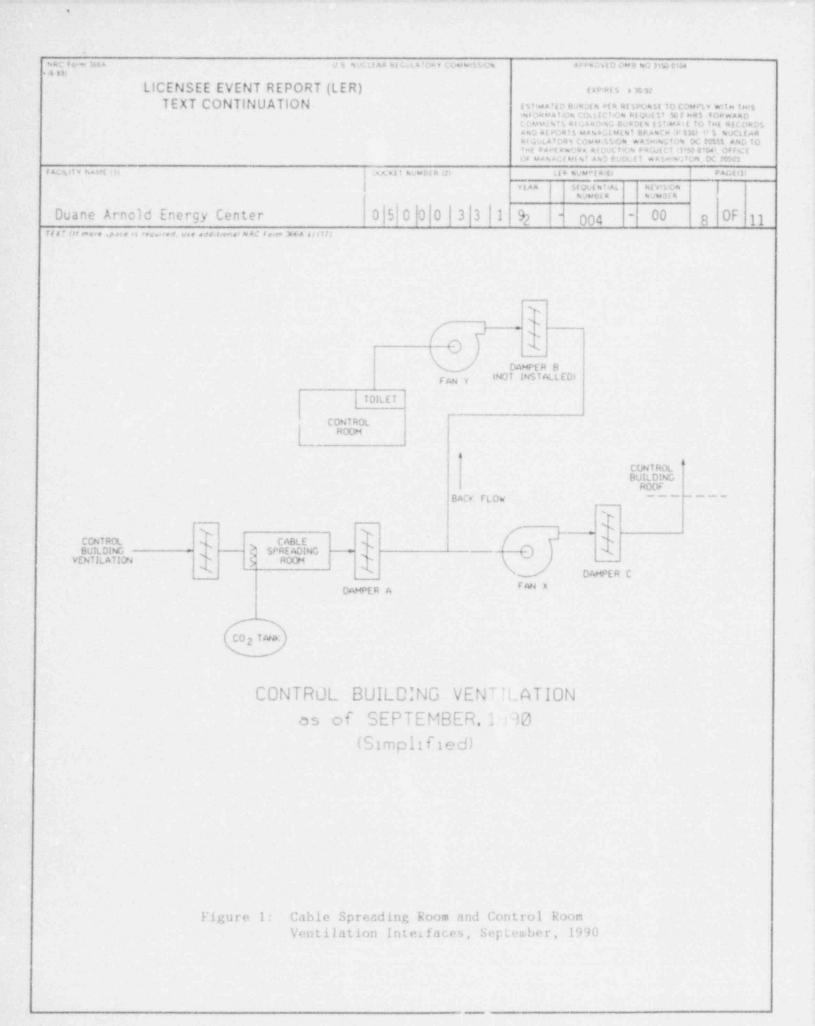
The Duane Arnold Energy Center completed installation of the carbon dioxide fire suppression system or the Cable Spreading Room in 1974. At that time, during pre-operational testing, CO2 leakage into the Control Room was first detected. Overpressurization of the Cable Spreading Room during the CARDOX initiation was thought to be the cause, and modifications were performed to provide a pathway to relieve this excess pressure. An additional fire damper was installed and designed to close only if high temperatures indicative of an actual fire were detected (>360F) (See Figure 1, Damper A).

Further review after the September, 1990 event determined that a backdraft damper, designed to prevent a ventilation path from the CSR to the toilet area of the Control Room, was not installed as indicated on design drawings. (See Figure 1, Damper B). Its presence was assumed for the 1980 NUREG 0737 review. It has not been determined why the damper was not installed. It was also determined the modification made in 1974 to increase the CSR vent path and reduce the atmospheric pressure in the room had been rendered insifective by a damper and fan further along in the ducting, which on a CARDOX initiation would close, and shut off, respectively. (See Figure 1, Damper C and Fan X). The increase in the atmospheric pressure of the CSR during CO2 injection therefore would be higher than desired, which in turn could lead to higher flow rates into the Control Room via the toilet exhaust ventilation, and leakage of the penetration seals between the CS<sup>2</sup> and the Control Room.
